## Item #14889390 - 2017 Genie S45 4WD Diesel Telescopic Boom Lift

# Inspection Report

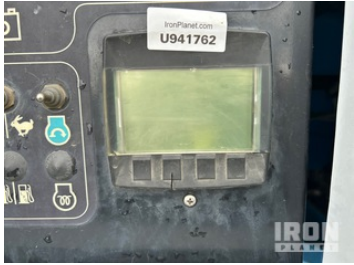
Control Station Ground		
Item	Assessment	Photo
Gauges	Display does not function gauges are inoperable

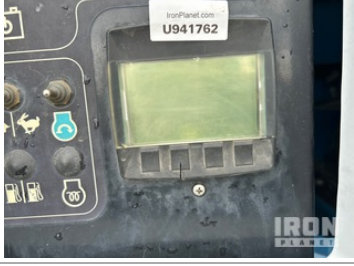
Oil Pressure	Gauge inoperable

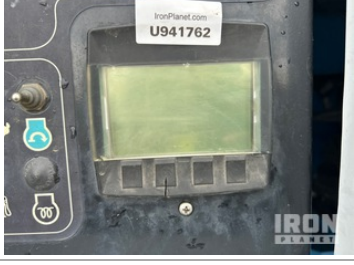
Warning Lights	Inoperable

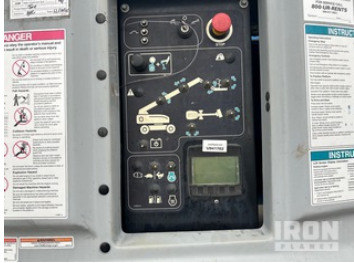
Limited Function Check	The main components are in place and operational as noted., Display screen does not function	
Control Station Ground # 1

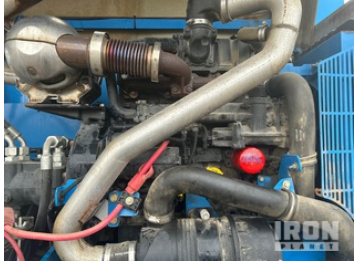
Onboard Generator	Operational, Power out outlet on lower control box no power in basket	 
Engine - Left Side

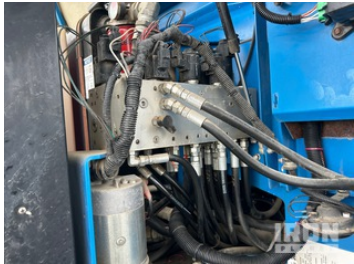
Valves	★★★☆☆ Dripping leak

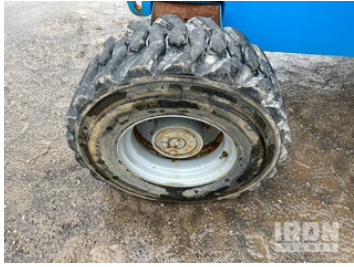
Brake System	★★★☆☆ The brake system functioned, stopping and holding the machine.	
Left Front Tire	Tears

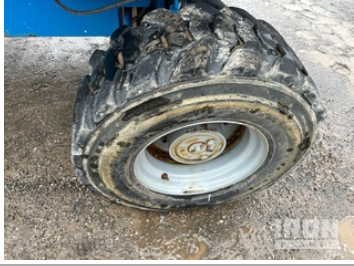
Left Rear Tire	Tears

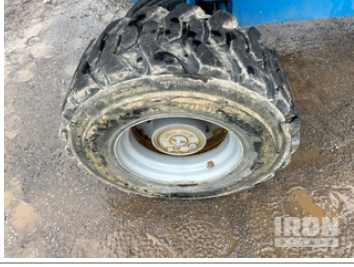
Right Rear Tire	Chunks missing, Tears

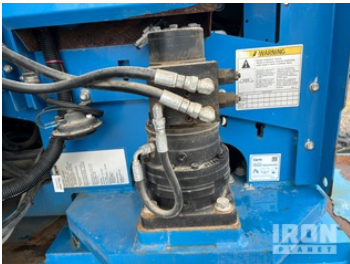
Swing Motor	★★★★☆ Dripping leak
