Item #14787252 - 2017 JLG 4069LE Electric Scissor Lift

Inspection Report

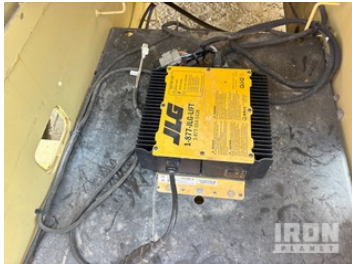
Electrical Operating System		
Item	Assessment	Photo
Operating Voltage	48 Volts	
Battery Condition	Weak or under-charged	
Cables and Connections	No visible damage or missing components

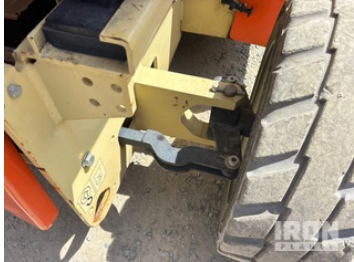
Chassis		
IronPlanet pin connection pivot point wear inspections are limited to sound, sight and feel observations. Dial indicator testing is not performed.		
Item	Assessment	Photo
Brake System	★★☆☆ The brake system functioned, stopping and holding the machine.	
Steering Linkage	★★★☆☆

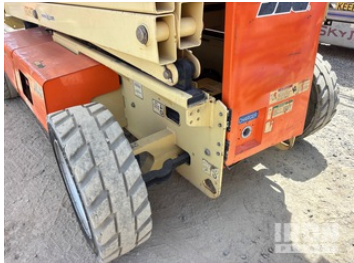
Frame Condition	★★★☆☆

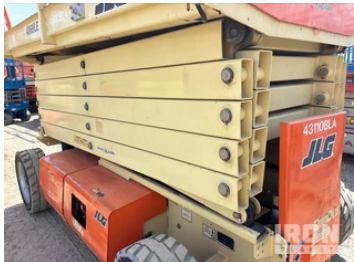
Scissor Linkage	★★★☆☆

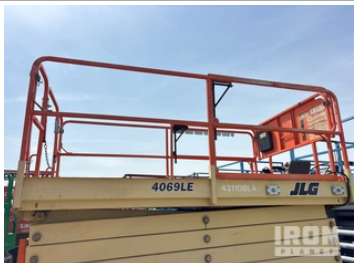
Platform Condition	★★★☆☆

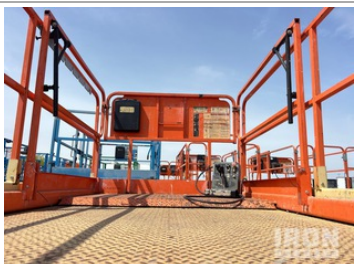
Platform Extension	★★★☆☆

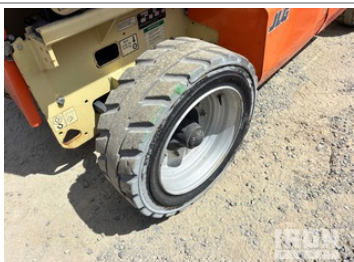
Left Front Tire	Chunks missing

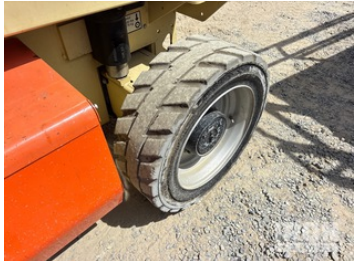
Left Rear Tire	Chunks missing

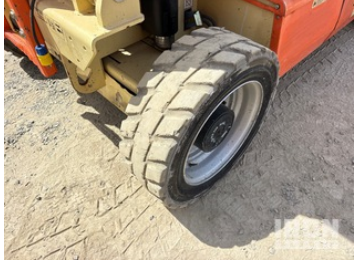
Right Rear Tire	Chunks missing

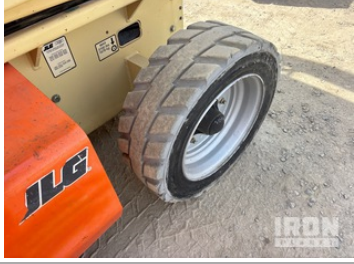
Right Front Tire	Chunks missing
