## Item #14825730 - 2015 Genie GS3232 Electric Scissor Lift

# Inspection Report

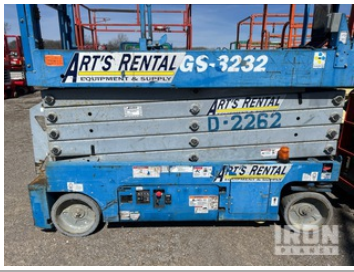
Paint	No visible damage

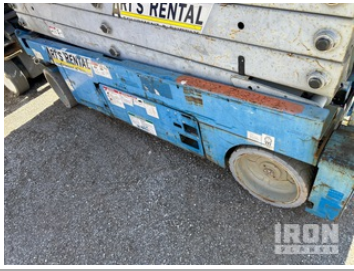
Body Panels	No visible damage or missing components

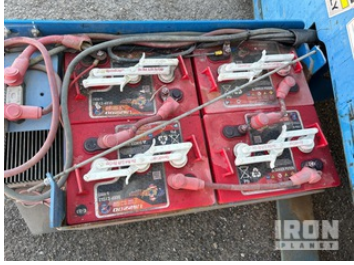
<b>Electrical Operating System</b>		
<b>Item</b>	<b>Assessment</b>	<b>Photo</b>
Operating Voltage	24 Volts	
Battery Condition	Functioned during the inspection, Weak or under-charged	
Cables and Connections	No visible damage or missing components

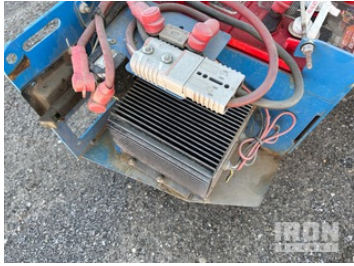
Battery Charger	Included Appears normal - Not operationally checked, 120 Volt, Single Phase

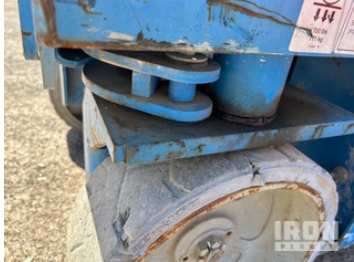
<b>Chassis</b>		
IronPlanet pin connection pivot point wear inspections are limited to sound, sight and feel observations. Dial indicator testing is not performed.		
<b>Item</b>	<b>Assessment</b>	<b>Photo</b>
Brake System	★★☆☆ The brake system functioned, stopping and holding the machine.	
Steering Linkage	★★☆☆

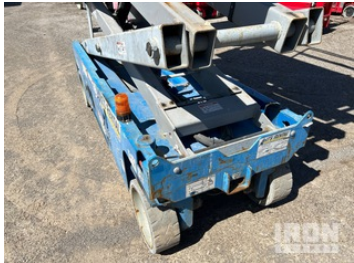
Frame Condition	★★☆☆

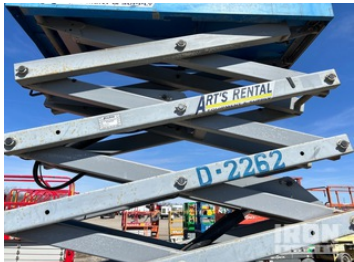
Scissor Linkage	★★☆☆

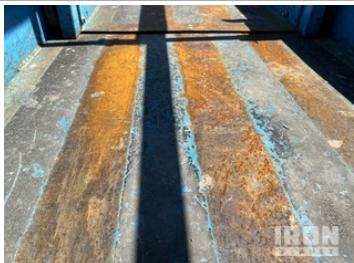
Platform Condition	★★☆☆

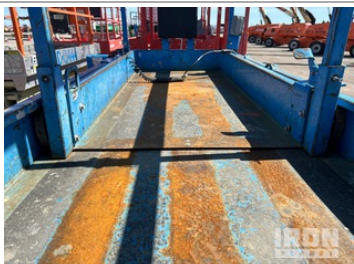
Platform Extension	★★☆☆

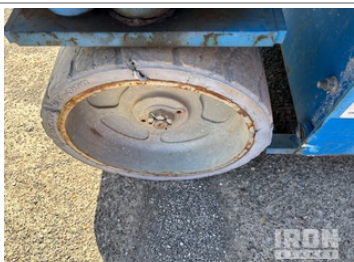
Left Front Tire	Chunks missing, Tears

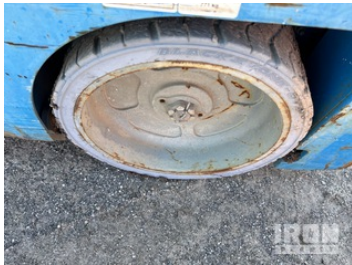
Left Rear Tire	Chunks missing, Tears

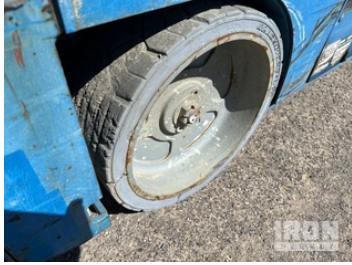
Right Rear Tire	Chunks missing, Tears

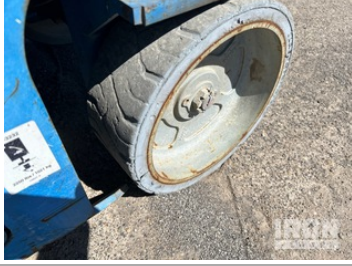
Right Front Tire	Chunks missing, Tears

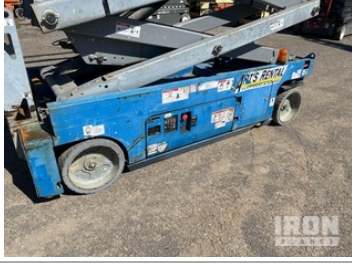
Wheel Condition	No visible damage or missing components
