Item #14825732 - 2015 Genie GS3232 Electric Scissor Lift

Inspection Report

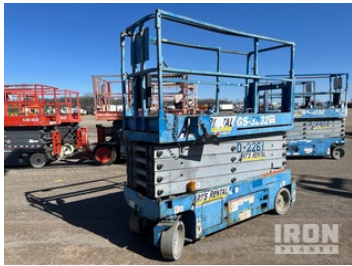
General Appearance		
Item	Assessment	Photo
Picture, Left Front Corner

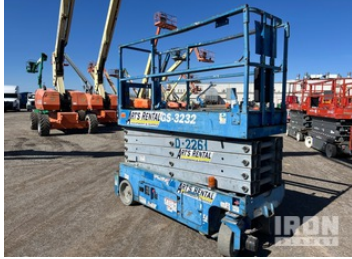
Picture, Right Front Corner

Serial Number / VIN	GS3215A-141552	 
Hour Meter / Odometer	305 hrs	 
Paint	No visible damage	 
Body Panels	No visible damage or missing components	 
Steps/Ladders		 
Basket / Safety Railing	Right railing bent	
General Appearance #1		 
General Appearance #2

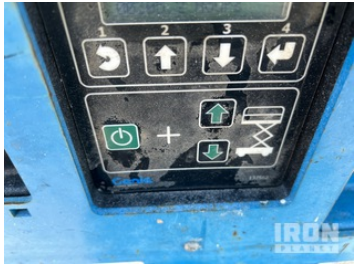
Function Controls	★★★★☆

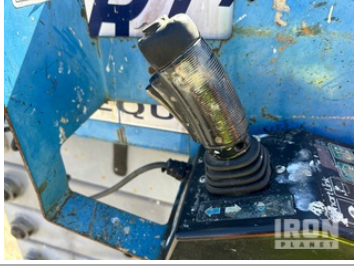
Safety Control Hand/Foot Switch	★★★★☆ Operational

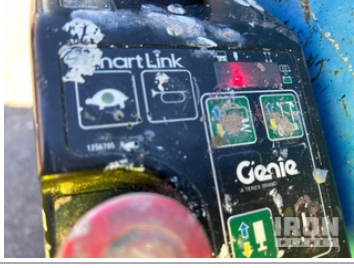
Upper Function Controls	★★★★☆

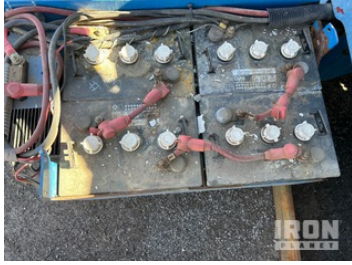
Electrical Operating System		
Item	Assessment	Photo
Operating Voltage	24 Volts	
Battery Condition	Functioned during the inspection, Weak or under-charged	
Cables and Connections	No visible damage or missing components

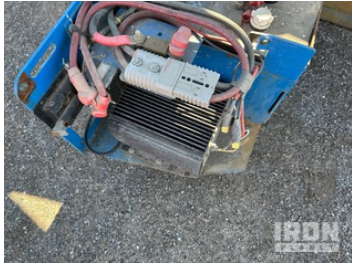
Battery Charger	Included Appears normal - Not operationally checked, 120 Volt, Single Phase

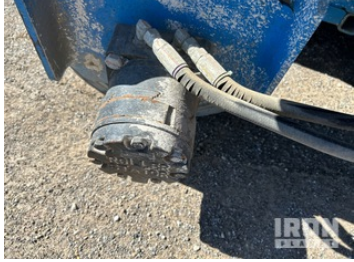
Item	Assessment	Photo
Drive Motors	★★★☆☆

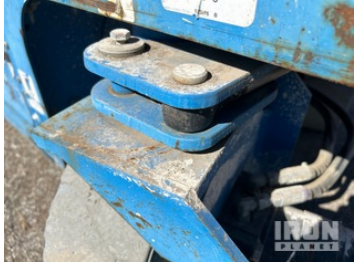
Chassis		
IronPlanet pin connection pivot point wear inspections are limited to sound, sight and feel observations. Dial indicator testing is not performed.		
Item	Assessment	Photo
Brake System	★★☆☆ The brake system functioned, stopping and holding the machine.	
Steering Linkage	★★☆☆

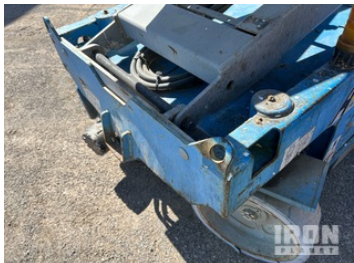
Frame Condition	★★☆☆

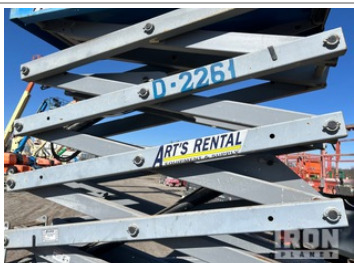
Scissor Linkage	★★☆☆

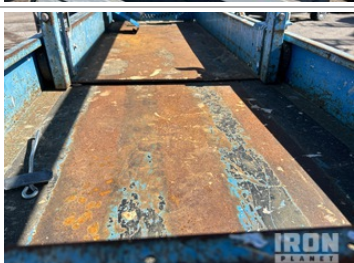
Platform Condition	★★☆☆

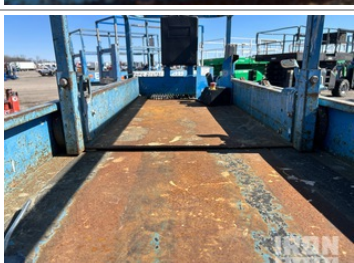
Platform Extension	★★☆☆

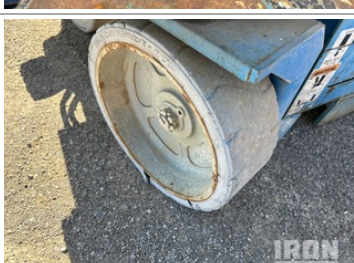
Left Front Tire	Chunks missing, Tears

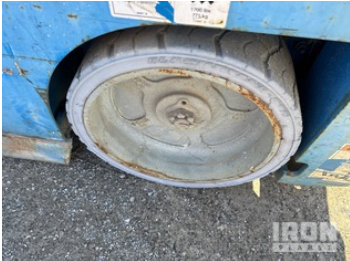
Left Rear Tire	Chunks missing, Tears

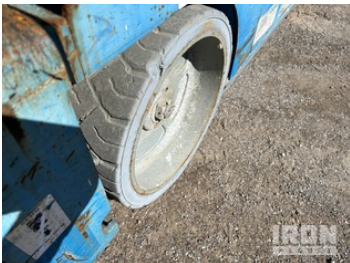
Right Rear Tire	Chunks missing, Tears

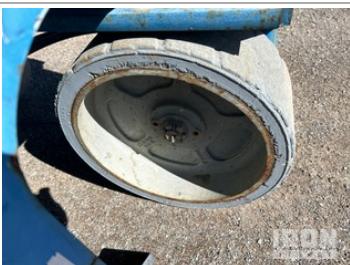
Right Front Tire	Chunks missing, Tears

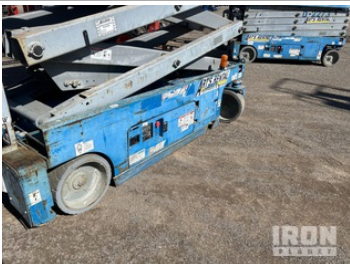
Wheel Condition	No visible damage or missing components

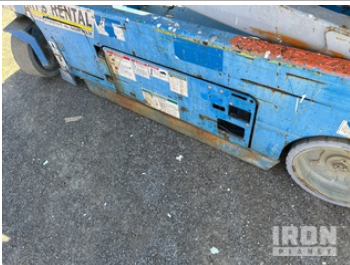
Wheel Studs	★★★★☆	
Pothole Protection Bars	★★★★☆ Functional
