Item #14825748 - 2017 Skyjack SJ 3226 Electric Scissor Lift

Inspection Report

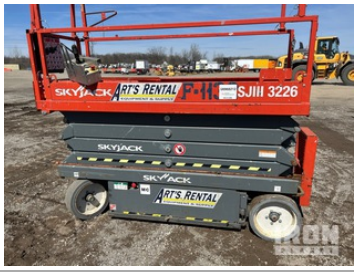
<p>Paint</p>	<p>No visible damage</p>

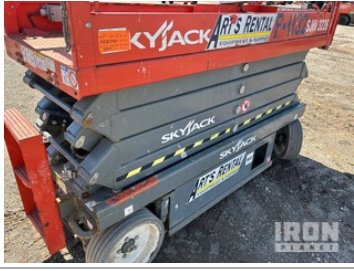
<p>Body Panels</p>	<p>No visible damage or missing components</p>

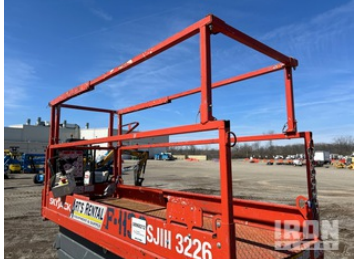
<p>Basket / Safety Railing</p>	<p>No visible damage or missing components</p>	
<p>General Appearance #1</p>

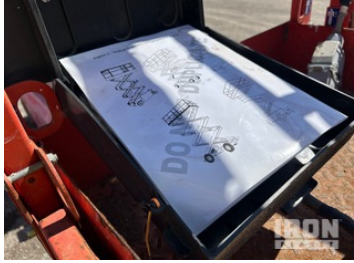
Safety		
Item	Assessment	Photo
Travel Alarm	Operational	
Horn	Inoperable	
Current Safety Manual	Yes	
Current Operator/Maintenance Manual	Yes	
ANSI Guidelines	Yes

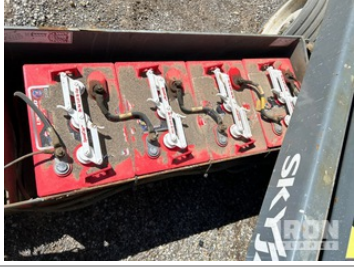
Electrical Operating System		
Item	Assessment	Photo
Operating Voltage	24 Volts	
Battery Condition	Functioned during the inspection, Weak or under-charged	
Cables and Connections	No visible damage or missing components

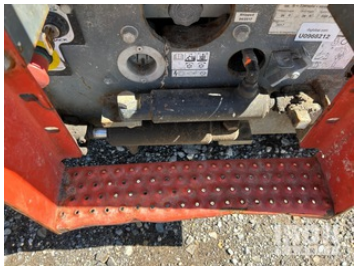
Chassis		
IronPlanet pin connection pivot point wear inspections are limited to sound, sight and feel observations. Dial indicator testing is not performed.		
Item	Assessment	Photo
Brake System	★★☆☆ The brake system functioned, stopping and holding the machine.

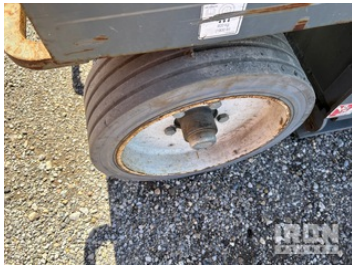
Left Front Tire	Chunks missing

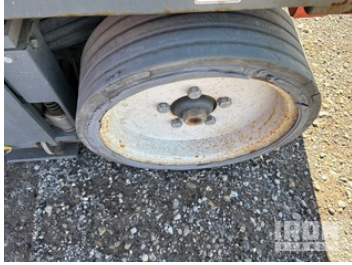
Left Rear Tire	Chunks missing, Tears

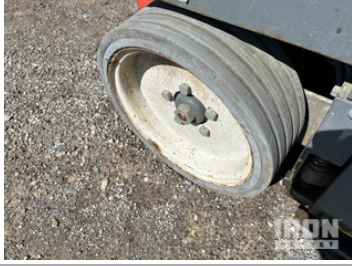
Right Rear Tire	Tears

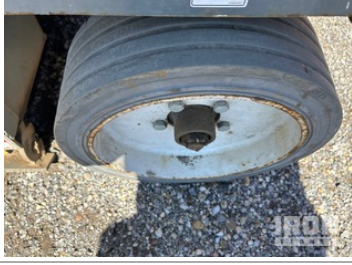
Right Front Tire	Tears

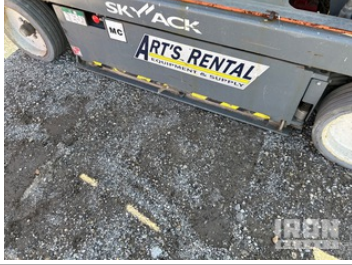
Wheel Condition	Right rear bent	 
Wheel Studs	★★★★☆	
Pothole Protection Bars	★★★★☆ Functional
