Item #14825733 - 2015 Genie GS3232 Electric Scissor Lift

Inspection Report

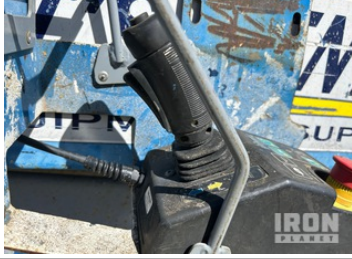
Safety Control Hand/Foot Switch	★★☆☆ Operational

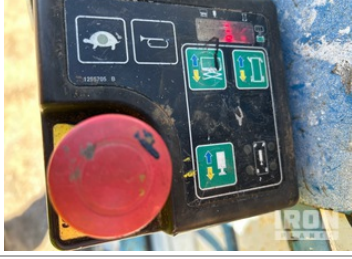
Upper Function Controls	★★☆☆

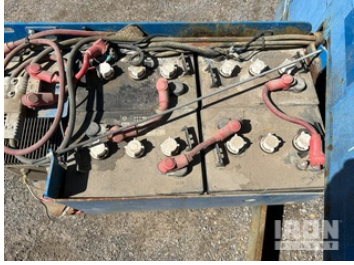
Electrical Operating System		
Item	Assessment	Photo
Operating Voltage	24 Volts	
Battery Condition	Functioned during the inspection, Weak or under-charged	
Cables and Connections	No visible damage or missing components

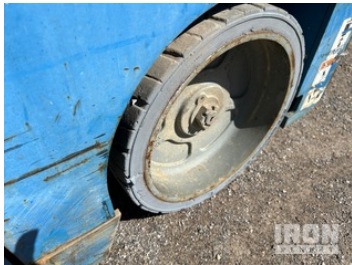
Left Rear Tire	Chunks missing, Tears

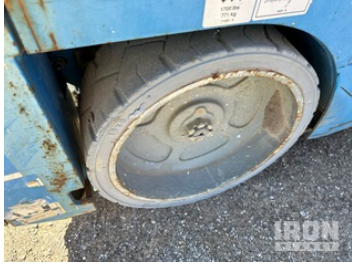
Right Rear Tire	Chunks missing, Tears

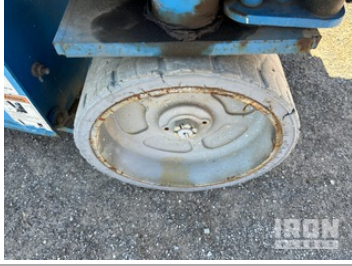
Right Front Tire	Chunks missing, Tears

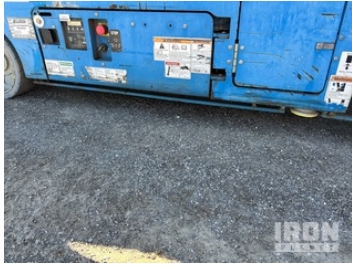
Wheel Studs	★★★★☆	
Pothole Protection Bars	★★★☆☆ Right side does not function
