Item #14787186 - 2017 Skyjack SJ85AJ 4WD Diesel Articulating Boom Lift

Inspection Report

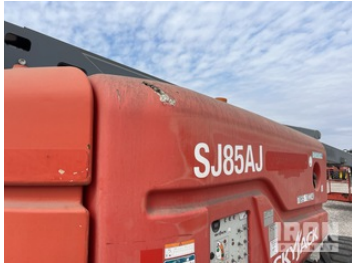
Body Panels	Hydraulic compartment door damaged, Metal damage on front and rear covers.

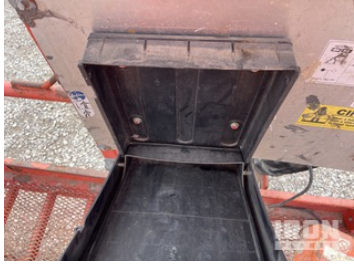
Safety		
Item	Assessment	Photo
Travel Alarm	Inoperable	
Horn	Operational	
Swing Brake	Operational	
Current Safety Manual	No	
Current Operator/Maintenance Manual	No	
ANSI Guidelines	No	
Safety #1

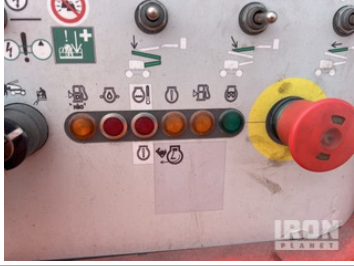
Oil Pressure	Warning light inoperable

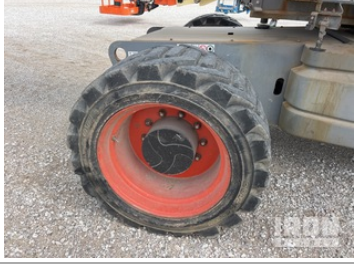
Left Front Tire	Cracks, Chunks missing

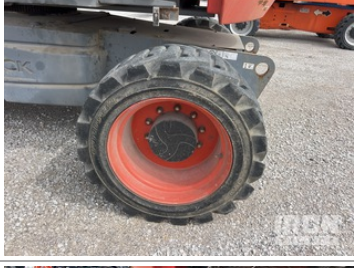
Left Rear Tire	Cracks, Chunks missing

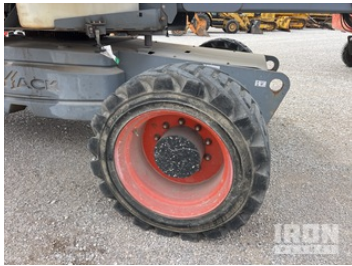
Right Front Tire	Cracks, Chunks missing
