Item #14787003 - 2017 JLG 600S 4WD Diesel Telescopic Boom Lift

Inspection Report

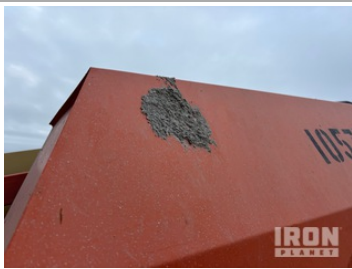
Paint	Concrete residue

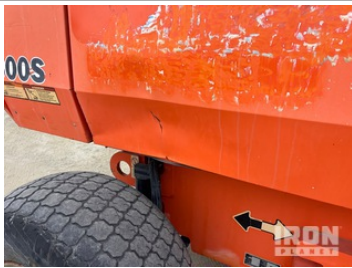
Body Panels	Engine compartment door damaged, Hydraulic compartment door damaged

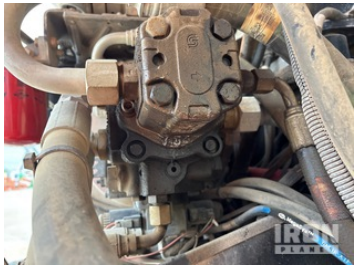
Hydraulics		
See photos for condition		
Item	Assessment	Photo
Pumps (Hydraulics)	★ ★ ☆ ☆ Dripping leak

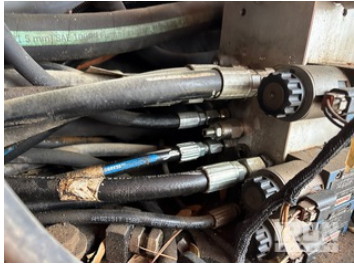
Hoses (Hydraulic)	★ ★ ★ ☆ Seeping hoses connected to valve body

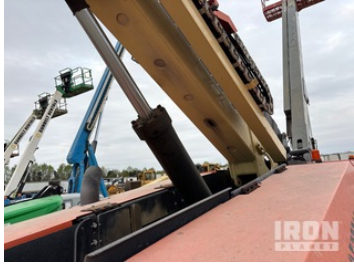
Boom Lift Cylinder	★ ★ ☆ ☆ Seepage

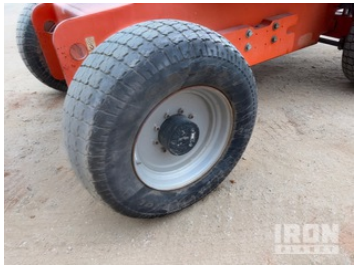
Brake System	★★★☆☆ The brake system functioned, stopping and holding the machine.	
Left Front Tire	Cracks, Chunks missing, Tears

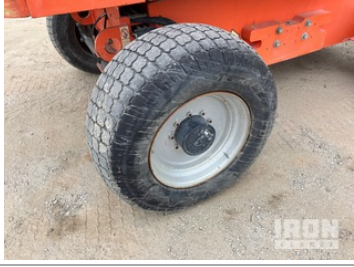
Right Rear Tire	Cracks, Chunks missing, Tears

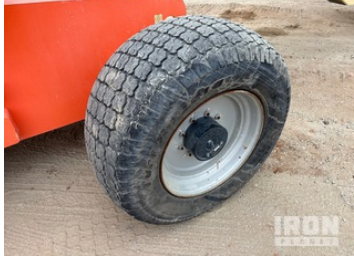
Right Front Tire	Cracks, Chunks missing, Tears

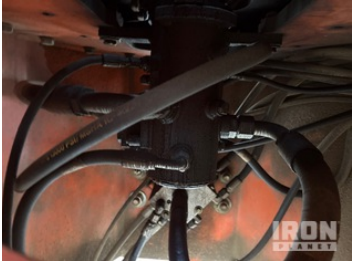
Hydraulic Center Swivel	★★☆☆☆ Dripping leak

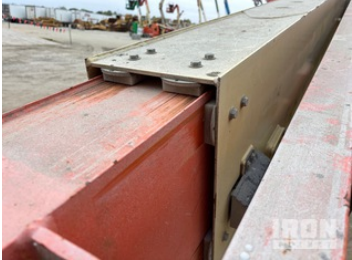
Boom Wear Guides	★★☆☆☆ Cracked guides

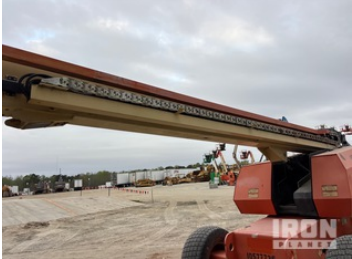
Cable Tray Ladder	Damaged pulley
