Item #14787250 - 2017 JLG 4069LE Electric Scissor Lift

Inspection Report

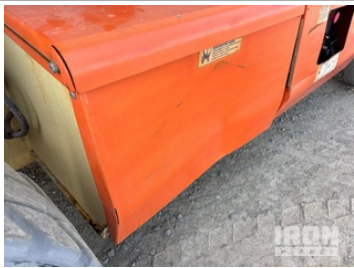
<p>Body Panels</p>	<p>Battery compartment door damaged, Battery charger door damaged</p>

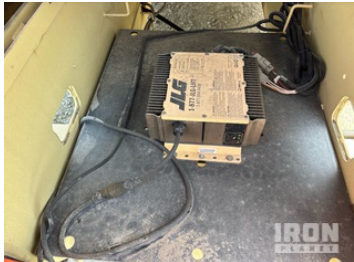
Battery Charger	Included Appears normal - Not operationally checked, Damaged cord, 110 Volt, Single Phase Plug damaged

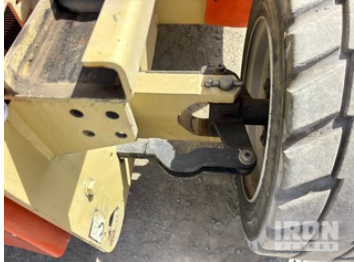
Chassis		
IronPlanet pin connection pivot point wear inspections are limited to sound, sight and feel observations. Dial indicator testing is not performed.		
Item	Assessment	Photo
Brake System	★★☆☆ The brake system functioned, stopping and holding the machine.	
Steering Linkage	★★☆☆

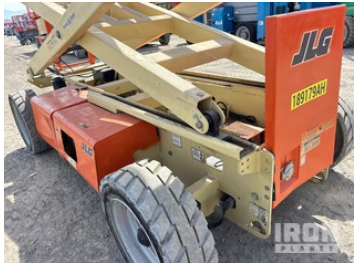
Frame Condition	★★☆☆

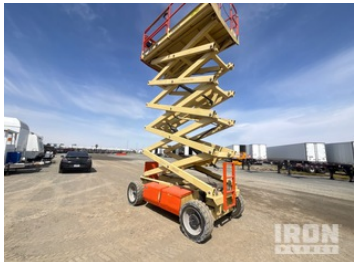
Scissor Linkage	★★☆☆

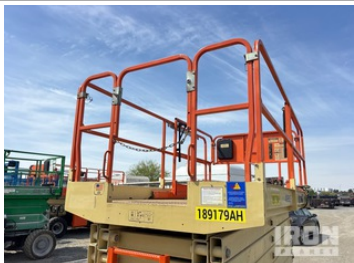
Platform Condition	★★☆☆

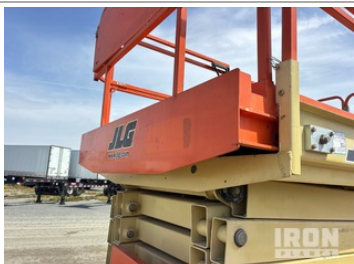
Platform Extension	★★☆☆

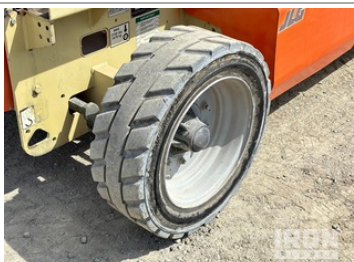
Left Front Tire	Cracks, Chunks missing

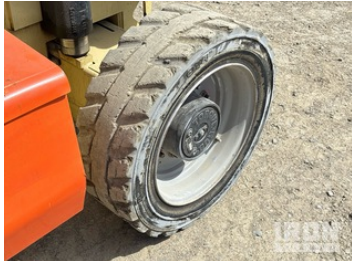
Left Rear Tire	Cracks, Chunks missing

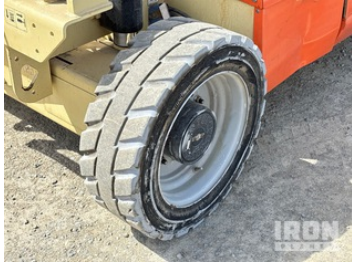
Right Rear Tire	Cracks

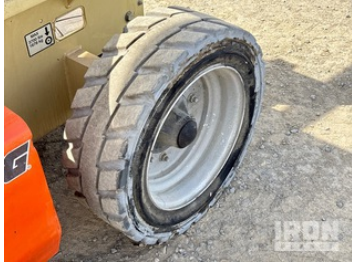
Right Front Tire	Cracks
