Item #14855878 - 2017 JLG 460SJ 4WD Diesel Telescopic Boom Lift

Inspection Report

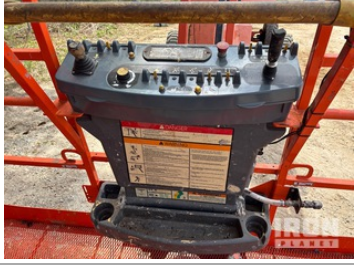
| Control Station | | |
|---|--|--|
| Control Console | No visible damage or missing components | |

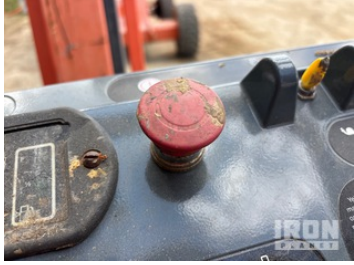
| Control Station | | |
|---|--|--|
| Emergency Shut Off Switch | Operational | |

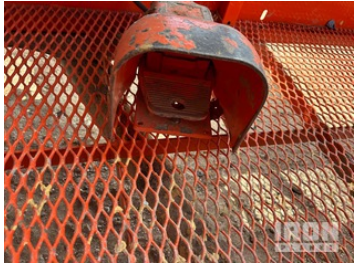
| Control Station | | |
|---|--|--|
| Safety Control Hand/Foot Switch | ★★★★☆ Operational | |

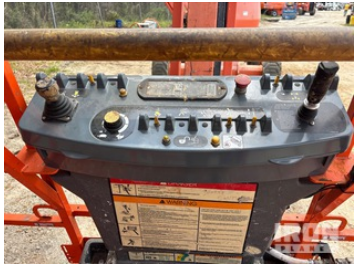
| Control Station | | |
|---|--|--|
| Function Controls | ★★★★☆ | |

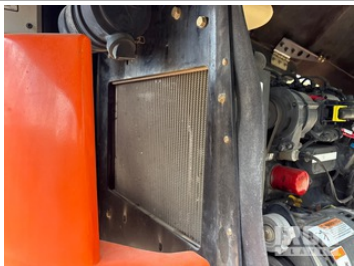
| Engine | | |
|---|---|--|
| Radiator | ★★★★☆ | |

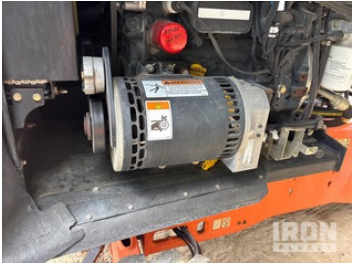
| Onboard Generator | Not operationally checked | |

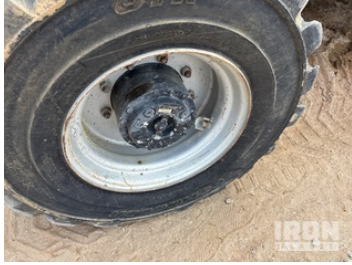
| Drivetrain | | |
|--|---|--|
| Left Front Final Drive | ★★★★☆ | |

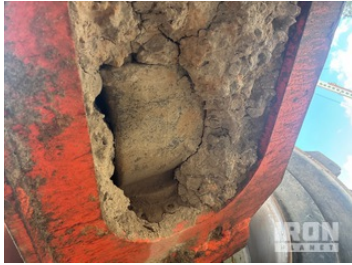
| Drivetrain | | |
|--|---|--|
| Left Front Drive Motor | ★★★★☆ | |

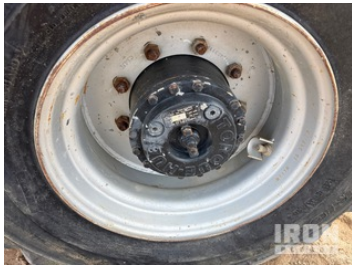
| Drivetrain | | |
|--|---|--|
| Left Rear Final Drive | ★★★★☆ | |

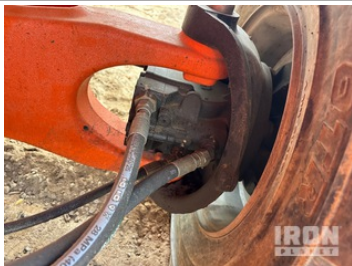
| Drivetrain | | |
|--|---|--|
| Left Rear Drive Motor | ★★★★☆ | |

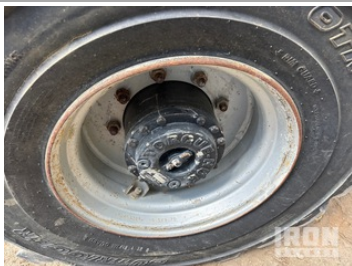
| Drivetrain | | |
|--|---|--|
| Right Rear Final Drive | ★★★★☆ | |

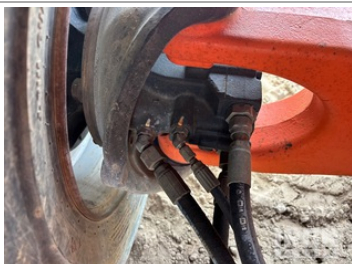
| Drivetrain | | |
|--|---|--|
| Right Rear Drive Motor | ★★★★☆ | |

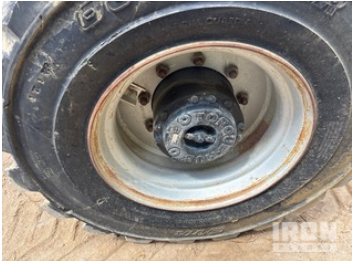
| Right Front Final Drive | ★★★★☆ | |

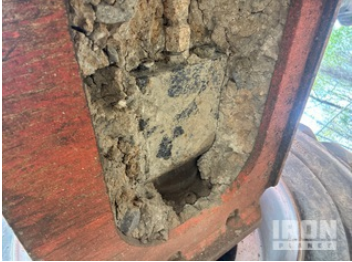
| Right Front Drive Motor | ★★★★☆ | |

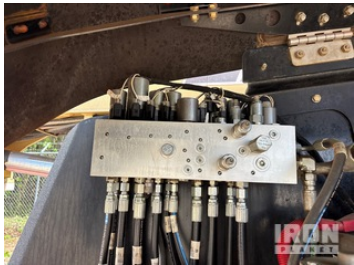
| Hydraulics | | |
|---|---|--|
| Valves | ★★★★☆ | |

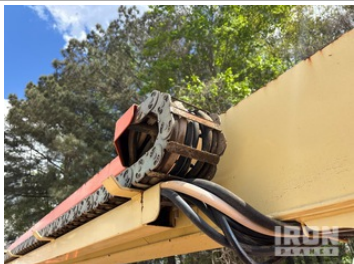
| Hydraulics | | |
|---|---|--|
| Hoses (Hydraulic) | ★★★★☆ | |

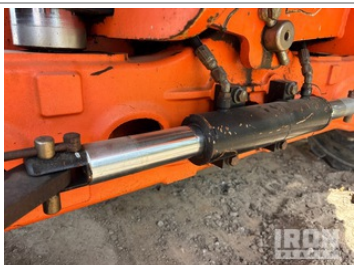
| Hydraulics | | |
|---|---|--|
| Steering Cylinders | ★★★★☆ | |

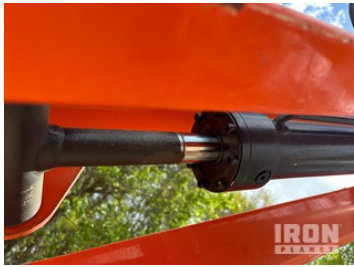
| Jib Cylinder | ★★★★☆ | |

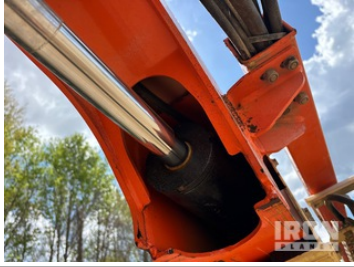
| Basket Tilt Cylinder | ★★★★☆ | |

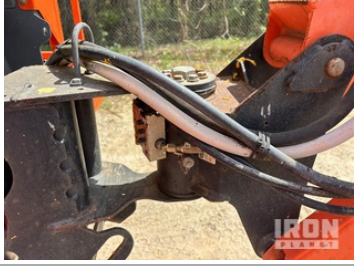
| Basket Rotator Motor | ★★★★☆ | |

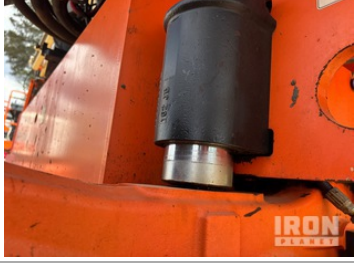
| Frame Leveling Cylinders | ★★★★☆ | |

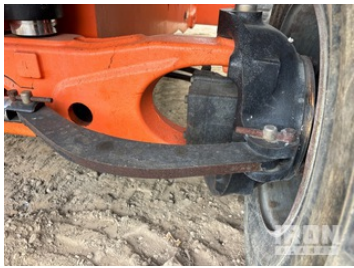
| Chassis | | |
|--|---|--|
| Steering Linkage | ★★★☆☆ | |

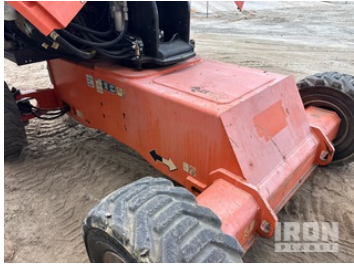
| Chassis | | |
|--|---|--|
| Frame Condition | ★★★☆☆ | |

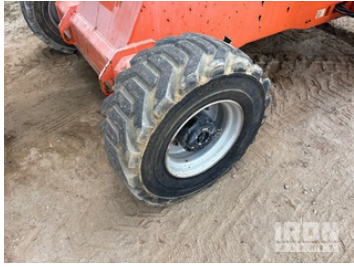
| Chassis | | |
|--|---|--|
| Left Front Tire | Cracks, Chunks missing, Tears | |

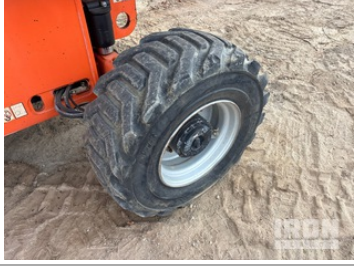
| Chassis | | |
|--|---|--|
| Left Rear Tire | Cracks, Chunks missing, Tears | |

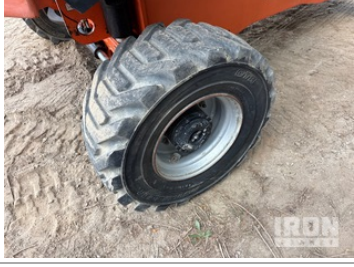
| Chassis | | |
|--|---|--|
| Right Rear Tire | Cracks, Chunks missing, Tears | |

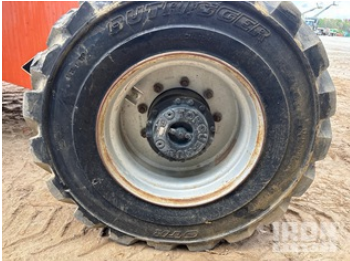
| Wheel Condition | No visible damage or missing components | |

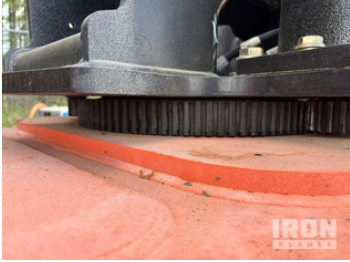
| Turntable Bearing | ★★★★☆ | |

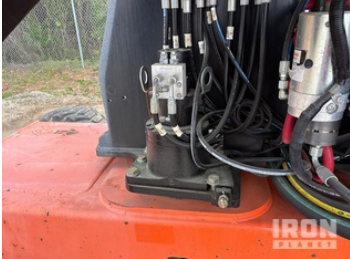
| Swing Motor | ★★★★☆ | |

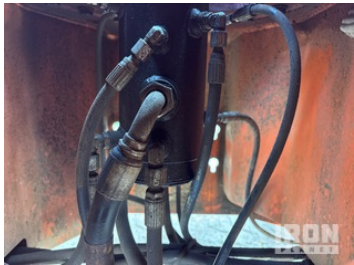
| Hydraulic Center Swivel | ★★★★☆ | |

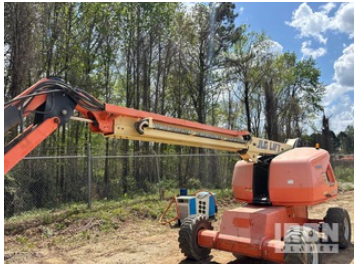
| Boom Condition | ★★★★☆ | |

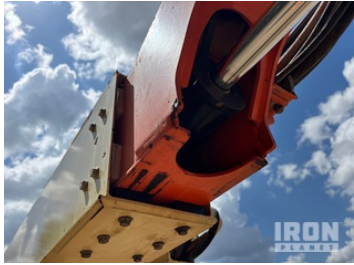
| Boom Wear Guides | ★★★★☆ | |

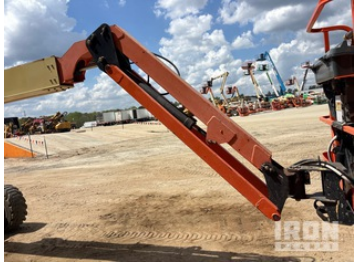
| Jib Condition | ★★★★☆ | |
