Item #15029341 - 2019 JLG 4069LE Electric Scissor Lift

Inspection Report

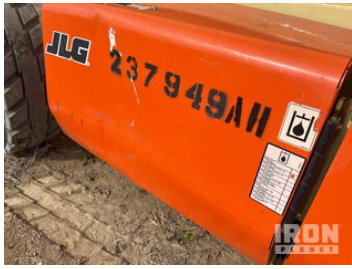
<p>Body Panels</p>	<p>Hydraulic compartment door damaged</p>

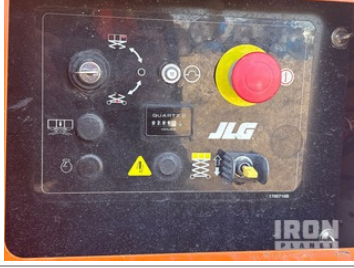
Function Controls	★★★★☆

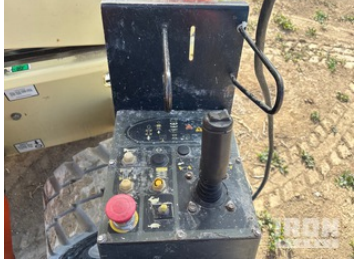
Item	Assessment	Photo
Control Console	Material buildup

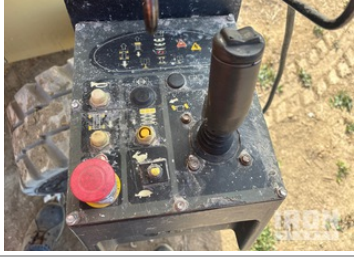
Upper Function Controls	★★☆☆

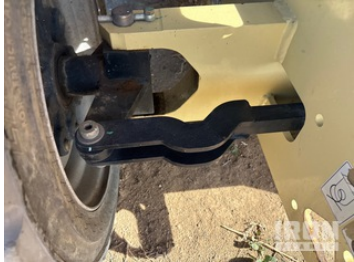
Chassis		
IronPlanet pin connection pivot point wear inspections are limited to sound, sight and feel observations. Dial indicator testing is not performed.		
Item	Assessment	Photo
Brake System	★★☆☆ The brake system functioned, stopping and holding the machine.	
Steering Linkage	★★☆☆

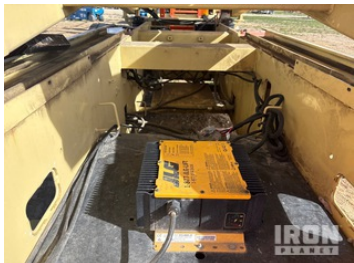
Frame Condition	★★☆☆

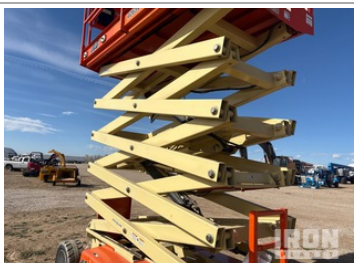
Scissor Linkage	★★☆☆

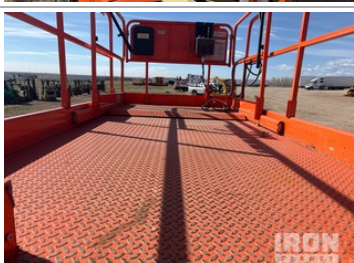
Platform Condition	★★☆☆

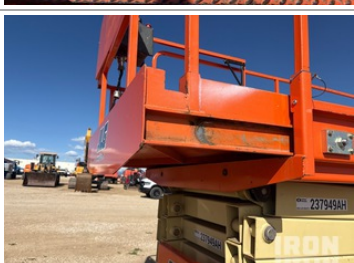
Platform Extension	★★☆☆

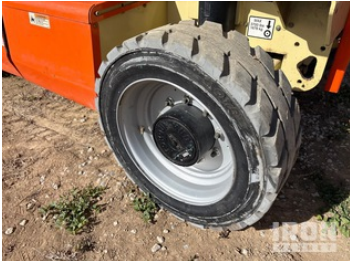
Left Rear Tire	Cracks

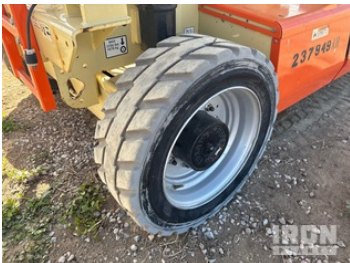
Right Rear Tire	Cracks, Tears

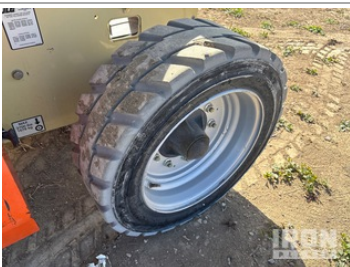
Right Front Tire	Cracks
