## Item #14787279 - 2019 JLG 4069LE Electric Scissor Lift

# Inspection Report

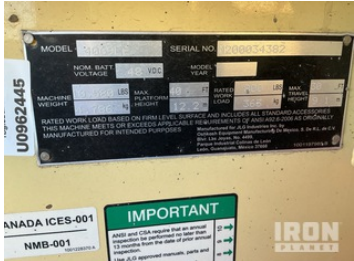
Serial Number / VIN	M200034382

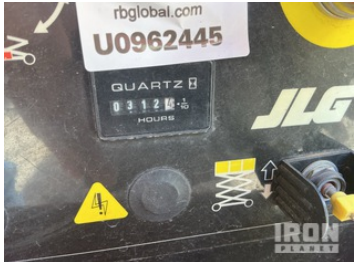
CE Mark	No CE mark found	
Hour Meter / Odometer	312 hrs

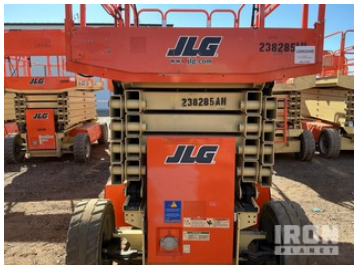
Paint	No visible damage

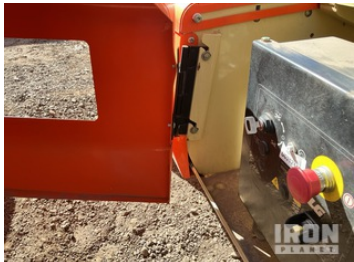
Body Panels	Ground control station door bent

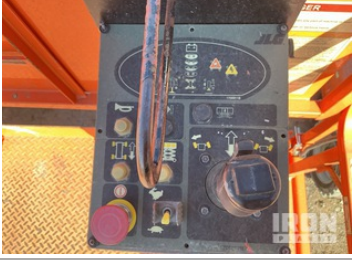
Upper Function Controls	★★★★☆

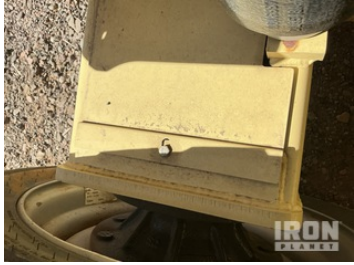
<b>Drivetrain</b>		
Operational test is limited to low speed in a confined flat area without load. Differential interlocks, full transmission shifting and functionality of all drive axles cannot be fully verified. Inspector listens for abnormal noises, observes leaks and notes physical damage.		
<b>Item</b>	<b>Assessment</b>	<b>Photo</b>
Drive Motors	★ ★ ★ ☆

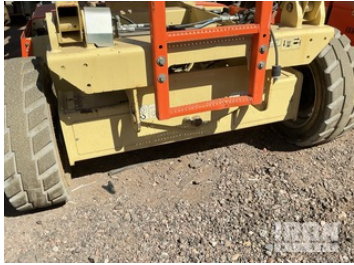
Rear Drive Axle	★ ★ ★ ☆

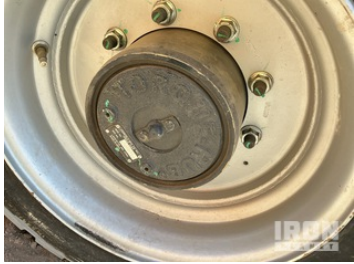
Final Drives	★ ★ ★ ☆

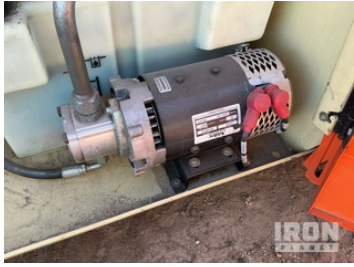
Hydraulics		
Item	Assessment	Photo
Pumps (Hydraulics)	★★★★☆

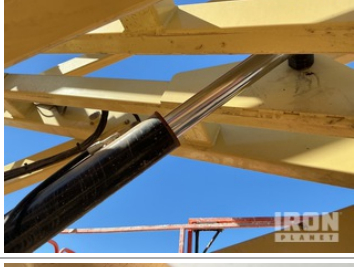
Lift Cylinders	★★★★☆

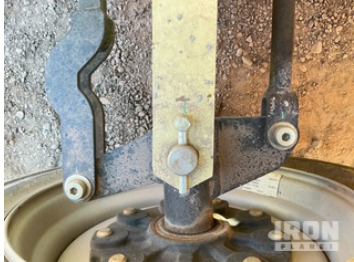
<b>Chassis</b>		
IronPlanet pin connection pivot point wear inspections are limited to sound, sight and feel observations. Dial indicator testing is not performed.		
<b>Item</b>	<b>Assessment</b>	<b>Photo</b>
Brake System	★★☆☆ The brake system functioned, stopping and holding the machine.	
Steering Linkage	★★☆☆

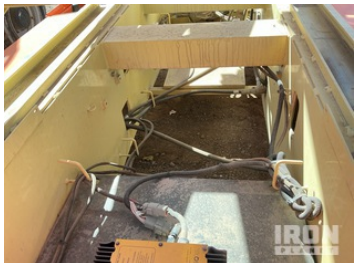
Frame Condition	★★☆☆

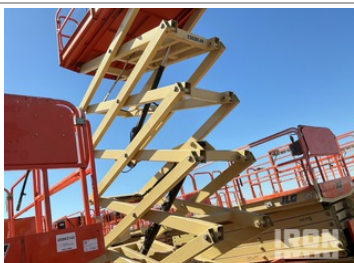
Scissor Linkage	★★☆☆

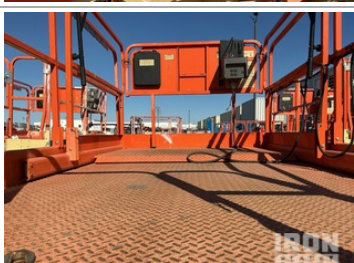
Platform Condition	★★☆☆

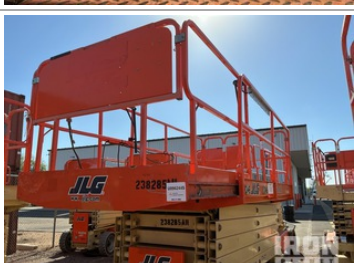
Platform Extension	★★☆☆
