## Item #14787253 - 2018 JLG 4069LE Electric Scissor Lift

# Inspection Report

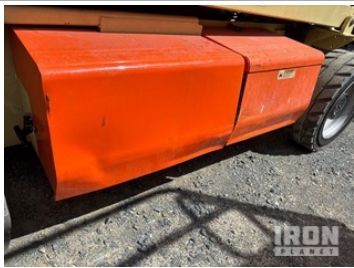
<p>Body Panels</p>	<p>Battery compartment door damaged, Hydraulic compartment door damaged</p>

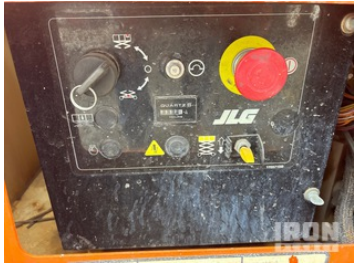
<b>Control Station Ground</b>		
<b>Item</b>	<b>Assessment</b>	<b>Photo</b>
Function Controls	★ ★ ★ ☆

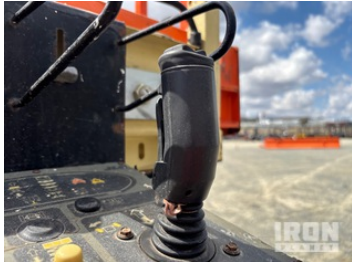
Safety Control Hand/Foot Switch	★★☆☆ Operational

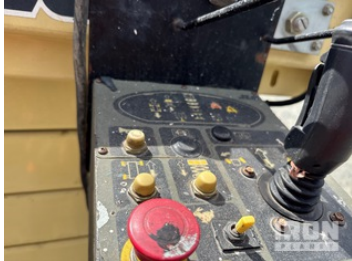
Upper Function Controls	★★☆☆

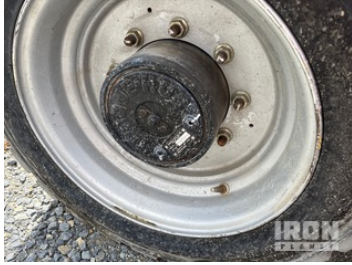
Item	Assessment	Photo
Drive Motors	★★★☆☆

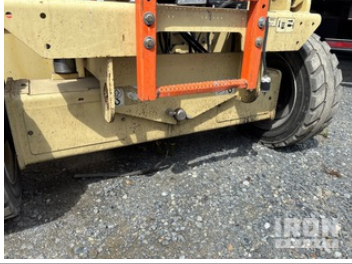
Rear Drive Axle	★★★☆☆
