Item #14787255 - 2018 JLG 4069LE Electric Scissor Lift

Inspection Report

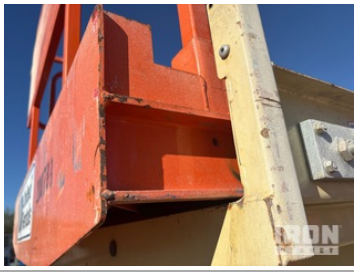
Paint	Damage

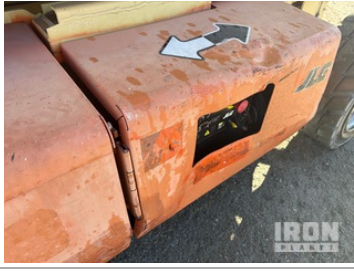
Body Panels	Engine compartment door heavy rust / corrosion, Battery compartment door heavy rust / corrosion

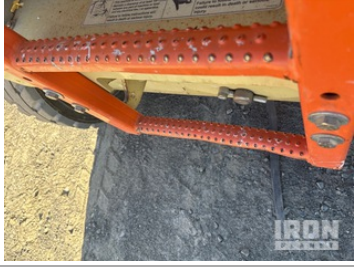
Steps/Ladders	Bottom step bent

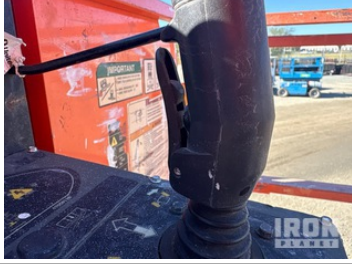
Safety Control Hand/Foot Switch	★★☆☆ Operational

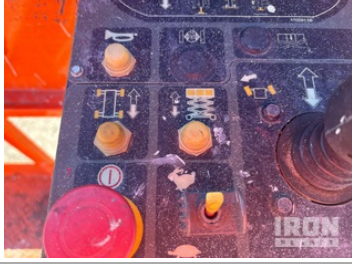
Upper Function Controls	★★☆☆

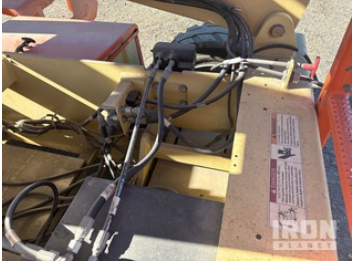
Chassis		
IronPlanet pin connection pivot point wear inspections are limited to sound, sight and feel observations. Dial indicator testing is not performed.		
Item	Assessment	Photo
Brake System	★★☆☆ The brake system functioned, stopping and holding the machine.

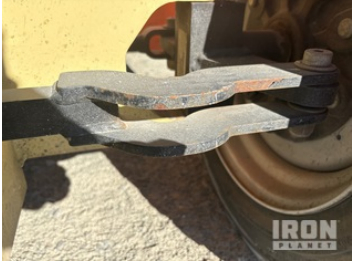
Steering Linkage	★★☆☆

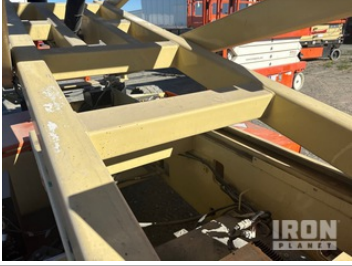
Frame Condition	★★☆☆

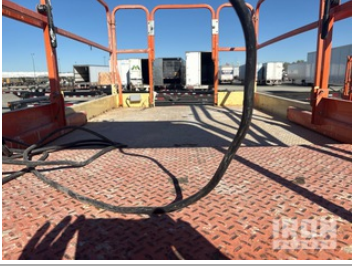
Platform Condition	★★☆☆

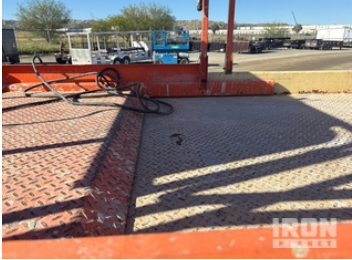
Platform Extension	★★☆☆

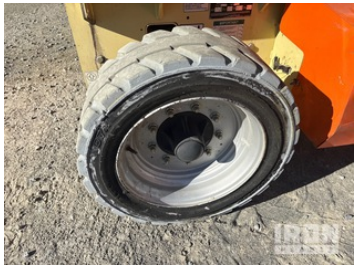
Left Front Tire	Tears

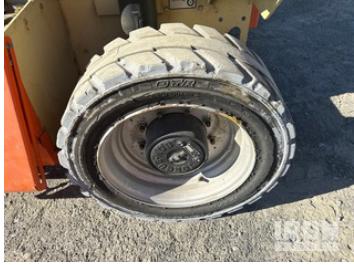
Left Rear Tire	Cracks, Chunks missing, Tears

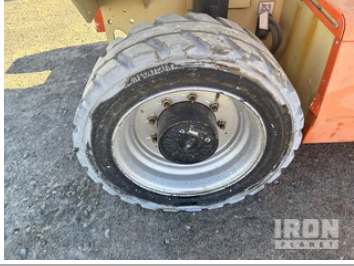
Right Rear Tire	Cracks, Chunks missing, Tears

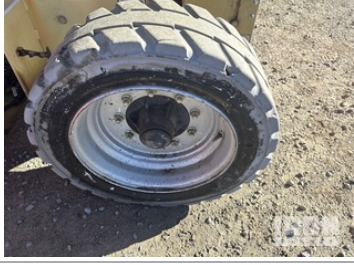
Right Front Tire	Chunks missing, Tears
