Item #14825735 - 2016 Genie GS3232 Electric Scissor Lift

Inspection Report

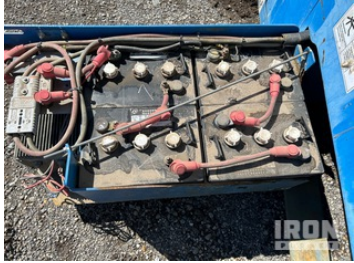
Electrical Operating System		
Item	Assessment	Photo
Operating Voltage	14 Volts	
Battery Condition	Functioned during the inspection, Weak or under-charged	
Cables and Connections	No visible damage or missing components

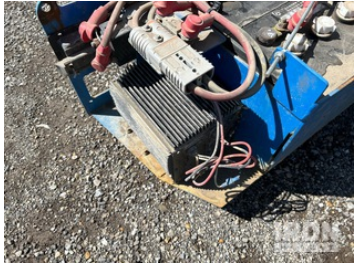
Battery Charger	Included Appears normal - Not operationally checked, 120 Volt, Single Phase

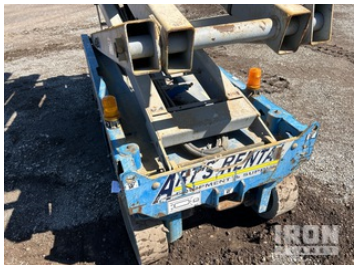
Chassis		
IronPlanet pin connection pivot point wear inspections are limited to sound, sight and feel observations. Dial indicator testing is not performed.		
Item	Assessment	Photo
Brake System	★★☆☆ The brake system functioned, stopping and holding the machine.	
Steering Linkage	★★☆☆	 
Frame Condition	★★☆☆

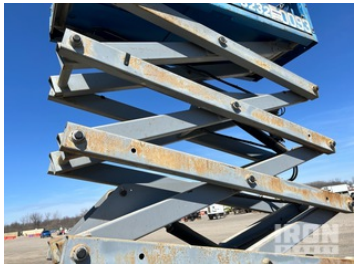
Scissor Linkage	★★☆☆

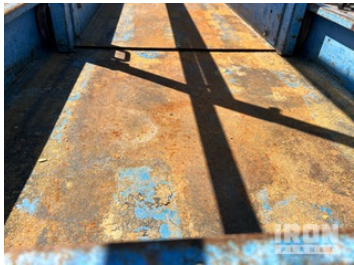
Platform Condition	★★☆☆

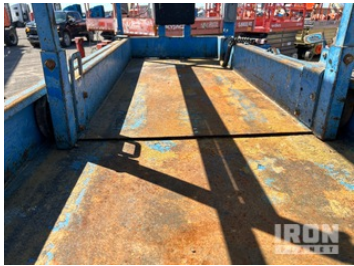
Platform Extension	★★☆☆

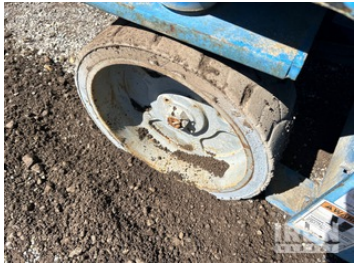
Left Front Tire	Tears

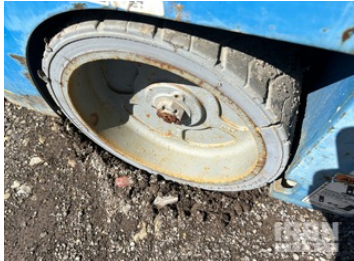
Left Rear Tire	Tears

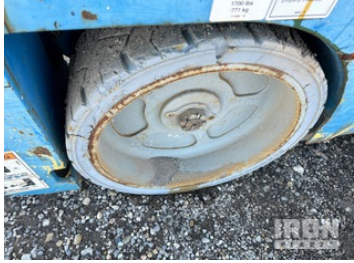
Right Rear Tire	Chunks missing, Tears

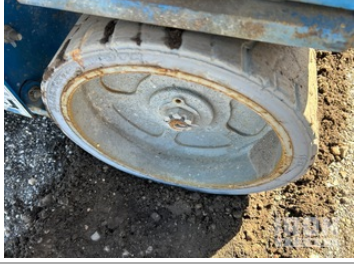
Right Front Tire	Chunks missing, Tears

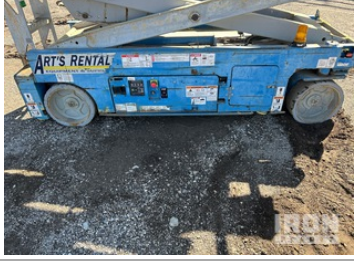
Wheel Condition	No visible damage or missing components
