Item #15111381 - 2017 Skyjack SJ45T 4WD Diesel Telescopic Boom Lift

Inspection Report

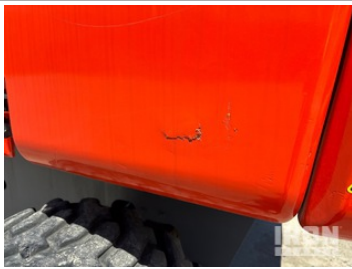
Body Panels	Engine compartment door damaged, Hydraulic compartment door damaged

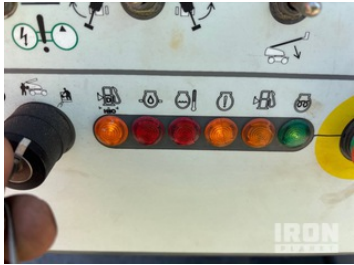
Oil Pressure	Fault indicator would not come on. Cannot verify operation.

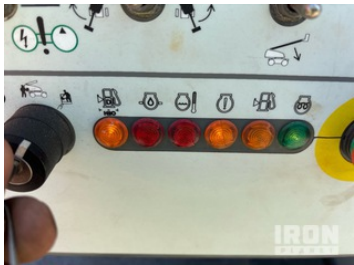
Warning Lights	Operational, Some fault indicators would not come on. Cannot verify operation.

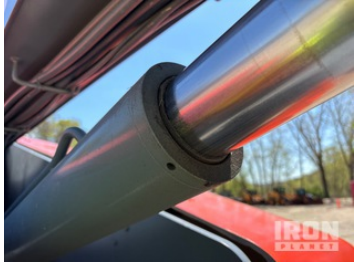
Hydraulics		
See photos for condition		
Item	Assessment	Photo
Pumps (Hydraulics)	★ ★ ☆ ☆ Dripping leak	 
Valves	★ ★ ★ ☆	 
Hydraulic Tank	★ ★ ★ ☆	 
Hoses (Hydraulic)	★ ★ ★ ☆	 
Steering Cylinders	★ ★ ★ ☆	 
Boom Lift Cylinder	★ ★ ★ ☆

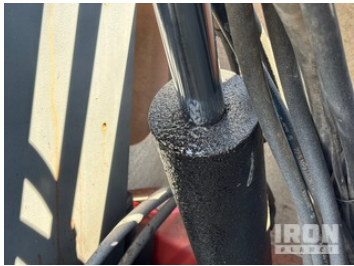
<p>Secondary Boom Cylinder</p>	<p>★★☆☆ Dripping leak</p>

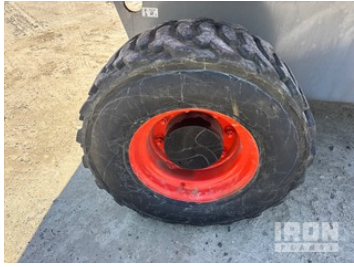
Brake System	☆☆☆☆ The brake system functioned, stopping and holding the machine.	
Left Front Tire	Chunks missing, Tears

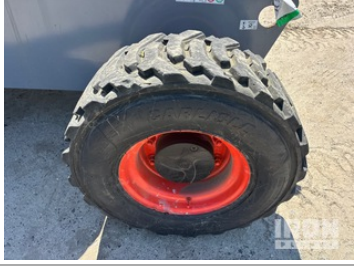
Left Rear Tire	Chunks missing, Tears

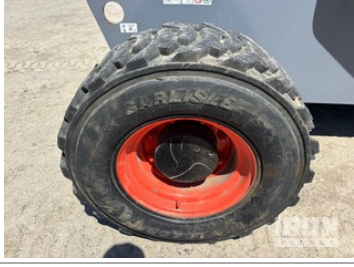
Right Rear Tire	Chunks missing, Tears
