## Item #15110976 - 2018 JLG 600S 4WD Diesel Telescopic Boom Lift

# Inspection Report

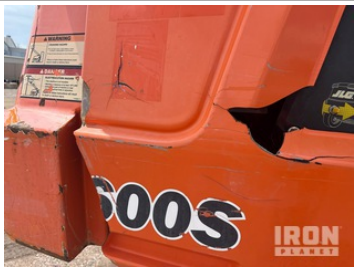
Body Panels	Engine compartment door damaged, Hydraulic compartment door damaged

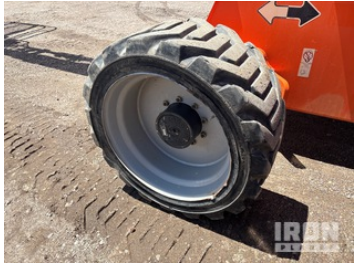
Brake System	★★★☆☆ The brake system functioned, stopping and holding the machine.	
Left Front Tire	Chunks missing

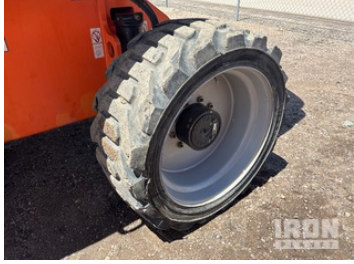
Left Rear Tire	Cracks, Chunks missing

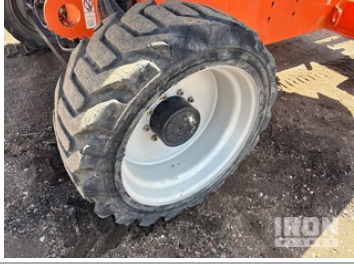
Right Rear Tire	Chunks missing
