### Item #15110212 - 2018 JLG 1043 Telehandler

# Inspection Report

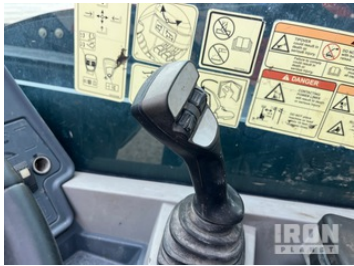
<p>Hydraulic Controls</p>	<p>★★☆☆☆ Will not return to center, Outrigger controls stick.</p>

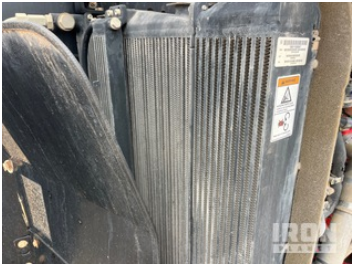
Radiator	★★★★☆

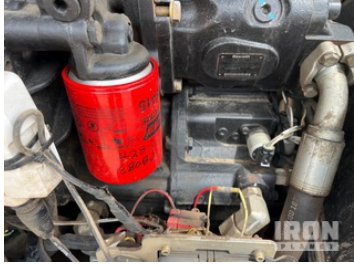
<b>Drivetrain</b>		
Operational test is limited to low speed in a confined flat area without load. Differential interlocks, full transmission shifting and functionality of all drive axles cannot be fully verified. Inspector listens for abnormal noises, observes leaks and notes physical damage.		
<b>Item</b>	<b>Assessment</b>	<b>Photo</b>
Transmission	★★☆☆ Operational

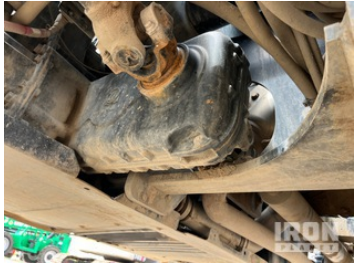
Transfer Case / Drop Box	★★☆☆ Operational

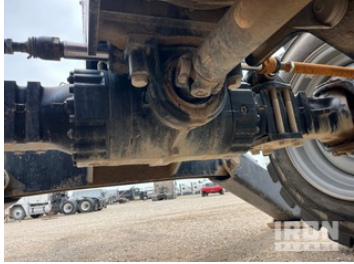
Front Drive Axle	★★☆☆

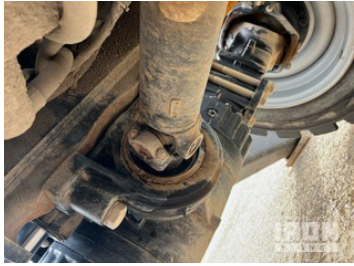
Front Axle Oscillating Pin	★★☆☆

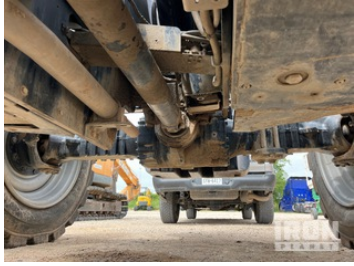
Rear Drive Axle	★★☆☆

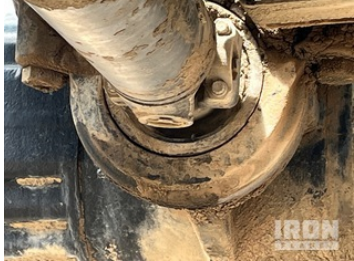
Rear Axle Oscillating Pin	★★☆☆

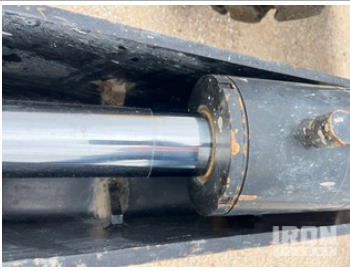
Outrigger Cylinders	★★★★☆ Control sticks

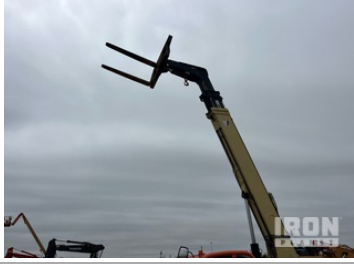
Boom Condition	☆☆☆☆

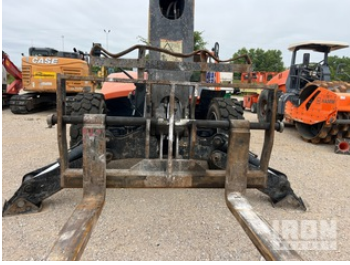
Load Back Rest	<p>★★☆☆</p> <p>Crossbar bent</p>
