Inspection Report (Boom Lift)

Year	2013
Make	Skyjack
Model	SJ45T
Serial Number	98001112
Hour Meter Reading	3896
Previous Application (e.g., earth moving, mining, demolition, etc)	Rental

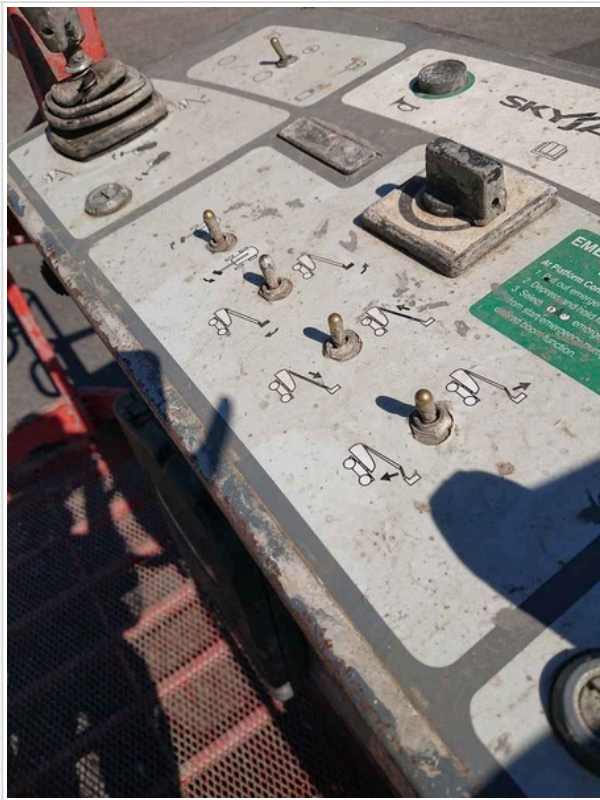
Controls & Switches Photos

Hour Meter Activity	0
Other Gauge Activity	0
Controls & Switches	2 - Above Average Wear
Comments	Toggles caked with debris

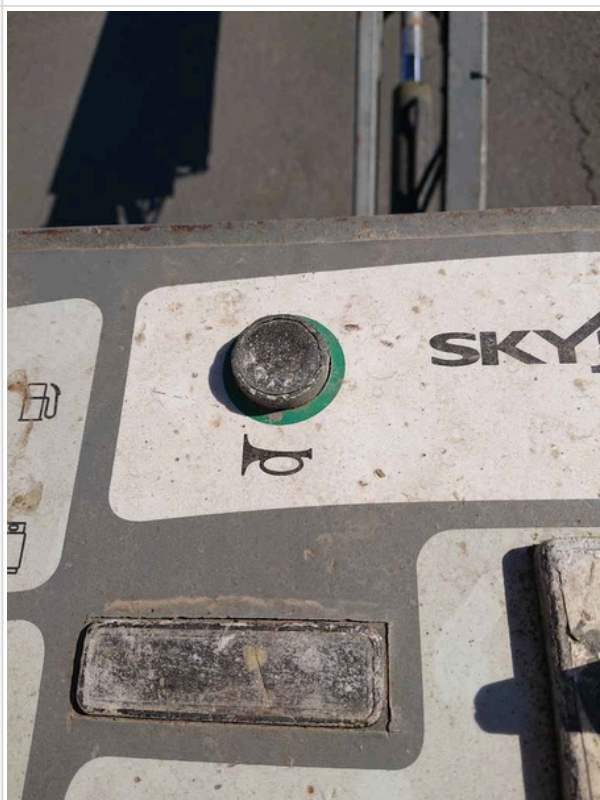
Horn	2 - Above Average Wear
Comments	Worn but functional
Horn Photos

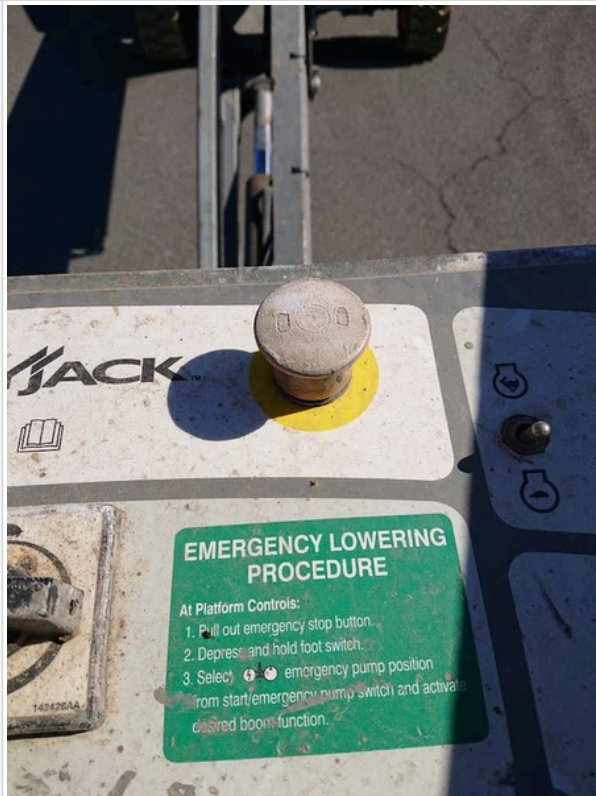
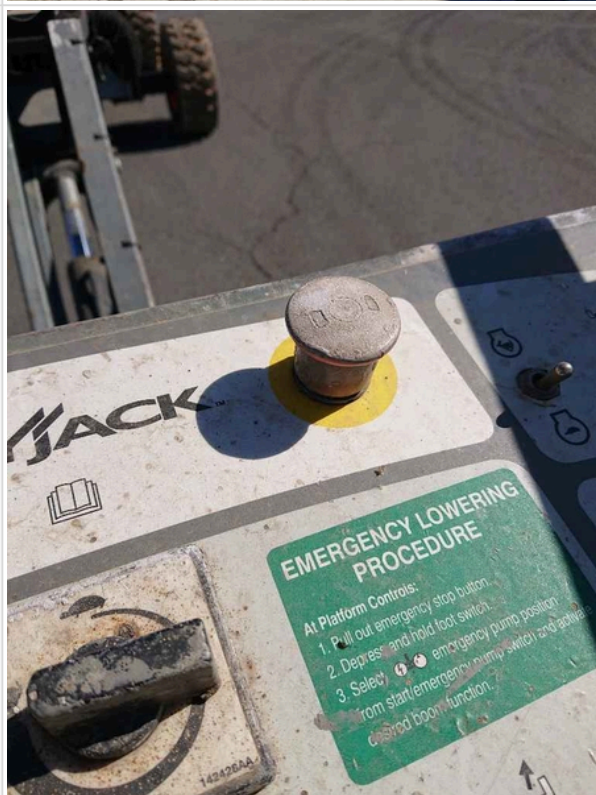
Swing Brake	0
Safety Lock Out / Stop	2 - Above Average Wear
Comments	Recommend replacing; suncracked
Safety Lock Out / Stop Photos

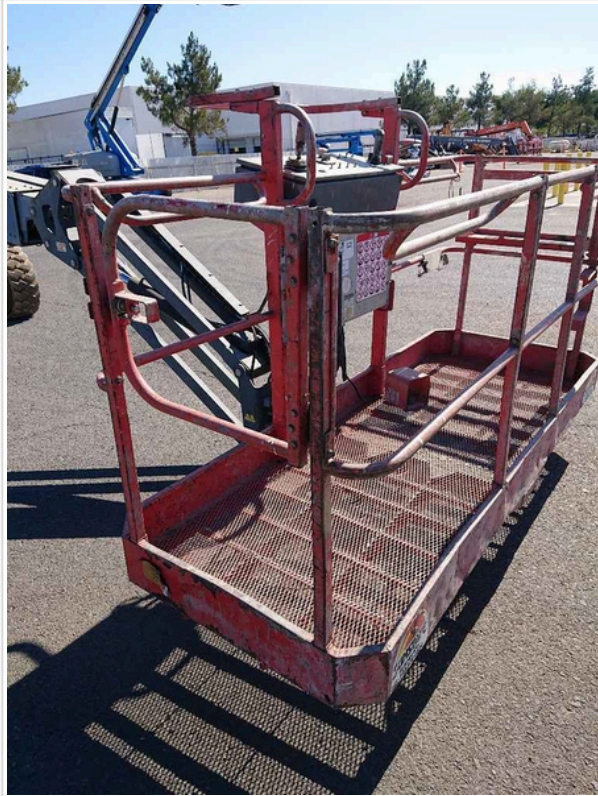
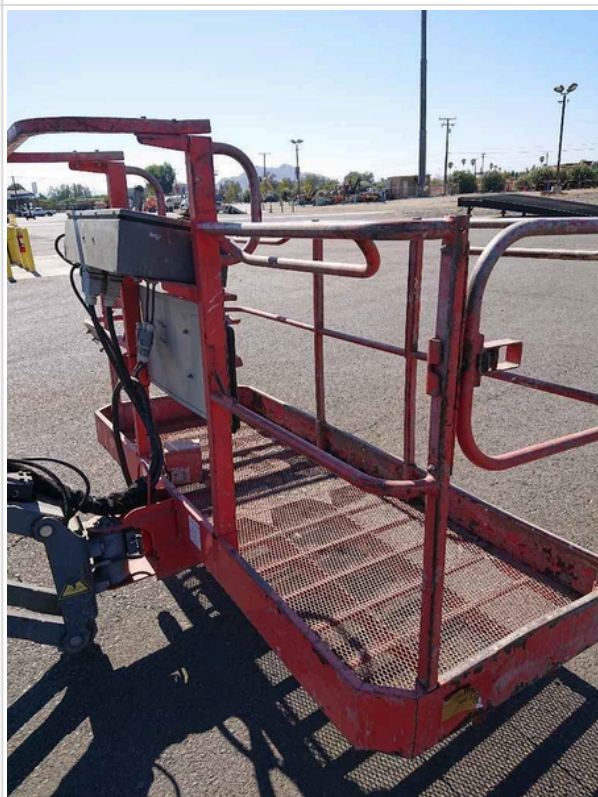
Platform Safety Rails & Appearance	3 - Normal Wear & Tear
Comments	Aged but no compromising damage noted
Platform Safety Rails & Appearance Photos

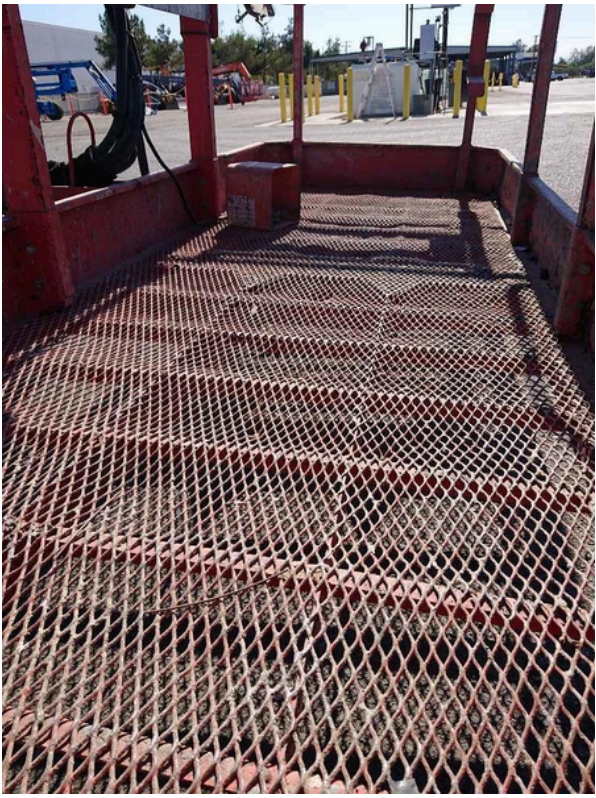
Platform Floor	2 - Above Average Wear	
Comments	Areas where flooring expanded metal sunken in	
Platform Floor Photos

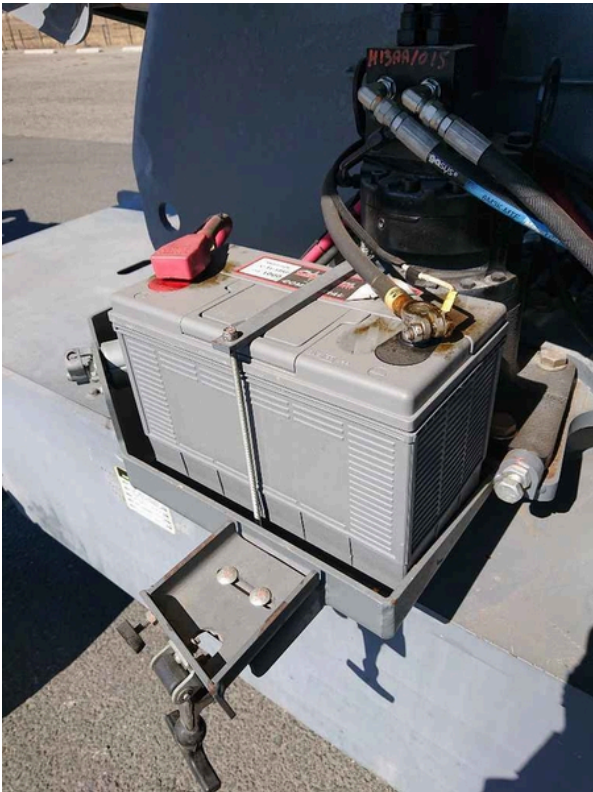
Unusual Noise Notes	No unusual noises heard
Engine Smoke (Upon Start-up, Idle, Shutdown)	No
Engine Smoke Notes	No engine smoke issues observed
Engine Exhaust Color	Clear
Battery	3 - Normal Wear & Tear
Battery Condition	Clean & dry appearance, tight connections, Like new, recently replaced
Battery Condition Photos

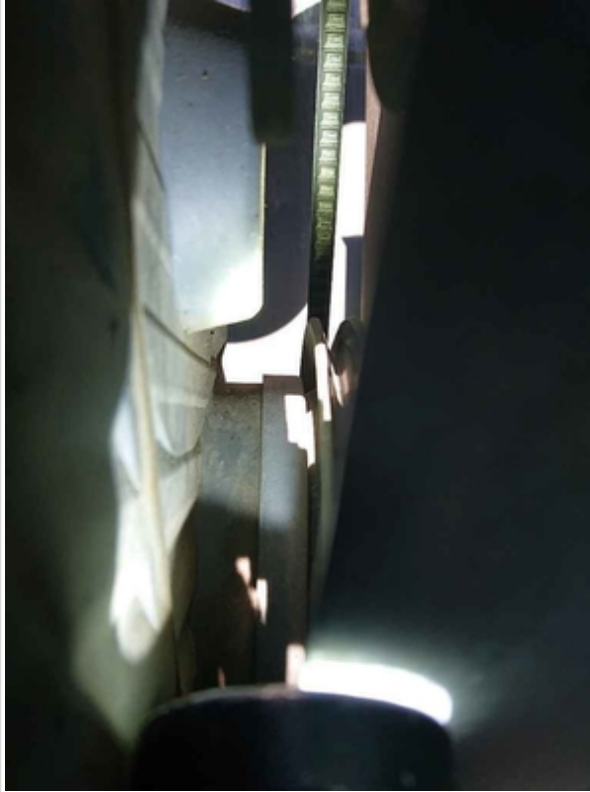
Belt Photos

Radiator	3 - Normal Wear & Tear
Radiator Photos	 
Belts	1 - Service Required
Belt Condition	Cracks, missing grooves, or separating layers on one or more belts

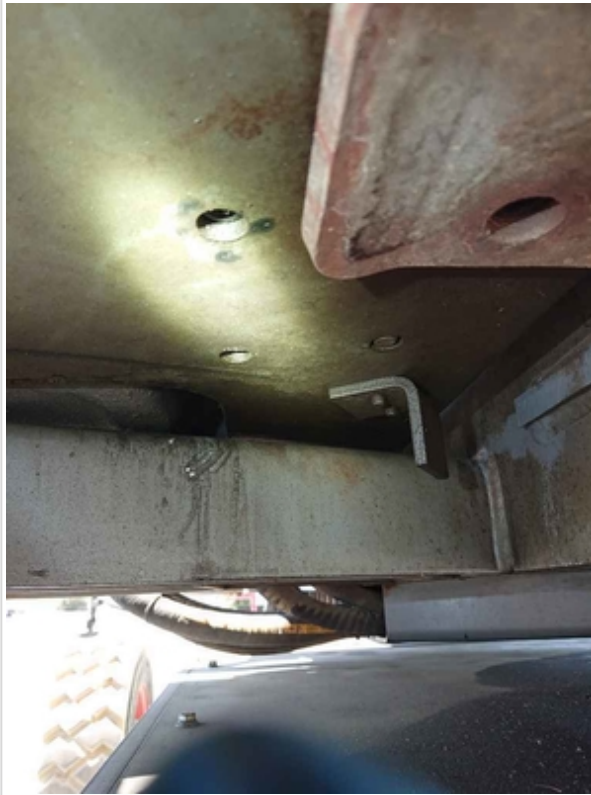
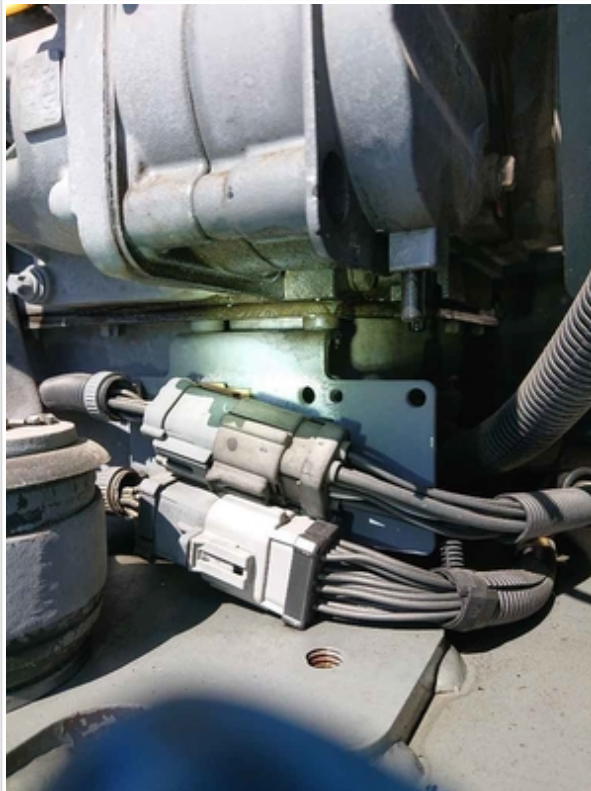
Oil Leak Photos

Water Pump	2 - Above Average Wear
Water Pump Condition	Other (see comments)
Comments	Inaccessible
Cooling System Leaks	No
Coolant Color / Appearance	0
Oil Leaks	Yes
Oil Leak Notes	Wet areas with drops forming due to oil leakage, Other (see comments)
Comments	Wet/leaking at oil pan; difficult/inaccessible to pinpoint exact source

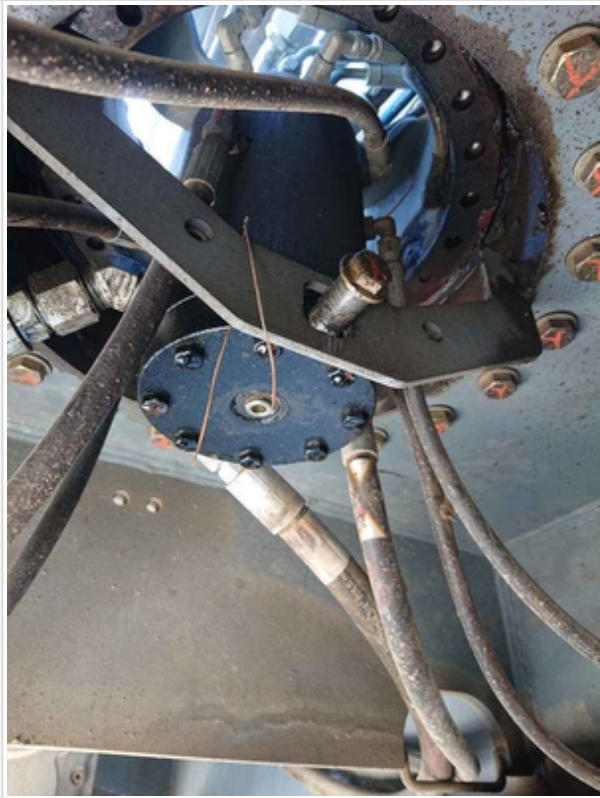
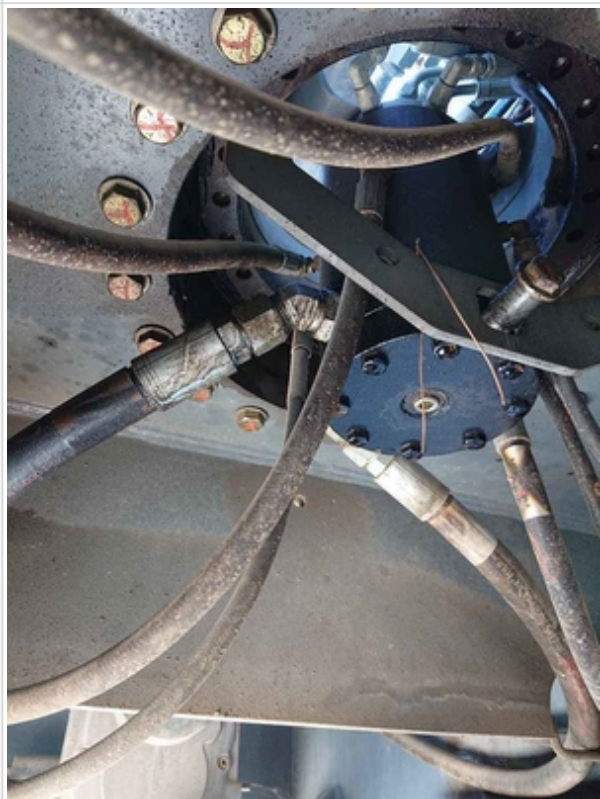
Transmission Photos

Transmission	1 - Service Required
Transmission Condition	Leaking transmission fluid observed, No unusual noises or vibrations
Comments	Hydrostatic. Drive motor leaking; see photos

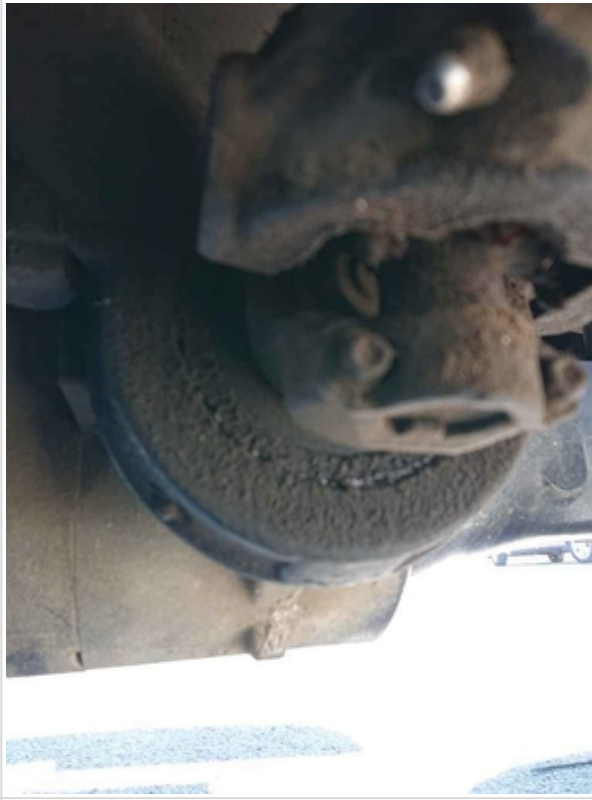
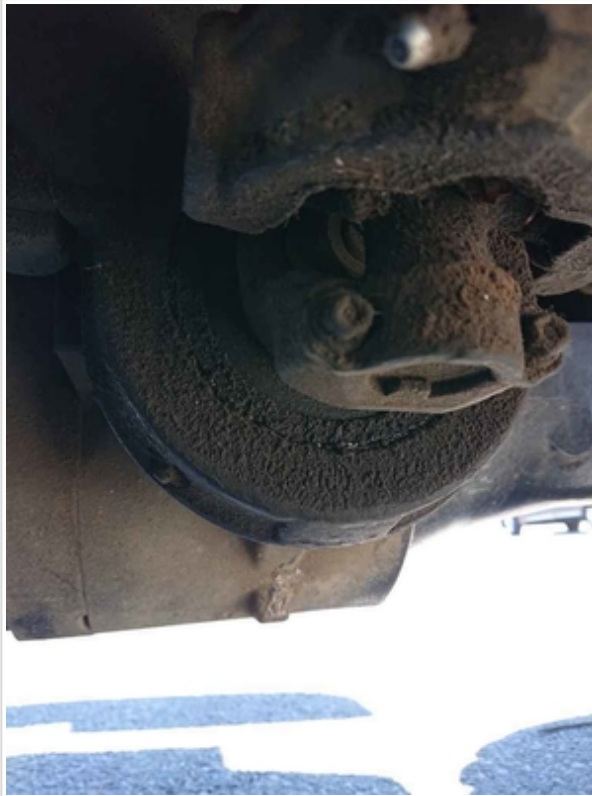
Rear Axle Appearance Photos

Rear Axle Appearance	3 - Normal Wear & Tear
Comments	Front and rear pivot bearing seals have seepage possibly from over lubrication

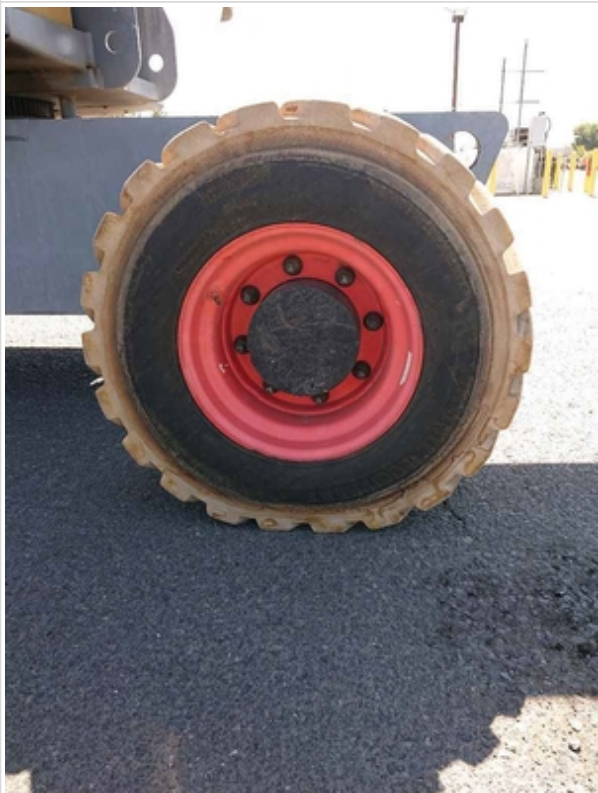
Wheels & Tires	3 - Normal Wear & Tear
Comments	Date stamps illegible, rear right has screw in tread (no leak observed)
Wheels & Tires Photos

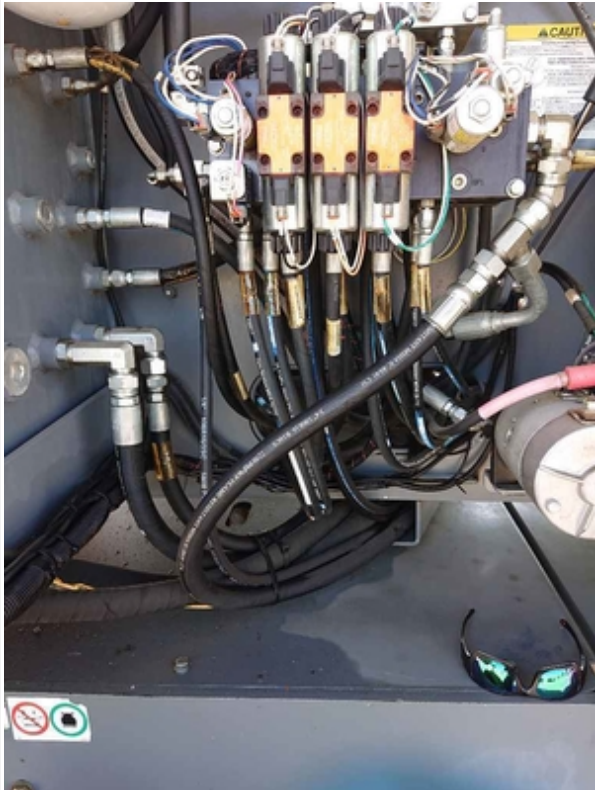
Wet or Damp Hydraulic Lines / Fittings	Yes
Appearance of Hydraulic Lines / Fittings	3
Hydraulic Lines / Fittings Condition	Active leaks in hoses or fittings observed
Comments	Cooler wet with active leak, filter leaking, reservoir drain plug leaking
Appearance of Hydraulic Lines / Fittings Photos
