Inspection Report (Mini Excavator)

Year	2015
Make	Bobcat
Model	E26
Serial Number	B33212850
Hour Meter Reading	2565

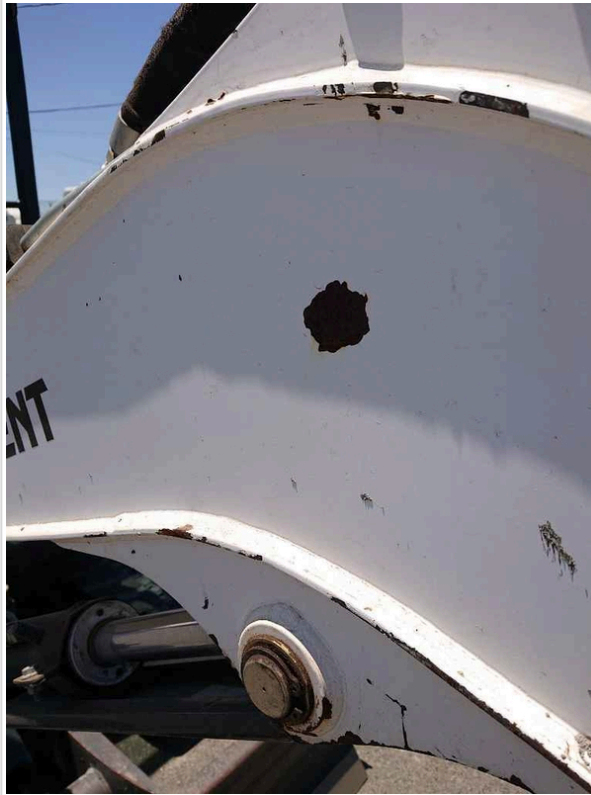
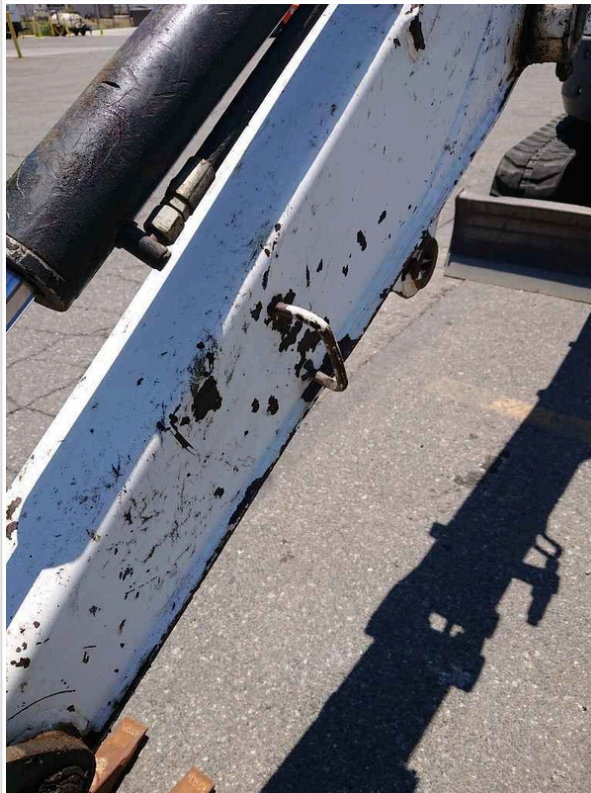
Front Photos

Front	3 - Normal Wear & Tear
Front Condition	Visible chipped paint or dents, Areas of surface rust observed, Other (see comments)
Comments	Broken/missing boom right hose guide

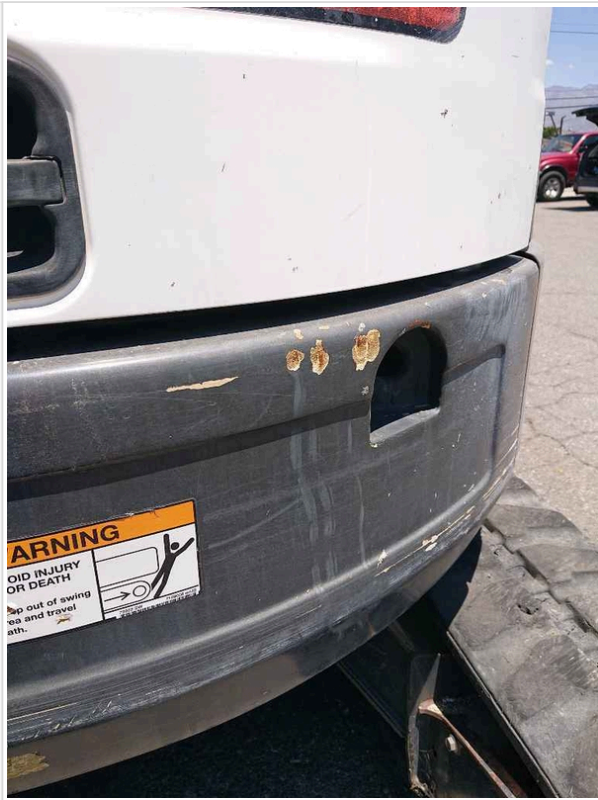
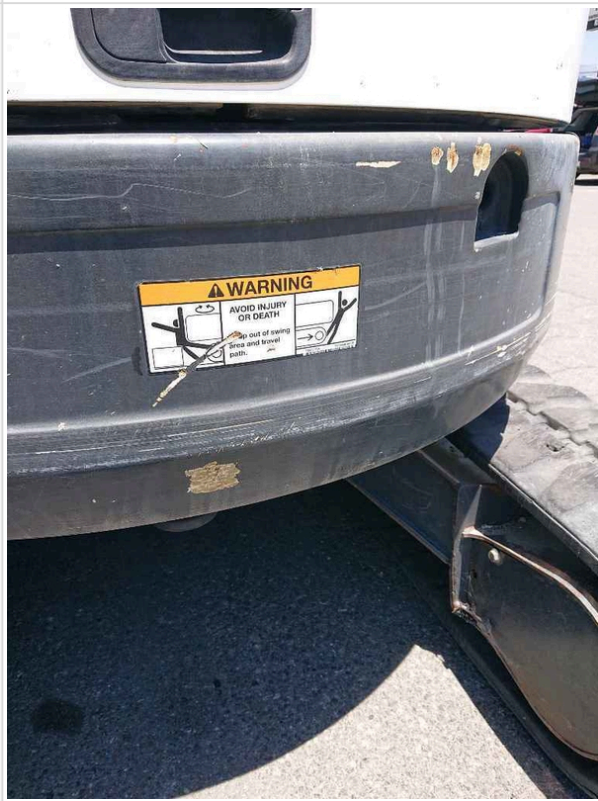
<p>Rear Photos</p>

Rear	3 - Normal Wear & Tear
Rear Condition	Visible chipped paint or dents

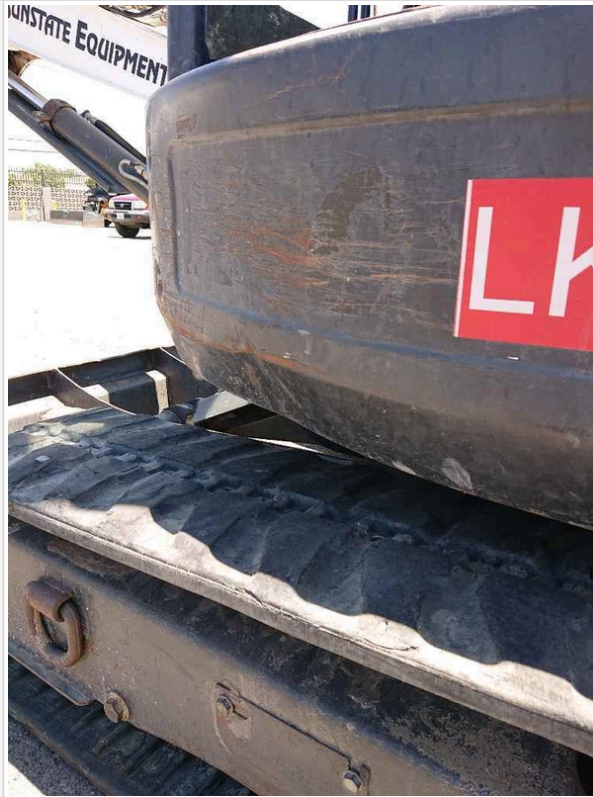
Left Photos

<p>Left</p>	<p>3 - Normal Wear & Tear</p>
<p>Left Condition</p>	<p>Visible chipped paint or dents</p>
<p>Comments</p>	<p>Normal wear, paint scuffs/deep scratches</p>

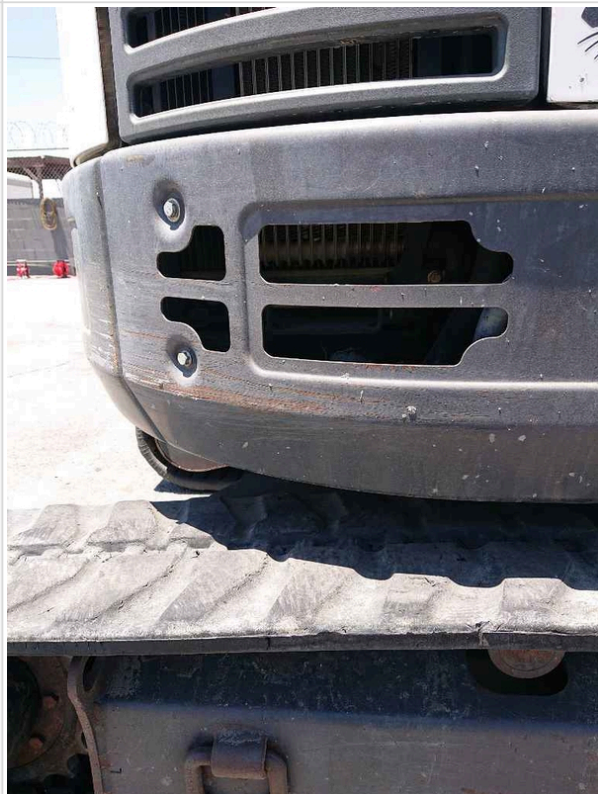
Right	3 - Normal Wear & Tear
Right Condition	Visible chipped paint or dents
Comments	Normal wear, paint scuffs/deep scratches
Right Photos

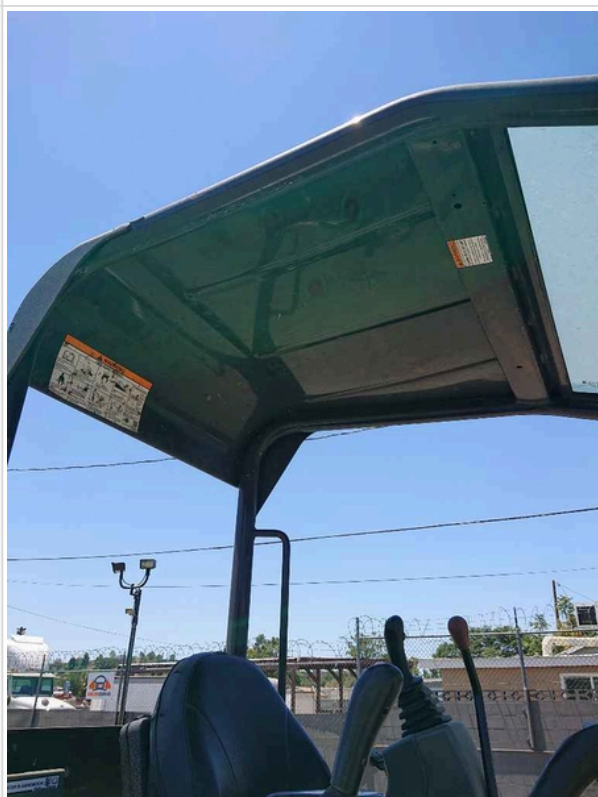
Upper	3 - Normal Wear & Tear
Upper Condition	No visible damage
Upper Photos

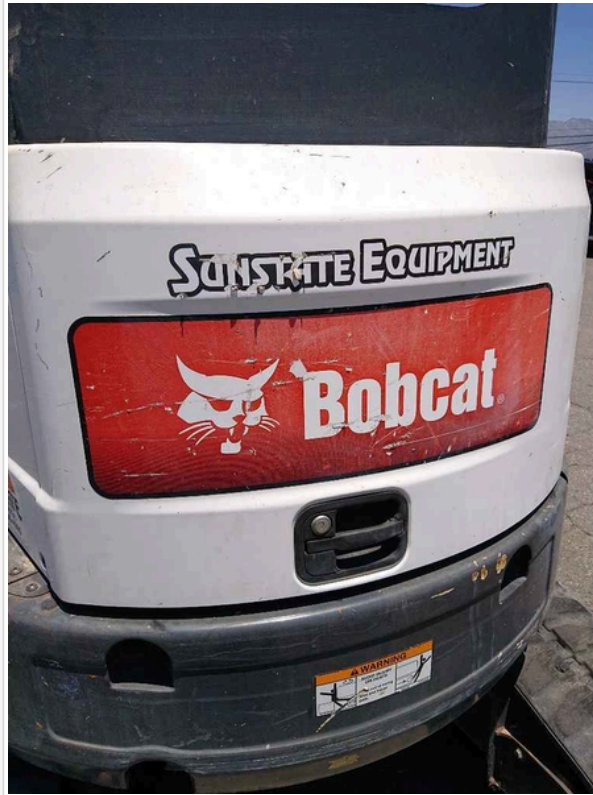
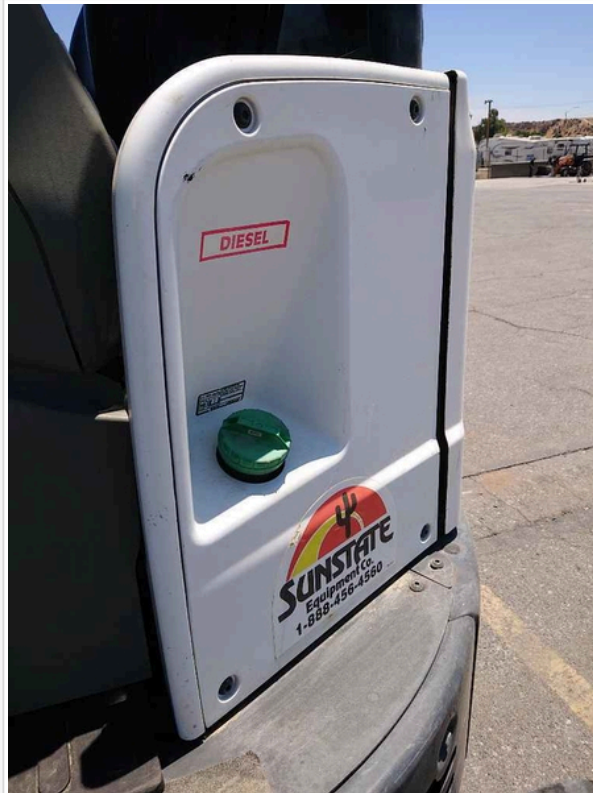
Body Panels Photos	 
--------------------	--

Body Panels (Any Rust Damage?)	3 - Normal Wear & Tear
Body Panel Condition	Visible chipped paint or dents
Comments	Nor rust observed

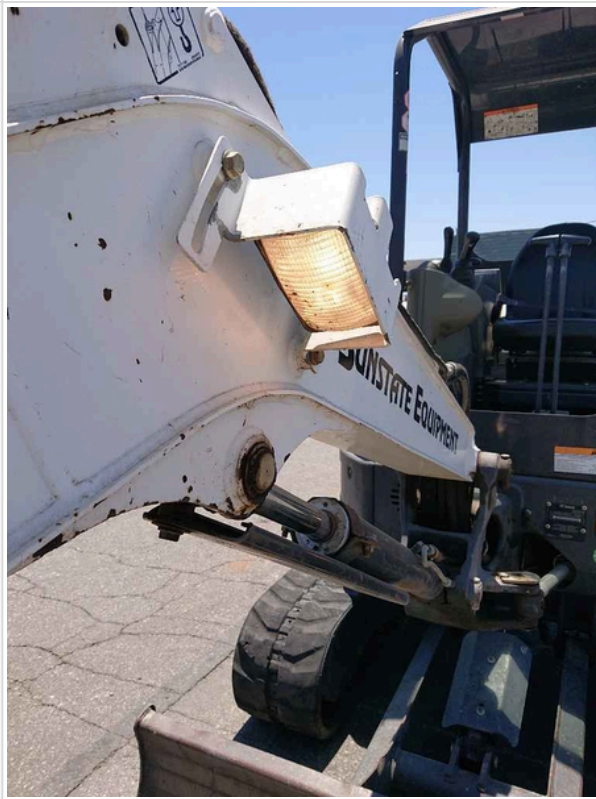
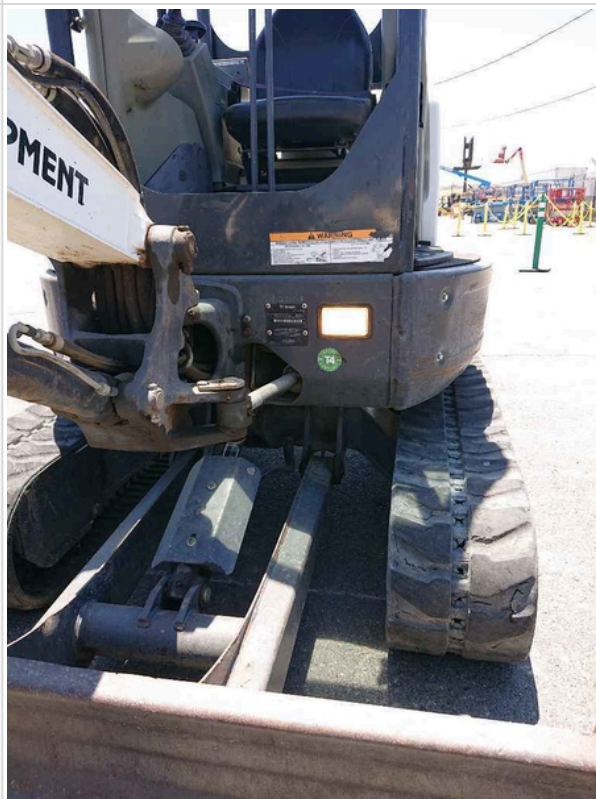
Lighting System Condition	No visible damage, lighting system is operational
Lighting System Photos

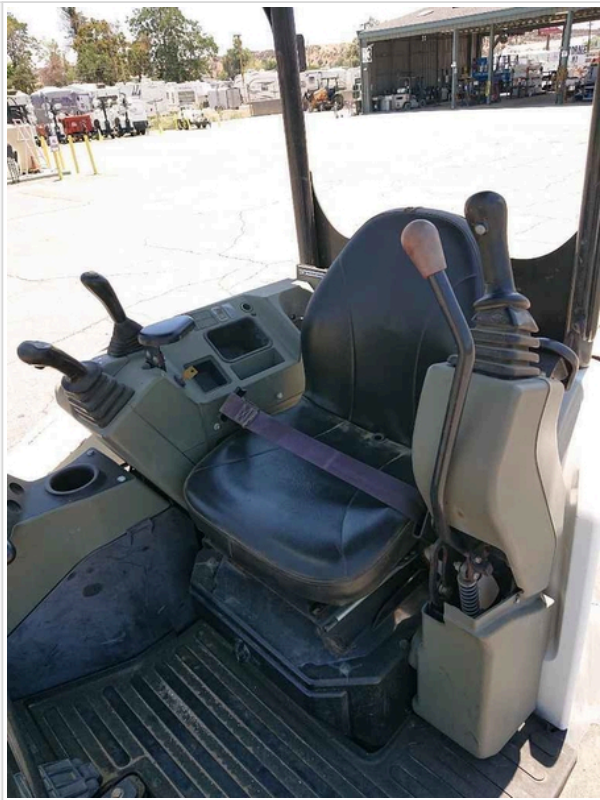
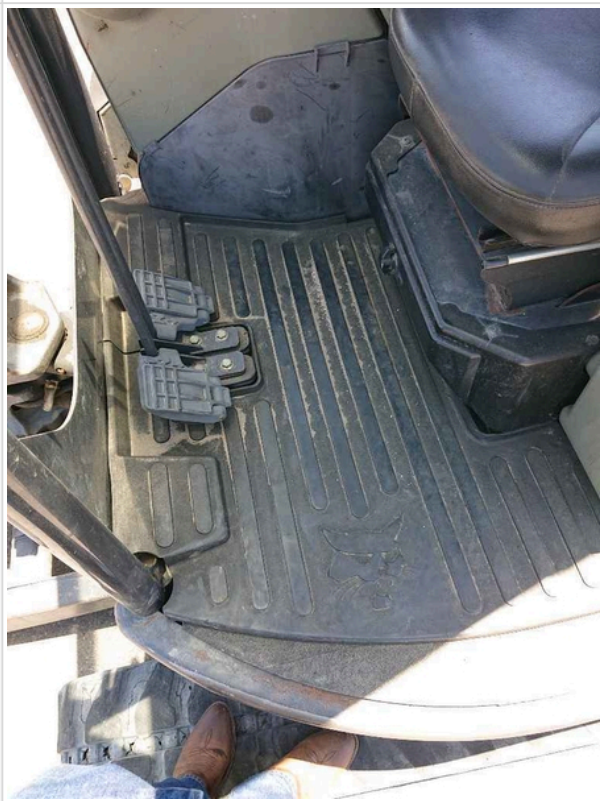
<p>Operator Cabin Photos</p>

Operator Cabin Overall	3 - Normal Wear & Tear
Operator Cabin Overall Condition	Minor cosmetic wear to cabin surfaces, floors, panels, and ceiling
Comments	Normal wear

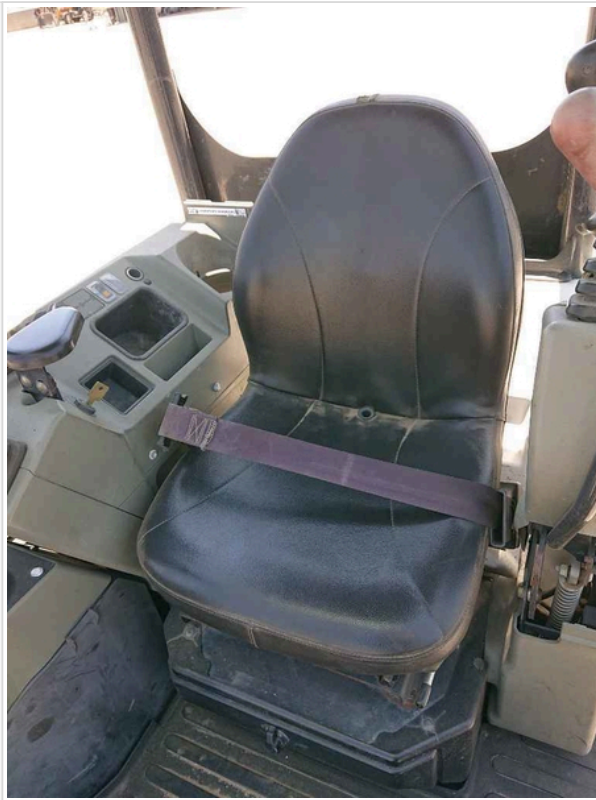
<p>Operator's Seat & Arm Rests Photos</p>

<p>Operator's Seat & Arm Rests</p>	<p>3 - Normal Wear & Tear</p>
<p>Operator's Seat & Arm Rests Condition</p>	<p>Seat(s) in good condition, no stains or tears in upholstery</p>

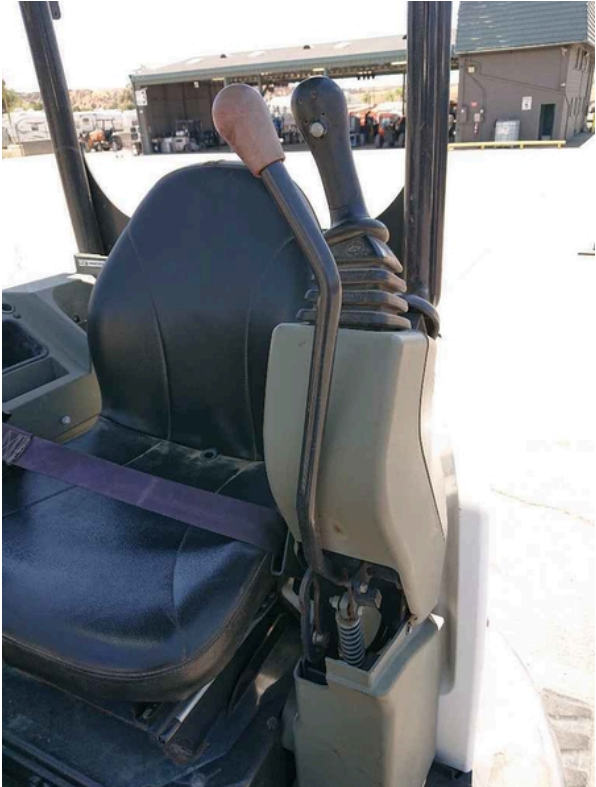
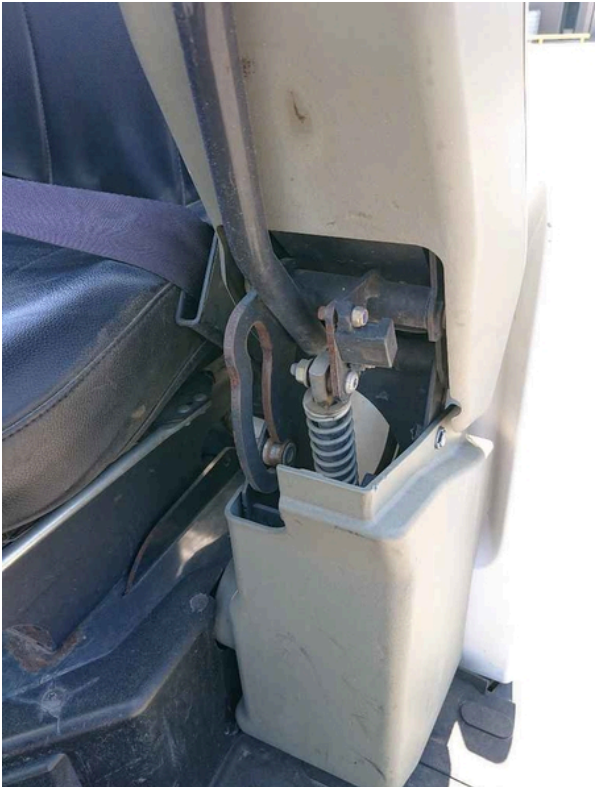
Safety Lock Out / Stop	3 - Normal Wear & Tear
Safety Lock Out / Stop Condition	Safety lock out device is present, in good condition, and functional
Safety Lock Out / Stop Photos

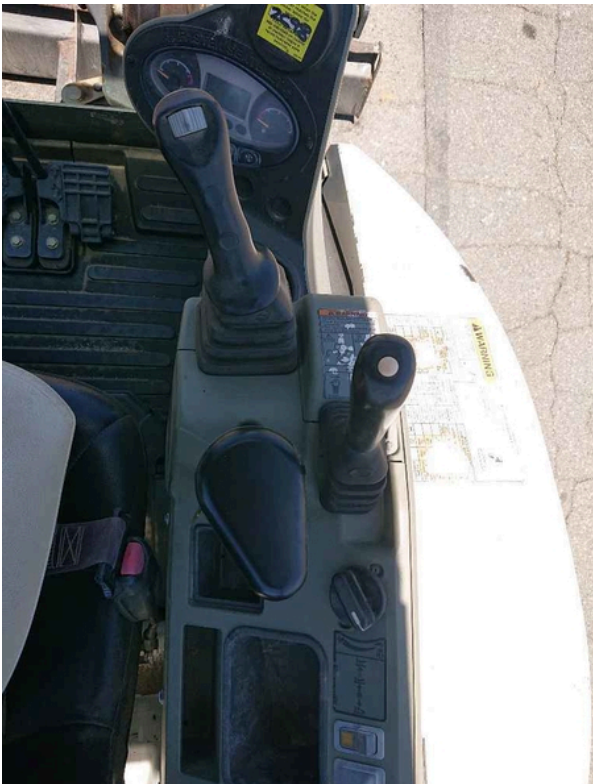
Controls & Switches Condition	All switches are installed and functional, Switches have good functionality, minor cosmetic damage observed
Comments	Normal wear
Controls & Switches Photos

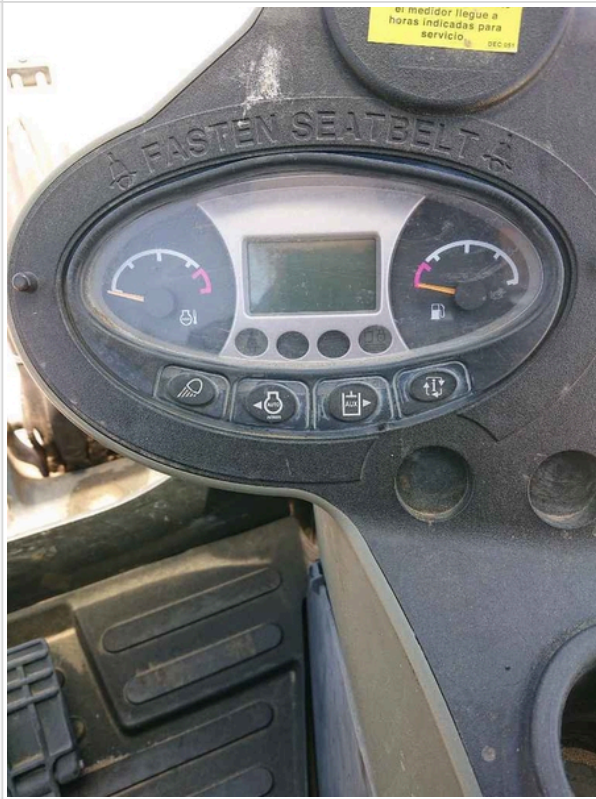
<p>Other Gauge Activity</p>	<p>3 - Normal Wear & Tear</p>
<p>Other Gauge Condition</p>	<p>All cockpit gauges are functional and in good condition, Gauges are functional, with some wear and/or cosmetic damage</p>

<p>Comments</p>	<p>Normal operation</p>
<p>Other Gauge Activity Photos</p>

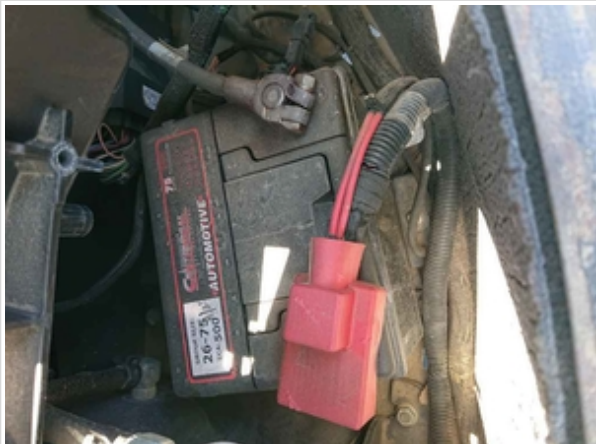
Blow-by (Visual Observation Check)	No	
Unusual Noises (Upon Start-up, Idle, Shutdown)	No	
Unusual Noise Notes	No unusual noises heard	
Engine Smoke (Upon Start-up, Idle, Shutdown)	No	
Engine Smoke Notes	No engine smoke issues observed	
Engine Exhaust Color	Clear, Clear at operating temperature	
Battery	3 - Normal Wear & Tear	
Battery Condition	Clean & dry appearance, tight connections	
Battery Condition Photos

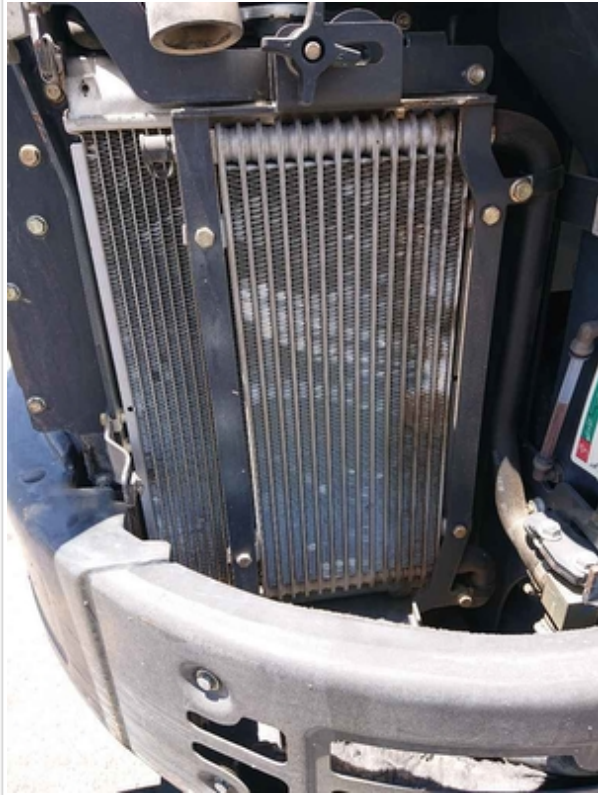
Radiator	3 - Normal Wear & Tear
Radiator Condition	Radiator fins & components appear to be in good working order, no signs of damage or leaks, Other (see comments)
Comments	Coolers are dirty, recommend cleaning out, slight fin bending
Radiator Photos

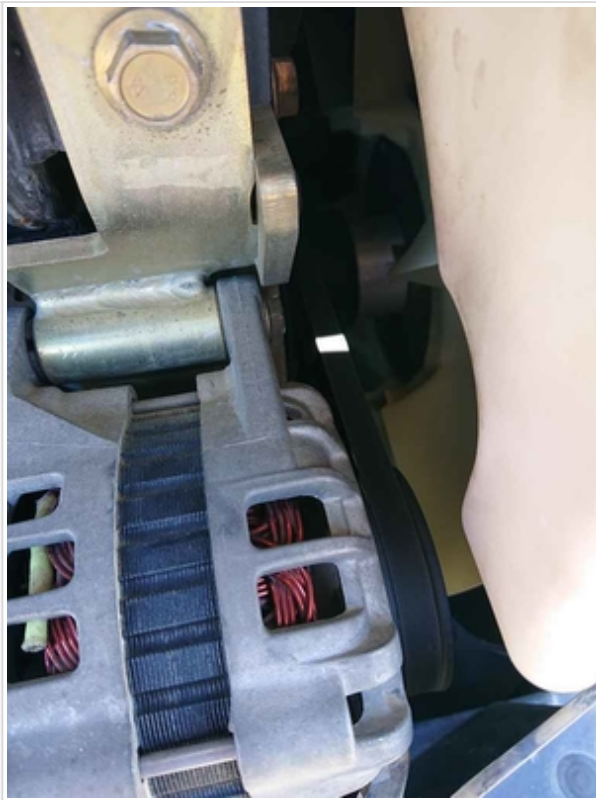
<p>Belt Photos</p>

Belts	1 - Service Required
Belt Condition	Cracks, missing grooves, or separating layers on one or more belts, Other (see comments)
Comments	Inaccessible for photos

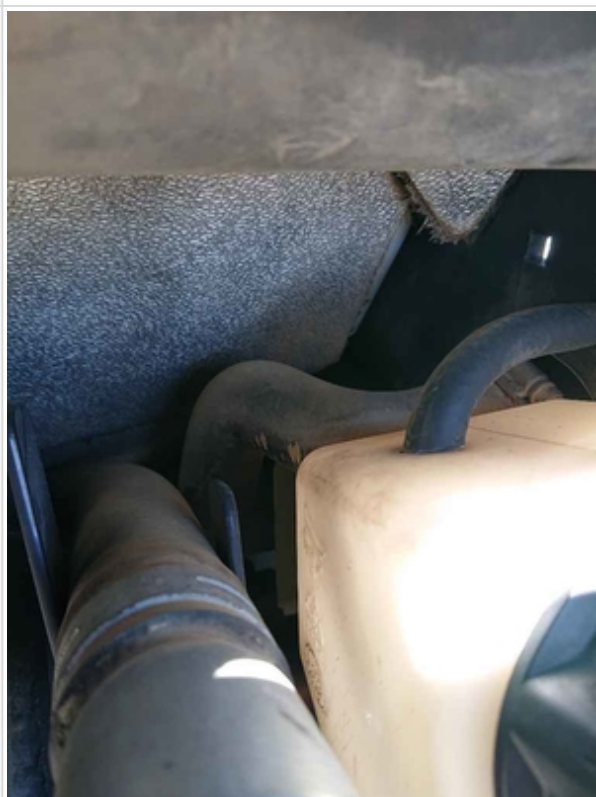
<p>Hoses</p>	<p>3 - Normal Wear & Tear</p>
<p>Hose Condition</p>	<p>Firm, pliant hoses with no signs of wear or leaks</p>
<p>Hose Photos</p>

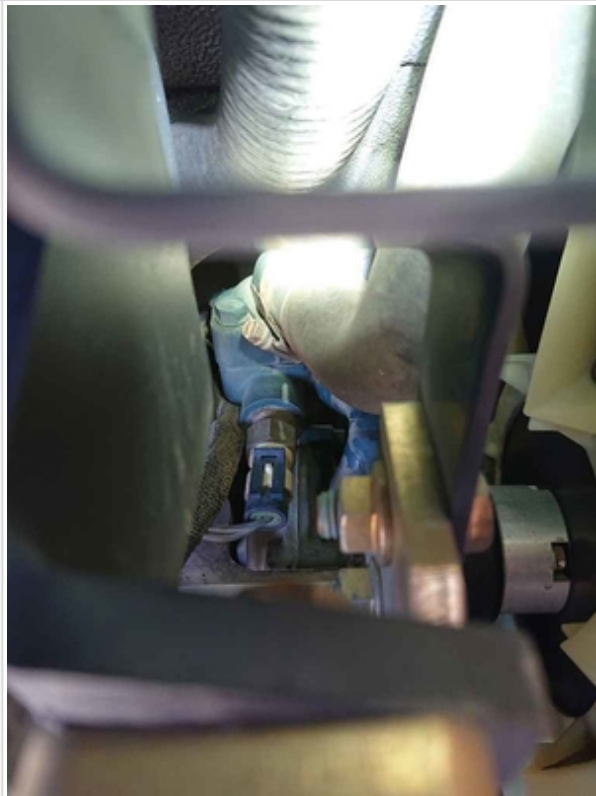
Water Pump Photos

Water Pump	3 - Normal Wear & Tear
Water Pump Condition	No unusual pump noises heard

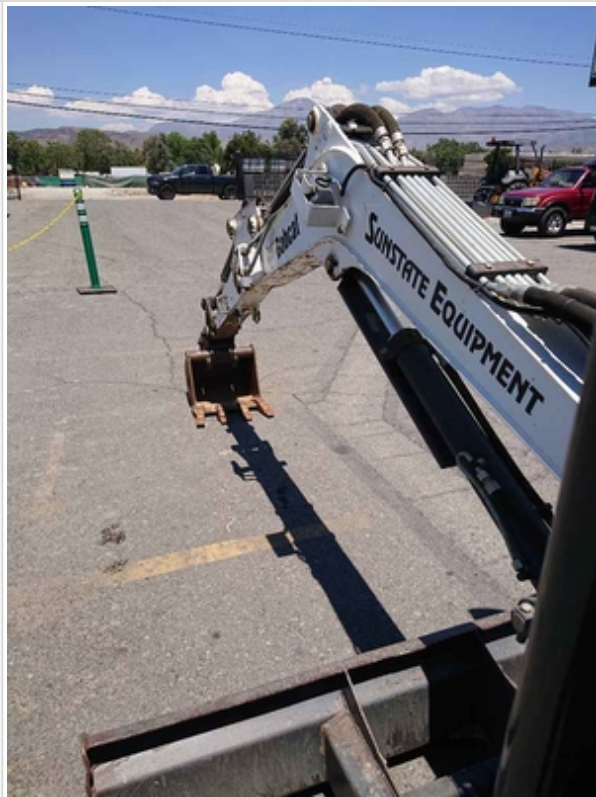
Instructions	<p>Evaluate the following on a 4 point scale (leave comments where an explanation is appropriate):</p> <p>4 = Like New, Recently Replaced 3 = Normal Wear & Tear 2 = Above Average Wear 1 = Service Required</p>
Boom Condition	<p>3 - Normal Wear & Tear</p>
Comments	<p>Normal wear</p>
Boom Photos

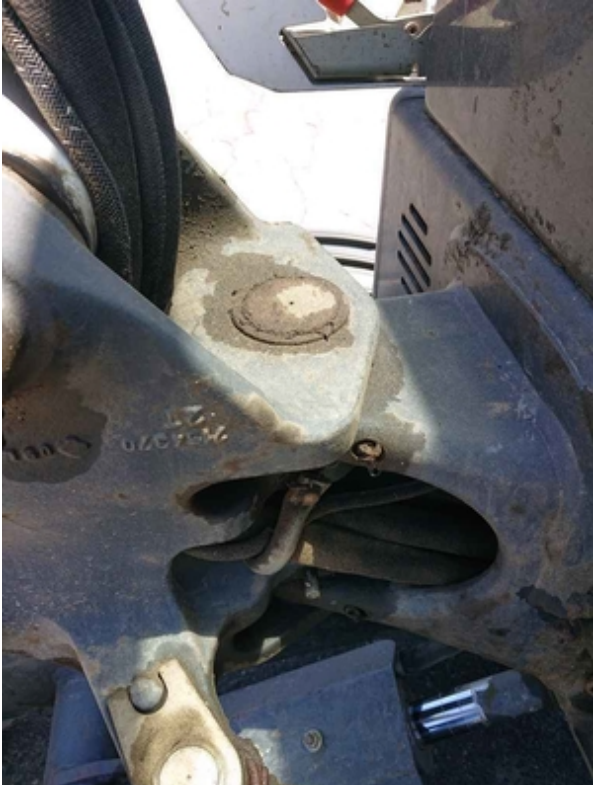
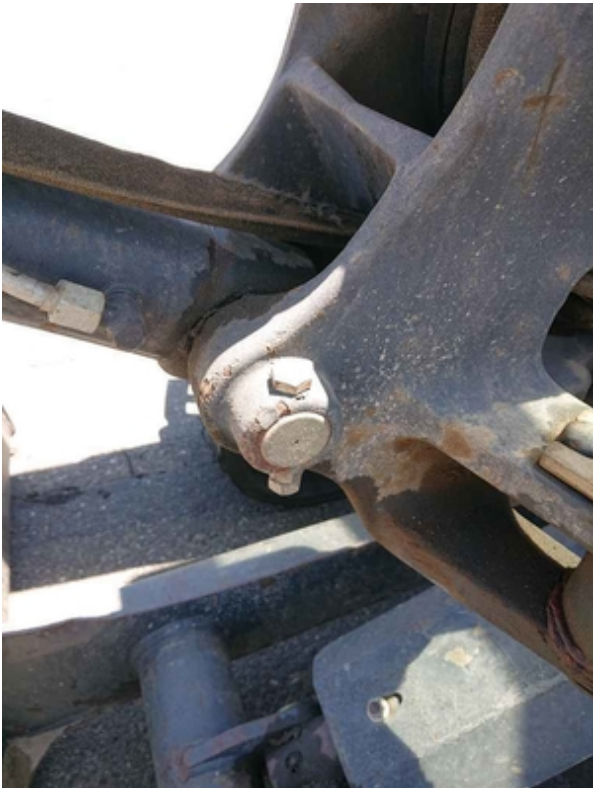
Stick Condition	3 - Normal Wear & Tear
Comments	Normal wear
Boom Base Pin & Bushings	3 - Normal Wear & Tear

Comments	Good condition
Boom Base Pin & Bushings Photos

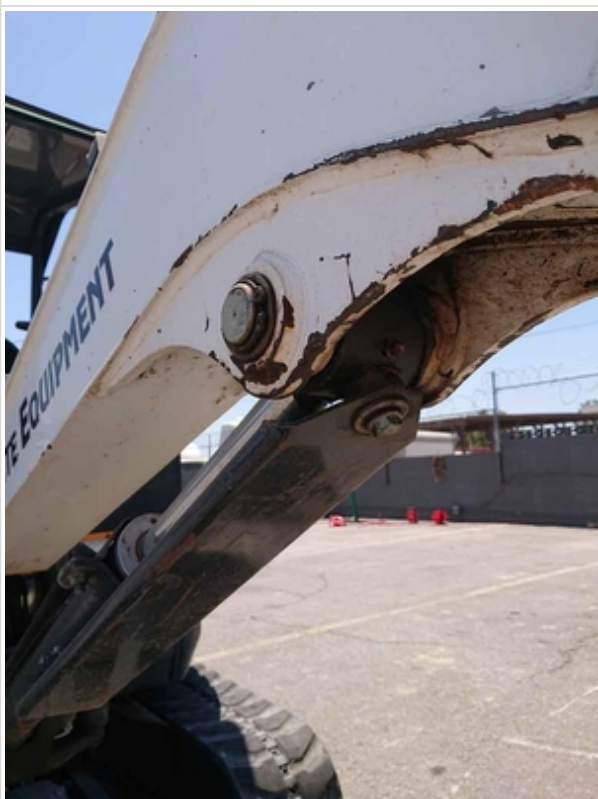
<p>Boom to Stick Pin & Bushings</p>	<p>3 - Normal Wear & Tear</p>	
<p>Comments</p>	<p>Good condition</p>	
<p>Boom to Stick Pin & Bushings Photos</p>

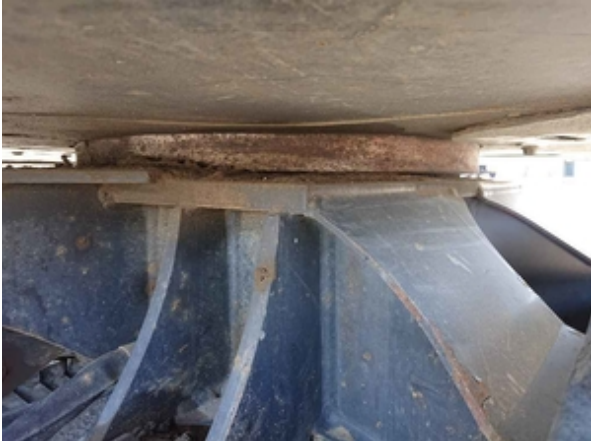
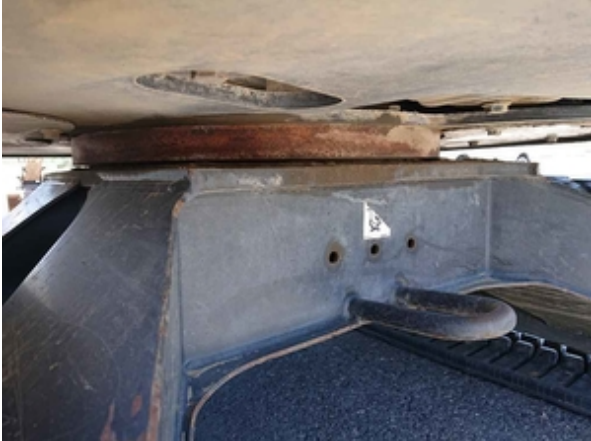
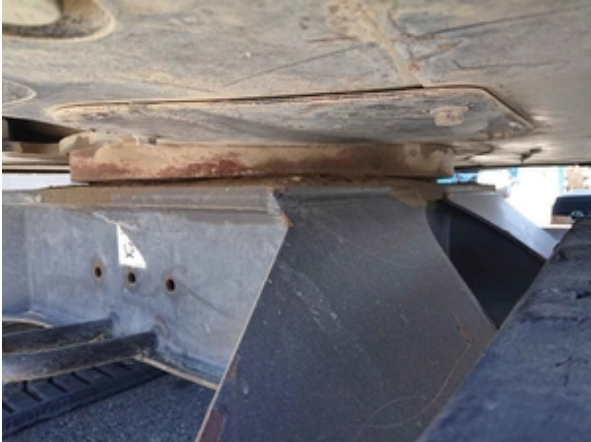
Stick to Bucket Pin & Bushings	3 - Normal Wear & Tear
Comments	Good condition
Turntable Bearing	3 - Normal Wear & Tear

Comments	No issues noted
Turntable Bearing Photos

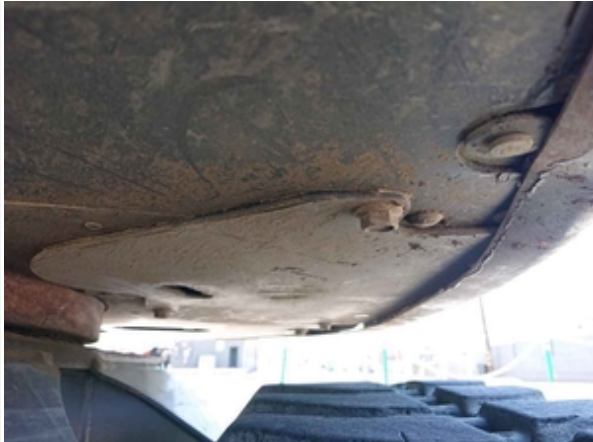
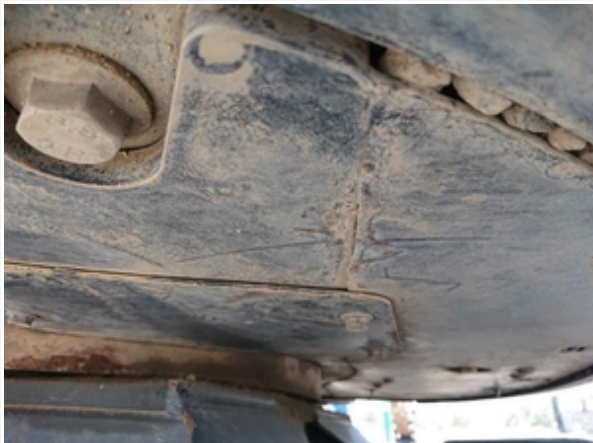
Bottom Covers	3 - Normal Wear & Tear	
Comments	No damage noted	
Bottom Covers Photos

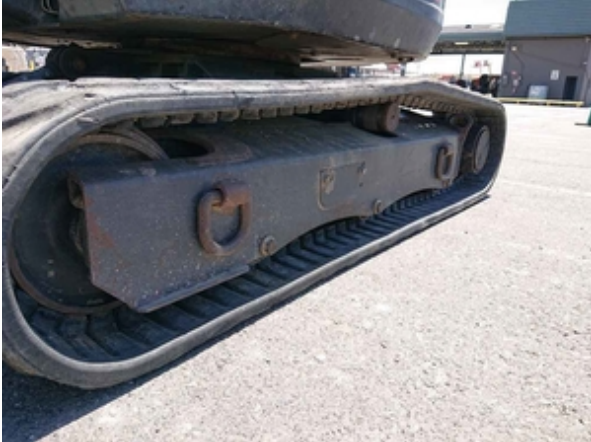
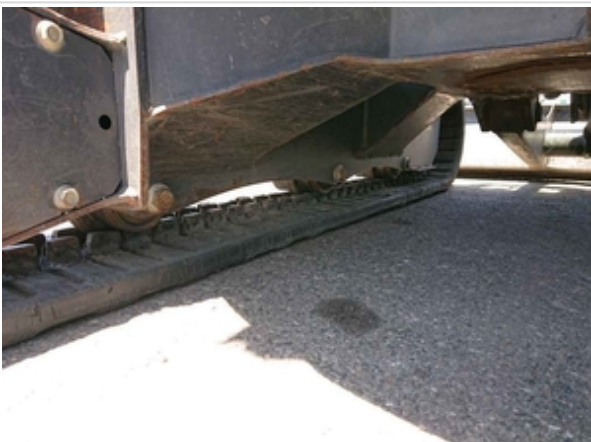
Instructions	<p>Evaluate the following on a 4 point scale (leave comments where an explanation is appropriate):</p> <p>4 = Like New, Recently Replaced 3 = Normal Wear & Tear 2 = Above Average Wear 1 = Service Required</p>
Roller Frames	<p>3 - Normal Wear & Tear</p>
Roller Frames Photos

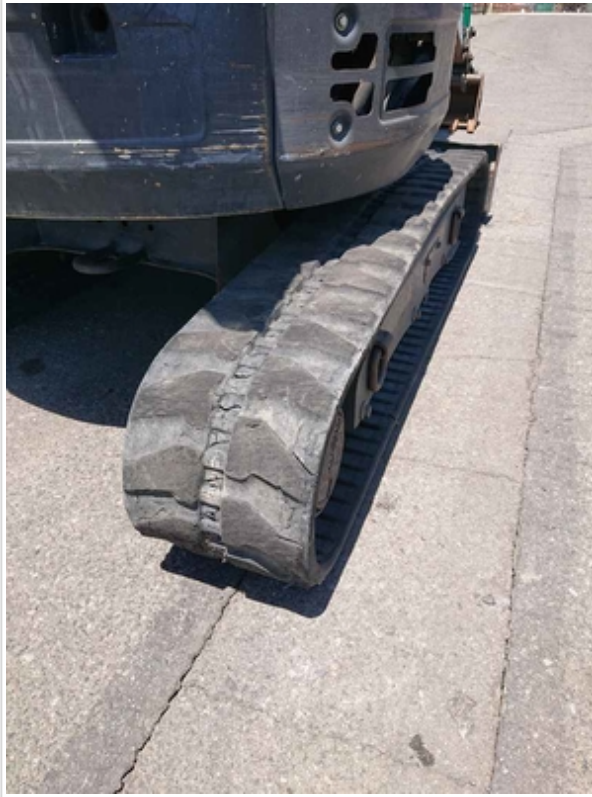
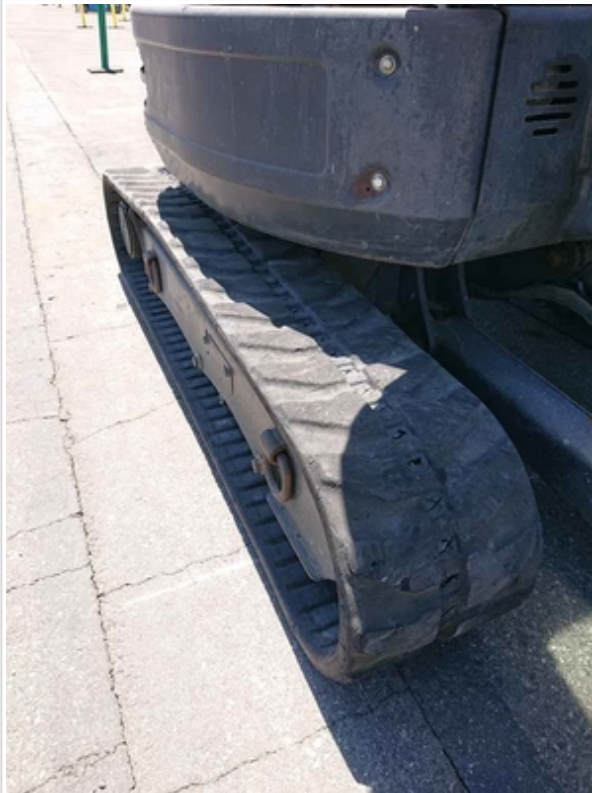
Track Belt Photos

<p>Track Belt</p>	<p>1 - Service Required</p>
<p>Comments</p>	<p>Slits/cracks in track belts observed</p>

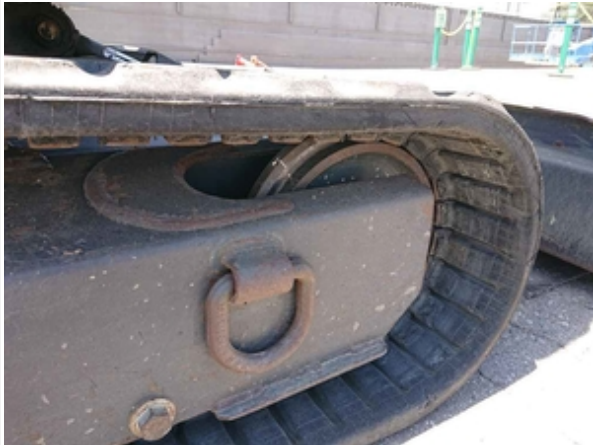
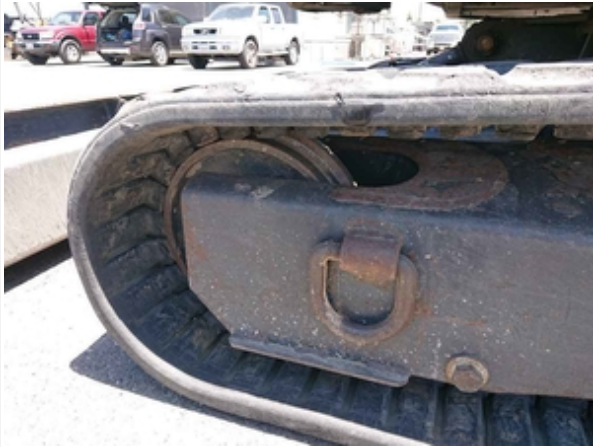
Comments	Inaccessible; track tension appears normal
Front Idlers	3 - Normal Wear & Tear
Comments	No issues noted
Front Idlers Photos

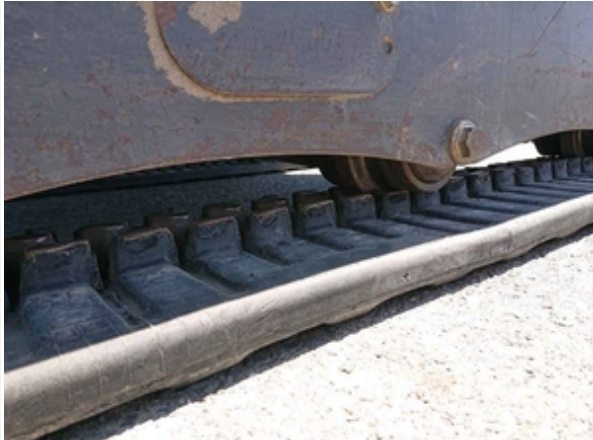
Rear Idlers	3 - Normal Wear & Tear
Comments	see rollers photos
Track Rollers	3 - Normal Wear & Tear
Track Rollers Photos

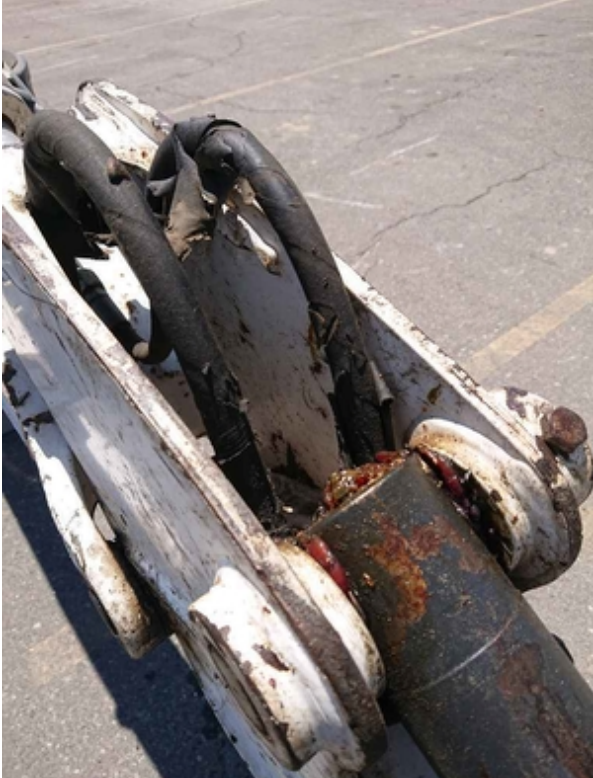
Wet or Damp Hydraulic Lines / Fittings	No
Appearance of Hydraulic Lines / Fittings	2
Hydraulic Lines / Fittings Condition	Hydraulic lines & fittings are clean and in good condition, Worn, cut, or damaged hose covering
Comments	Manifold inaccessible, no leaks noted throughout system
Appearance of Hydraulic Lines / Fittings Photos

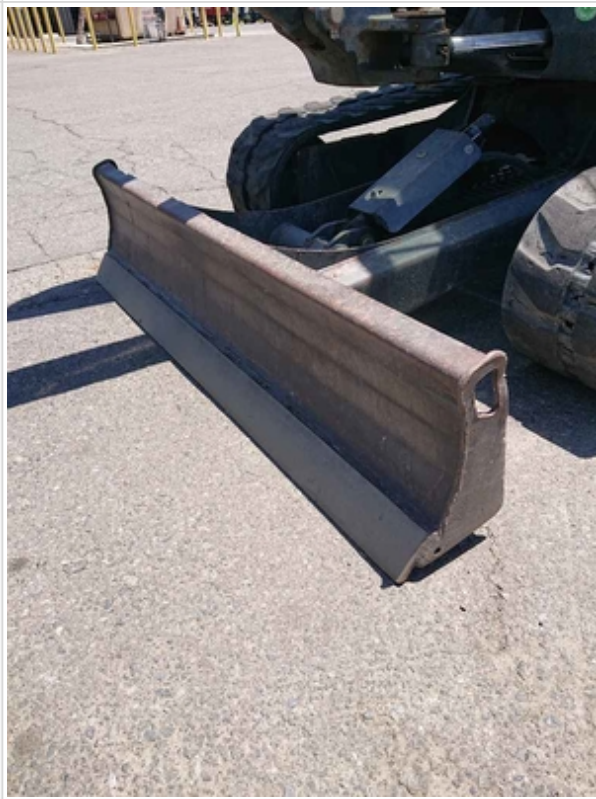
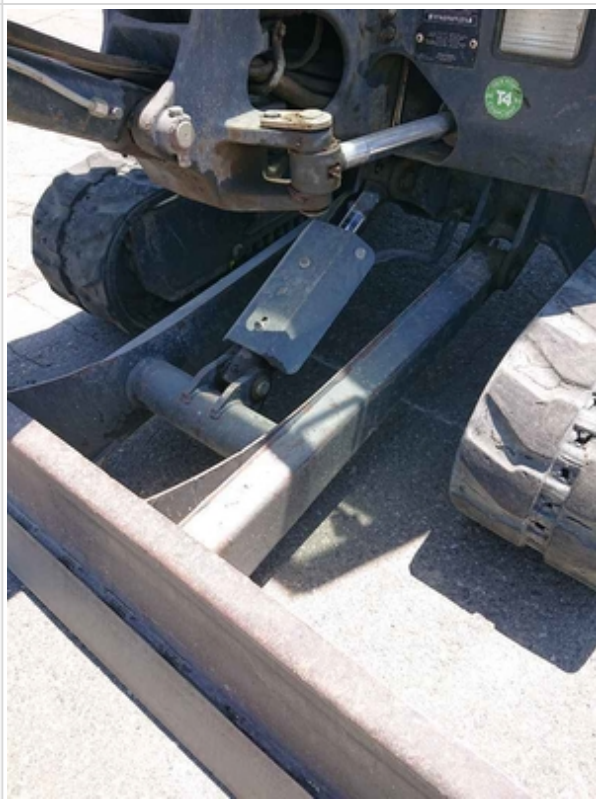
Comments	Blade/edges in good condition
Blade Photos
