Inspection Report (On-Highway Truck Basic Template)

| Make | Peterbilt |
| Model | 386 |
| Serial Number | 1XPHDP9X7BD118394 |

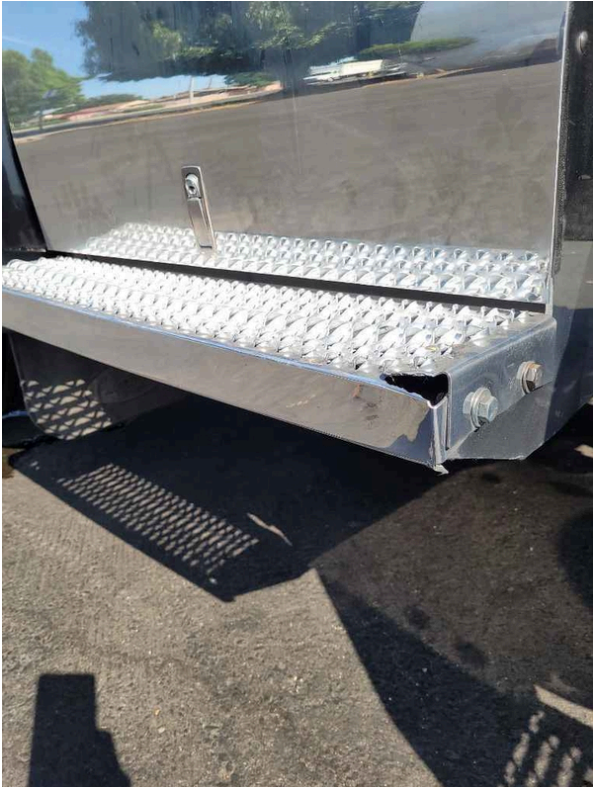
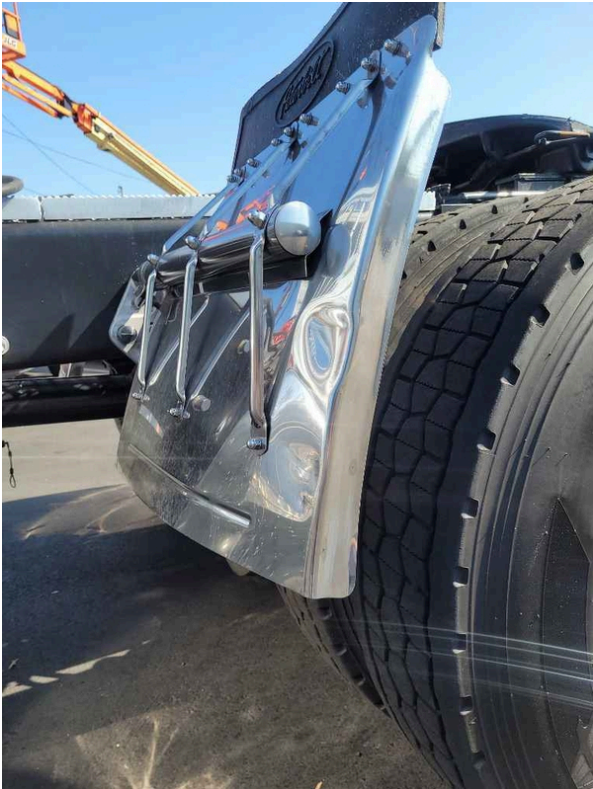
| Left Photos | |

| Comments | small crack on left side battery cover/step and small dent on left side mud guard |

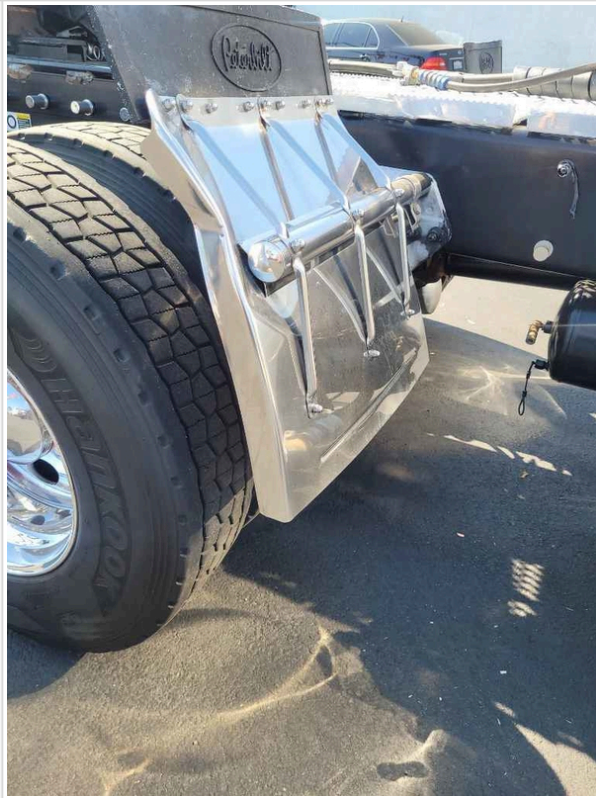
| Right Photos | |

| Comments | small dent on R/S mud guard the rest looks great |

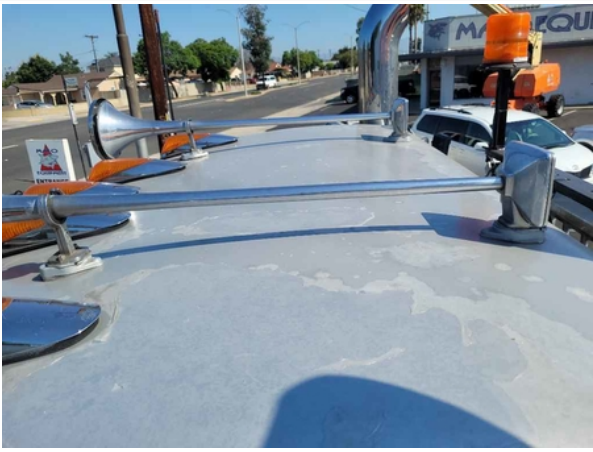
| Upper Photos | |

| Comments | minor clear coat peeling |

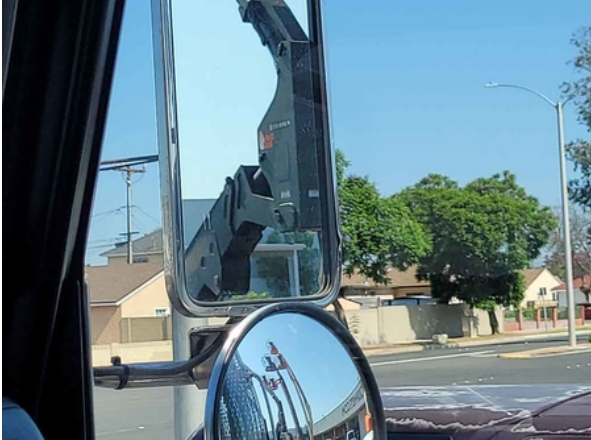
| Mirrors Photos | |

| Comments | small bend on right side mirror |

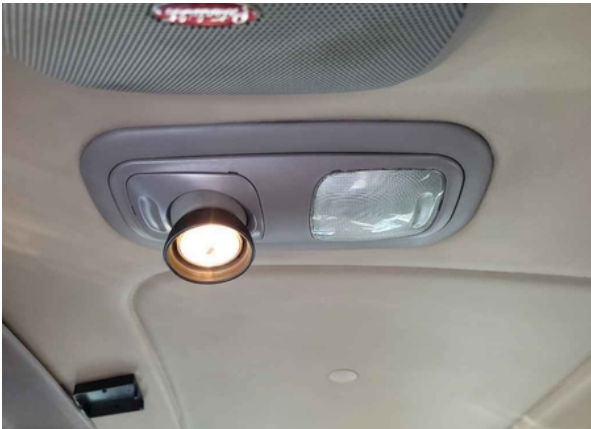
| Lighting System Photos | |

| Comments | factory lights all functional, right side beacon light not working, 2 overhead interior dome lamps not working, all other lights inside and out work properly |

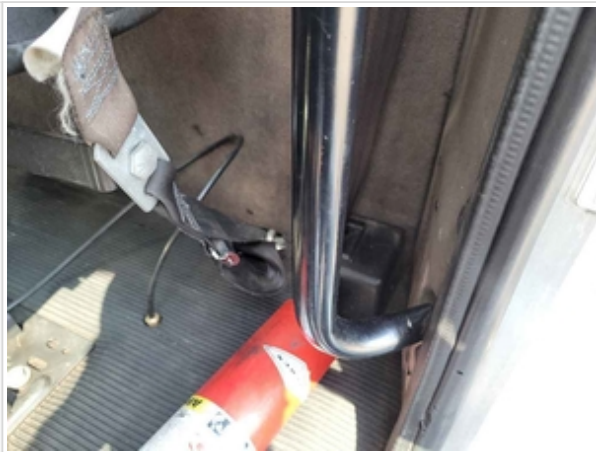
| <p>Seat Belt Photos</p> | |

| <p>Seat Belt</p> | <p>3 - Normal Wear & Tear</p> | |

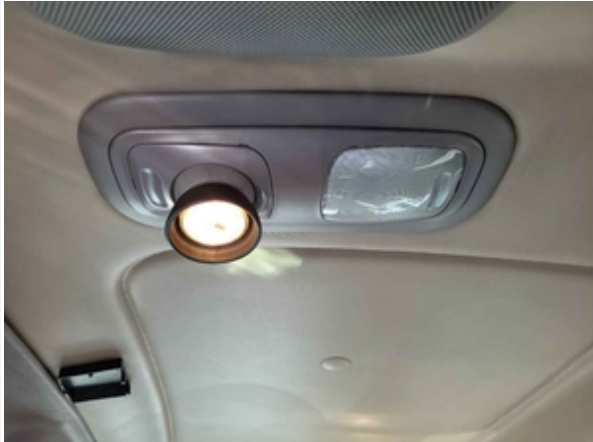
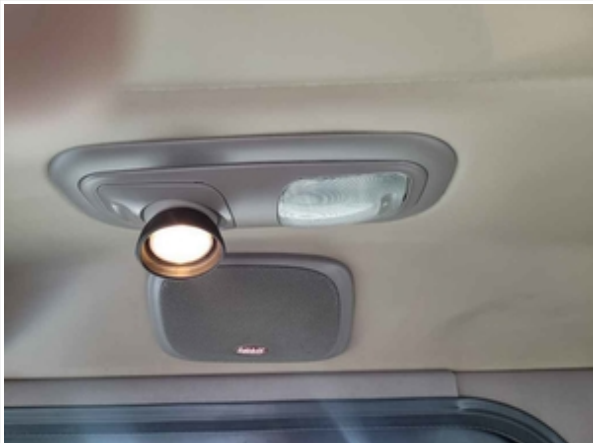
| Cabin Lights Photos | |

| Comments | some overhead dome lights inoperable |

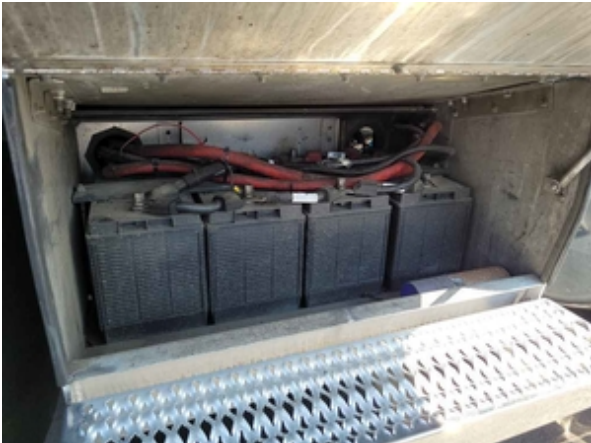
| Battery Condition Photos | |

| Comments | truck didn't start after sitting for a few days (per Chris) |

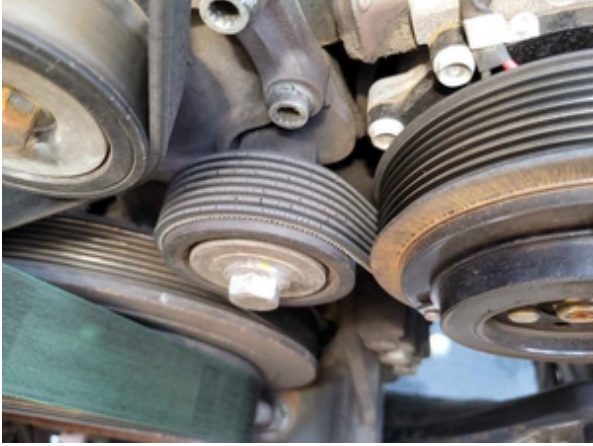
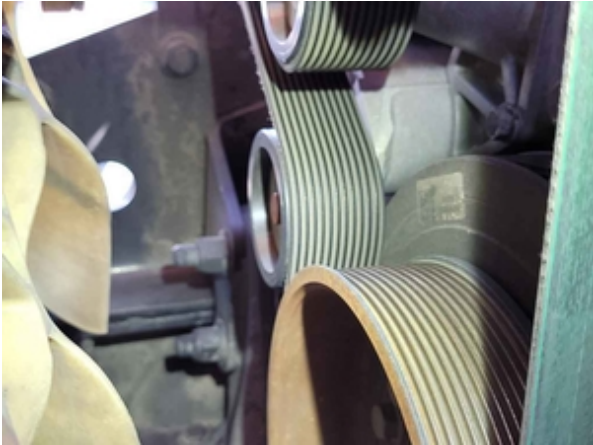
| Belt Photos | |

| Comments | alternator belt signs of small cracks fan belt good |

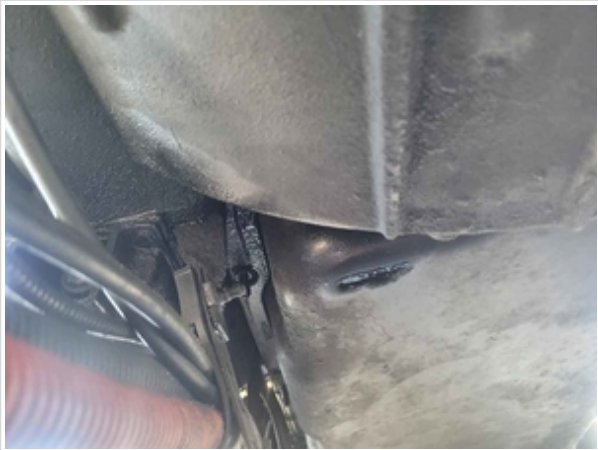
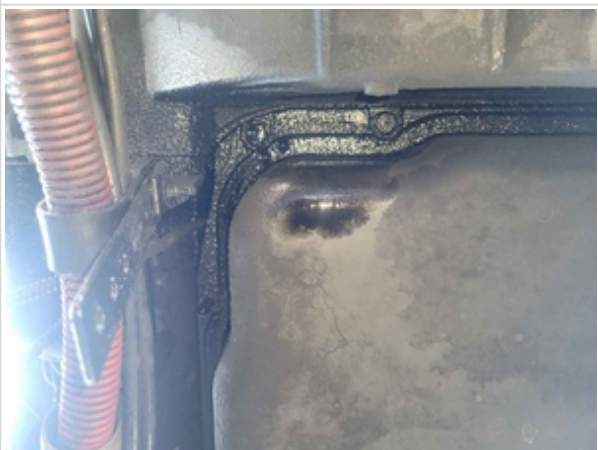
| Oil Leak Photos | | |

| Comments | possible oil leak at rear of oil pan or left rear side of engine block | |

| Overall Engine Comments | Besides the small oil leak, the Engine looks very well maintained! | |
