Inspection Report (On-Highway Lube Truck)

Year	2011
Make	Peterbilt
Model	367
Serial Number	1NPTLU0X1BD130009
Truck Odometer Reading	275,694miles 3,070hours
Current Inspection / State Cert / DOT	completed 4/20/22 @270,214 miles
Previous Application (e.g., earth moving, mining, demolition, etc)	asphalt and general construction

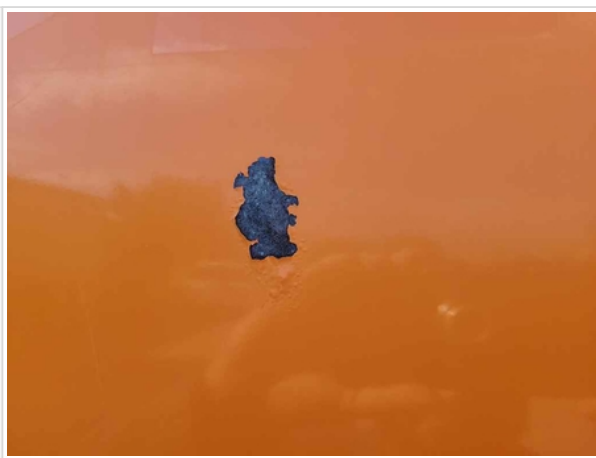
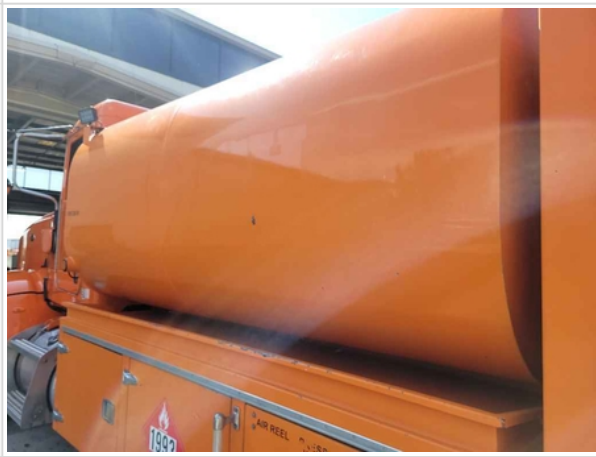
Left	3 - Normal Wear & Tear	
Left Condition	No visible damage, Other (see comments)	
Comments	minor scuff marks, small paint chips, small rust area on diesel fuel tank (2")	
Left Photos

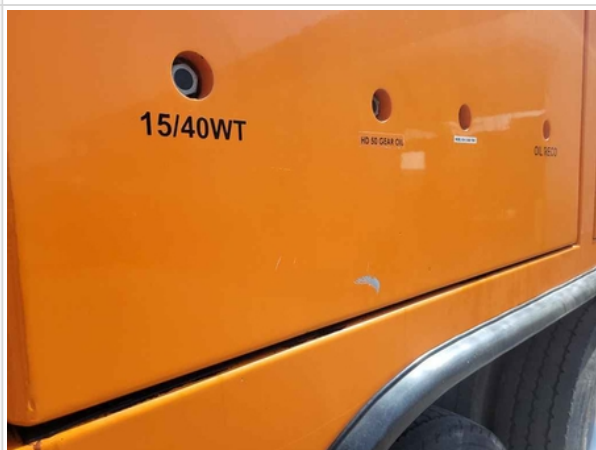
Right	4 - Like New, Recently Replaced	
Right Condition	Other (see comments)	
Comments	minor paint scratches,	
Right Photos

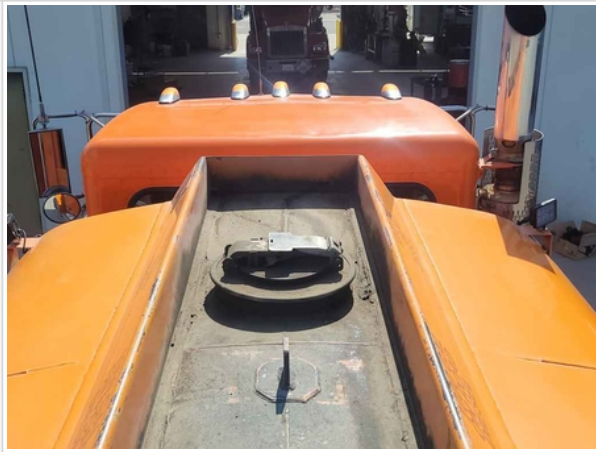
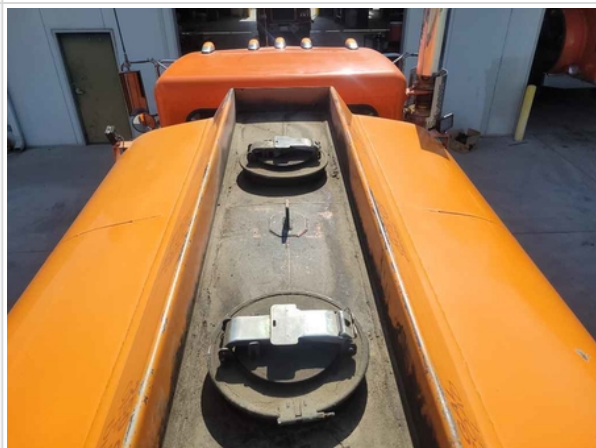
Upper	4 - Like New, Recently Replaced	
Upper Condition	No visible damage, Other (see comments)	
Comments	normal wear overall great condition	
Upper Photos

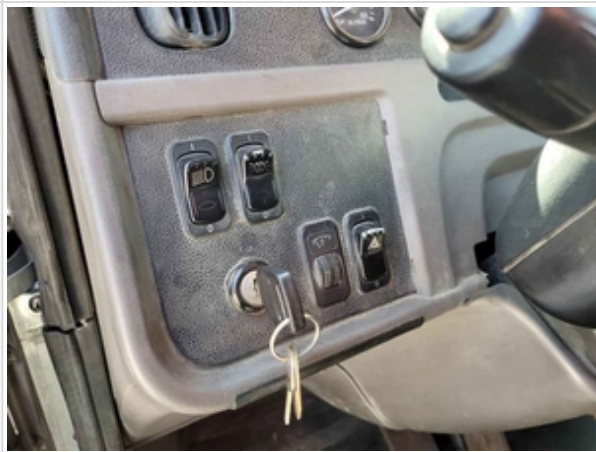
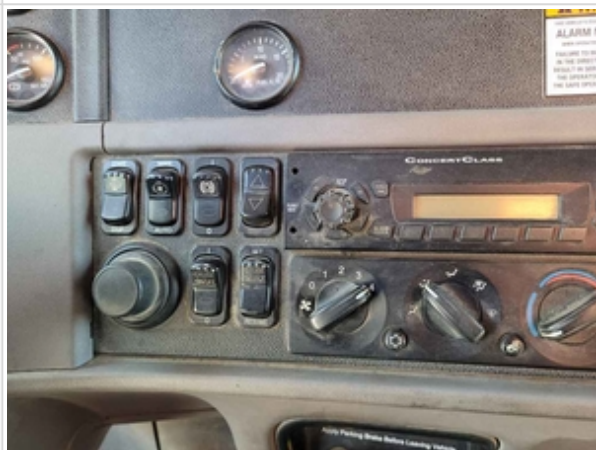
Controls & Switches	3 - Normal Wear & Tear	
Comments	A/C & Heater fan speed control only works in position #4 (1,2,3, inop.)	
Controls & Switches Photos

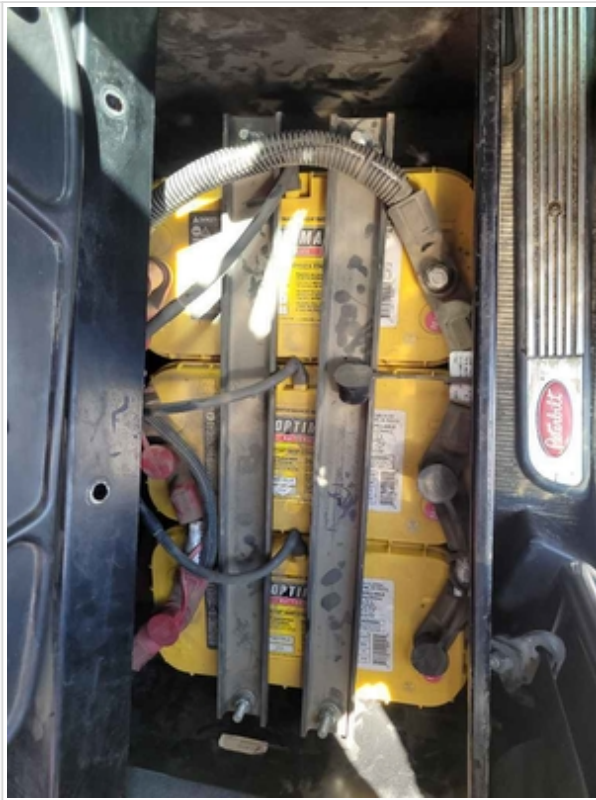
Blow-by (Visual Observation Check)	No	
Unusual Noises (Upon Start-up, Idle, Shutdown)	No	
Unusual Noise Notes	No unusual noises heard	
Engine Smoke (Upon Start-up, Idle, Shutdown)	No	
Engine Smoke Notes	No engine smoke issues observed	
Engine Exhaust Color	Clear	
Battery	4 - Like New, Recently Replaced	
Battery Condition	Like new, recently replaced, Other (see comments)	
Comments	batteries upgraded to Optima High Performance 10/2021

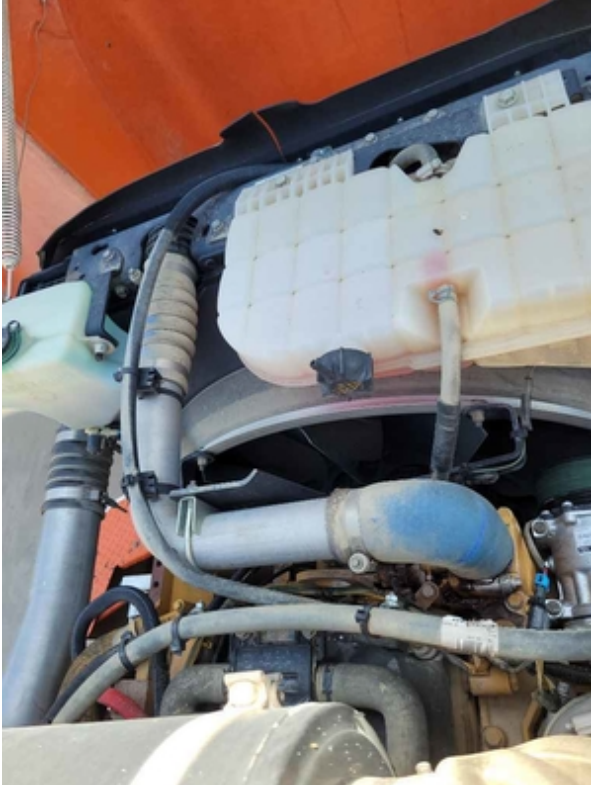
Water Pump	4 - Like New, Recently Replaced	
Water Pump Condition	No unusual pump noises heard, Other (see comments	
Comments	may have been recently replaced (looks new)	
Water Pump Photos

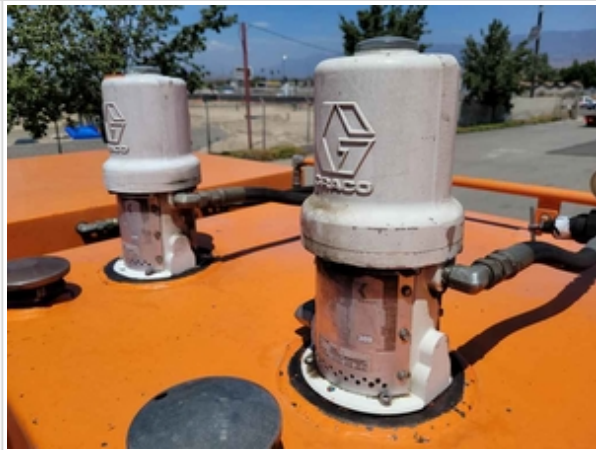
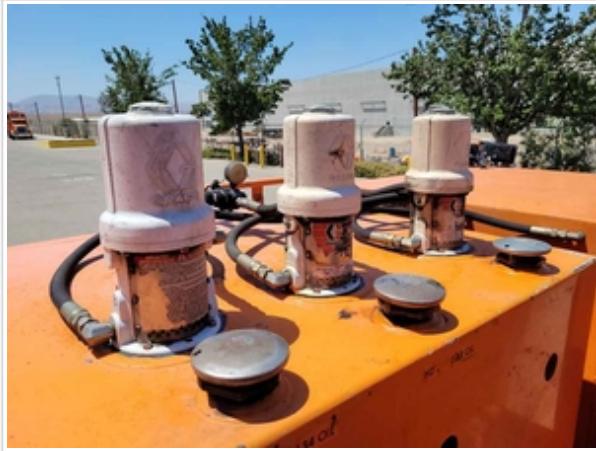
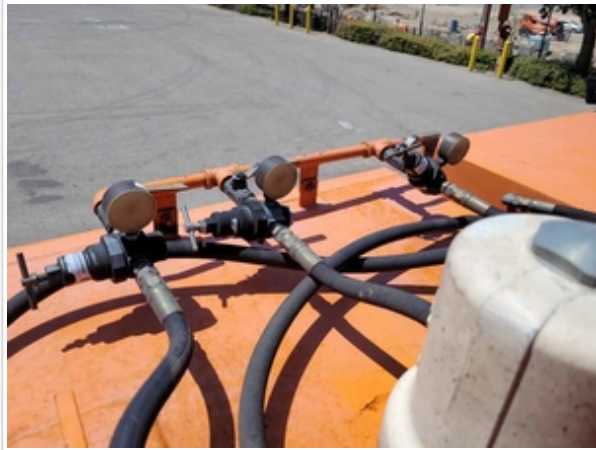
Interior Tank(s) Condition	3	
Comments	unable to capture picture, visually look okay	
Pump(s) Appearance	3	
Comments	air regulator gauges worn (unable to read psi properly)

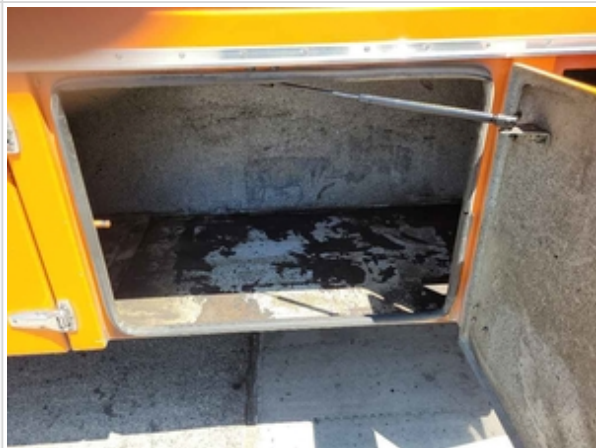
Storage	Check the condition of all storage cabinets (interior & exterior), latches, locks, hinges, and slide out features if applicable.
Toolboxes & Cabinets	3
Comments	some left side toolbox latches (slide out tool storage) broken
Toolboxes & Cabinets Photos

Latches & Locks	3
Comments	door latches all good, left side tool storage internal latches broken
