Inspection Report (Boom Lift)

Year	2013
Make	JLG
Model	1350 SJP
Serial Number	0300172111
Hour Meter Reading	2072.0
Previous Application (e.g., earth moving, mining, demolition, etc)	Rental

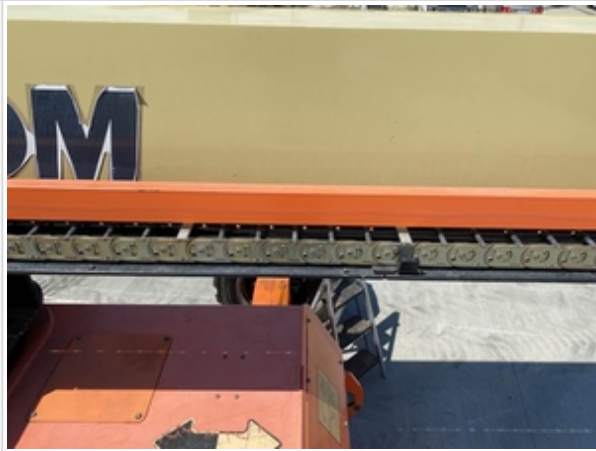
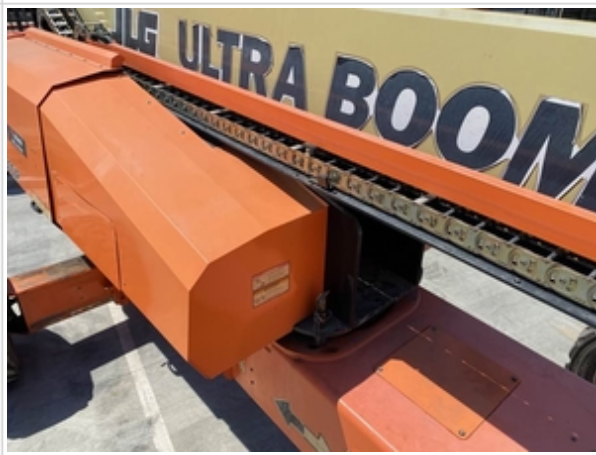
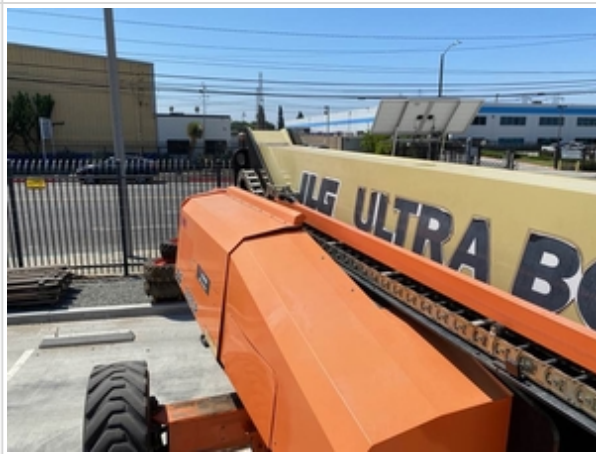
<p>Body Panels (Any Damage?)</p>	<p>3 - Normal Wear & Tear</p>	
<p>Comments</p>	<p>Small dent on left side top body panel</p>

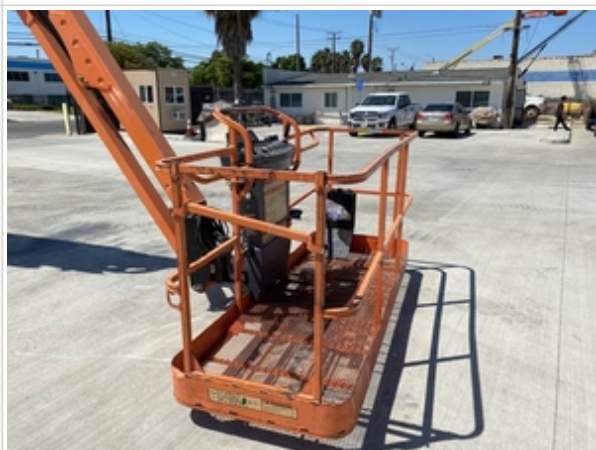
<p>Platform Safety Rails & Appearance</p>	<p>3 - Normal Wear & Tear</p>
<p>Comments</p>	<p>A few bent areas and small cracks at bottom panels top platform side rail bent</p>
<p>Platform Safety Rails & Appearance Photos</p>

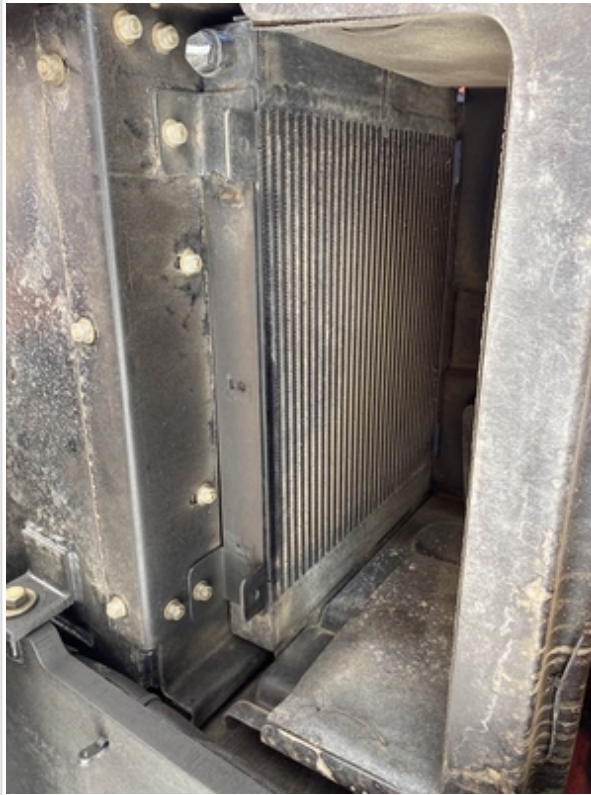
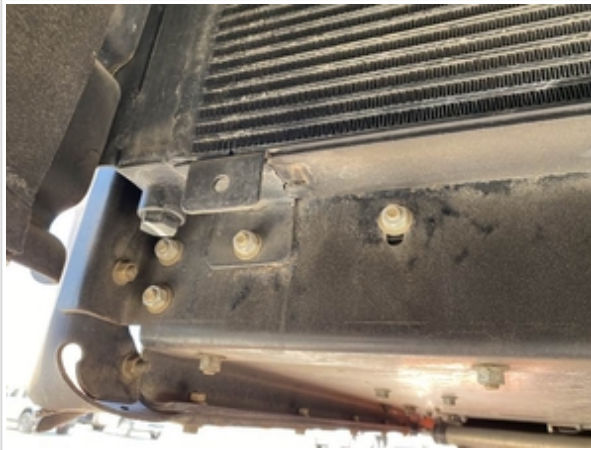
Radiator Photos

Radiator	3 - Normal Wear & Tear
Radiator Condition	Radiator fins & components appear to be in good working order, no signs of damage or leaks, Other (see comments)
Comments	Bottom left mounting bracket cracked at radiator

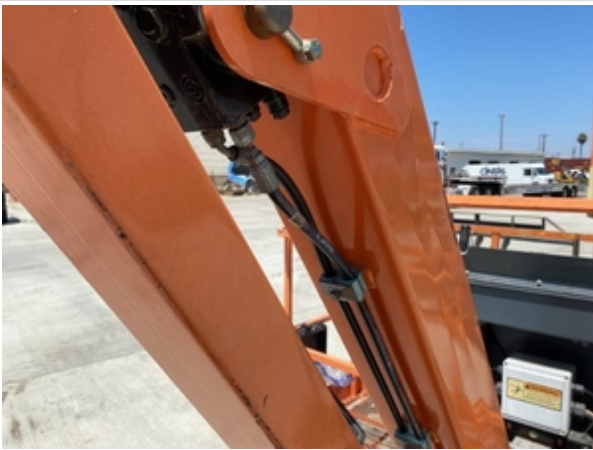
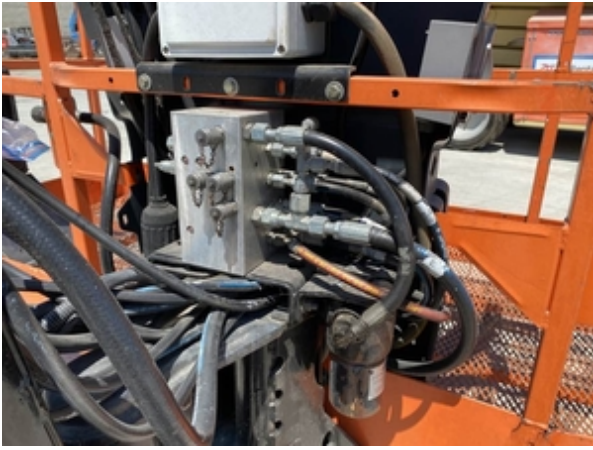
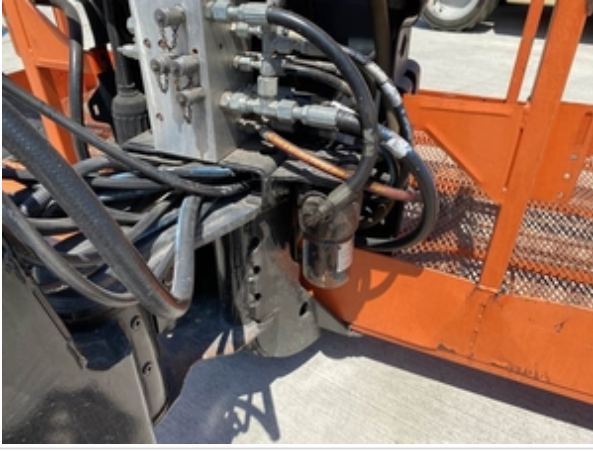
Hoses	3 - Normal Wear & Tear
Hose Condition	Firm, pliant hoses with no signs of wear or leaks, Dried seepages observed, Other (See commentss
Comments	90% of hose in great shape, a few hoses cracked and a few showing seepage

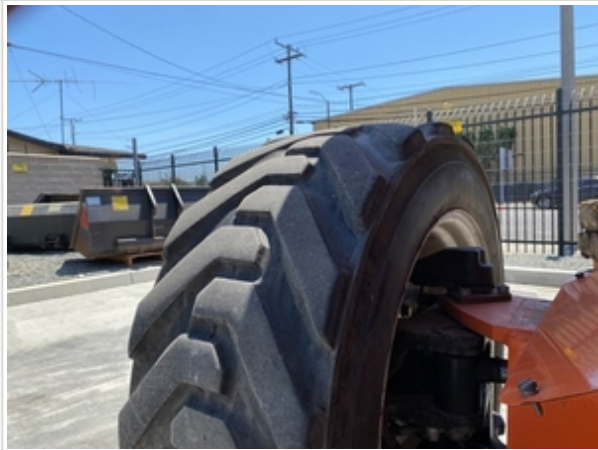
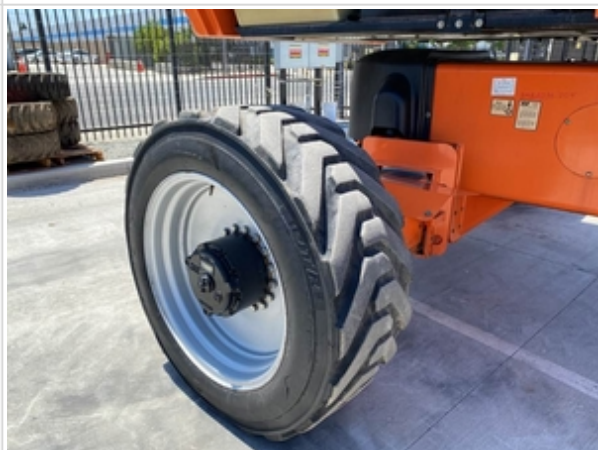
Wheels & Tires Photos

Wheels & Tires	3 - Normal Wear & Tear
Comments	Minor cuts on tires, normal wear, great condition
