Inspection Report (Mini Excavator)

Year	2006
Make	Neuson
Model	G - 2203 RD
Serial Number	AE00164
Hour Meter Reading	555.2
Previous Application (e.g., earth moving, mining, demolition, etc)	General construction (plumbing)

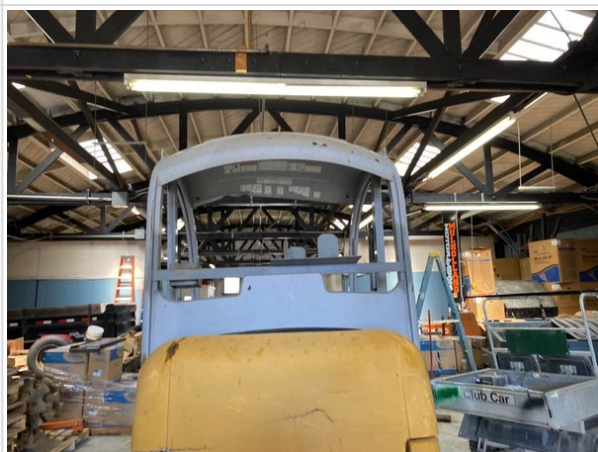
Rear	3 - Normal Wear & Tear	
Rear Condition	Visible chipped paint or dents, Other (see comments)	
Comments	Fiberglass hood cracked	
Rear Photos

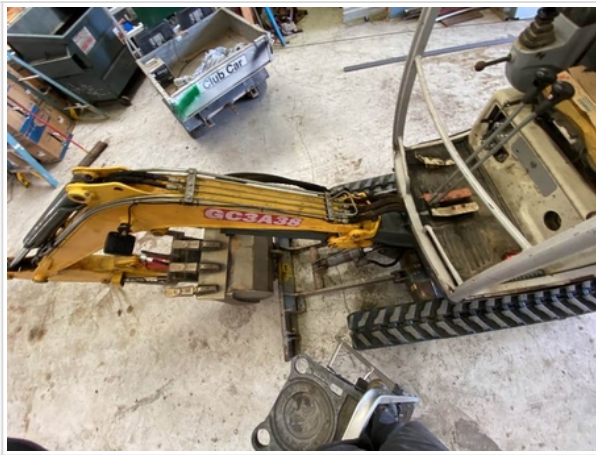
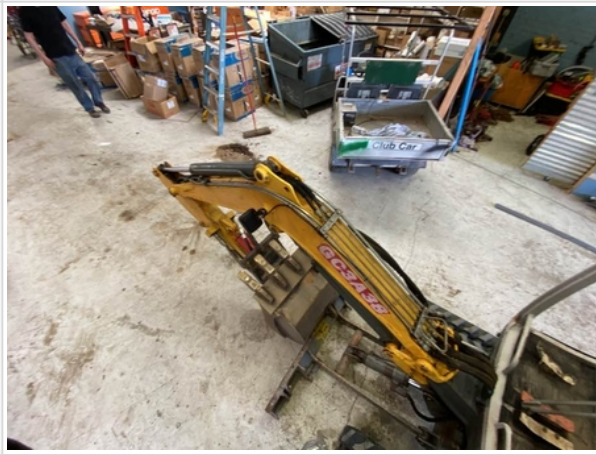
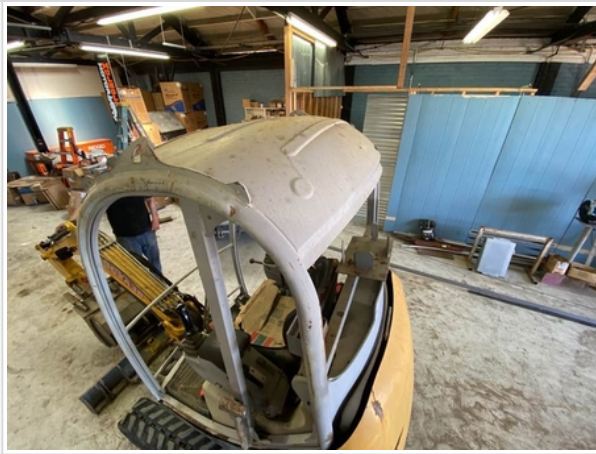
<p>Body Panels (Any Rust Damage?)</p>	<p>3 - Normal Wear & Tear</p>
<p>Body Panel Condition</p>	<p>Some panel misalignment observed, Visible chipped paint or dents</p>

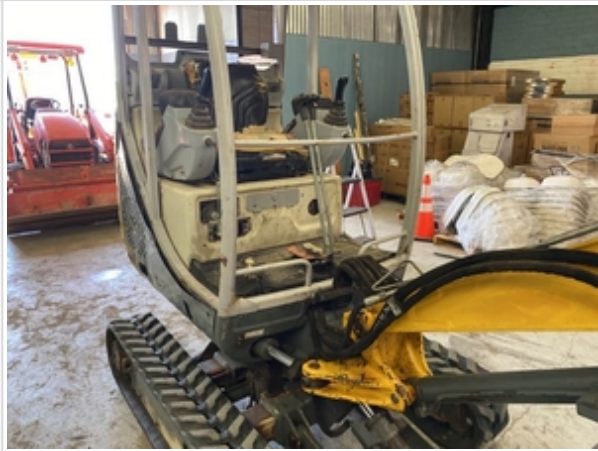
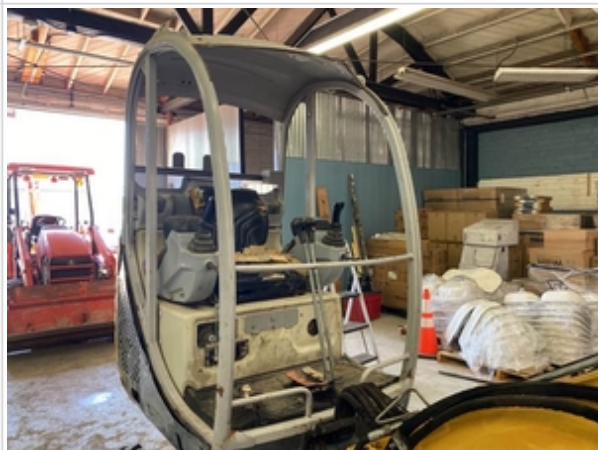
<p>Operator's Seat & Arm Rests</p>	<p>2 - Above Average Wear</p>	
<p>Operator's Seat & Arm Rests Condition</p>	<p>Seat(s) is damaged due to sun exposure; fading, cracking observed, Seat(s) has major surface staining or tears</p>	
<p>Operator's Seat & Arm Rests Photos</p>

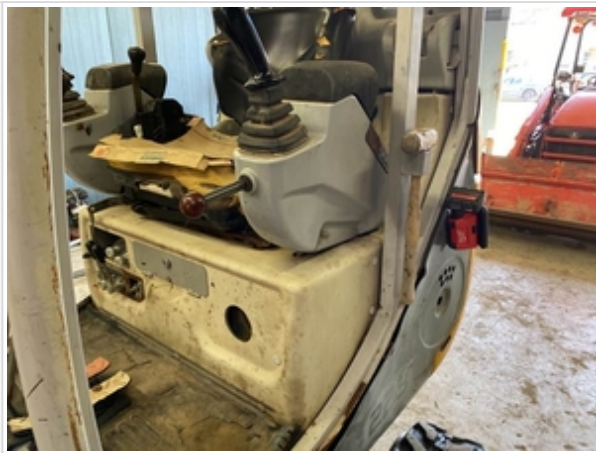
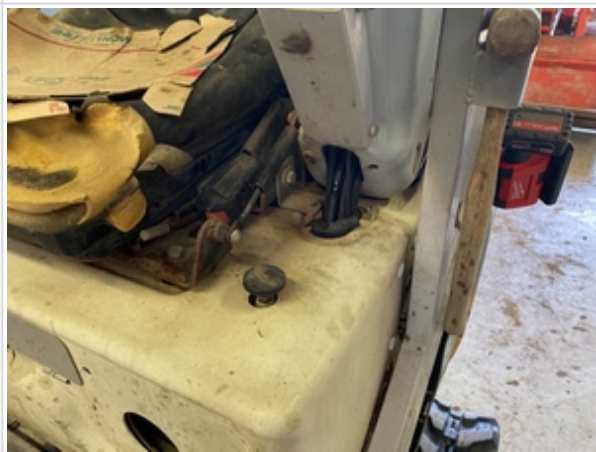
<p>Safety Lock Out / Stop Photos</p>

Seat Belt	3 - Normal Wear & Tear
Seat Belt Condition	Seat belt secures properly. Belt is intact and in good condition
Seat Belt Photos	 
Cabin Lights	0
Safety Lock Out / Stop	2 - Above Average Wear
Safety Lock Out / Stop Condition	Other (see comments)
Comments	Works when in upright condition, shock that holds it upright worn

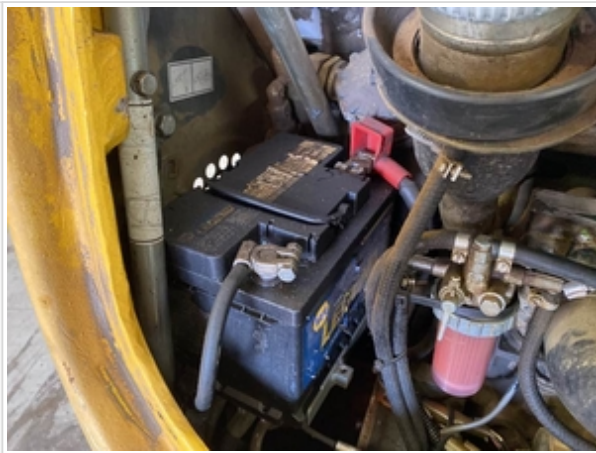
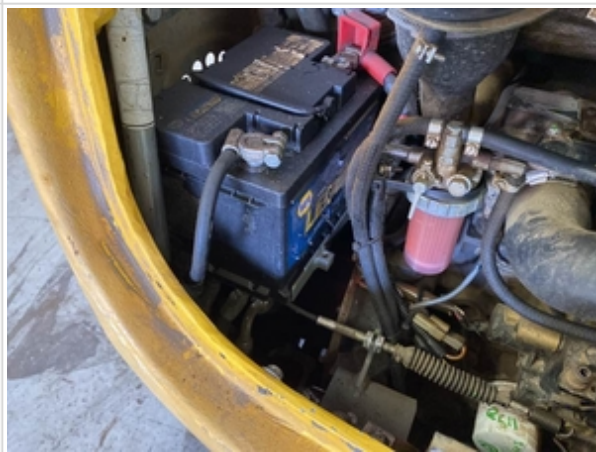
<p>Battery Condition Photos</p>

Blow-by (Visual Observation Check)	No
Unusual Noises (Upon Start-up, Idle, Shutdown)	Yes
Unusual Noise Notes	Other (see comments)
Comments	Sounds like metal brackets or muffler loose (only at idle)
Engine Smoke (Upon Start-up, Idle, Shutdown)	Yes
Engine Smoke Notes	Engine smoke observed upon start up, Other (see comments)
Comments	Normal diesel smoke at startup, fine at idle and high rpm
Engine Exhaust Color	Clear
Battery	3 - Normal Wear & Tear
Battery Condition	Other (see comments)
Comments	Just needs to be cleaned
