General Info

Year	2018
Make	John Deere
Model	26G
Serial Number	1FF026GXVJK263516
Hour Meter Reading	TBD current meter shows 6.5 hours
Previous Application (e.g., earth moving, mining, demolition, etc)	Equipment Rental

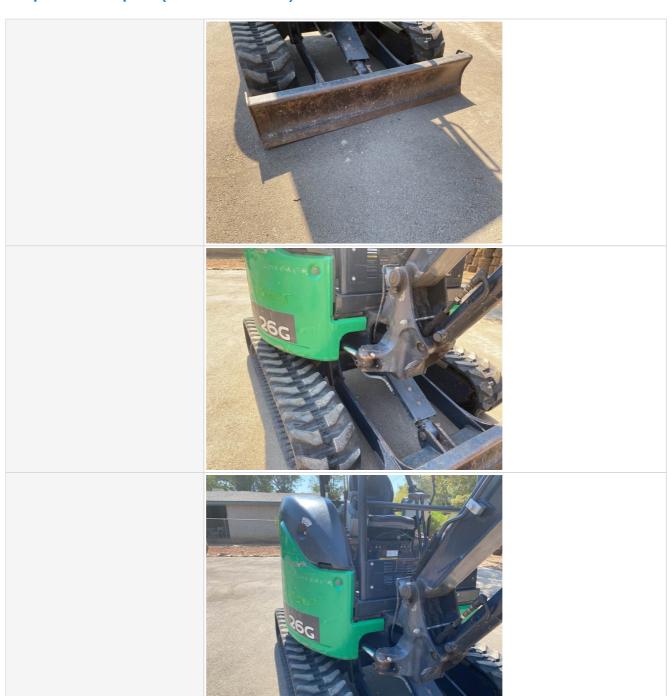
General Appearance Inspection Points	
General Appearance	
Front	3 - Normal Wear & Tear
Front Condition	No visible damage, Other (see comments)
Comments	Normal scuff marks
Front Photos

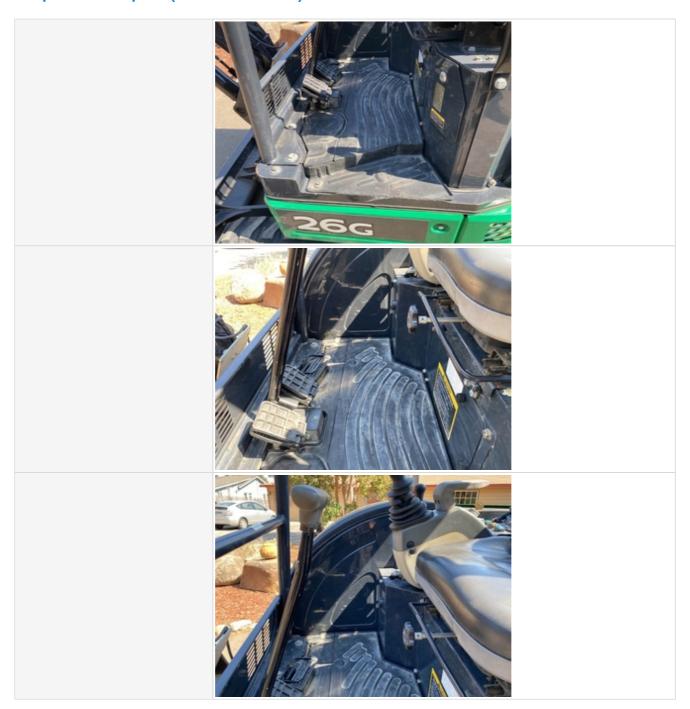
Good cabin appearance, solid floors, panels, and ceiling

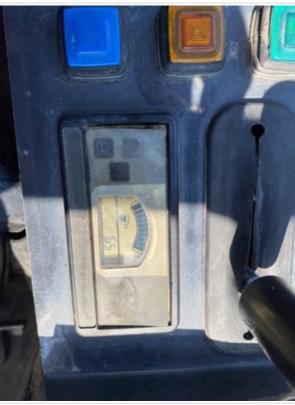
Hour Meter Activity Photos

mapedion report (Min	- Exocitation /
Controls & Switches	3 - Normal Wear & Tear
Controls & Switches Condition	All switches are installed and functional
Controls & Switches Photos	
Hour Meter Activity	3 - Normal Wear & Tear
Hour Meter Condition	Hour meter is functional and in good condition, Hour meter is functional, with some minor wear and/or cosmetic damage, Other (see comments)
Comments	6.5 hours on current hour meter

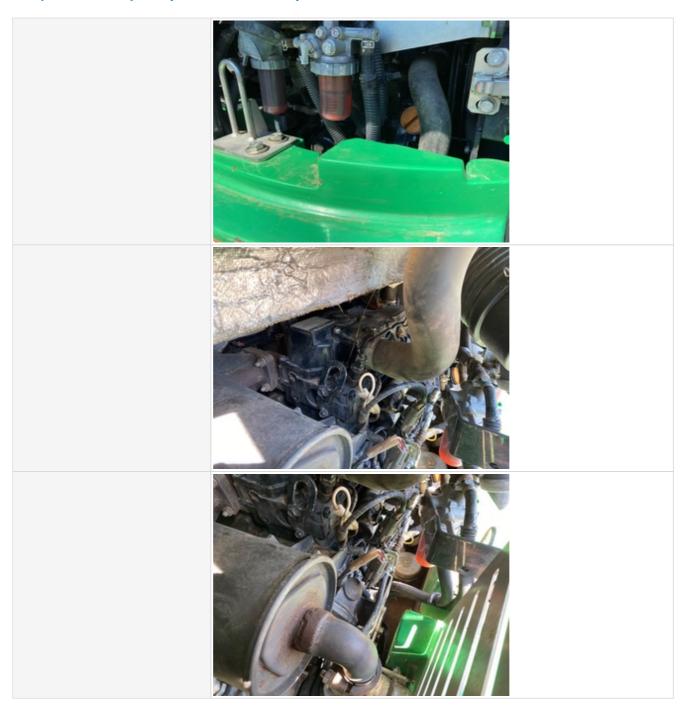
Lingine inspection i onto	
Engine	
Engine Type (Make, Model, Cylinders, Hp)	Yanmar - 3cyl 1.27 L 20HP
Engine Serial Number	19994
Engine Fuel Type	Diesel
Engine Photos

Oil Color / Appearance Notes	Clean oil appearance, no signs of cross contamination, Appropriate oil level
Fuel Leaks	No
Equipped with DPF (Diesel Particulate Filter)	No
Requires DEF (Diesel Exhaust Fluid)	No
Overall Engine Appearance	Clean & dry
Overall Engine Comments	Engine is super clean! Well maintained with no leaks. Sounds healthy and runs well.

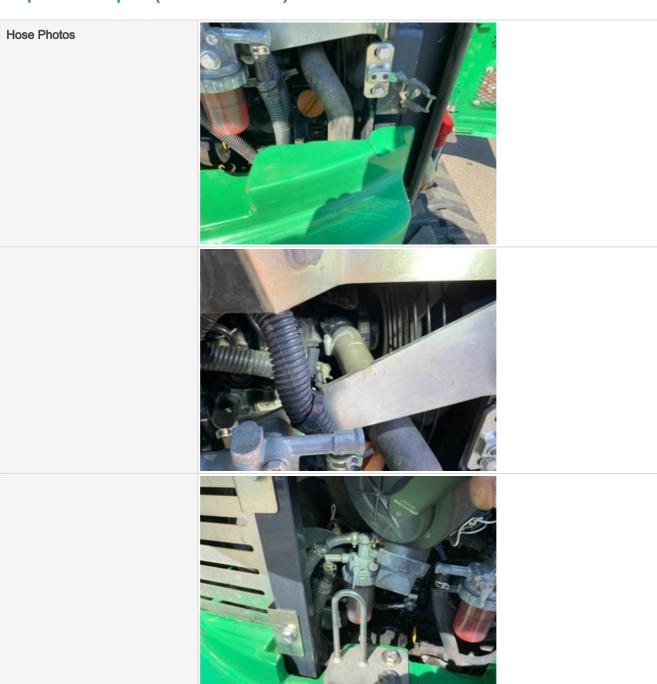
Belts	3 - Normal Wear & Tear
Belt Condition	Belts appear in good condition & alignment with proper tension
Belt Photos	
Hoses	3 - Normal Wear & Tear
Hose Condition	Firm, pliant hoses with no signs of wear or leaks

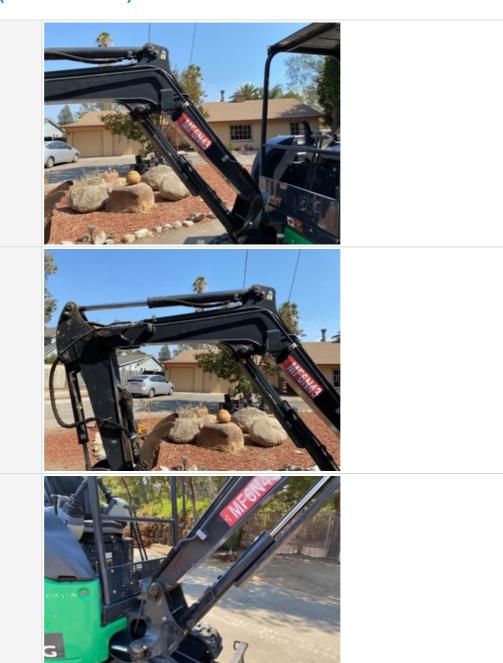
Chassis inspection Points)
Instructions	Evaluate the following on a 4 point scale (leave comments where an explanation is appropriate): 4 = Like New, Recently Replaced 3 = Normal Wear & Tear 2 = Above Average Wear 1 = Service Required
Boom Condition	3 - Normal Wear & Tear
Boom Photos	266

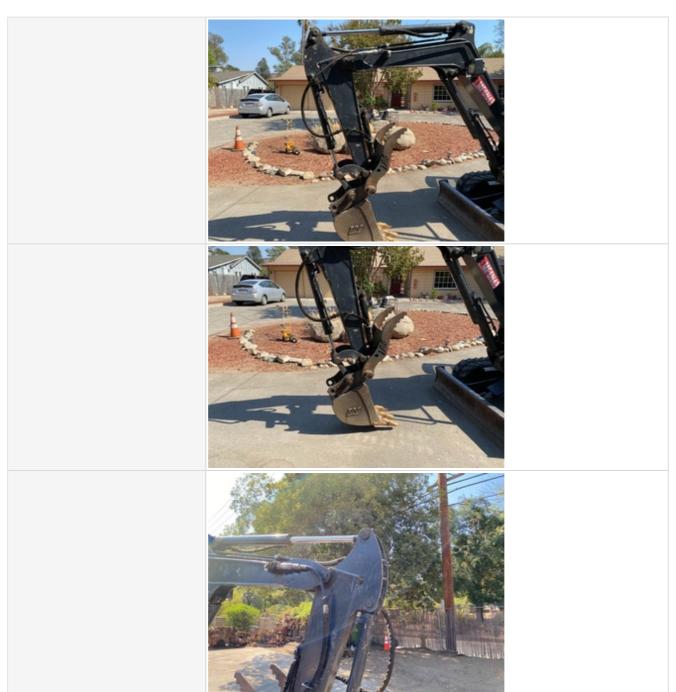
Stick Photos

Stick Condition

3 - Normal Wear & Tear

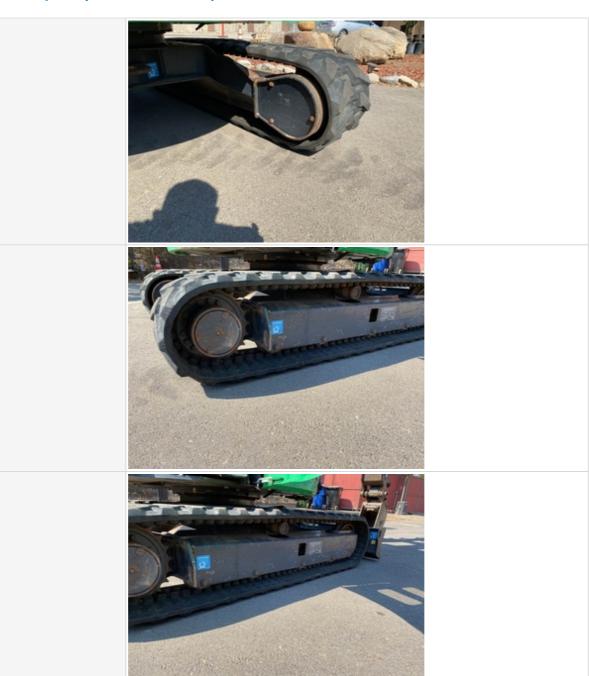
Instructions	Evaluate the following on a 4 point scale (leave comments where an explanation is appropriate):
	4 = Like New, Recently Replaced 3 = Normal Wear & Tear 2 = Above Average Wear 1 = Service Required
D. II. E	
Roller Frames Roller Frames Photos	3 - Normal Wear & Tear

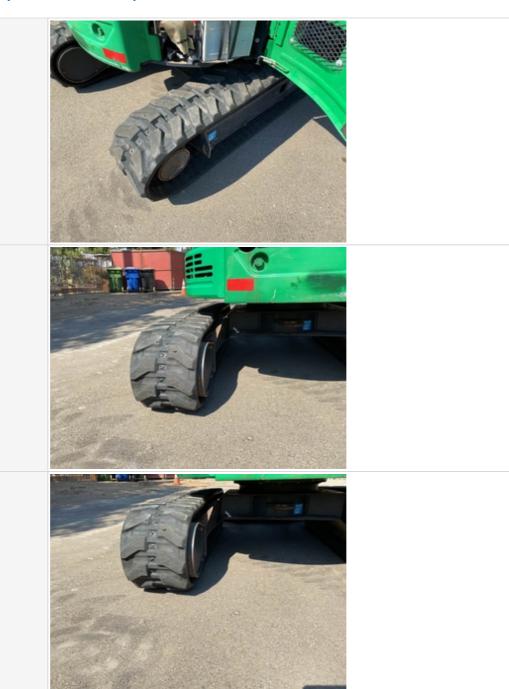
Rubber Belt Drive Lugs Photos

Rubber Belt Drive Lugs

3 - Normal Wear & Tear

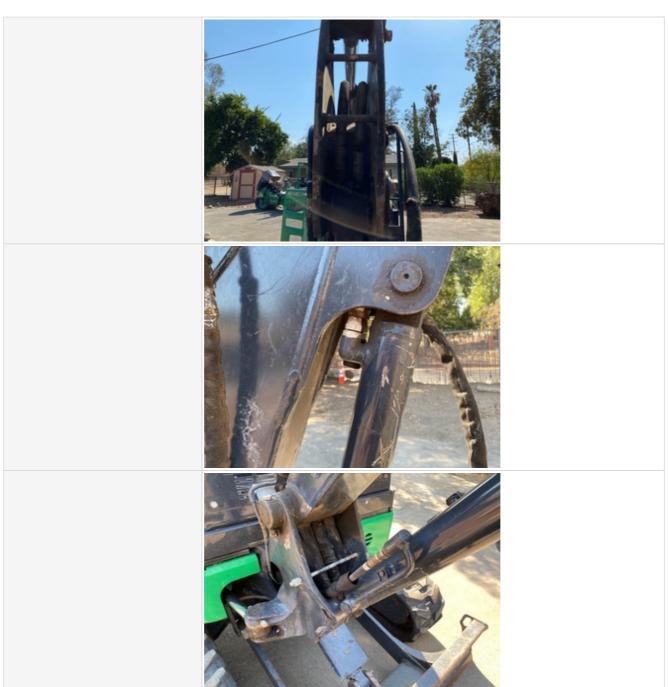
Appearance of Hydraulic Lines / Fittings Photos

Hydraulics Overall	
Wet or Damp Hydraulic Lines / Fittings	No
Appearance of Hydraulic Lines / Fittings	4
Hydraulic Lines / Fittings Condition	Hydraulic lines & fittings are clean and in good condition

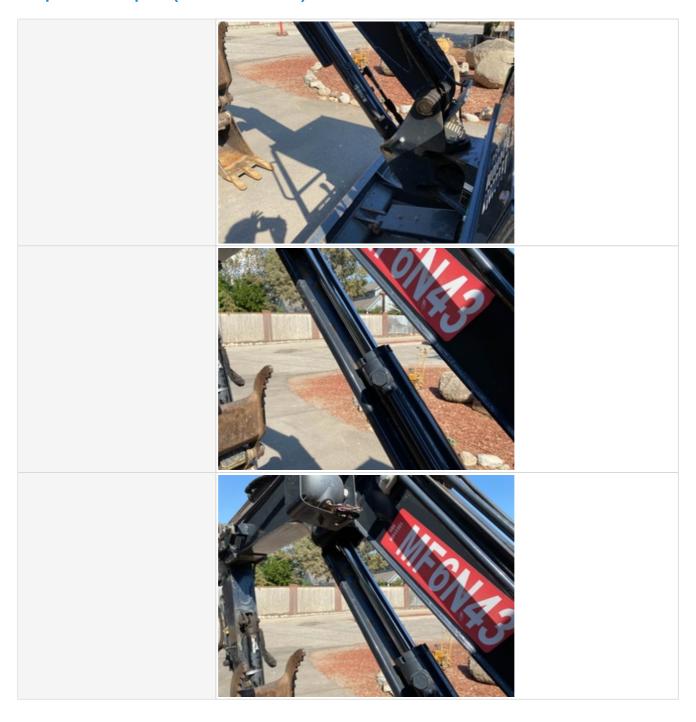
Tryaradiloo Oyiiriadio iriop	
Boom Cylinder	Check the boom cylinder. Note any wear, pitting, discoloration, etc. Take photos.
Boom Cylinder: Mounting Pin	4
Boom Cylinder: Oil Leaks	No
Boom Cylinder Photos

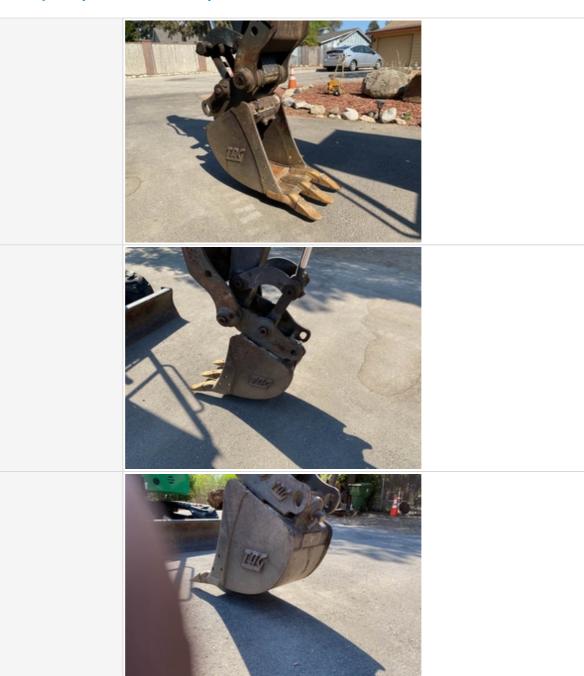
Ducket Inspection Forms	
Instructions	Evaluate the following on a 4 point scale (leave comments where an explanation is appropriate):
	4 = Like New, Recently Replaced 3 = Normal Wear & Tear 2 = Above Average Wear 1 = Service Required
Bucket Condition	3 - Normal Wear & Tear
Bucket Photos

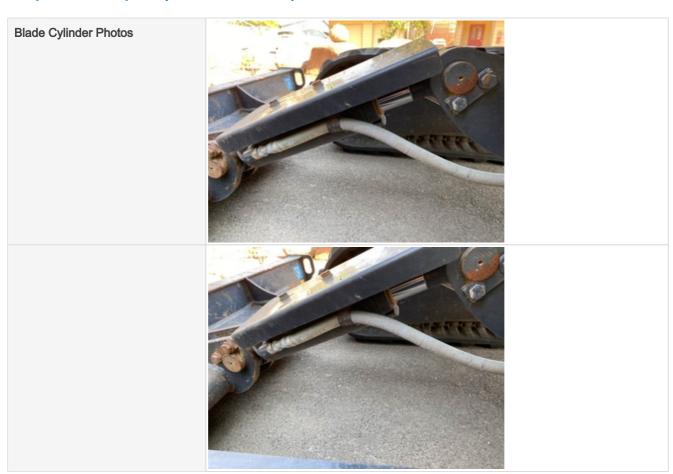
Blade Condition	3 - Normal Wear & Tear
Blade Edge	3 - Normal Wear & Tear
Blade Edge Photos	
Blade Hose & Fittings	3 - Normal Wear & Tear
Blade Cylinder	3 - Normal Wear & Tear

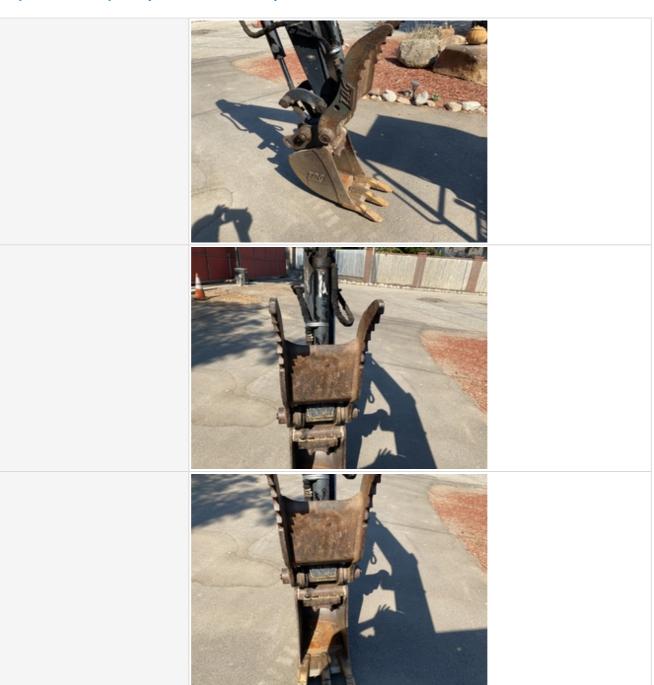
Additional Attachments	Additional Attachments	
Attachment Type	hydraulic thumb	
Attachment Make	Tag	
Attachment Size / Specs	12"	
Attachment Condition	3 - Normal Wear & Tear	
Attachment Photos
