Inspection Report (On-Highway Dump Truck)

Year	2014
Make	Caterpillar
Model	CT660
Serial Number	3HTJGTKT3EN019099
Truck Odometer Reading	172,828
Current Inspection / State Cert / DOT	Expired (no d.o.t. Inspection on hand)
Previous Application (e.g., earth moving, mining, demolition, etc)	Asphalt paving construction

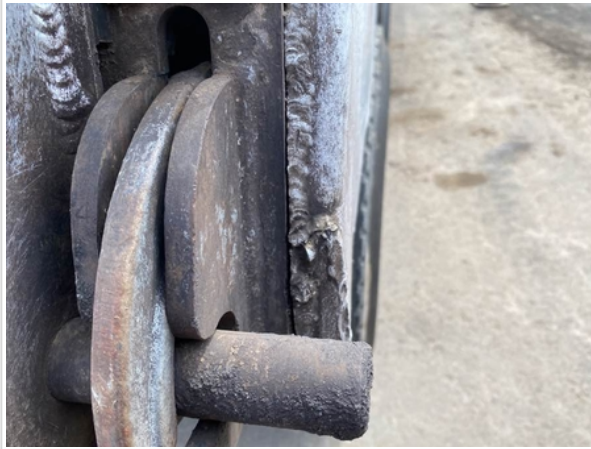
Rear	3 - Normal Wear & Tear	
Rear Condition	No visible damage, Other (see comments)	
Comments	Small crack on aluminum on rear tailgate latches	
Rear Photos

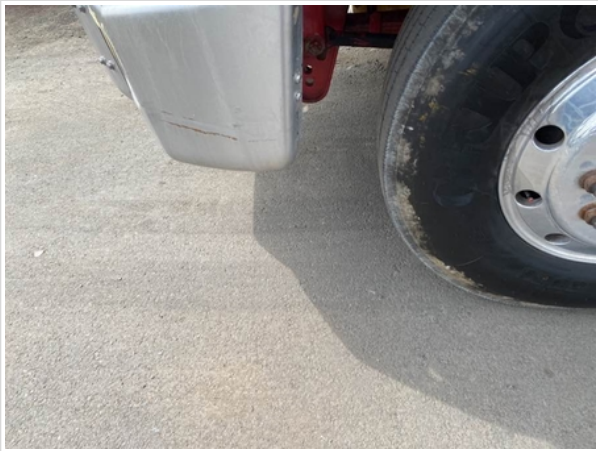
Left	3 - Normal Wear & Tear	
Left Condition	Other (see comments), Visible chipped paint or dents	
Comments	Dent on hydraulic reservoir and scuff marks on dump body	
Left Photos

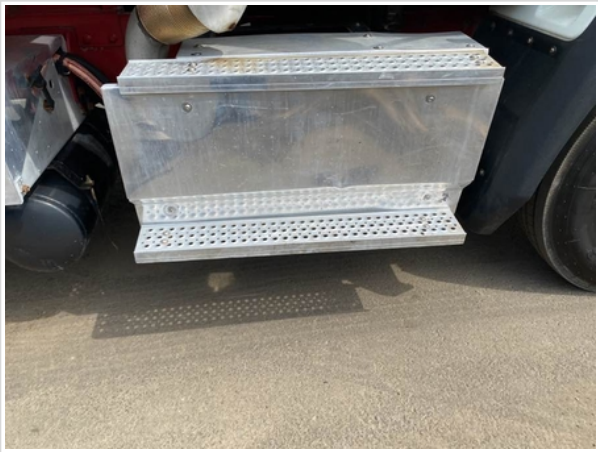
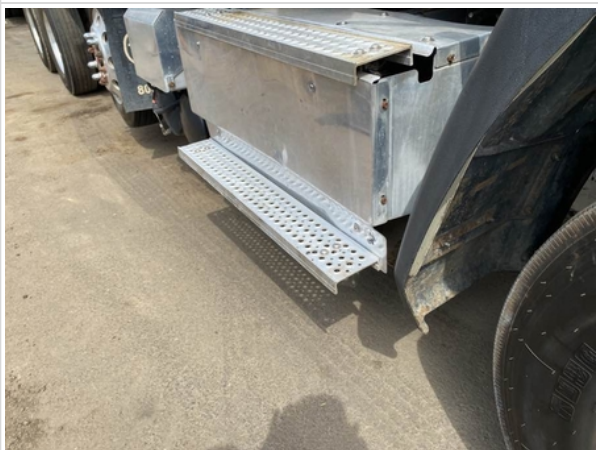
Right	3 - Normal Wear & Tear	
Right Condition	Visible chipped paint or dents, Other (see comments)	
Comments	Small dent on right side dpf cover and muffler stack bent	
Right Photos

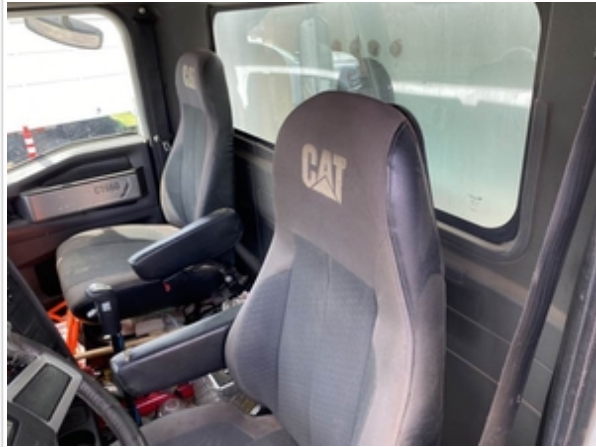
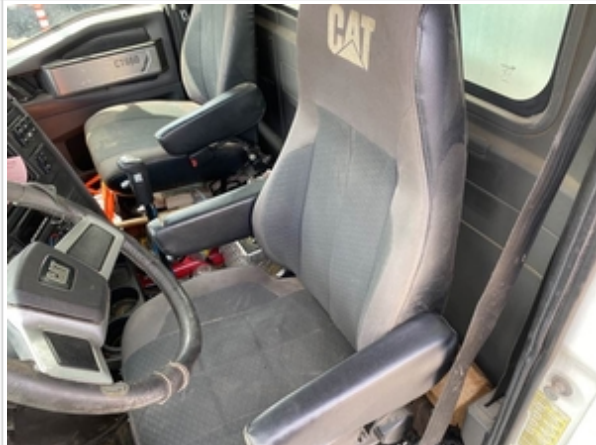
Operator's Seat & Arm Rests	3 - Normal Wear & Tear
Comments	Minor wear and small tear on driver bottom cushion
Operator's Seat & Arm Rests Photos

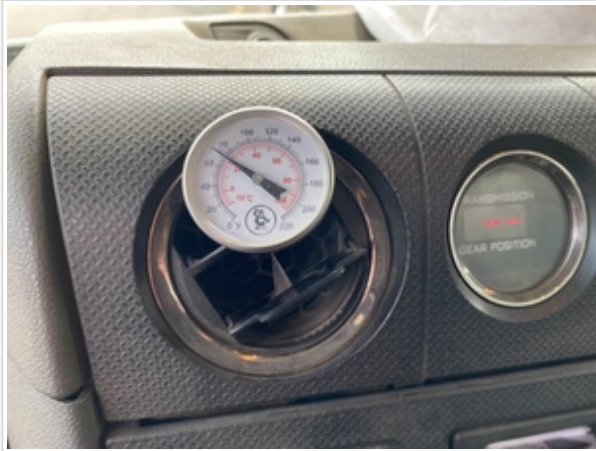
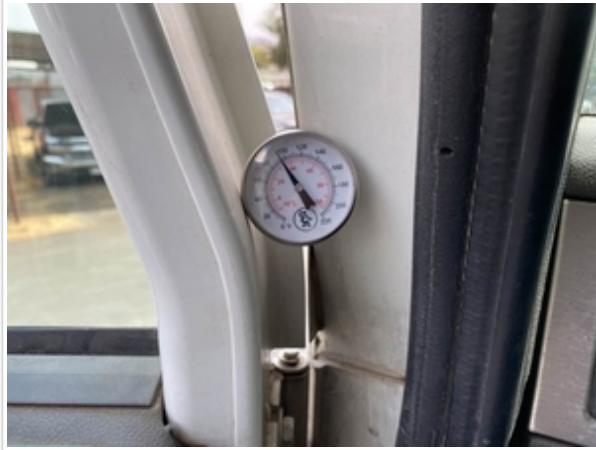
Heater & A/C	3 - Normal Wear & Tear
Comments	A/C temp 27 degrees below ambient temp, may need a service (still functioning well)

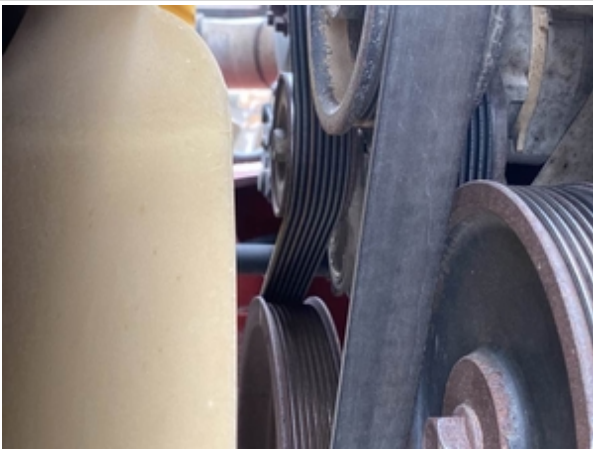
Belts	3 - Normal Wear & Tear	
Belt Condition	Frayed belt edges observed, Belts appear in good condition & alignment with proper tension	
Comments	A/c belt needs to be replaced soon, fan serpentine okay	
Belt Photos

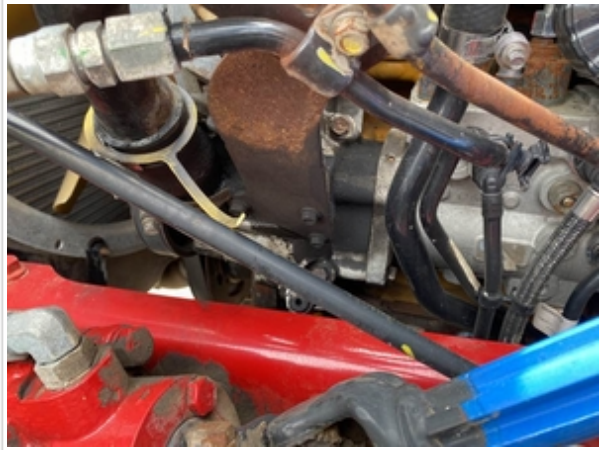
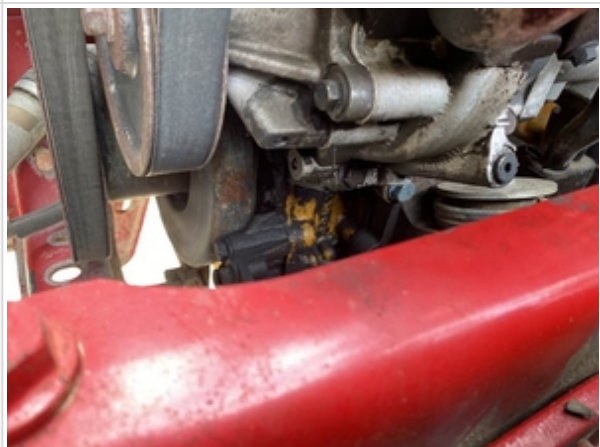
Cooling System Leaks	No	
Coolant Color / Appearance	3 - Normal Wear & Tear	
Coolant Color/Appearance Notes	Normal Translucent appearance, no visual signs of contamination	
Oil Leaks	Yes	
Oil Leak Notes	Dried oil seepages seen, Wetness & discoloration observed	
Comments	Oil leak present at left side oil fill tube to block & left side rear behind air compressor	
Oil Leak Photos

Overall Engine Appearance	Clean & dry
Overall Engine Comments	Overall engine looks good. Only visual issues found would be the two engine oil leaks on left side of engine.

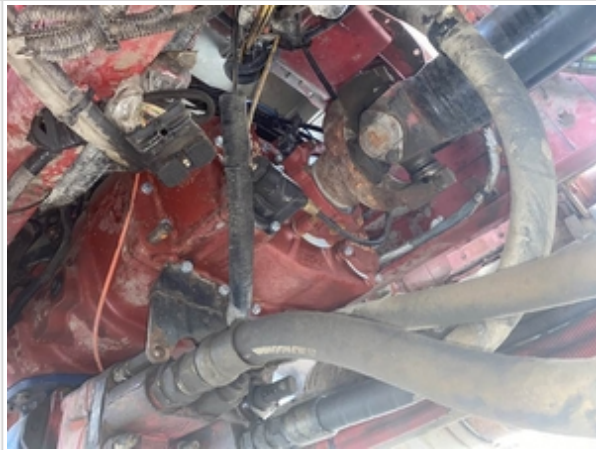
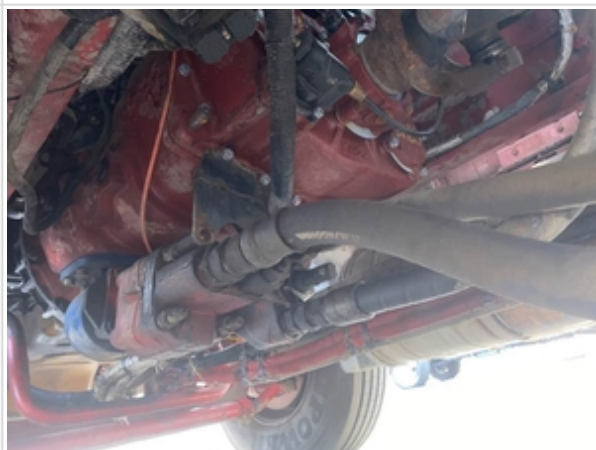
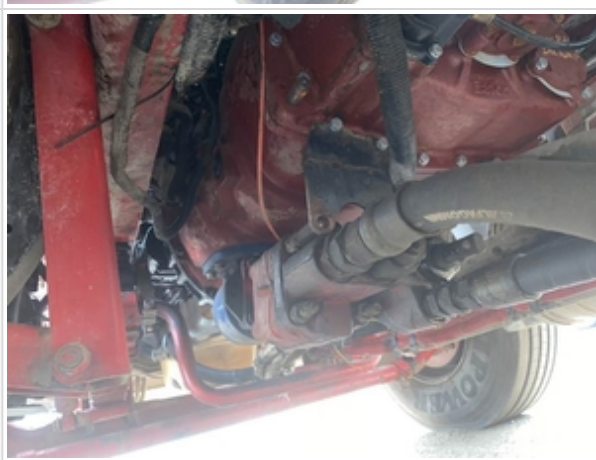
Transmission Info (Make/Model)	Eaton 13spd Manual Transmission
Drive Type	4X2
Overdrive	No
Transmission	3 - Normal Wear & Tear
Transmission Condition	No unusual noises or vibrations, Leaking transmission fluid observed

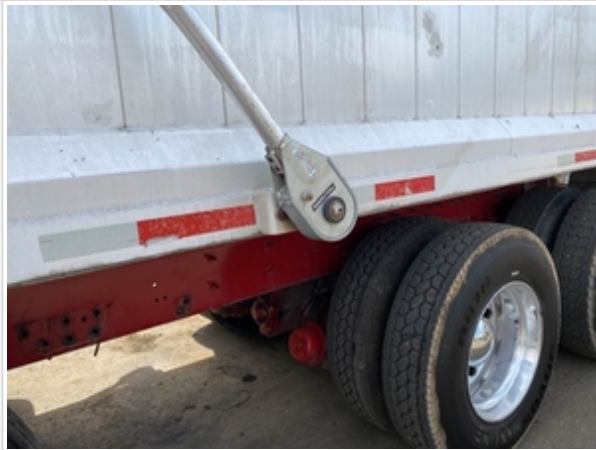
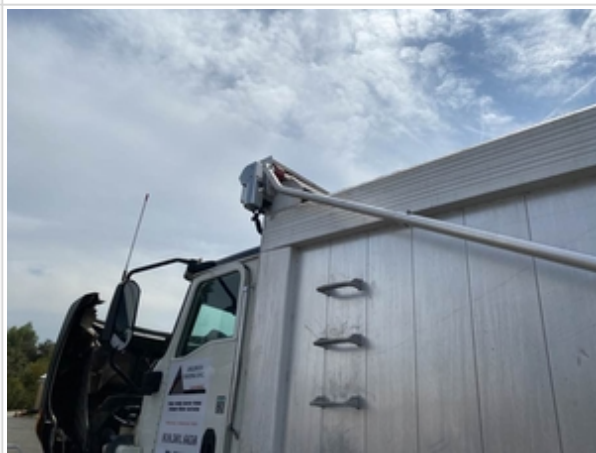
Tarp	1
