Inspection Report (On-Highway Service Truck)

Year	2015
Make	Ford
Model	F450
Serial Number	1FD0X4GTXFEB96166
Truck Odometer Reading	145,802
Current Inspection / State Cert / DOT	90 day inspection performed August 26th 2022 by in house mechanic
Previous Application (e.g., earth moving, mining, demolition, etc)	Grading General Construction Service Truck

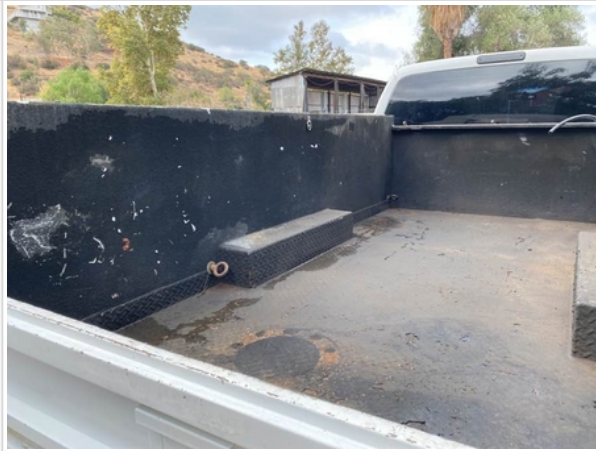
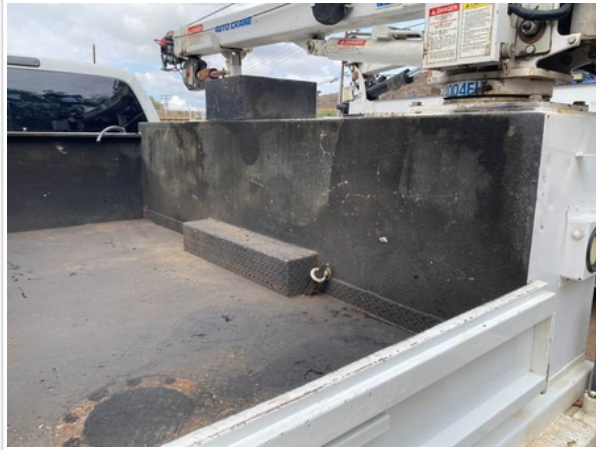
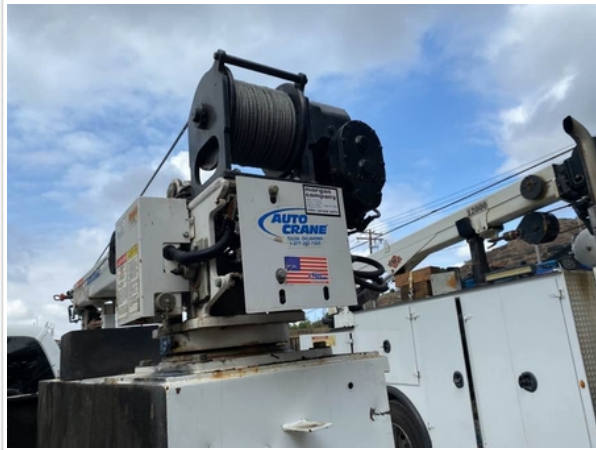
Left	3 - Normal Wear & Tear
Left Condition	No visible damage

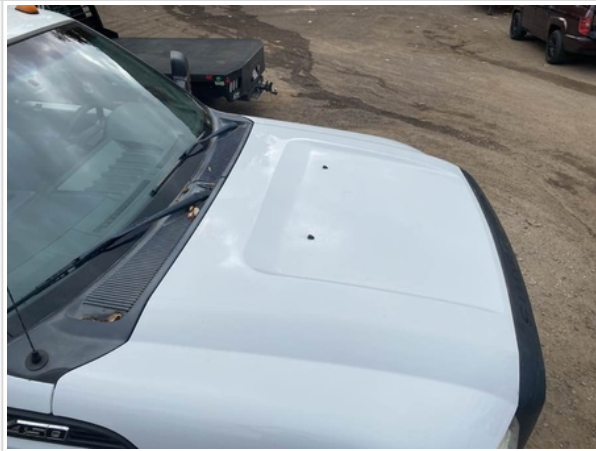
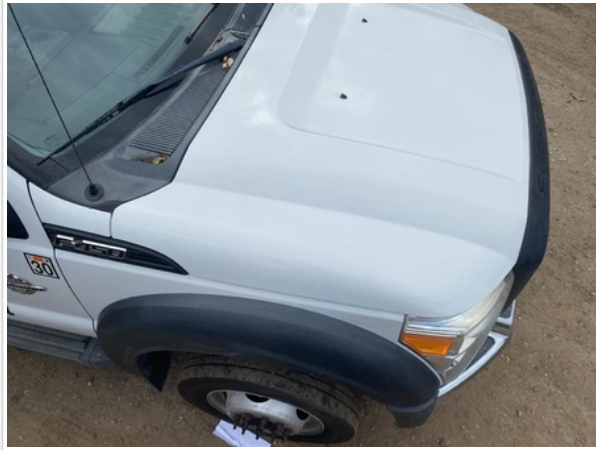
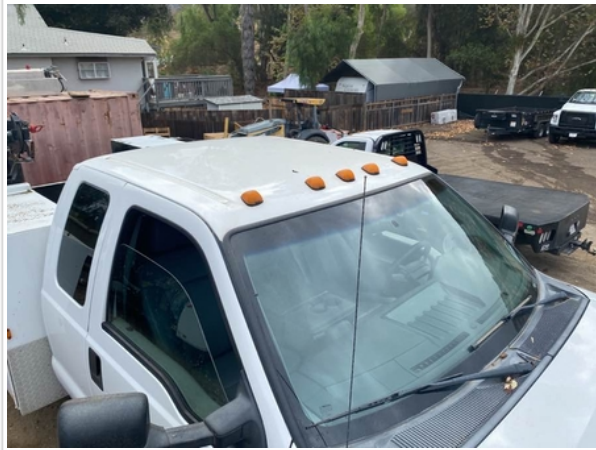
Upper Photos

Upper	3 - Normal Wear & Tear
Upper Condition	No visible damage

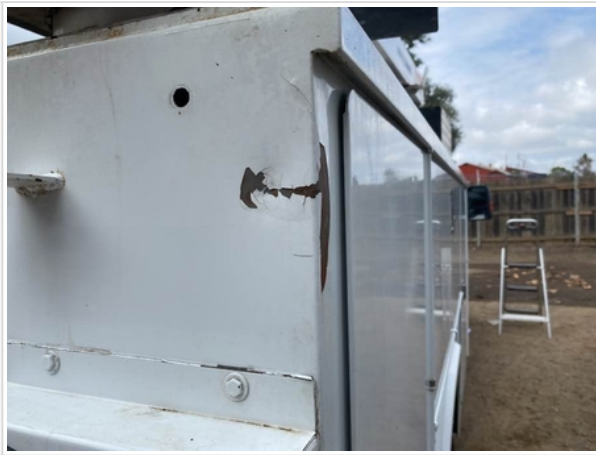
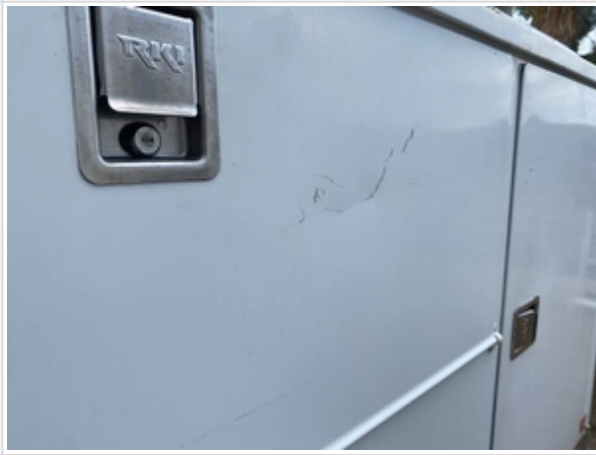
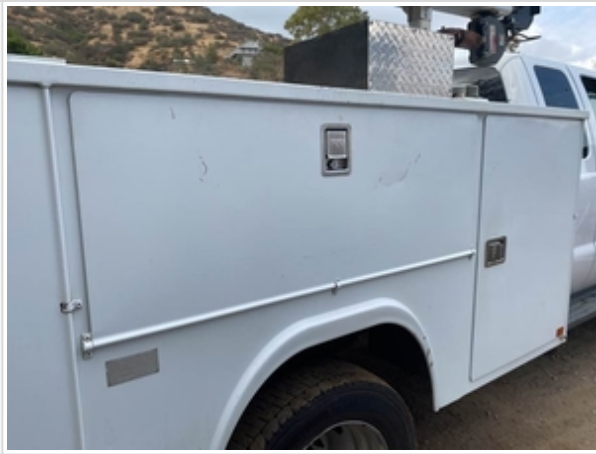
Body Panels Photos

Body Panels (Any Rust Damage?)	3 - Normal Wear & Tear
Body Panel Condition	No visible damage, good paint condition and panel fitment, Other (see comments)
Comments	Normal scuff marks and small dents and paint chips on rear of service body

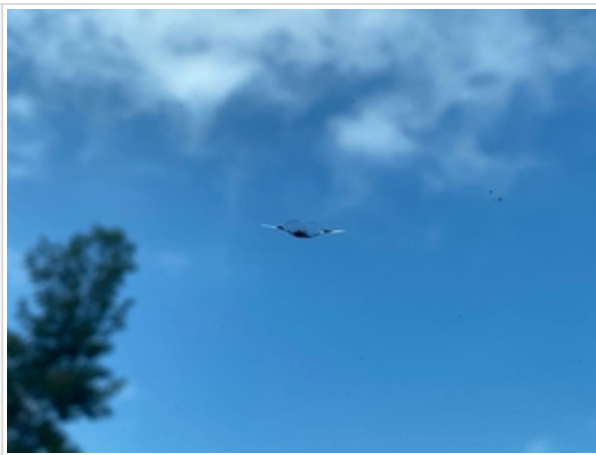
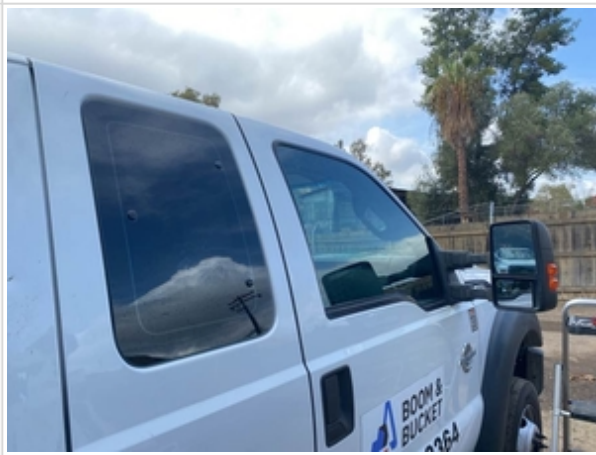
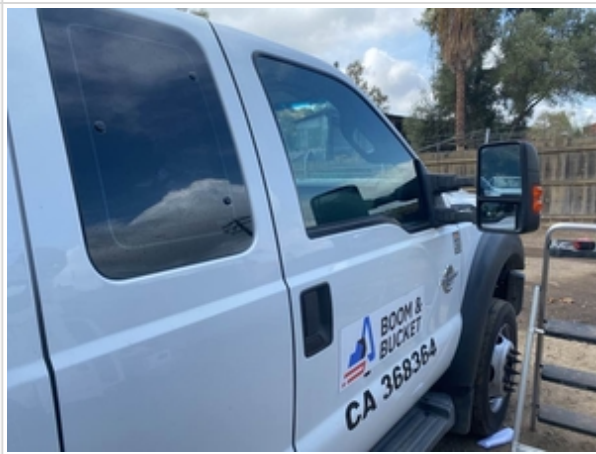
Mirrors Photos

Mirrors	3 - Normal Wear & Tear	
Mirror Condition Notes	Mirrors present and intact, no visible damage

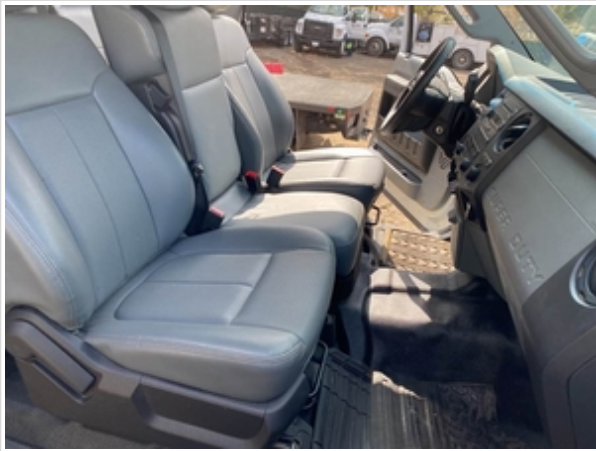
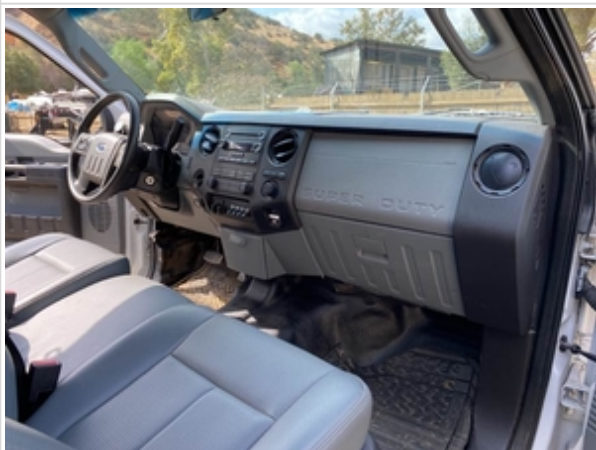
Operator's Seat & Arm Rests	4 - Like New, Recently Replaced	
Comments	Really good clean condition	
Operator's Seat & Arm Rests Photos

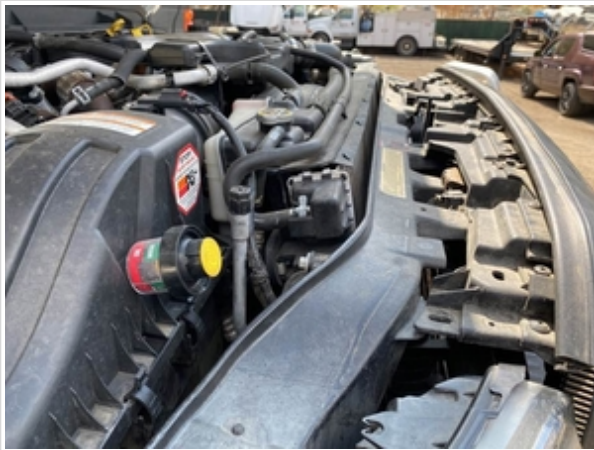
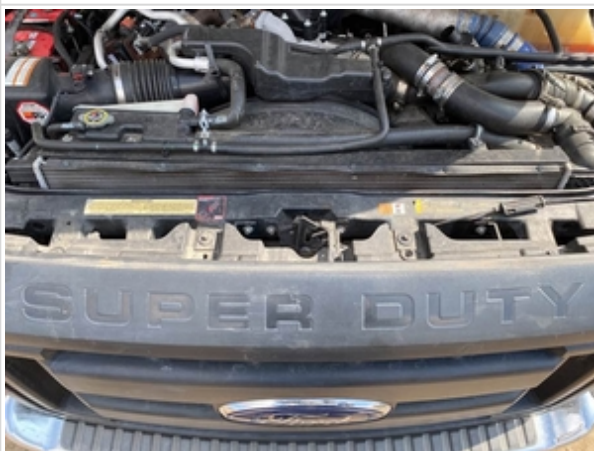
Radiator Photos

Radiator	3 - Normal Wear & Tear
Radiator Condition	Radiator fins & components appear to be in good working order, no signs of damage or leaks

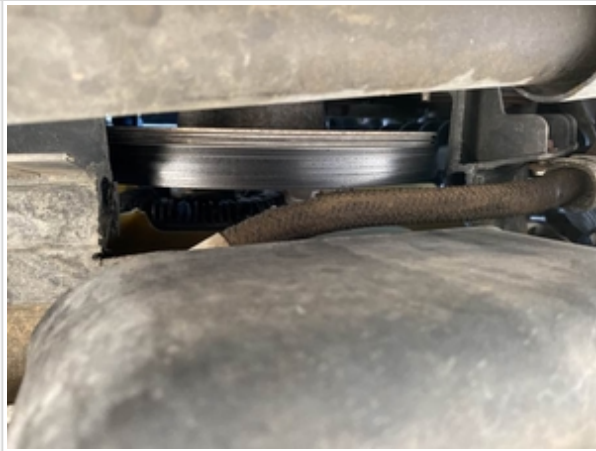
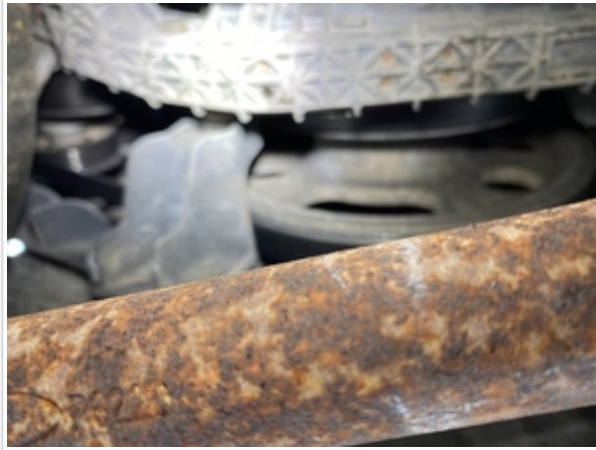
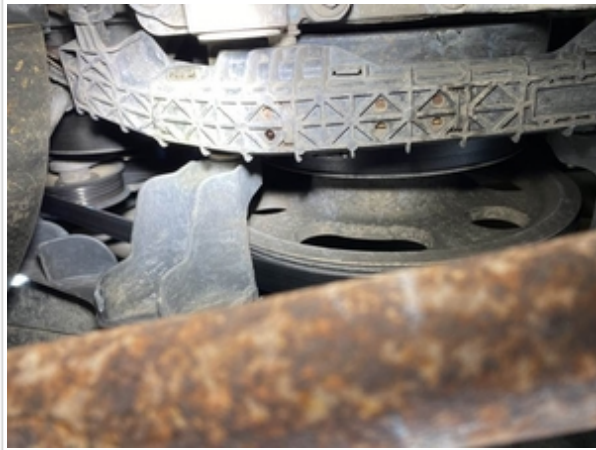
Belts	3 - Normal Wear & Tear
Belt Condition	Belts appear in good condition & alignment with proper tension, Other (see comments)
Comments	Auxiliary belt that drives air compressor may be misaligned with crank dampner
Belt Photos

Overall Engine Appearance	Clean & dry
Overall Engine Comments	Minor oil leak could be coming from oil pan gasket left side. Mechanic also said that all 8 injectors were recently replaced. The engine harness was also recently replaced. Recently serviced. Serpentine belt for air compressor needs to be realigned and/or replaced.

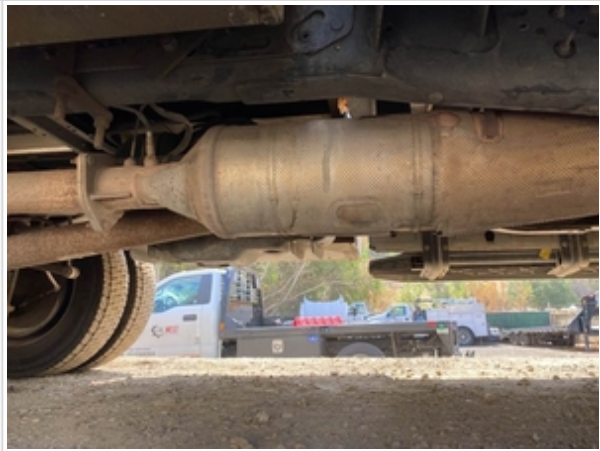
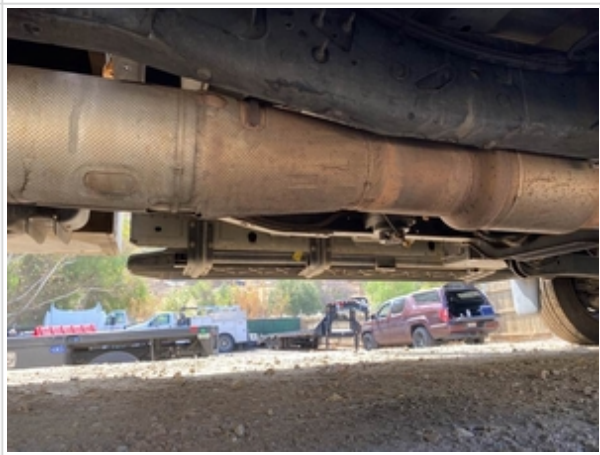
DPF Photos

Oil Color / Appearance	3 - Normal Wear & Tear
Oil Color / Appearance Notes	Clean oil appearance, no signs of cross contamination, Appropriate oil level
Fuel Leaks	No
Equipped with DPF (Diesel Particulate Filter)	Yes
DPF Condition	3 - Normal Wear & Tear
DPF Condition Notes	Filter housing is intact with no signs of damage or malfunction, DPF indicator is not illuminated

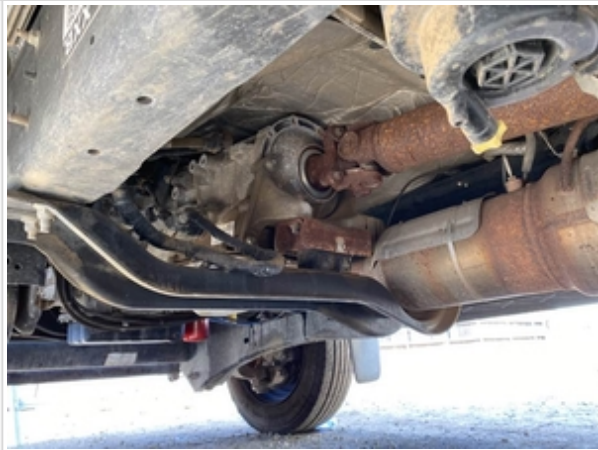
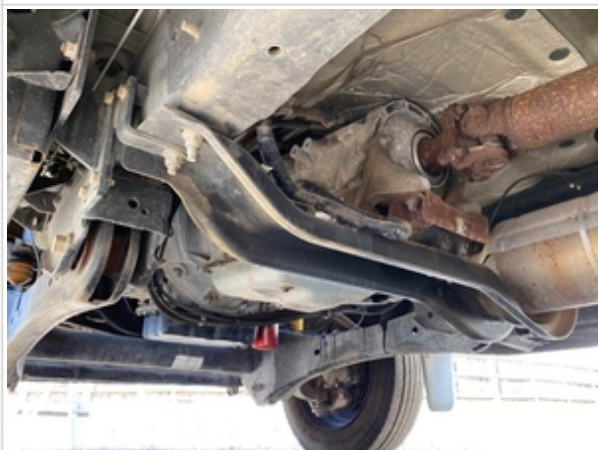
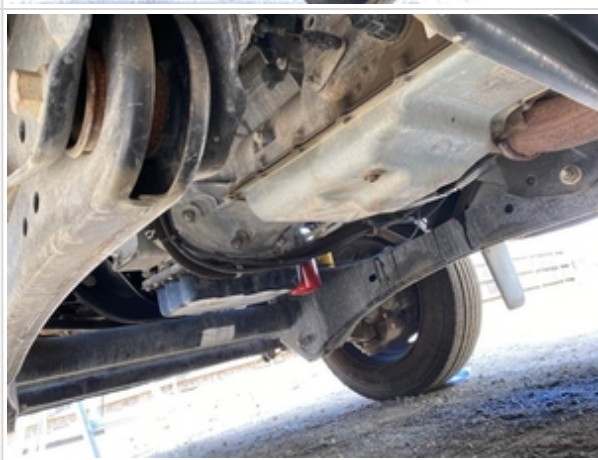
Transmission Condition Photos

Drivetrain	
Transmission Info (Make/Model)	Automatic 6 speed Ford Trans
Drive Type	4X2
Overdrive	Yes
Transmission	3 - Normal Wear & Tear
Transmission Condition	No unusual noises or vibrations

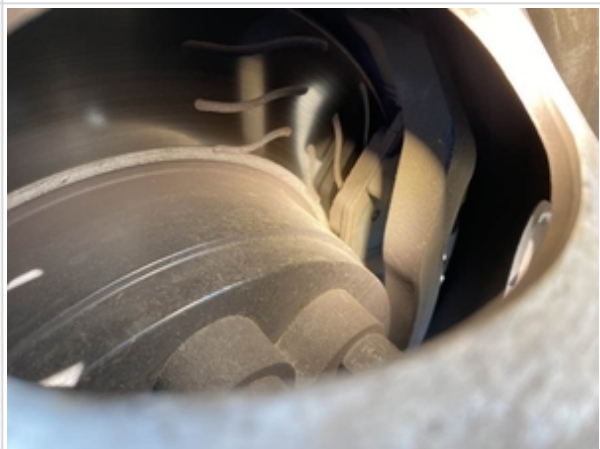
Brake Shoe Thickness	70%
Comments	3 out of 4 brakes shoes are at 70% of brake pad life left. Rear left side brake pads down to 10%
Brake Shoe Photos

Engine Brake Configuration	N/A
Parking Brake	2 - Above Average Wear
Parking Brake Condition	Other (see comments)
Comments	Parking brake barely holds at idle while in drive (needs adjustment)
Overall Drivetrain Comments	Overall drivetrain components look solid with no major obvious repairs needed. Parking brake should be adjusted. Rear driver side brake pads below 30 % should be replaced soon.

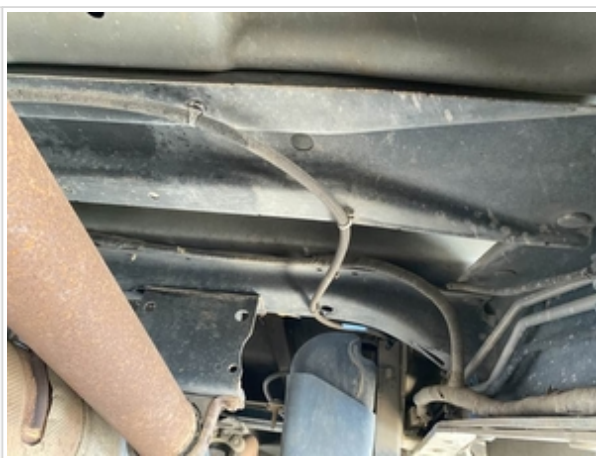
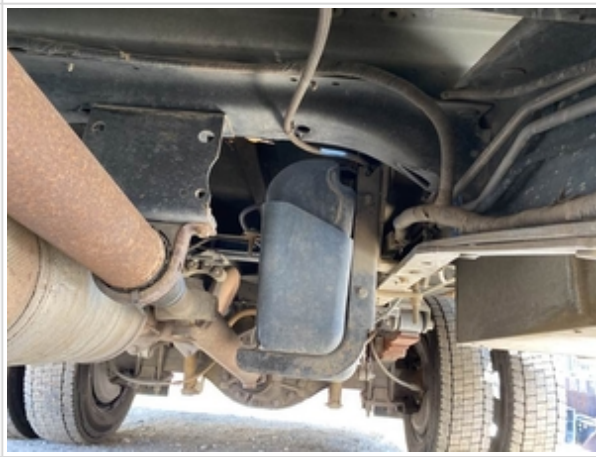
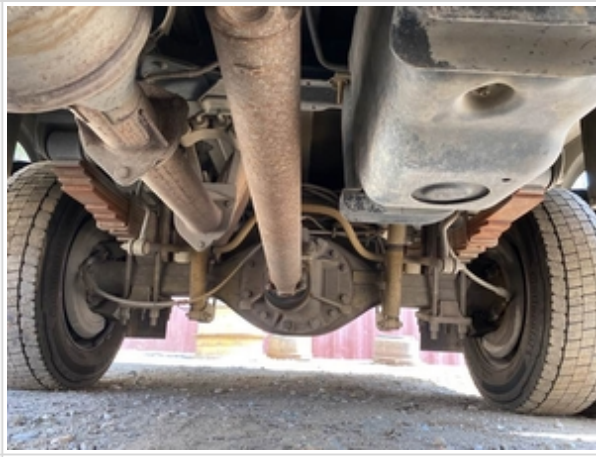
Overall Chassis & Undercarriage Photos

Overall Chassis	3
Overall Chassis Comments	Overall chasis in solid condition with no major obvious problems found.

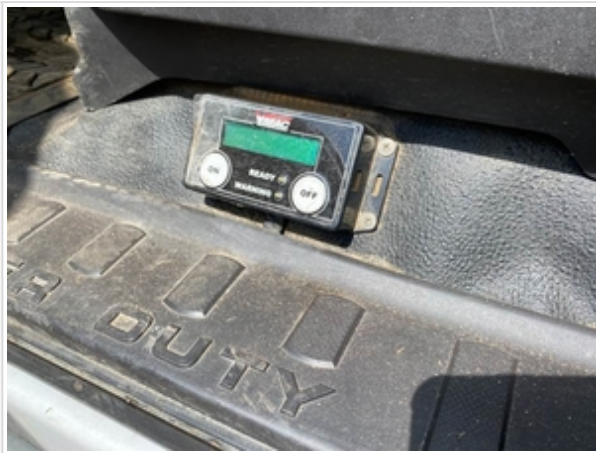
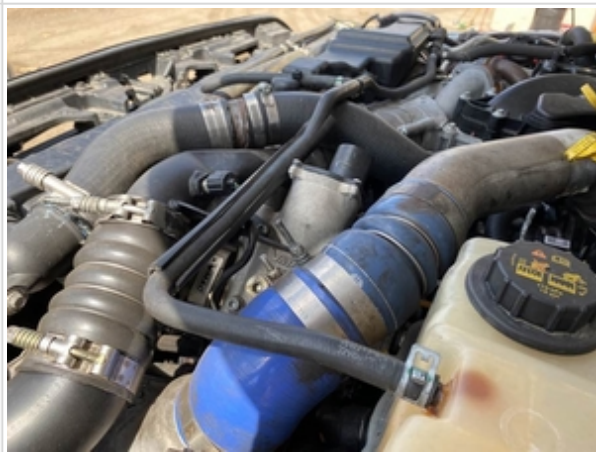
Air Compressor Photos

Air Compressor Condition	3
Air Compressor Functionality	Operating as expected
Comments	However, hose reel not installed and air is leaking to atmosphere. Compressor belt alignment needs to be addressed. Compressor sounds strong and air tank mounted correctly under cab. Possible pulley worn or misaligned and serpentine belt needs adjustment

Exterior Rating	4 - Like New, Recently Replaced
Interior Rating	4 - Like New, Recently Replaced
Safety Rating	3 - Normal Wear & Tear
Quality Rating	4 - Like New, Recently Replaced
Functionality Rating	3 - Normal Wear & Tear
Overall Rating	3 - Normal Wear & Tear
What's Great About the Machine	Pictures don't do this truck Justice. It's super clean inside and out. Normal wear & tear but all minor. The engine has had major repairs done that makes this truck extra dependable. The engine harness and all eight injectors were recently replaced. The engine had a full service and the powertrain maintenance is kept up well. In addition, with a well known brand like Autocrane, this service truck is equipped to perform major repairs with lifting capacities up to 4,000 lbs.
What Needs Work	Engine mounted air compressor needs to be addressed for full functioning performance. The serpentine belt may be misaligned and may be causing the noise heard at idle. (Should be a simple fix). The rear driver side brake pads should be replaced soon. (Below 30% of brake pad left) (Autocrane) fixed crane annual certification should be performed for safety protocols. Possible minor engine oil leak at underneath left side of engine from what seems to be the engine oil pan gasket. Air line open to atmosphere and should be connected to an air hose reel or plugged.

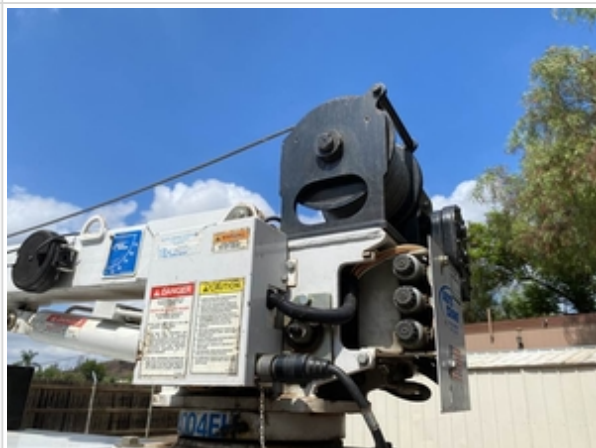
Crane Condition	3	
Crane Functionality	Operating as expected	
Comments	Crane in good shape	
Crane Photos

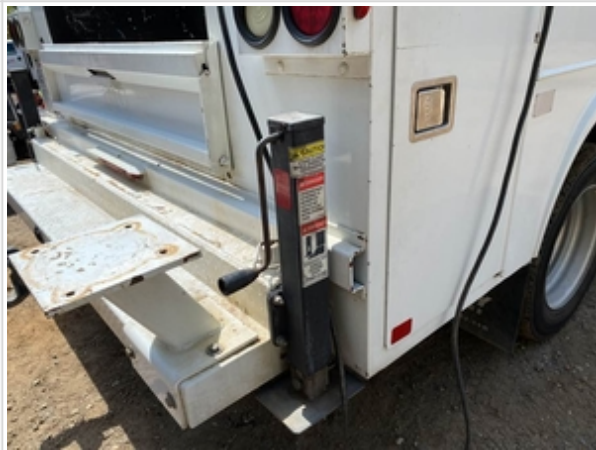
Stabilizer Jacks Condition	3	
Stabilizer Jacks Functionality	Operating as expected	
Stabilizer Jacks Photos
