Inspection Report (Asphalt Paver)

Year	2016
Make	Leeboy
Model	8515C
Serial Number	134860
Hour Meter Reading	1,927 hours
Previous Application (e.g., earth moving, mining, demolition, etc)	Asphalt Paving Construction

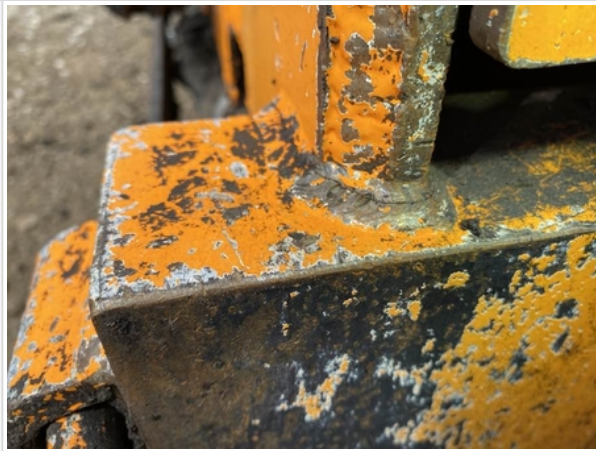
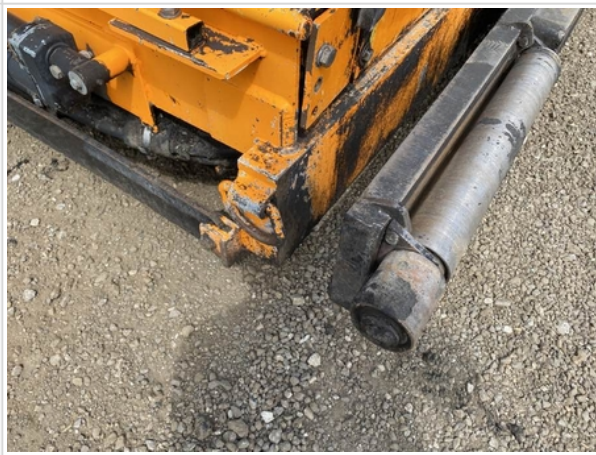
Rear	3 - Normal Wear & Tear	
Rear Condition	No visible damage, Other (see comments)	
Comments	Normal wear and tear	
Rear Photos

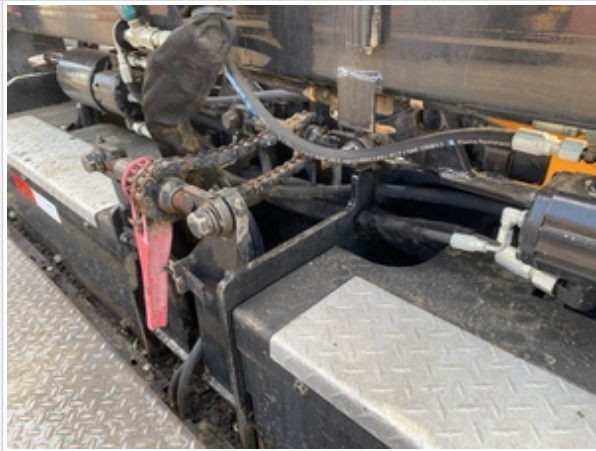
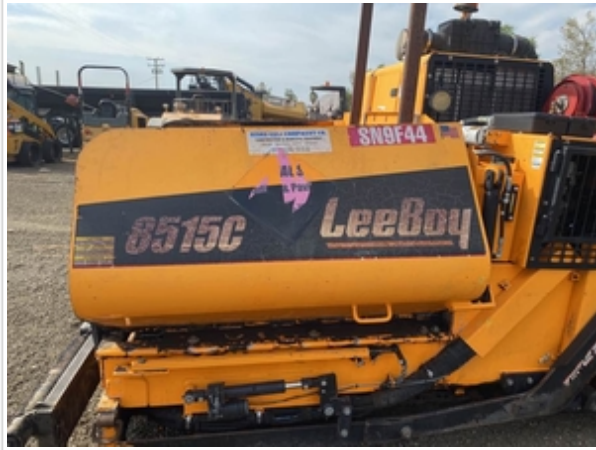
Left	3 - Normal Wear & Tear	
Left Condition	No visible damage, Other (see comments)	
Comments	Normal wear and tear	
Left Photos

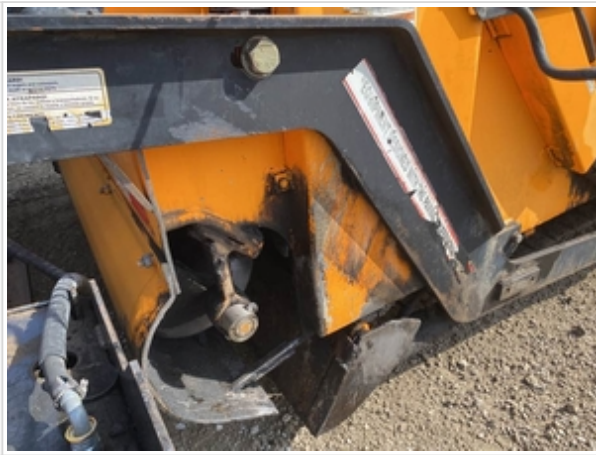
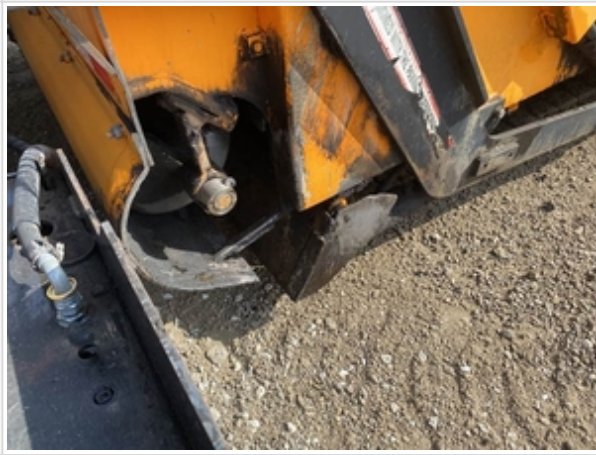
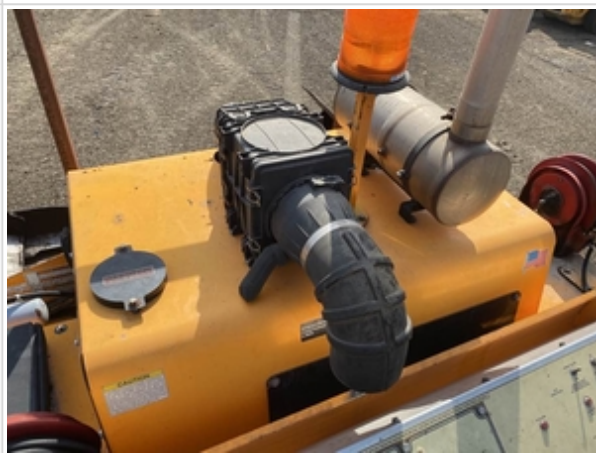
Upper	3 - Normal Wear & Tear
Upper Condition	No visible damage
Upper Photos

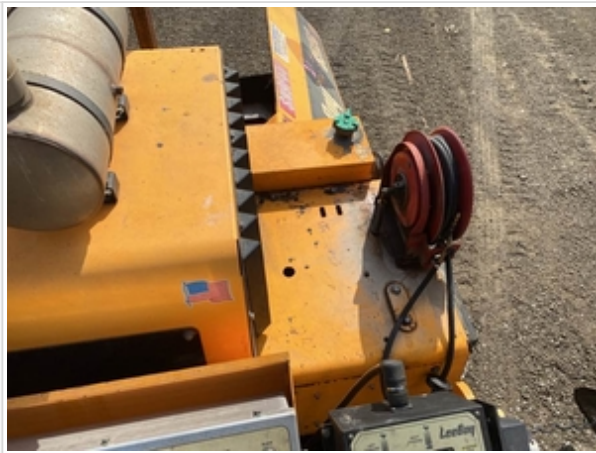
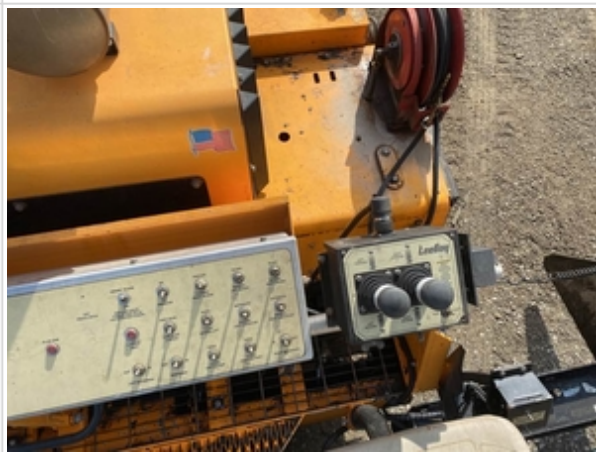
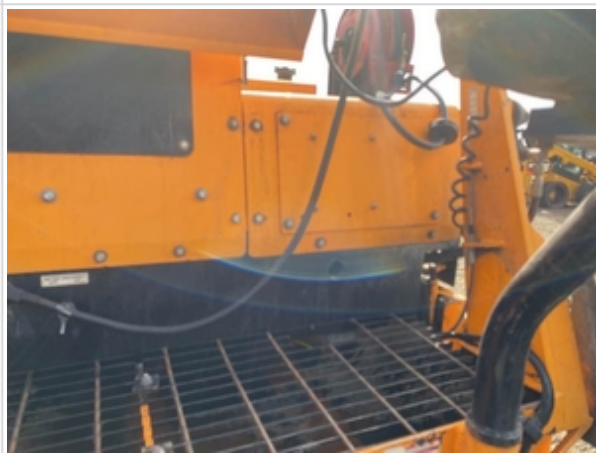
Body Panels (Any Rust Damage?)	3 - Normal Wear & Tear	
Body Panel Condition	No visible damage, good paint condition and panel fitment	
Body Panels Photos

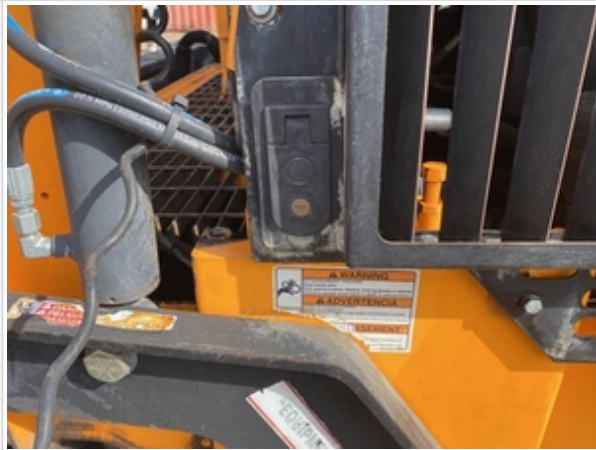
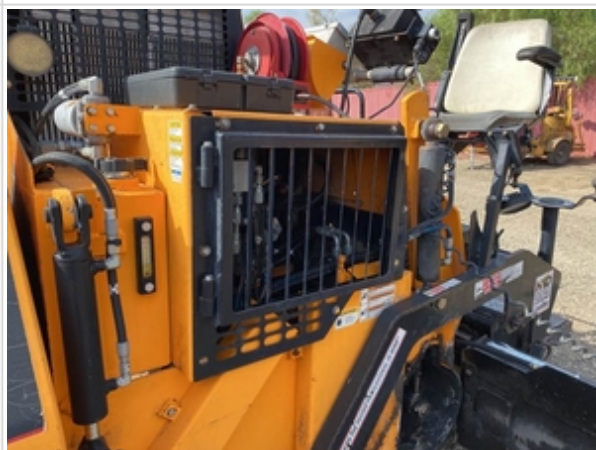
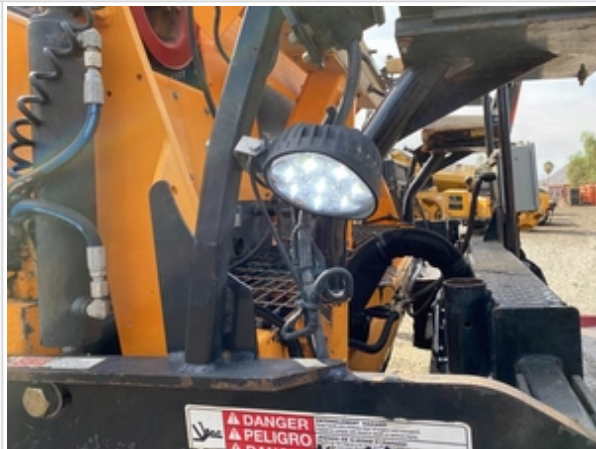
Glass Condition	0	
Mirrors	0	
Lighting System	3 - Normal Wear & Tear	
Lighting System Condition	One or more exterior lights are non-operational, Other (see comments)	
Comments	Beacon inoperable and right side light halfway working	
Lighting System Photos

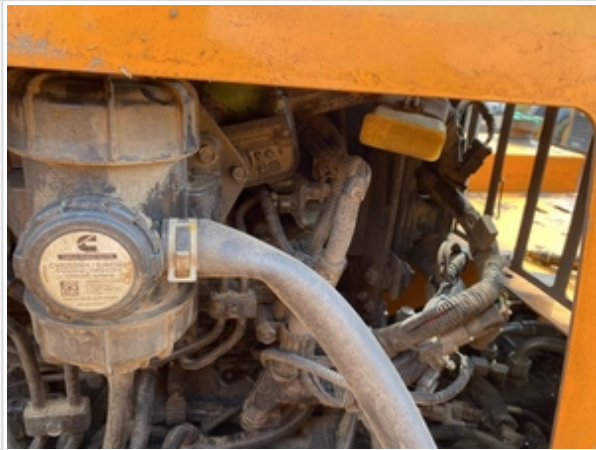
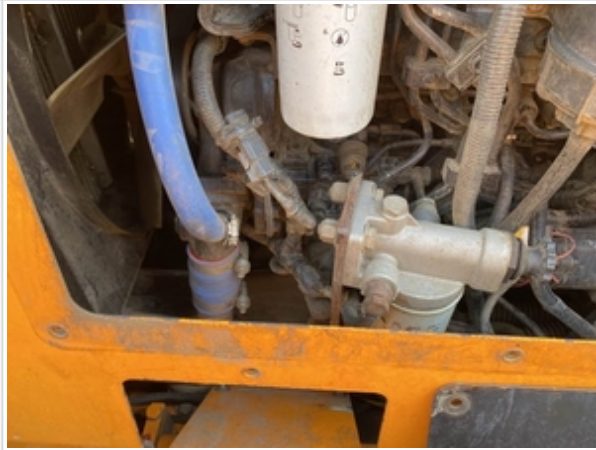
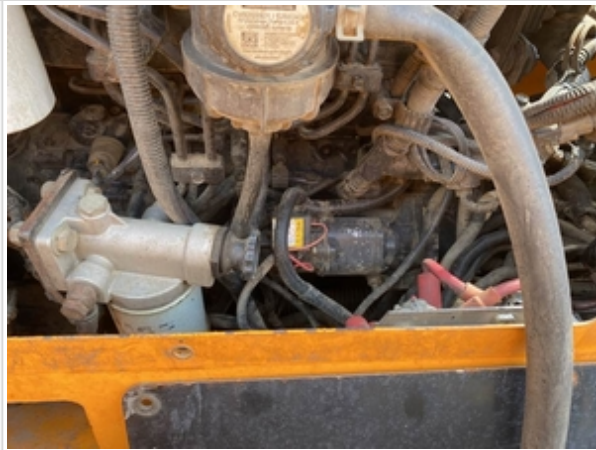
Blow-by (Visual Observation Check)	No
Unusual Noises (Upon Start-up, Idle, Shutdown)	No
Unusual Noise Notes	Other (see comments)
Comments	Slight misfire at idle, above idle engine sounds normal
Engine Smoke (Upon Start-up, Idle, Shutdown)	No
Engine Smoke Notes	No engine smoke issues observed

Equipped with DPF (Diesel Particulate Filter)	No
Requires DEF (Diesel Exhaust Fluid)	No
Overall Engine Appearance	Dusty & dry
Overall Engine Comments	Slight misfire at idle when cold. Once engine warms up misfire goes away and engine sounds healthy at all engine rpm's. No active leaks found.

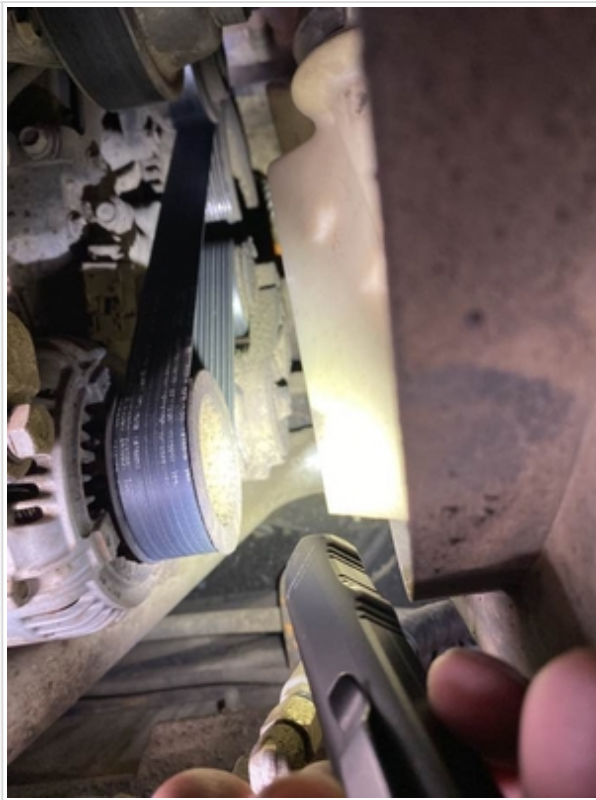
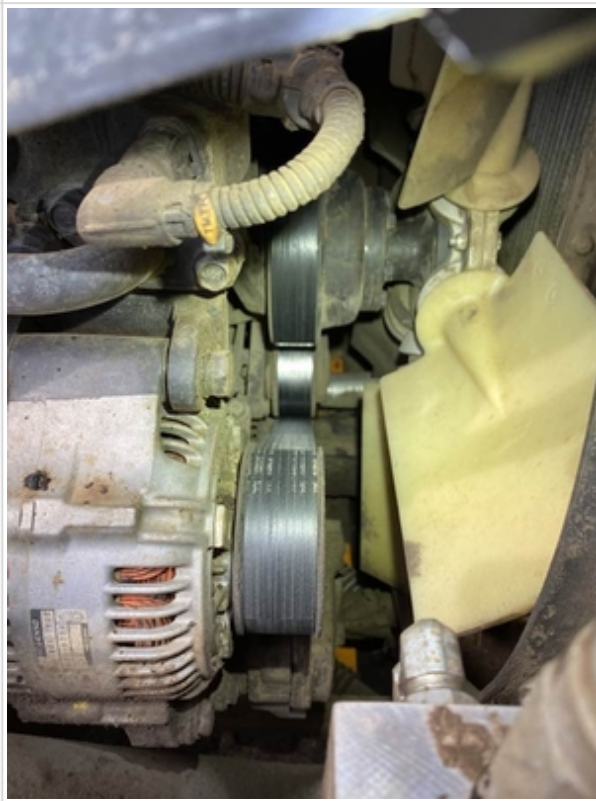
<p>Belt Photos</p>

Belts	3 - Normal Wear & Tear
Belt Condition	Belts appear in good condition & alignment with proper tension

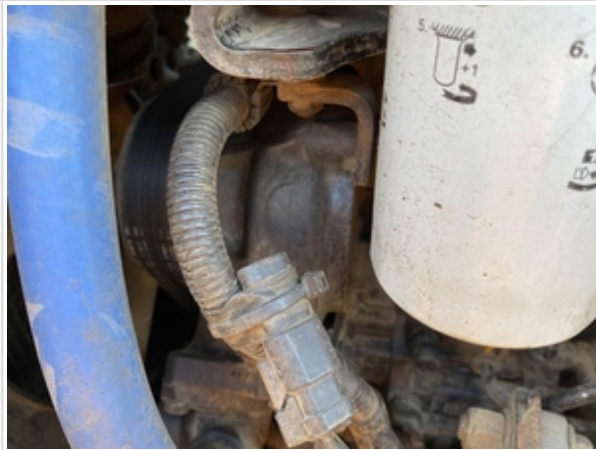
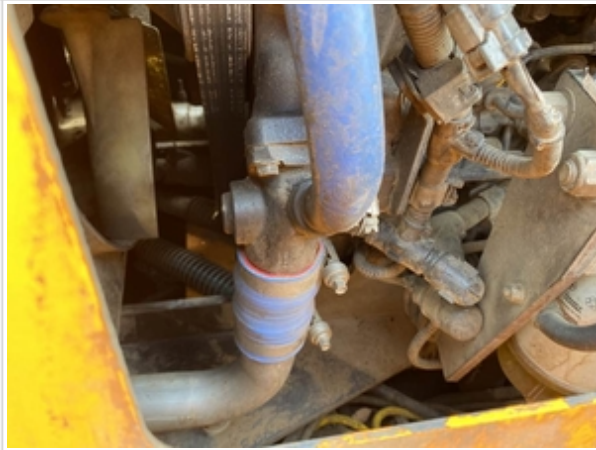
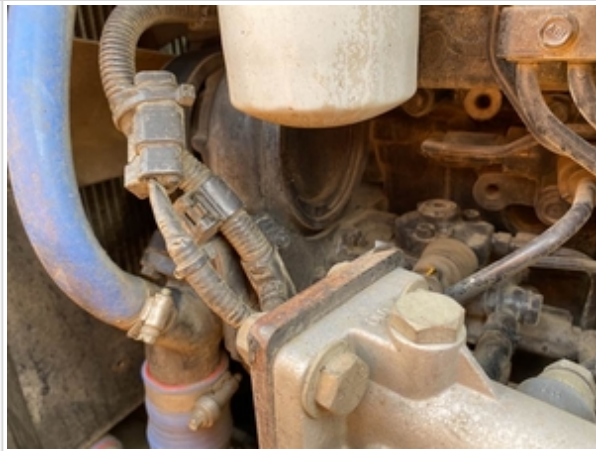
Water Pump Photos

Water Pump	3 - Normal Wear & Tear
Water Pump Condition	No unusual pump noises heard

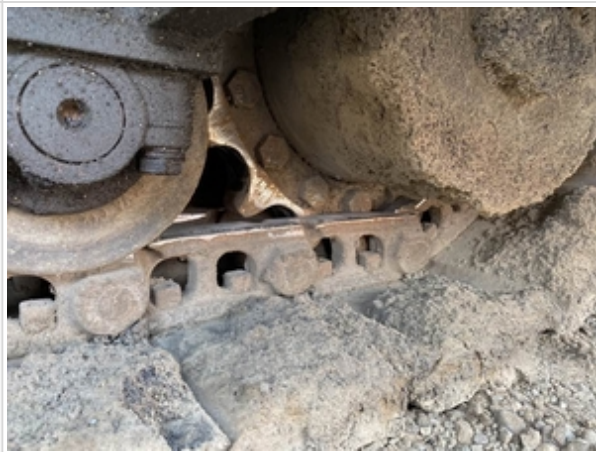
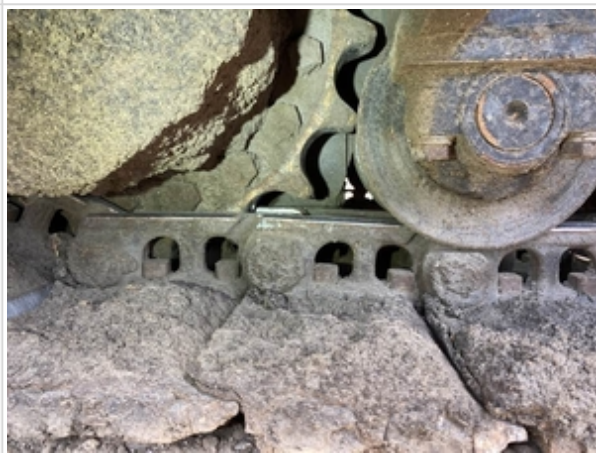
<p>Sprockets</p>	<p>3 - Normal Wear & Tear</p>	
<p>Comments</p>	<p>Normal wear</p>	
<p>Sprockets Photos</p>

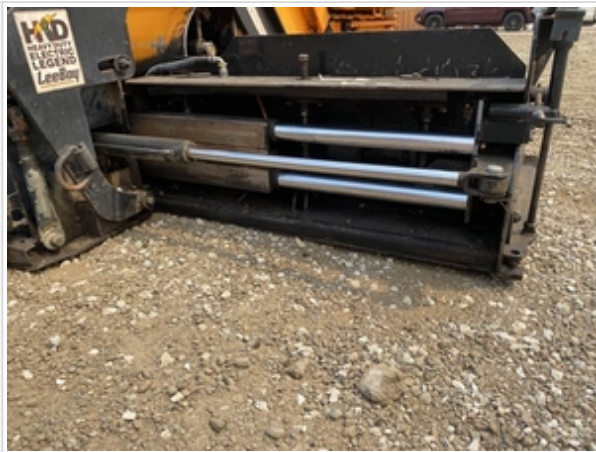
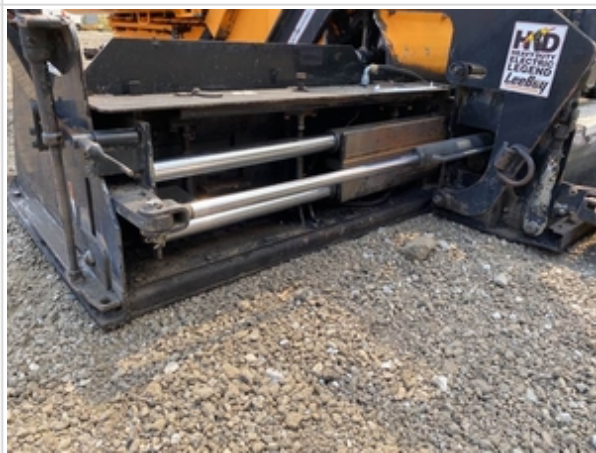
<p>Screed Extension Cylinders Photos</p>

<p>Screed Extension Cylinders: Mounting Pin</p>	<p>3</p>	
<p>Screed Extension Cylinders: Oil Leaks</p>	<p>No</p>
