Inspection Report (Telehandler)

Year	2016
Make	JCB
Model	512 - 56 Telehandler
Serial Number	JCB5CH2GC02433899
Hour Meter Reading	3,334 hours
Previous Application (e.g., earth moving, mining, demolition, etc)	General Concrete Construction

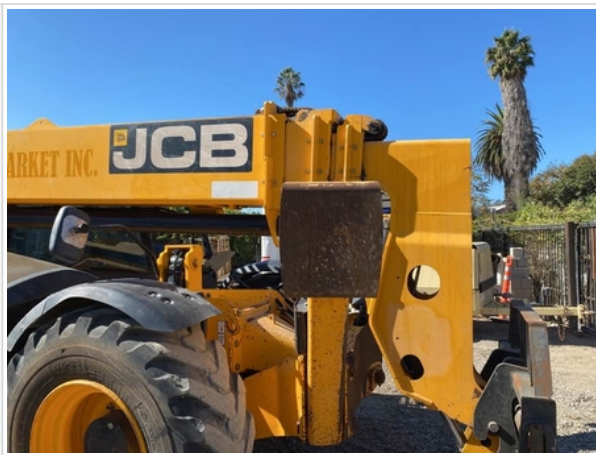
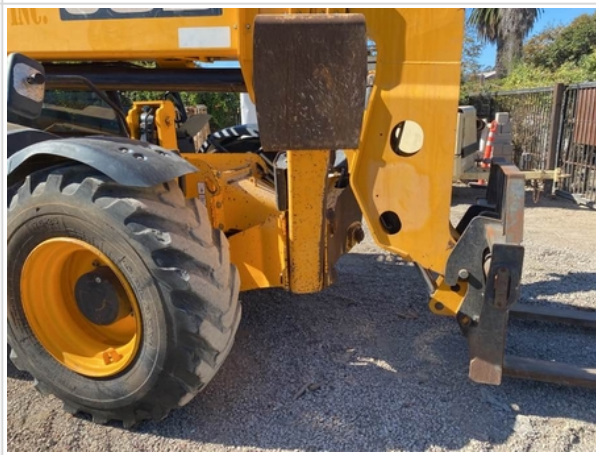
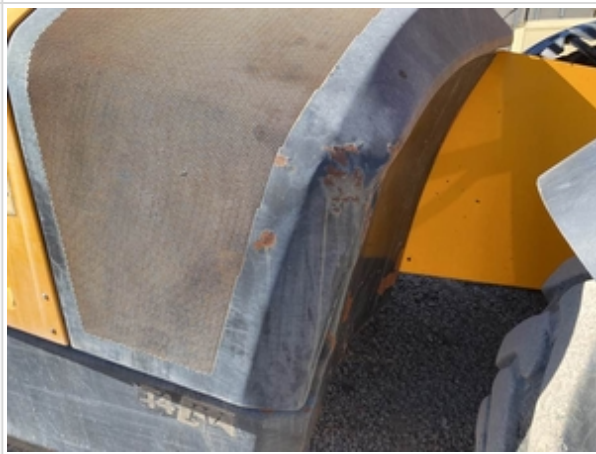
Right	3 - Normal Wear & Tear	
Right Condition	Other (see comments)	
Comments	Right side bottom of engine compartment exterior has a small dent and other areas on engine compartment exterior have scuff marks. Front fender has cracks in it	
Right Photos

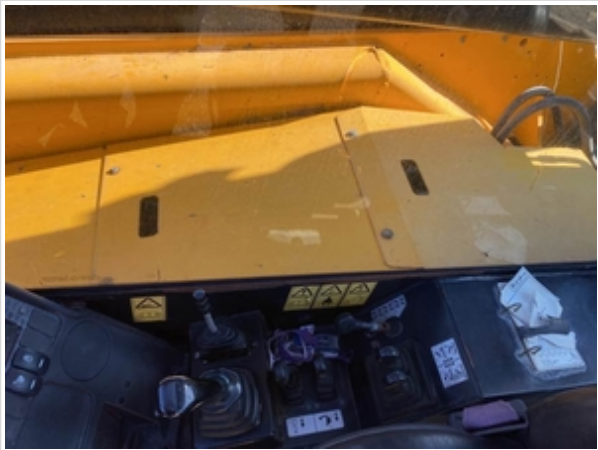
Body Panels (Any Rust Damage?)	3 - Normal Wear & Tear
Body Panel Condition	No visible damage, good paint condition and panel fitment, Other (see comments)
Comments	Dent on bottom side of engine compartment
Body Panels Photos

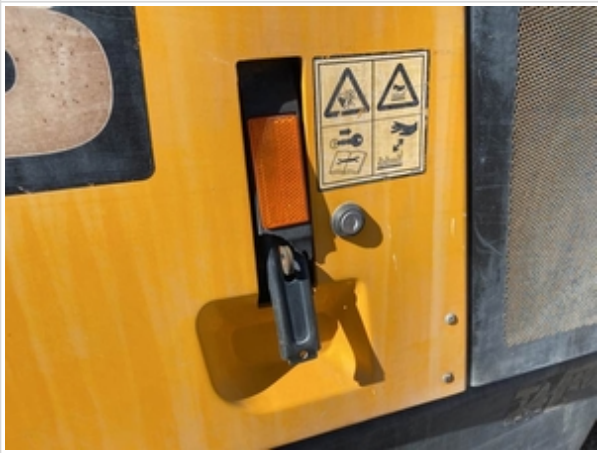
Doors / Canopy Latches	3 - Normal Wear & Tear	
Doors / Canopy Latches Condition	Other (see comments)	
Comments	Small break in hood latch but still operating okay	
Doors / Canopy Latches Photos

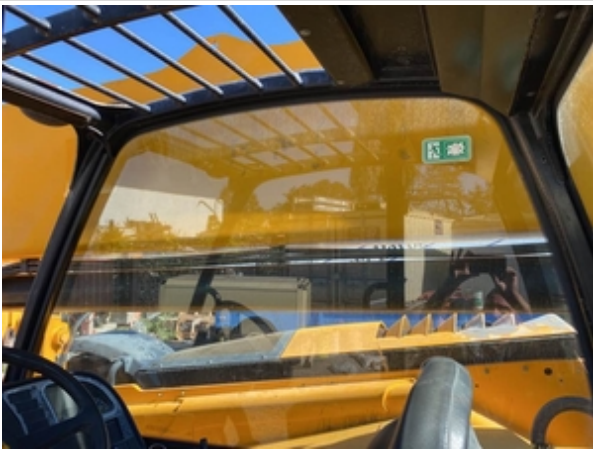
Mirrors	3 - Normal Wear & Tear	
Mirror Condition Notes	Minor chips or cracks observed	
Mirrors Photos

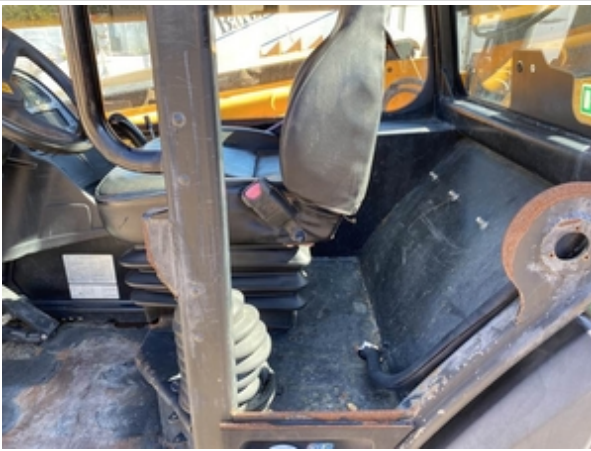
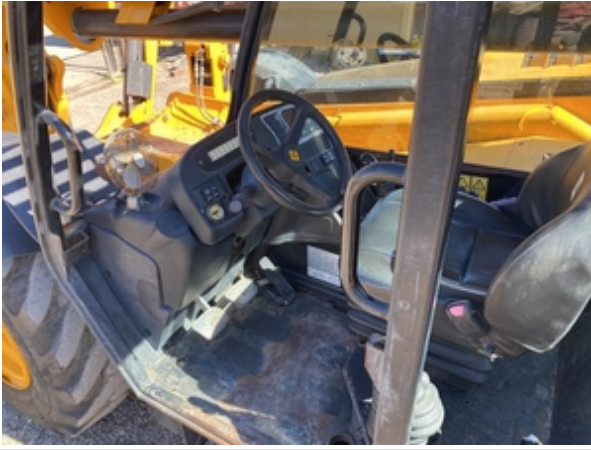
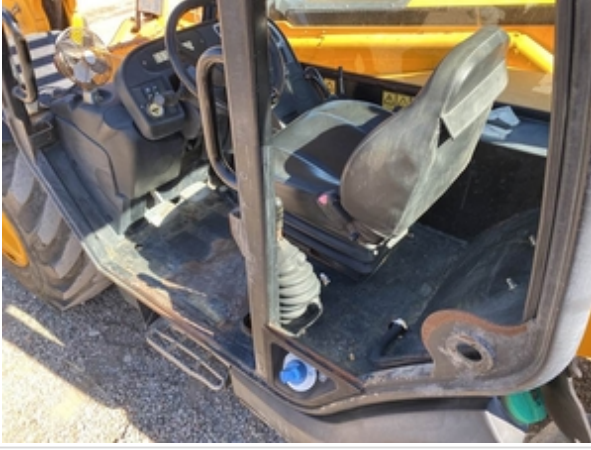
Operator Cabin Overall	3 - Normal Wear & Tear
Operator Cabin Overall Condition	Good cabin appearance, solid floors, panels, and ceiling, Minor cosmetic wear to cabin surfaces, floors, panels, and ceiling, Other (see comments)
Comments	Operator display panel above steer wheel missing
Operator Cabin Photos

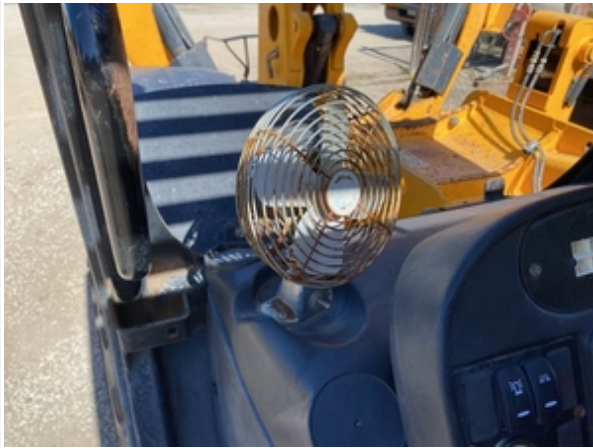
Heater & A/C	0	
Fans / Vents	2 - Above Average Wear	
Fans / Vents Condition	Other (see comments)	
Comments	Aftermarket fan works but may need to be replaced soon (bearings sound worn)

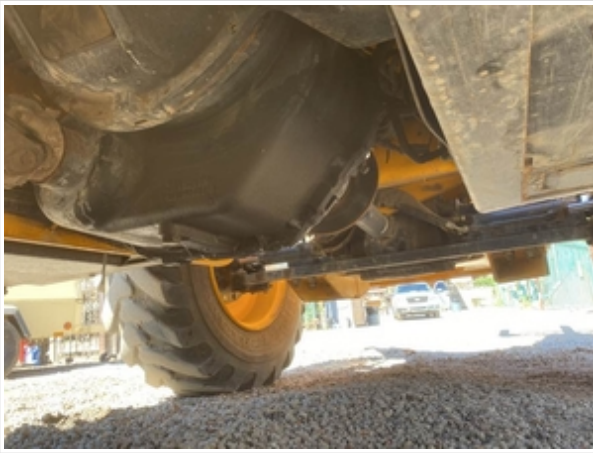
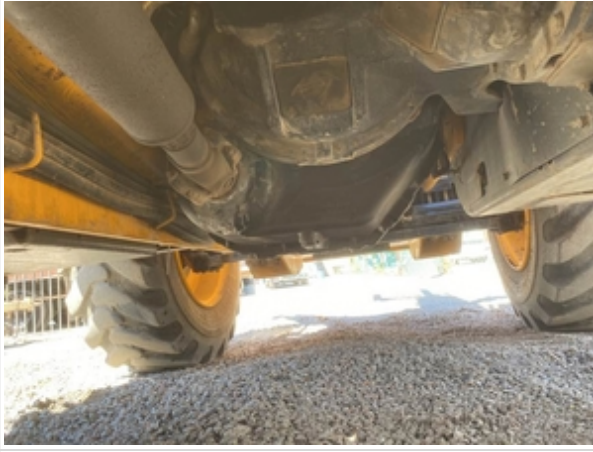
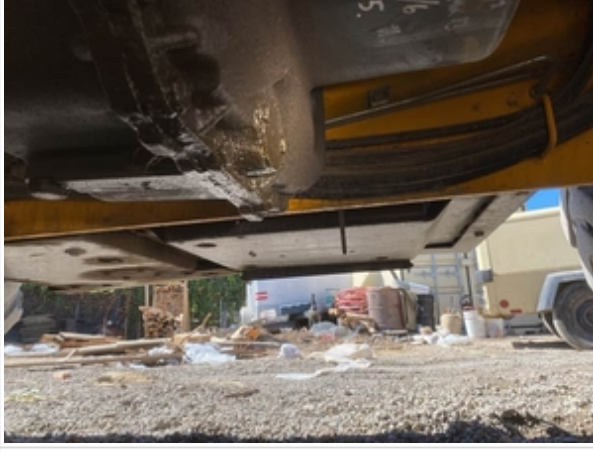
Drivetrain	
Transmission Info	Power shift 4 speed transmission
Transmission	3 - Normal Wear & Tear
Transmission Condition	No unusual noises or vibrations, Leaking transmission fluid observed, Other (see comments)
Comments	Minor

Overall Drivetrain Comments	Overall transmission operates great in all gears. Minor leak at bottom of trans. may just be o-ring for screen inspection cover.

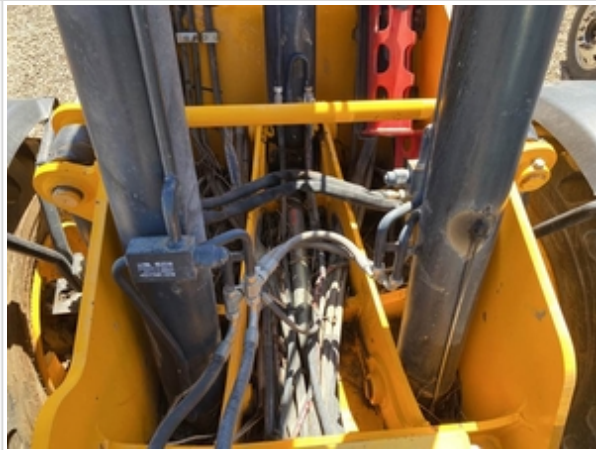
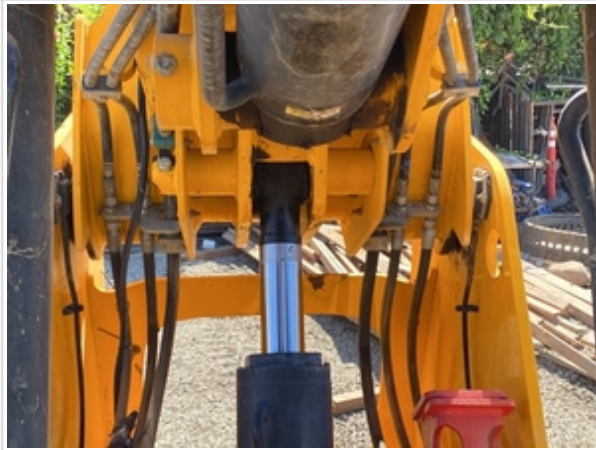
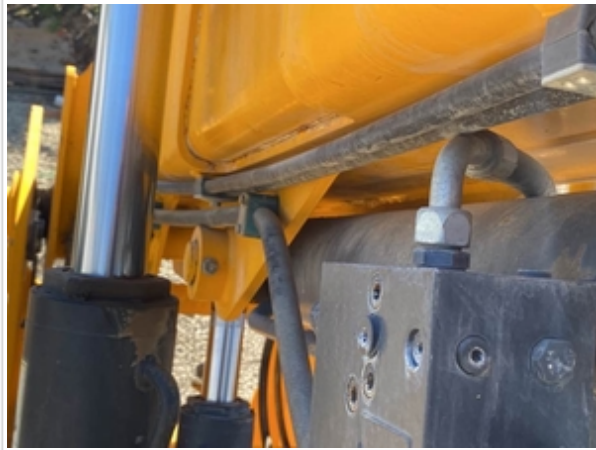
Hydraulic Lines / Fittings Condition	Hydraulic lines & fittings are clean and in good condition, Other (see comments), Active leaks in hoses or fittings observed
Comments	Small seepage leaks around main control valve accumulator and some lines
Appearance of Hydraulic Lines / Fittings Photos
