Inspection Report (Wheel Loader)

Year	2011
Make	CAT
Model	966H
Serial Number	A6J01857
Hour Meter Reading	11,024
Previous Application (e.g., earth moving, mining, demolition, etc)	Excavating, Trenching, Mass Grading

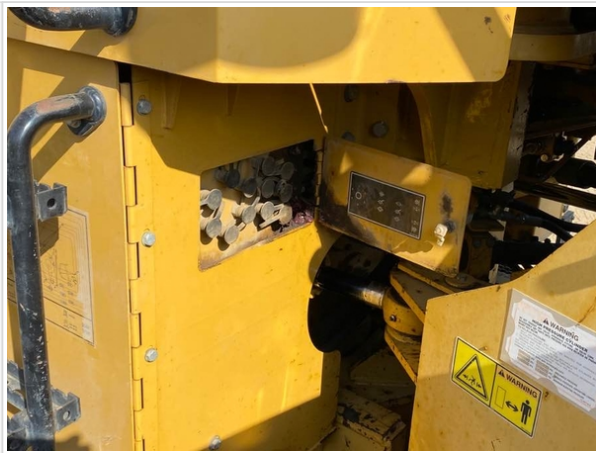
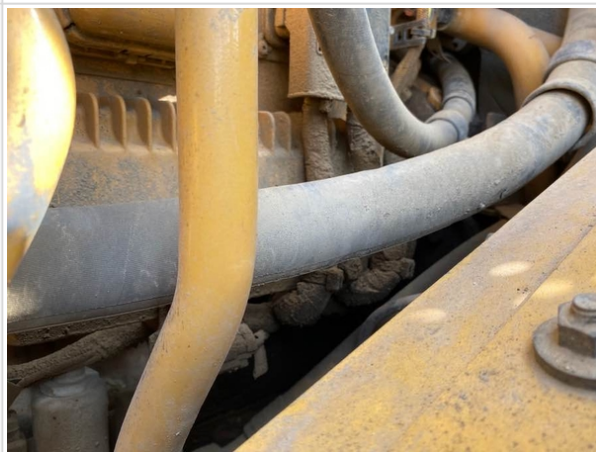
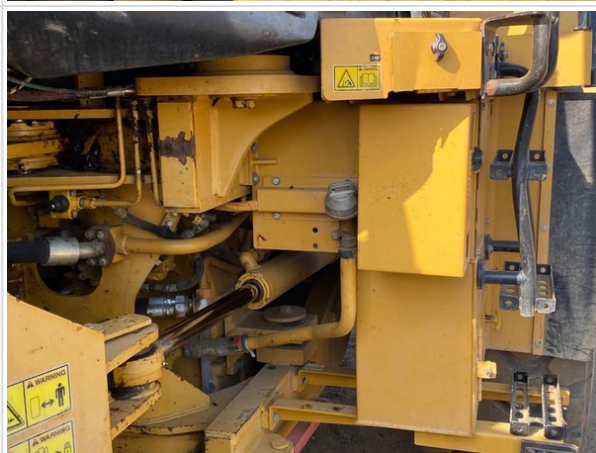
Front	3 - Normal Wear & Tear
Front Condition	No visible damage, Other (see comments)
Comments	Normal wear and tear
Front Photos

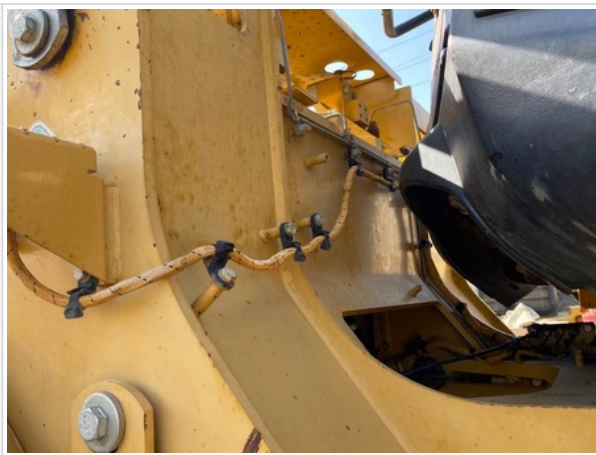
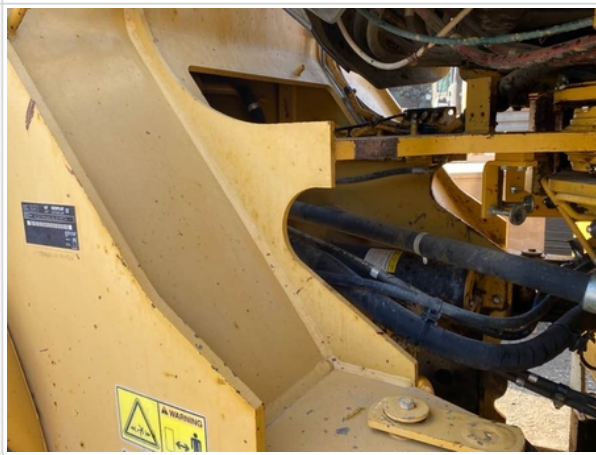
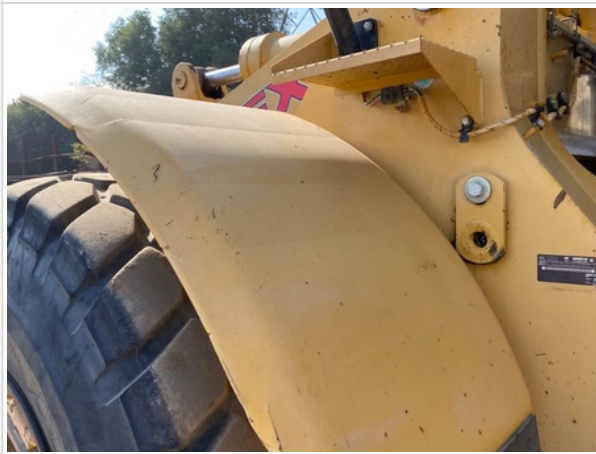
Rear	3 - Normal Wear & Tear
Rear Condition	No visible damage, Other (see comments)
Comments	Normal wear and tear

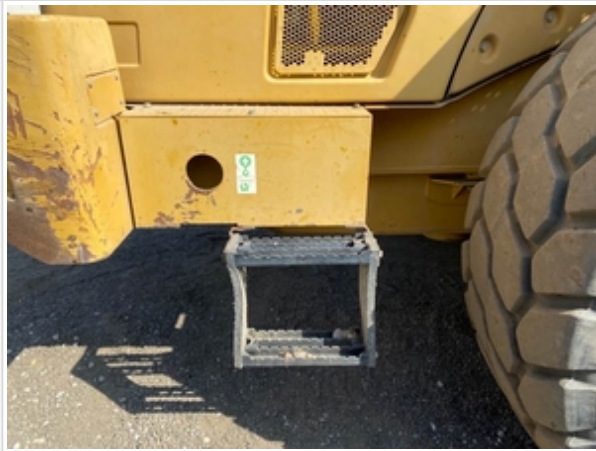
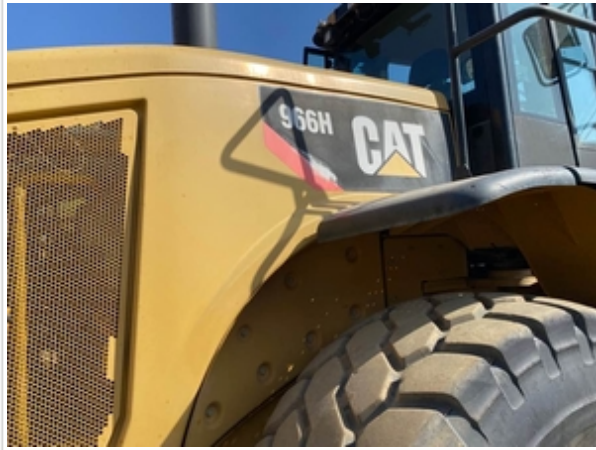
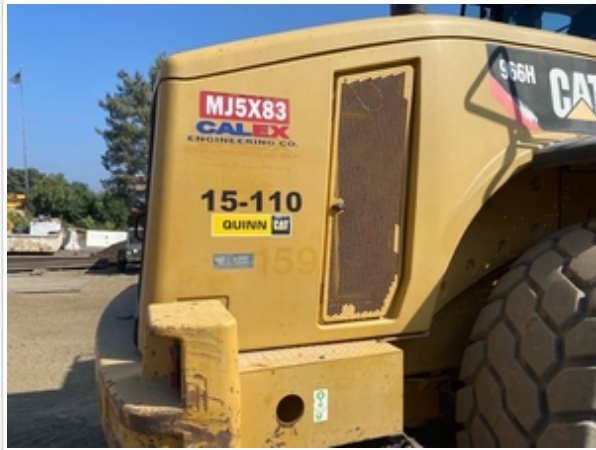
Right	3 - Normal Wear & Tear
Right Condition	Other (see comments)
Comments	Normal wear, scuff marks on rear counterweight, r/s fender bottom corner minor damage & mudflap slightly torn

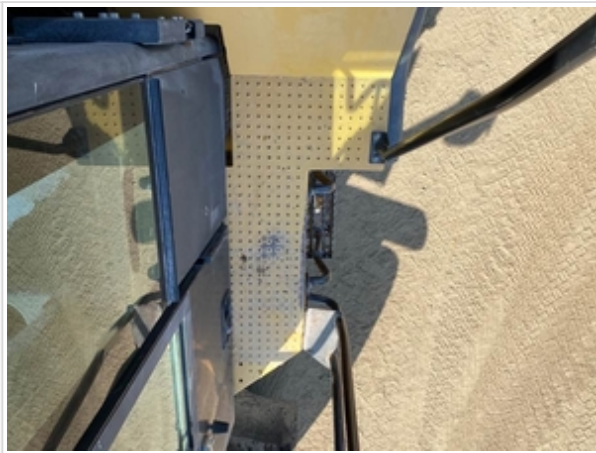
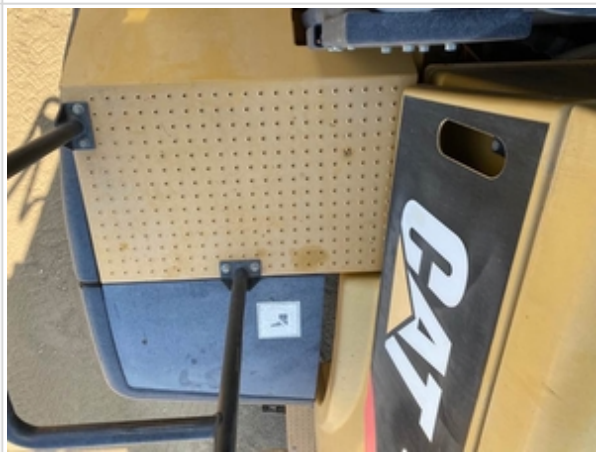
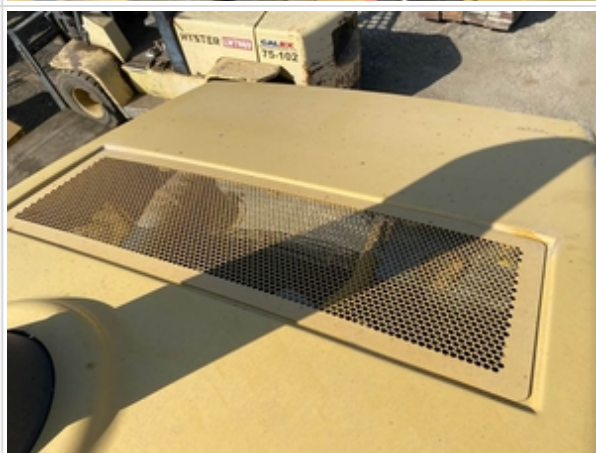
Upper	3 - Normal Wear & Tear
Upper Condition	No visible damage, Other (see comments)
Comments	R.O.P.S. Top Plastic cover corner cracked

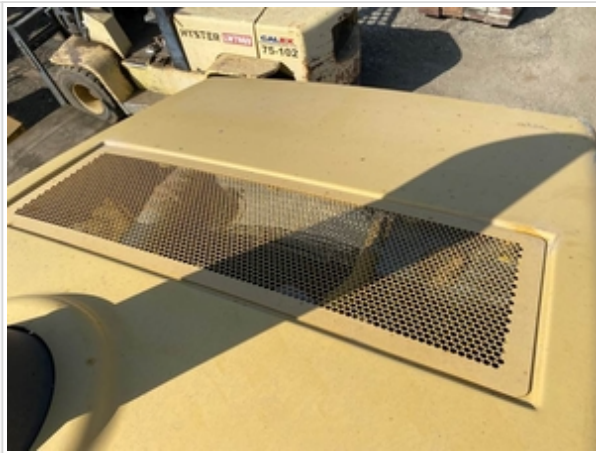
Body Panels (Any Rust Damage?)	3 - Normal Wear & Tear
Body Panel Condition	No visible damage, good paint condition and panel fitment, Other (see comments)
Comments	L/S hood switch access panel bent

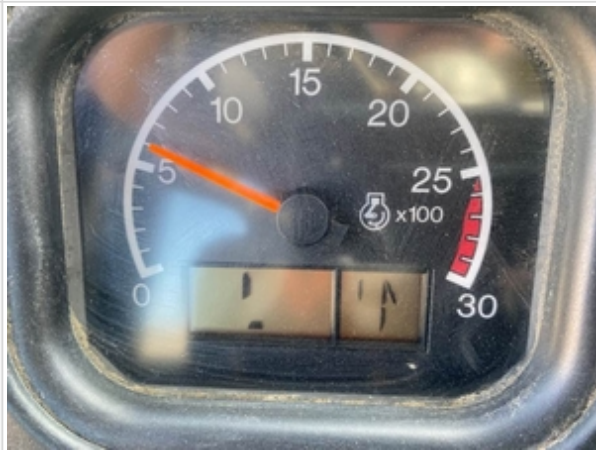
Other Gauge Activity	3 - Normal Wear & Tear
Other Gauge Condition	One or more gauges are unreadable or not functioning (specify in comments), Gauges are functional, with some wear and/or cosmetic damage, Other (see comments)
Comments	Transmission digital display below RPM defective
Other Gauge Activity Photos

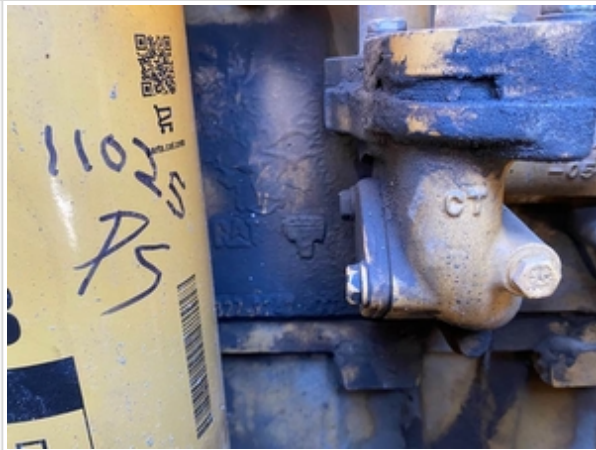
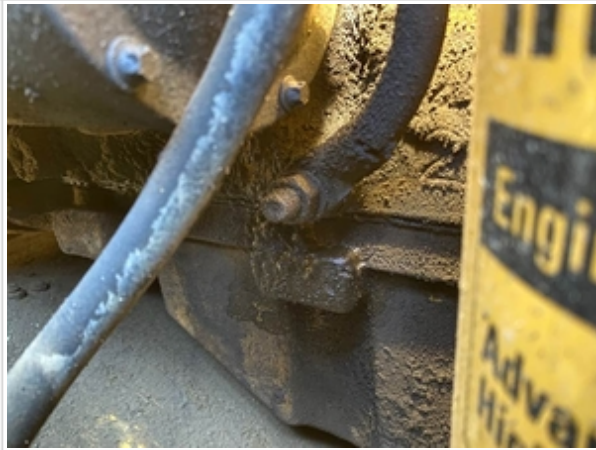
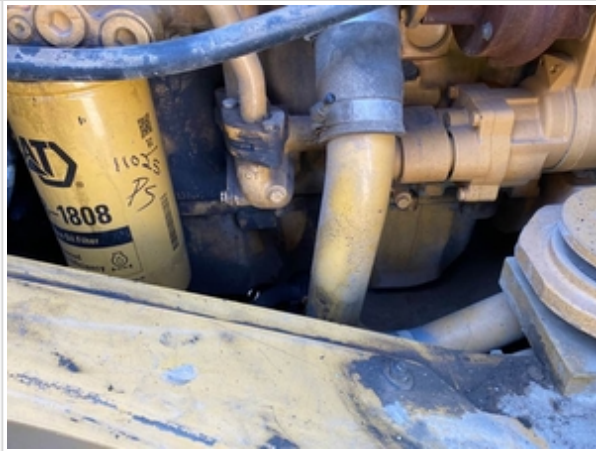
Cooling System Leaks	No	
Coolant Color / Appearance	3 - Normal Wear & Tear	
Coolant Color/Appearance Notes	Normal Translucent appearance, no visual signs of contamination	
Oil Leaks	Yes	
Oil Leak Notes	Dried oil seepages seen, Wetness & discoloration observed, Other (see comments)	
Comments	Minor oil leaks possibly from oil pan and or surrounding l/s lower engine area	
Oil Leak Photos

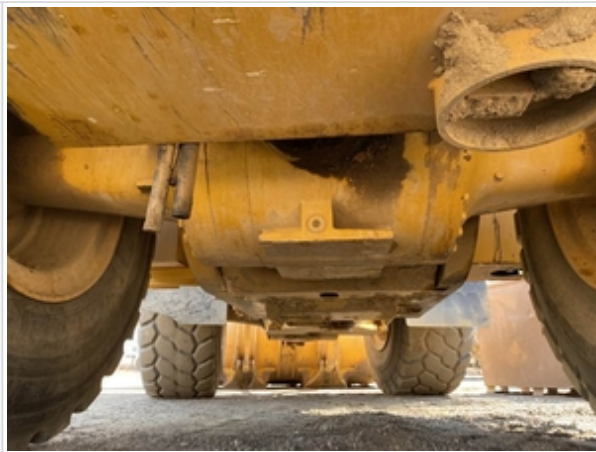
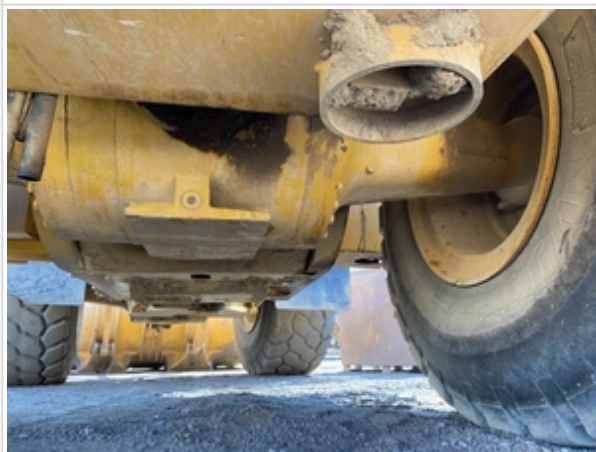
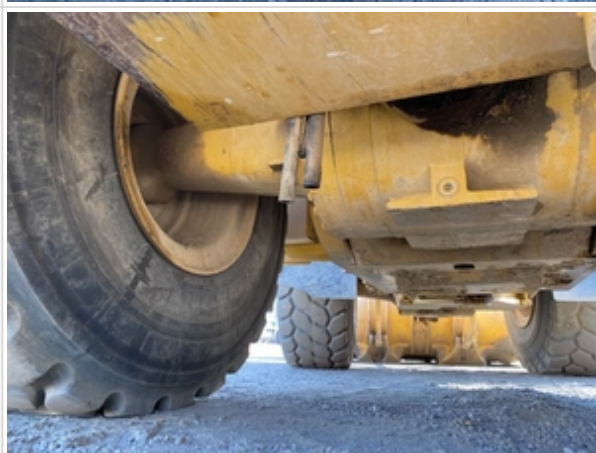
Rear Axle Appearance	3 - Normal Wear & Tear
Comments	Residual buildup on axle is excess grease from upper oscillation mount

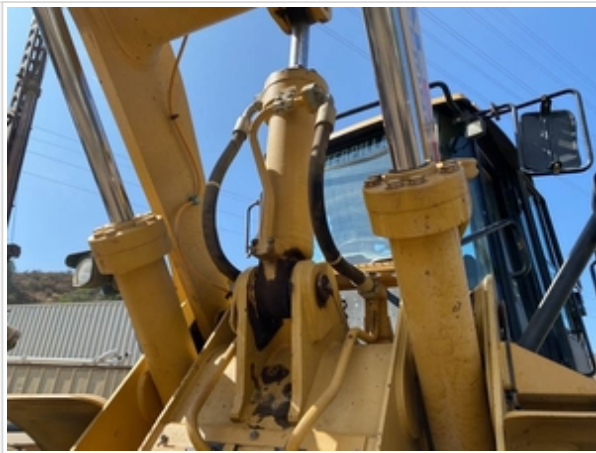
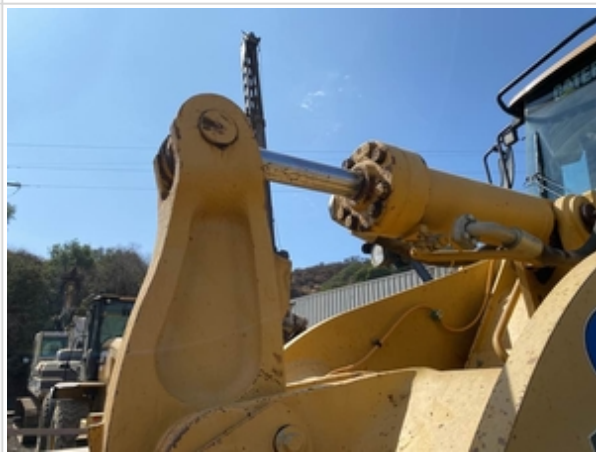
Bucket Cylinder	Check the bucket cylinder. Note any wear, pitting, discoloration, etc. Take photos.	
Bucket Cylinder: Mounting Pin	3	
Bucket Cylinder: Oil Leaks	No	
Comments	Cylinder rod in good shape. Chrome has grease splatter from power washing	
Bucket Cylinder Photos

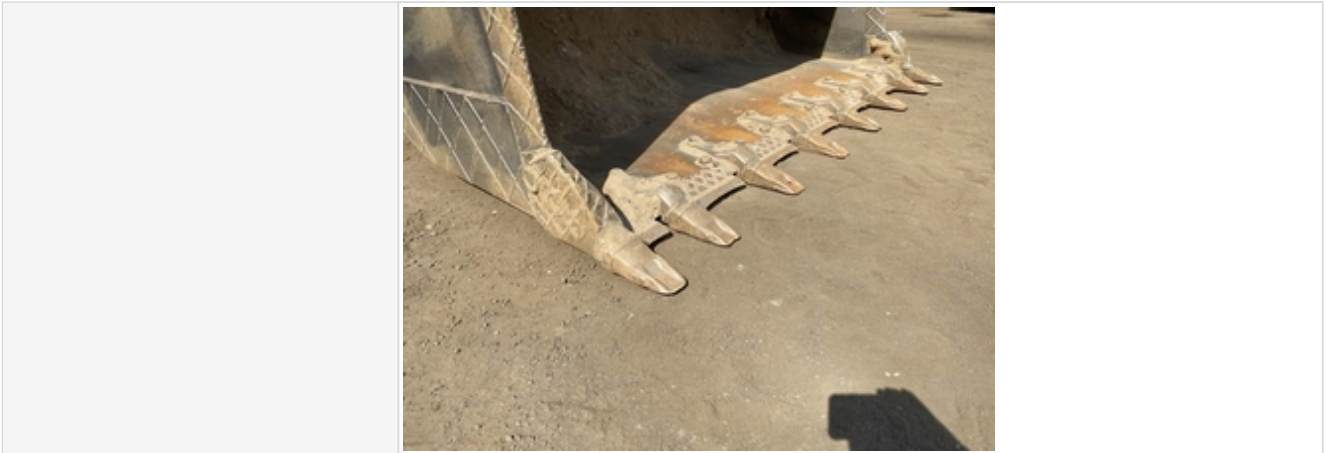
<p>Bucket Edge/Shanks/Teeth</p>	<p>3 - Normal Wear & Tear</p>
<p>Comments</p>	<p>Teeth in good shape segment edges look like they could be flipped to extend life.</p>
