Inspection Report (Generator)

Year	2016
Make	Multiquip
Model	Whisperwatt DCA - 70SSIU4F
Serial Number	7353197
Hour Meter Reading	15,272
Previous Application (e.g., earth moving, mining, demolition, etc)	General construction

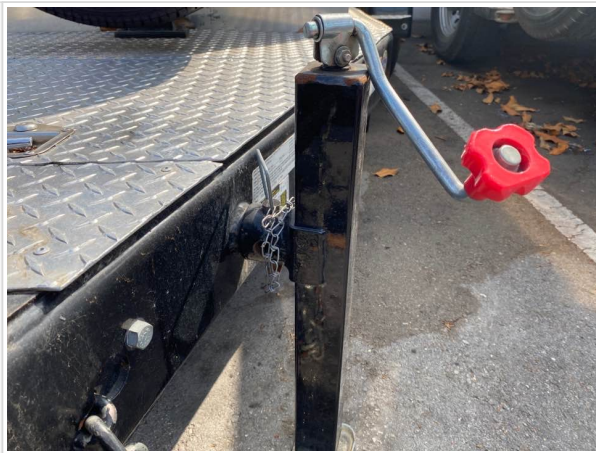
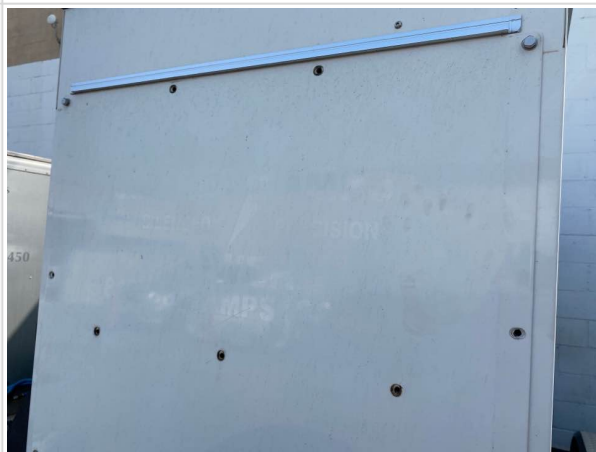
Front	3 - Normal Wear & Tear
Front Condition	No visible damage, Other (see comments)
Comments	Front panel hardware missing

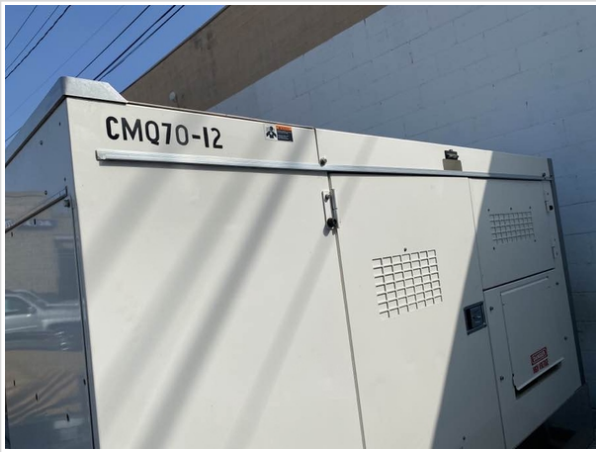
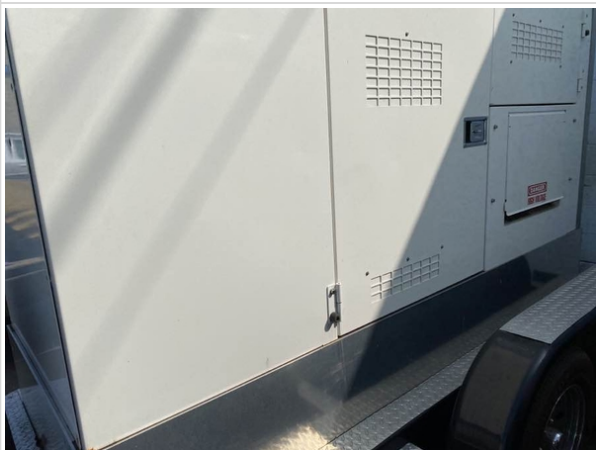
Left	3 - Normal Wear & Tear	
Left Condition	No visible damage, Other (see comments)	
Comments	No major damage just surface scratch on left side engine compartment door	
Left Photos

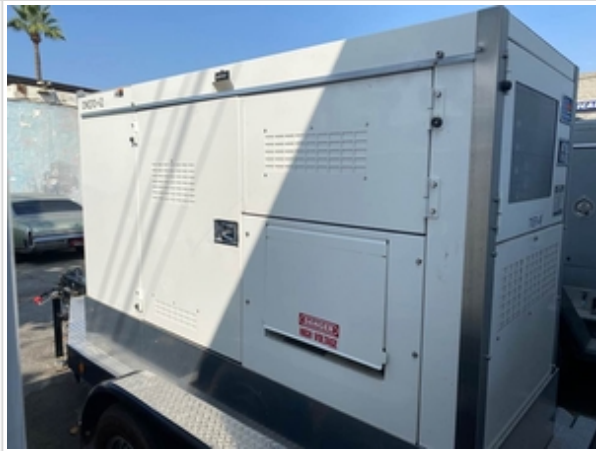
<p>Left Photos</p>

Left	3 - Normal Wear & Tear
Left Condition	Other (see comments), No visible damage
Comments	Minor surface scratch on l/s door

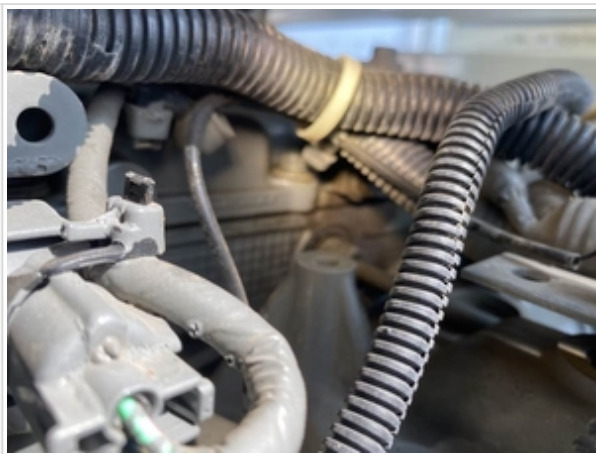
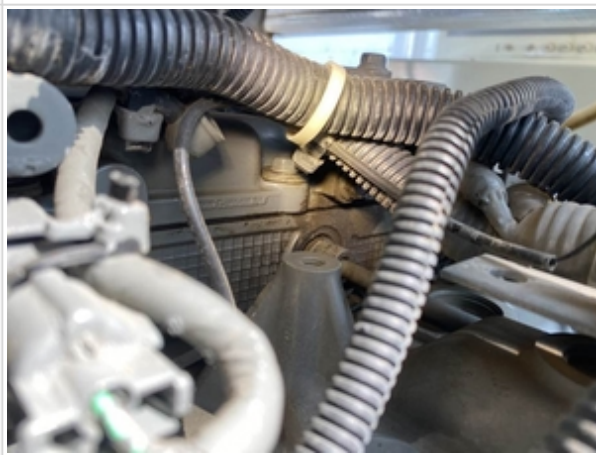
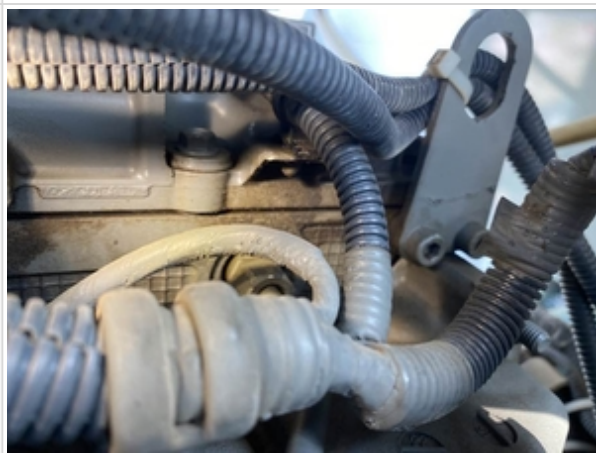
<p>Oil Leak Photos</p>

Coolant Color / Appearance	3 - Normal Wear & Tear
Coolant Color/Appearance Notes	Normal Translucent appearance, no visual signs of contamination
Oil Leaks	Yes
Oil Leak Notes	Dried oil seepages seen, Other (see comments)
Comments	Possible oil seepage coming from valve cover, oil coming out of cold side and charge side

Overall Engine Appearance	Clean & dry
Overall Engine Comments	Besides the small oil leak from turbo and seepage from valve cover, the rest of the engine looks well maintained. Engine oil buildup around intake and discharge hoses from turbo may be an indication of wet stacking.

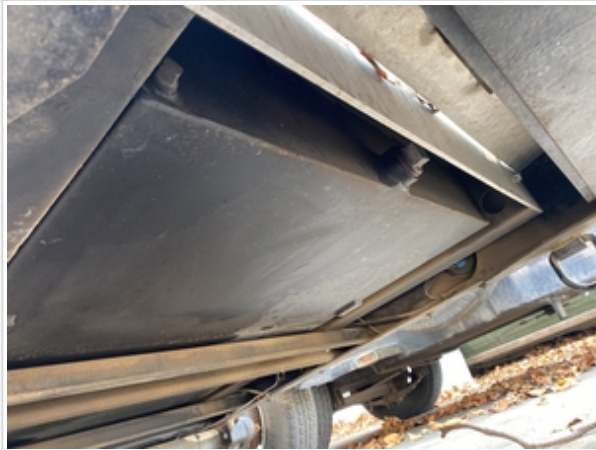
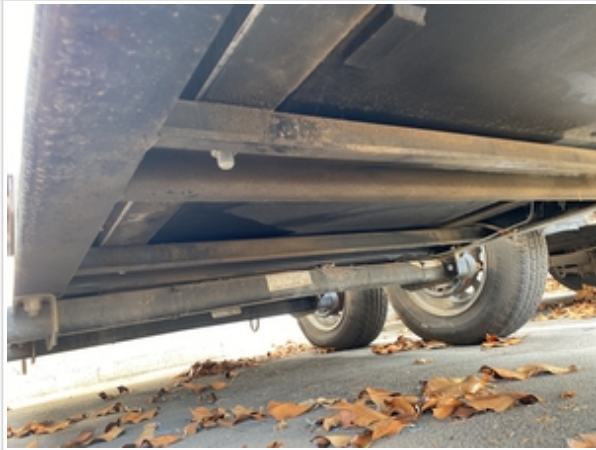
Bottom Surface Photos

Display Screen Appearance	3 - Normal Wear & Tear
<h3>Mounting Plate</h3>	
Overall Mounting Plate Appearance	0
Bottom Surface	3 - Normal Wear & Tear
Comments	Dusty normal wear
