Inspection Report (Wheel Loader)

Year	1996
Make	Kawasaki
Model	60z
Serial Number	60C1-0110
Hour Meter Reading	1220 + 1609
Previous Application (e.g., earth moving, mining, demolition, etc)	G

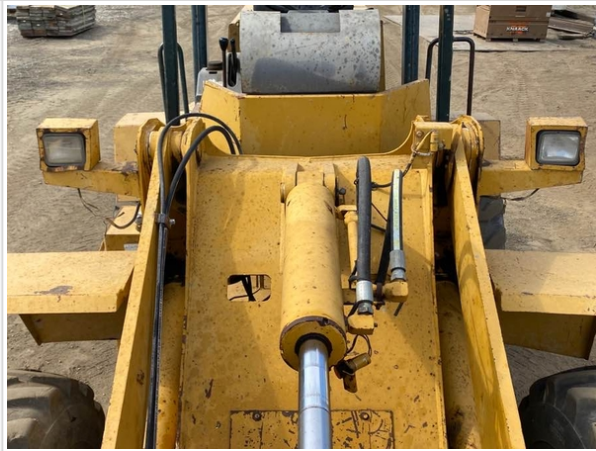
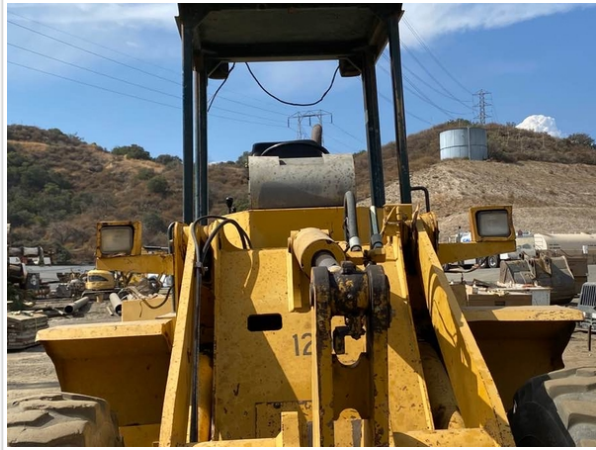
Front	3 - Normal Wear & Tear
Front Condition	Other (see comments)
Comments	Normal wear & tear

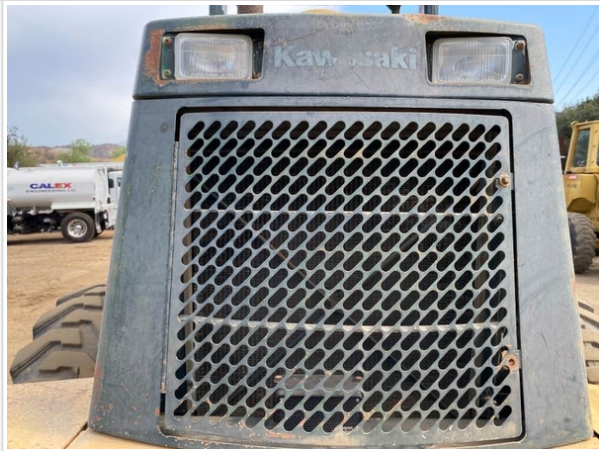
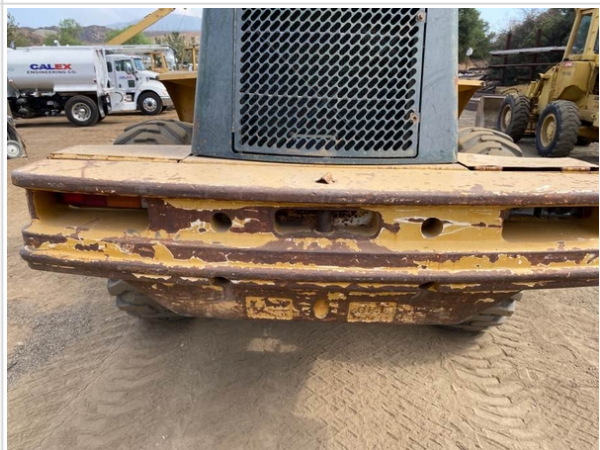
<p>Rear</p>	<p>3 - Normal Wear & Tear</p>
<p>Rear Condition</p>	<p>Other (see comments)</p>
<p>Comments</p>	<p>Normal wear and tear</p>
<p>Rear Photos</p>

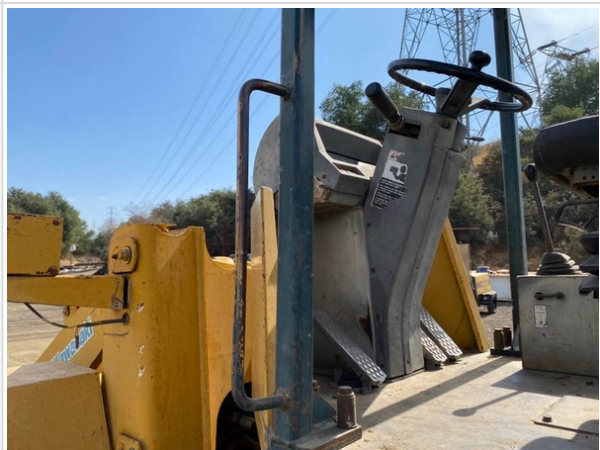
Left	3 - Normal Wear & Tear	
Left Condition	Other (see comments)	
Comments	Some damage to L/S fenders , normal wear	
Left Photos

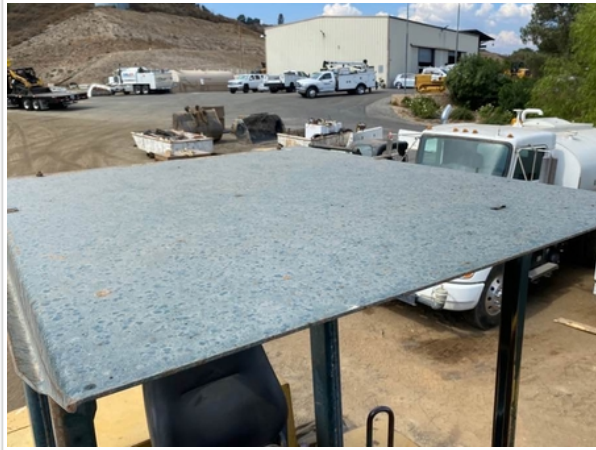
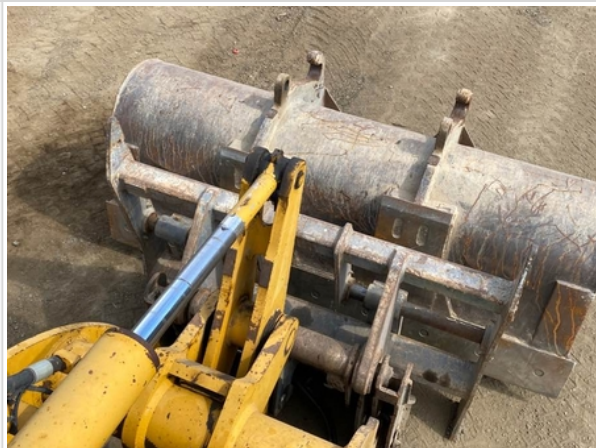
Upper	3 - Normal Wear & Tear	
Upper Condition	Other (see comments)	
Comments	Normal wear	
Upper Photos

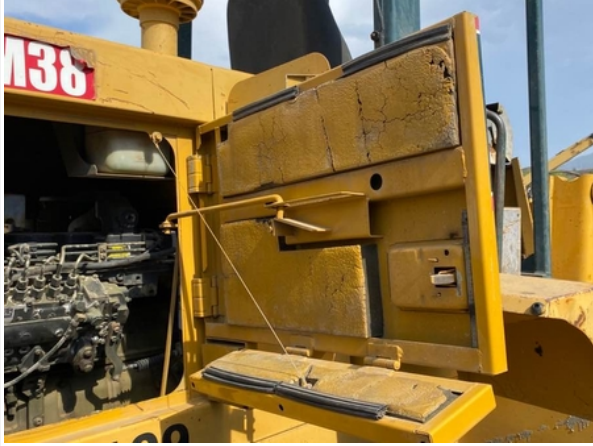
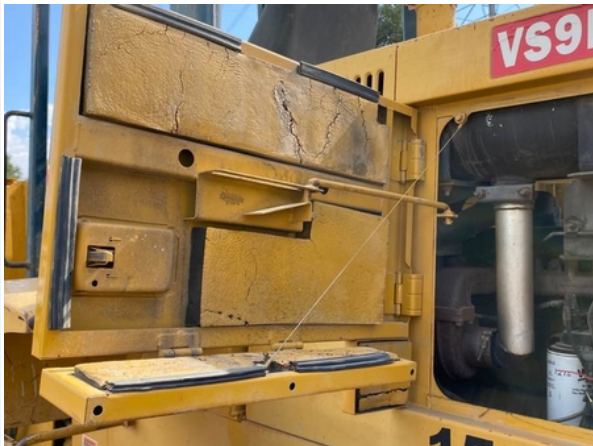
Body Panels (Any Rust Damage?)	3 - Normal Wear & Tear
Body Panel Condition	Other (see comments)
Comments	Fenders have some impact damage, compartment panels in good condition
Body Panels Photos

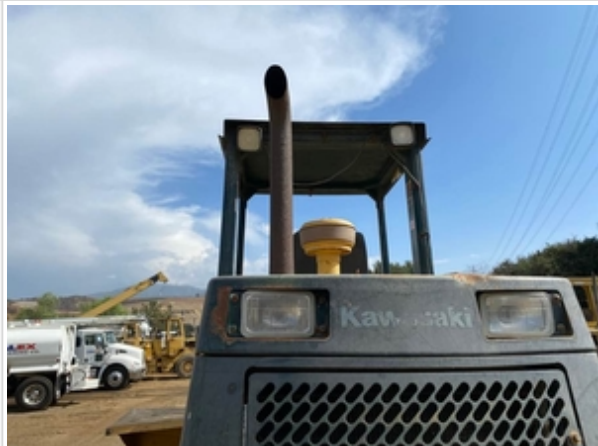
Glass Condition	0	
Mirrors	0	
Lighting System	2 - Above Average Wear	
Lighting System Condition	Overall lighting system is non-operational	
Lighting System Photos

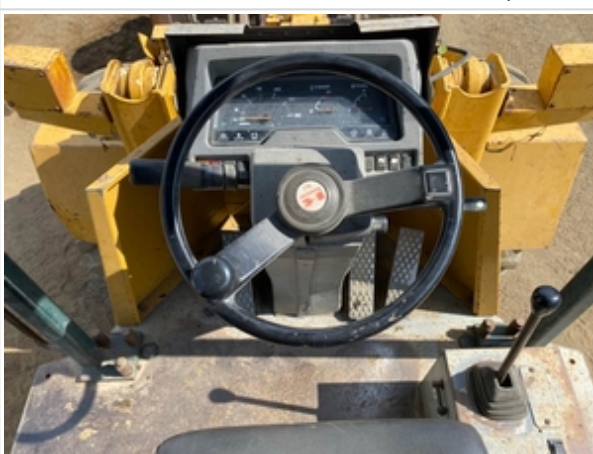
Operator Cabin Overall	3 - Normal Wear & Tear
Operator Cabin Overall Condition	Minor cosmetic wear to cabin surfaces, floors, panels, and ceiling
Operator Cabin Photos

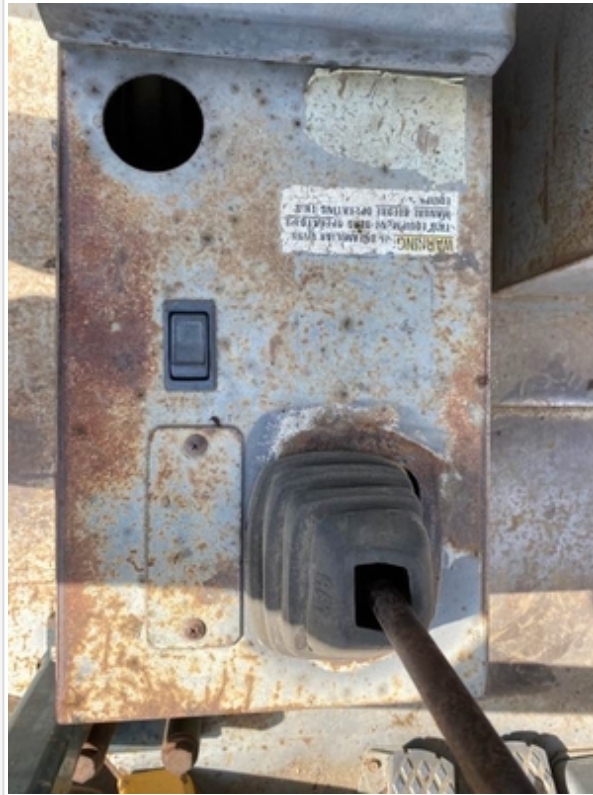
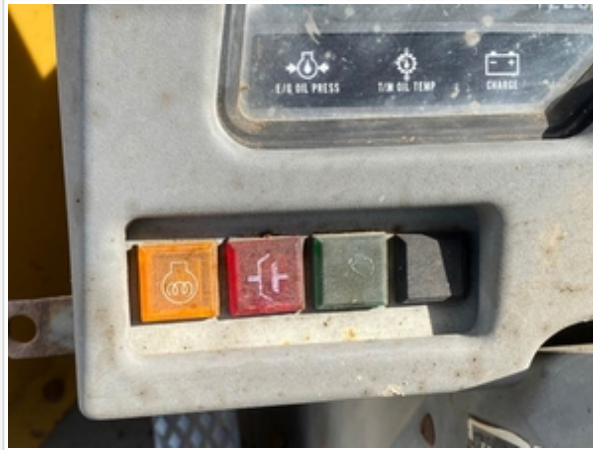
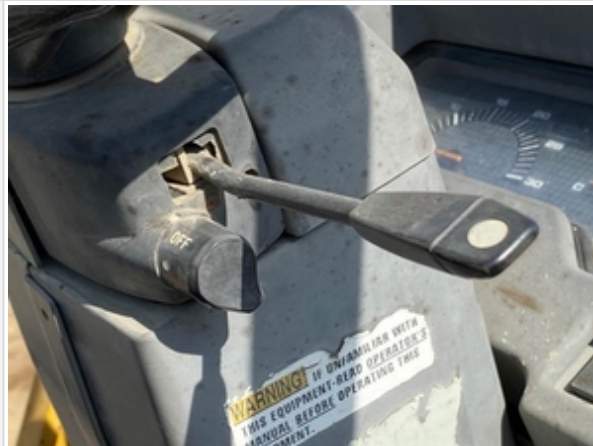
<p>Safety Lock Out / Stop Photos</p>	 
<p>Controls & Switches</p>	<p>2 - Above Average Wear</p>
<p>Controls & Switches Condition</p>	<p>One or more switches are inoperative or missing, Other (see comments)</p>
<p>Comments</p>	<p>Light switches inop.</p>
<p>Controls & Switches Photos</p>

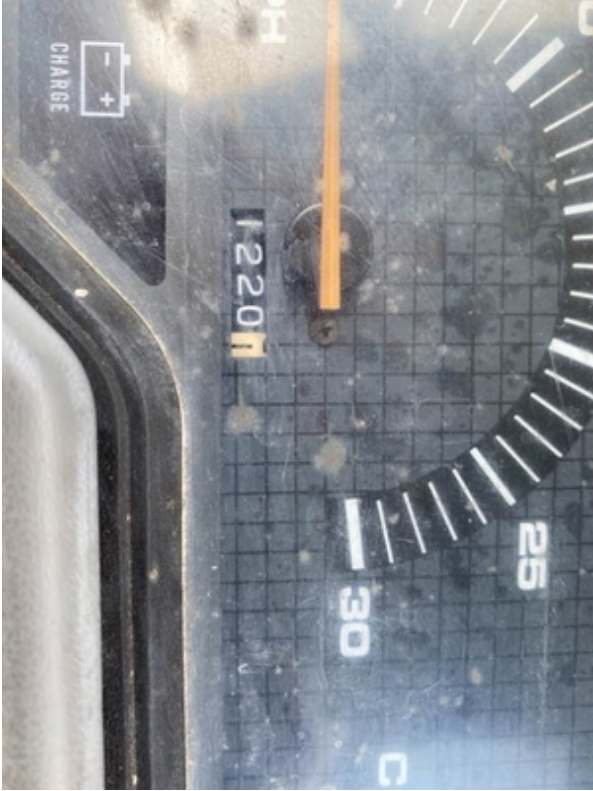
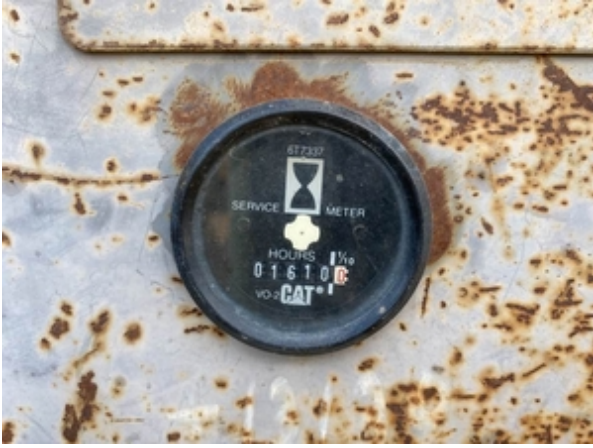
Hour Meter Activity	3 - Normal Wear & Tear
Hour Meter Condition	Hour meter is functional and in good condition, Other (see comments)
Comments	Hour meter added on r/s in addition to oem hour meter in dash
Hour Meter Activity Photos

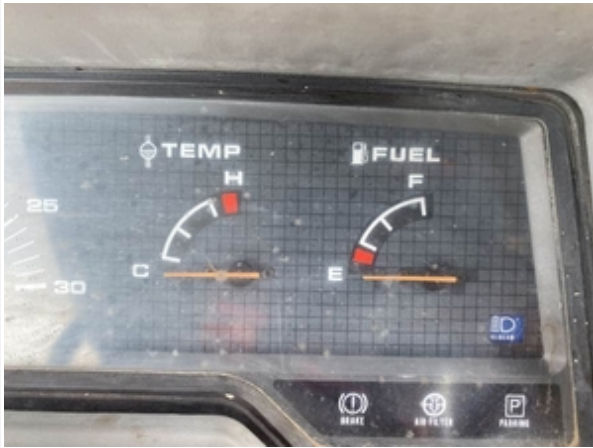
Other Gauge Activity	2 - Above Average Wear
Other Gauge Condition	One or more gauges are unreadable or not functioning (specify in comments)

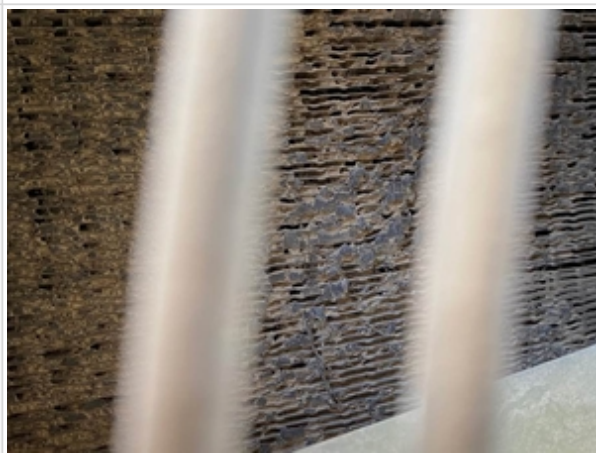
Radiator	3 - Normal Wear & Tear
Radiator Condition	Other (see comments), Radiator fins & components appear to be in good working order, no signs of damage or leaks
Comments	Right side of radiator needs to be clean (clogged)
Radiator Photos

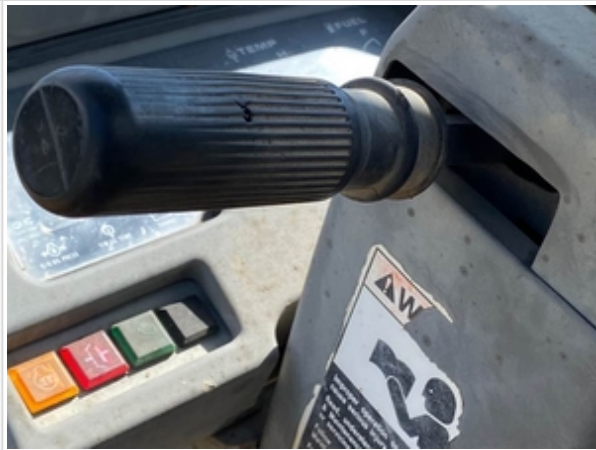
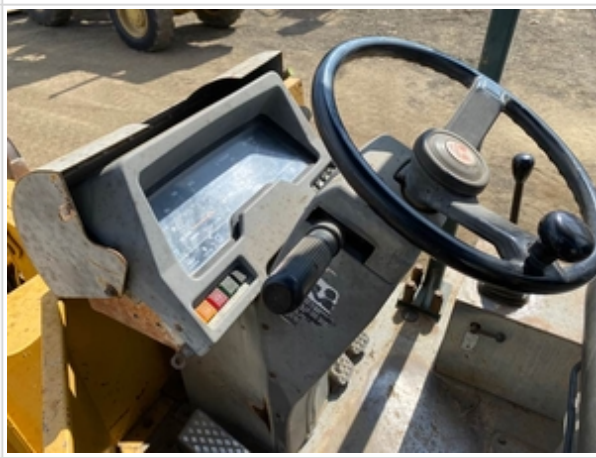
Clutch	0
Shift Lever	2 - Above Average Wear
Shift Lever Condition	Other Comments
Comments	Transmission shift lever has stiff movement both directions. Transmission operates okay.

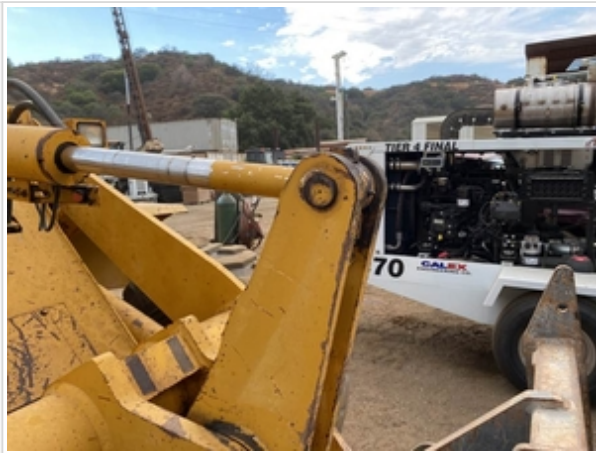
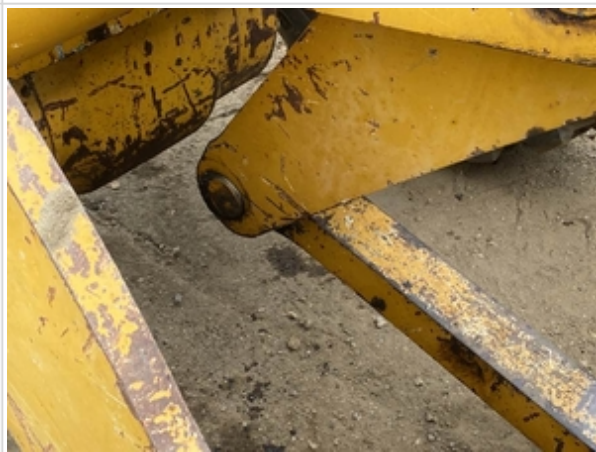
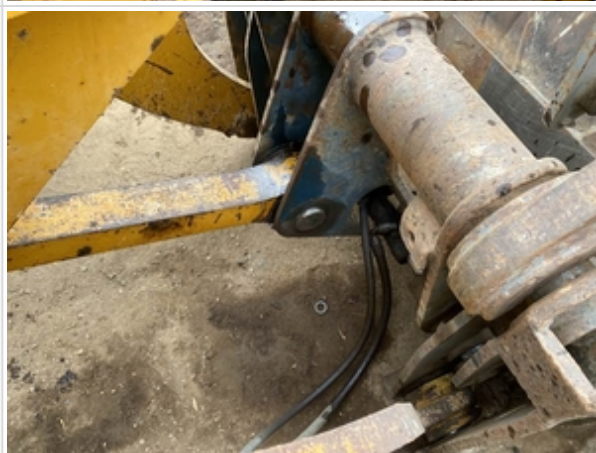
<p>Quick Coupler</p>	<p>2 - Above Average Wear</p>
<p>Comments</p>	<p>Lock cylinders need to be resealed</p>

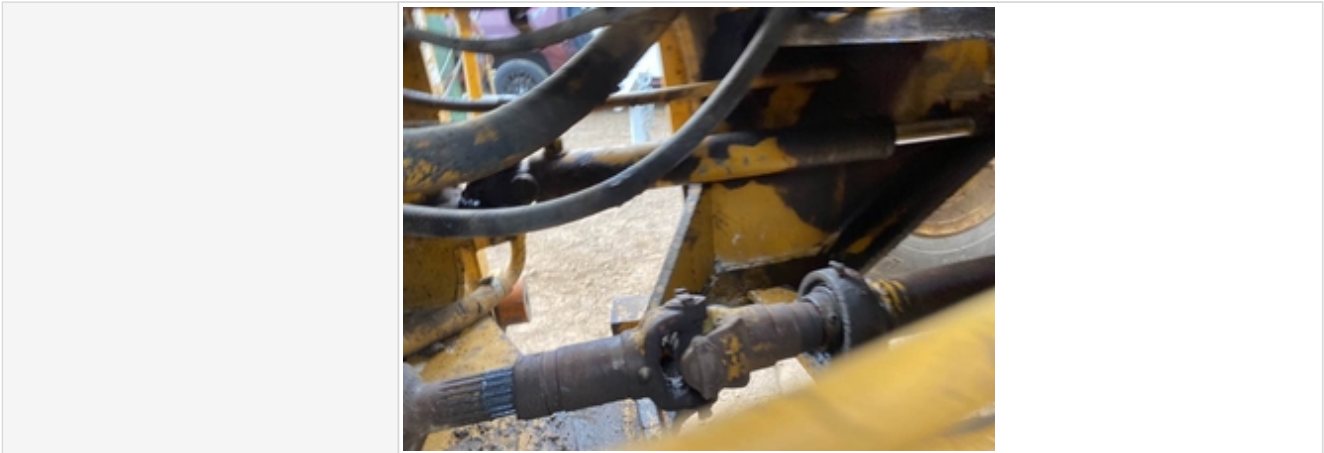
<p>Steering Cylinder</p>	<p>Check the steering cylinder. Note any wear, pitting, discoloration, etc. Take photos.</p>
<p>Steering Cylinder: Mounting Pin</p>	<p>3</p>
<p>Steering Cylinder: Oil Leaks</p>	<p>Yes</p>
<p>Comments</p>	<p>Residual buildup on cylinders may indicate seepage leak no active leaks found</p>
