Inspection Report (Generator)

Year	1997
Make	Wacker
Model	G125
Serial Number	764001010
Hour Meter Reading	6,579
Previous Application (e.g., earth moving, mining, demolition, etc)	General Construction

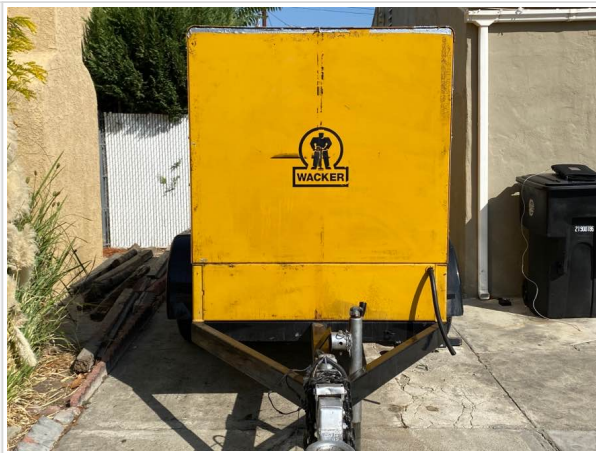
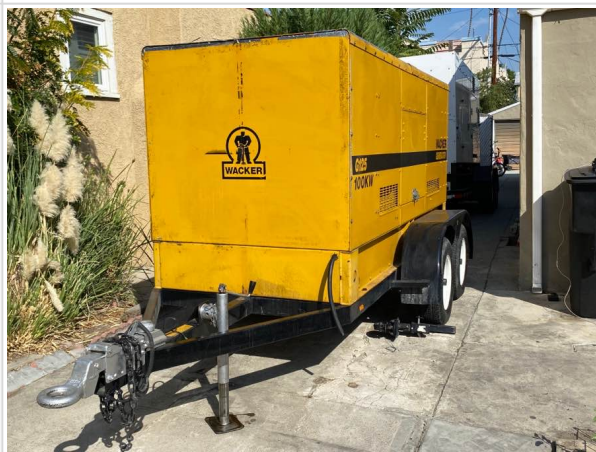
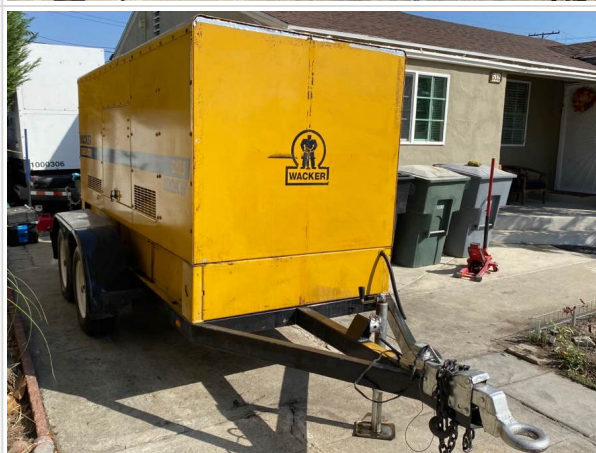
<p>Front Photos</p>

Front	3 - Normal Wear & Tear
Front Condition	No visible damage

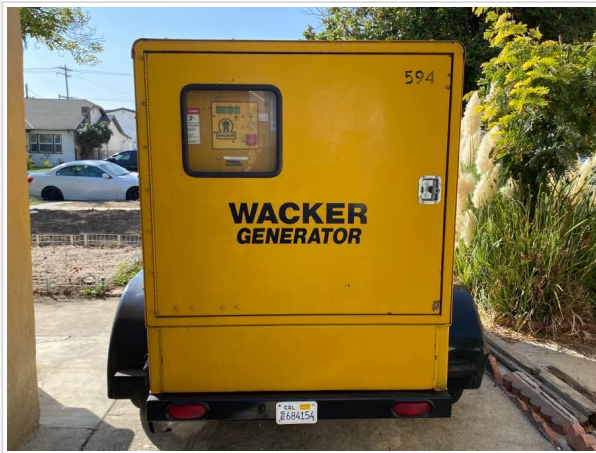
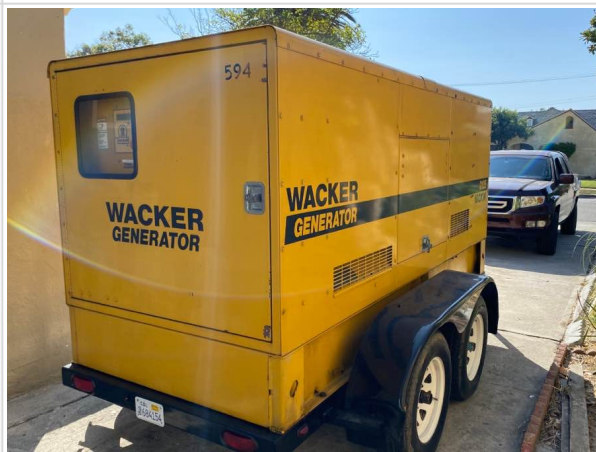
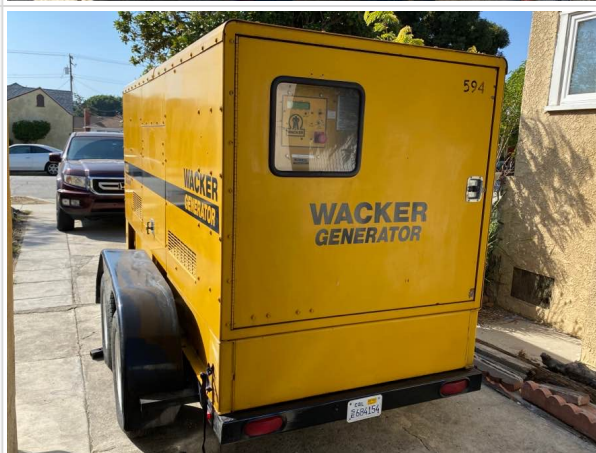
<p>Rear Photos</p>

<p>Rear</p>	<p>3 - Normal Wear & Tear</p>
<p>Rear Condition</p>	<p>No visible damage</p>

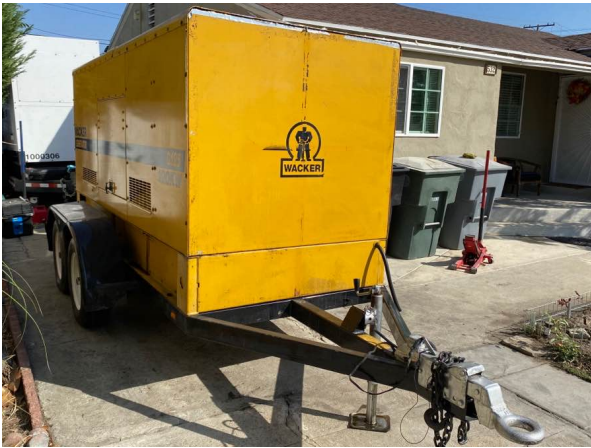
Left Photos

<p>Left</p>	<p>3 - Normal Wear & Tear</p>
<p>Left Condition</p>	<p>No visible damage</p>

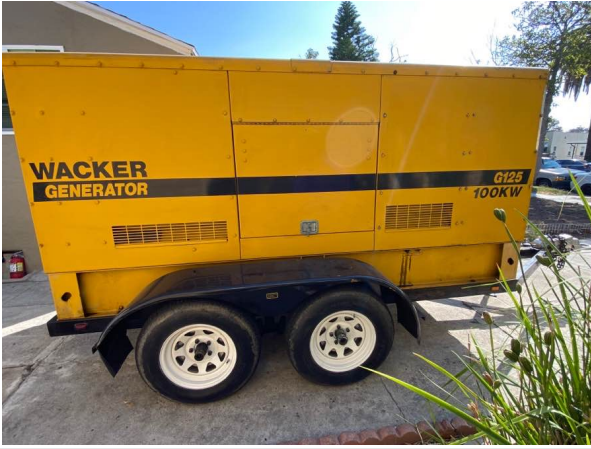
Right	3 - Normal Wear & Tear
Right Condition	No visible damage
Right Photos

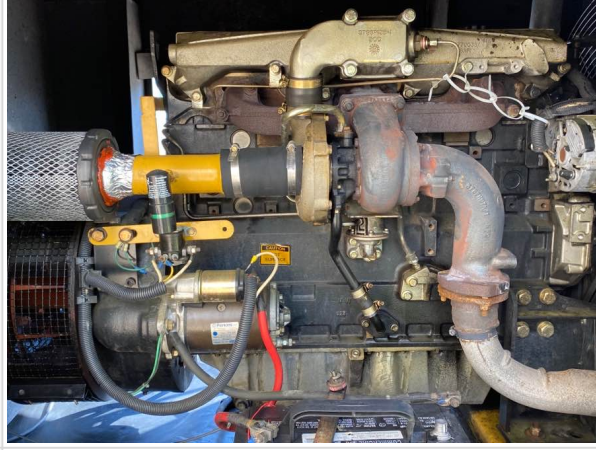
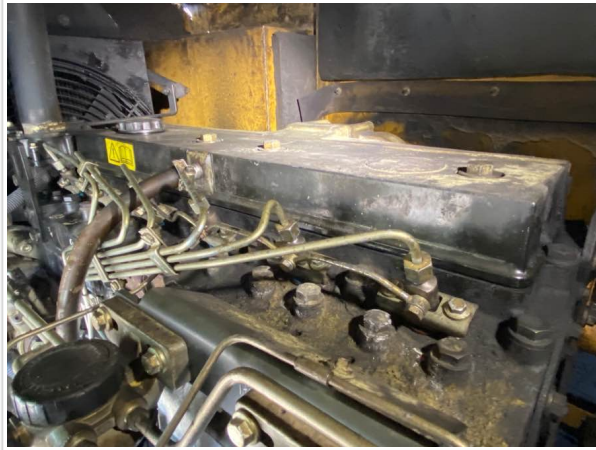
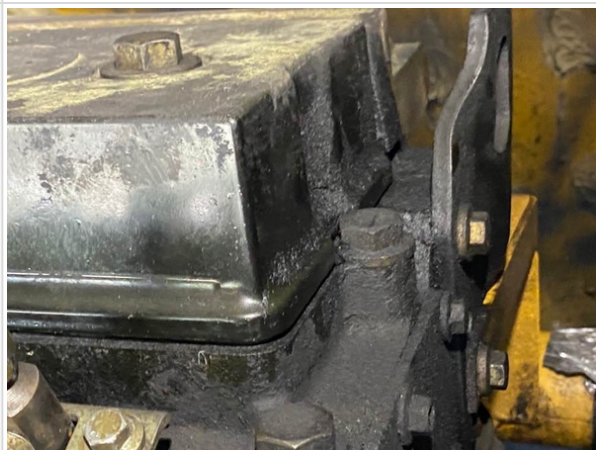
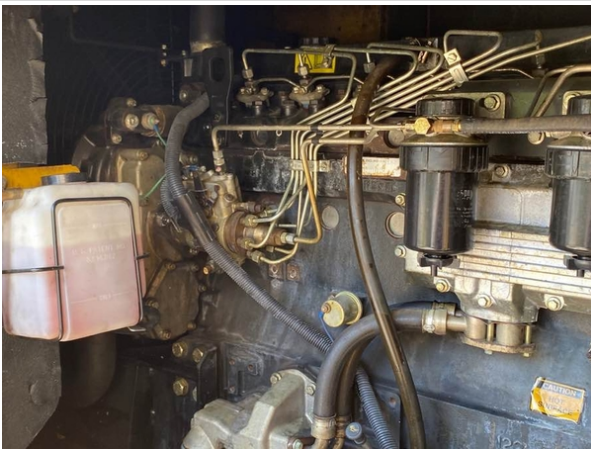
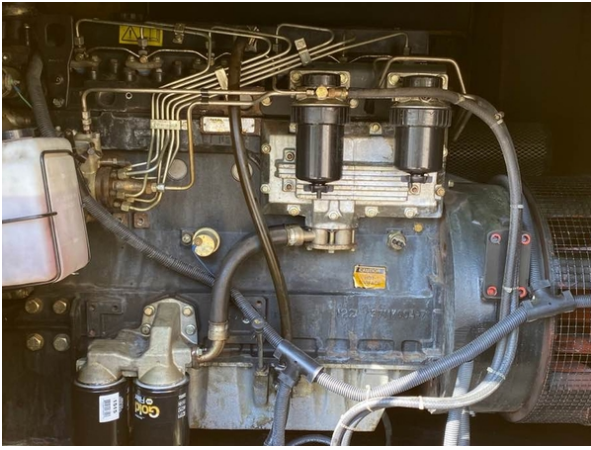
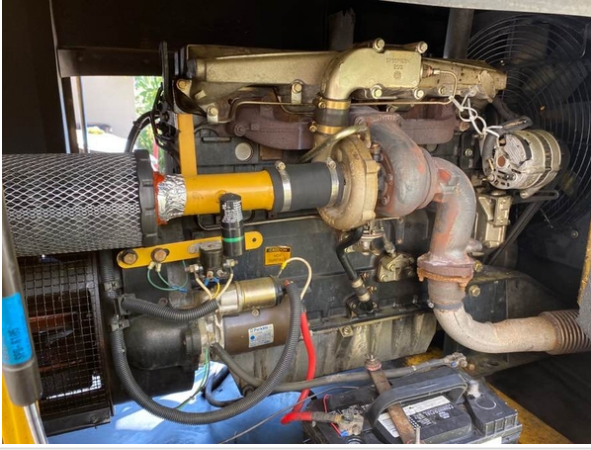
Equipped with DPF (Diesel Particulate Filter)	No
Requires DEF (Diesel Exhaust Fluid)	No
Overall Engine Appearance	Clean & dry, Areas of dried seepage seen on engine hoses & components
Overall Engine Comments	Overall engine well maintained. Possible small oil leak at valve cover.

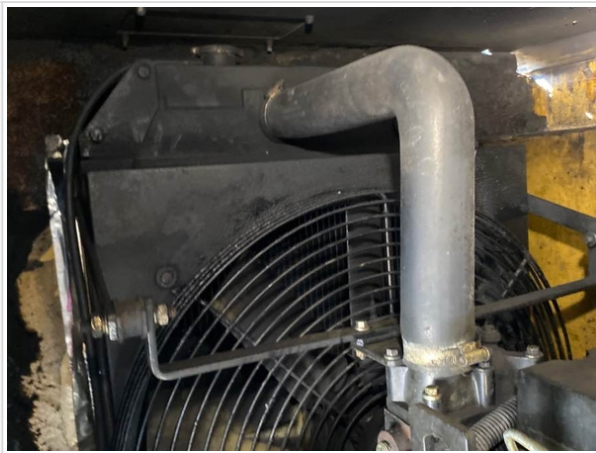
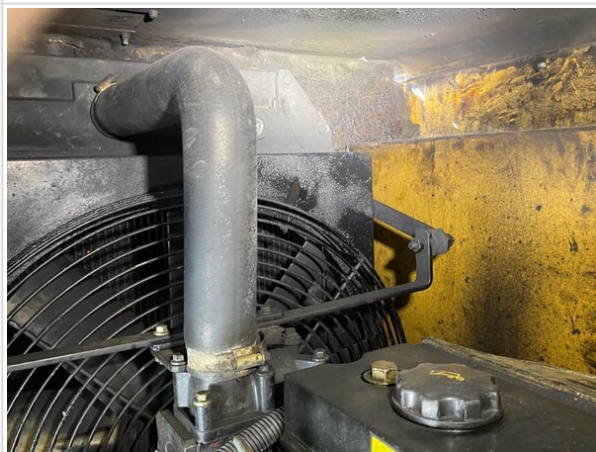
Radiator Photos

Radiator	3 - Normal Wear & Tear
Radiator Condition	Radiator fins & components appear to be in good working order, no signs of damage or leaks

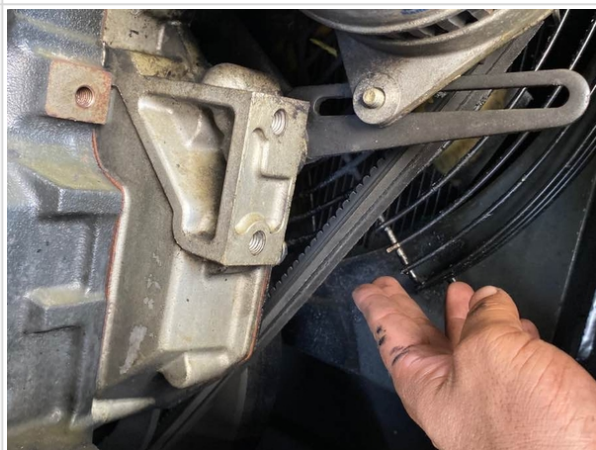
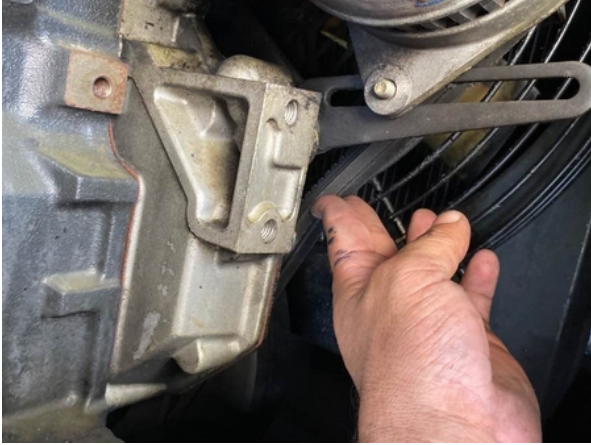
Belts	3 - Normal Wear & Tear
Belt Condition	Belts appear in good condition & alignment with proper tension
Belt Photos

Exterior Rating	3
Interior Rating	3
Safety Rating	3
Quality Rating	3
Functionality Rating	3
Overall Rating	3
What's Great About the Machine	The generators functions work well.
What Needs Work	Engine oil leak at front of engine, and at valve cover. Alternator belt loose. Turbo intake filter not OEM

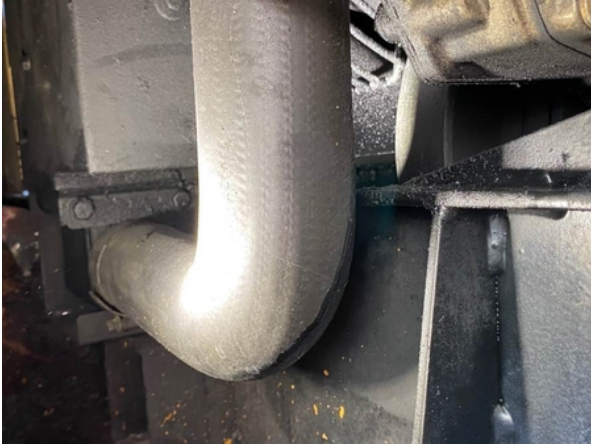
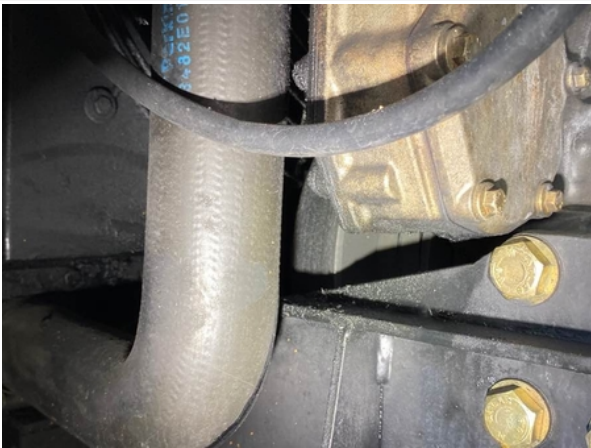
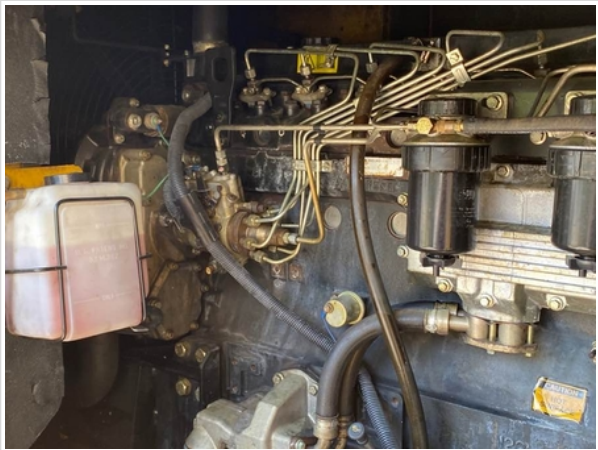
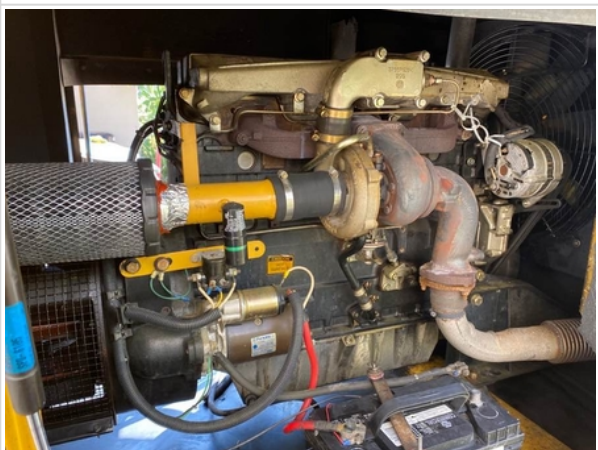
Hoses	3 - Normal Wear & Tear
Hose Condition	Firm, pliant hoses with no signs of wear or leaks
Hose Photos

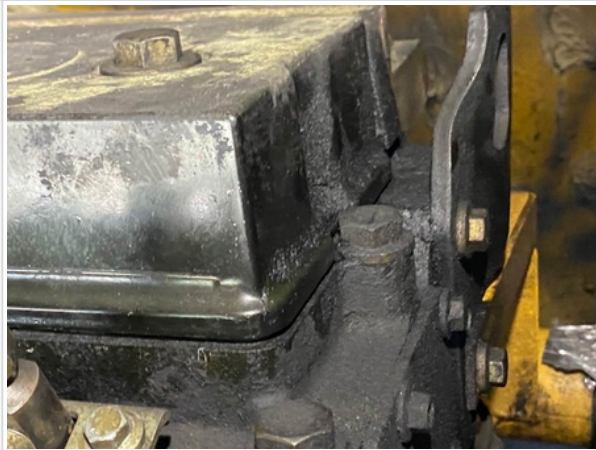
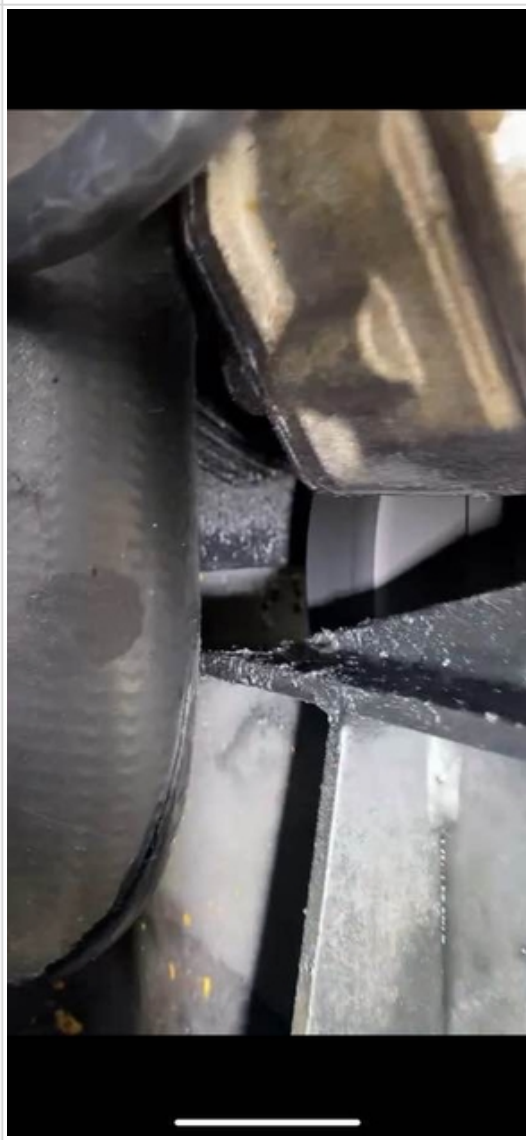
<p>Oil Leak Photos</p>

Water Pump	3 - Normal Wear & Tear	
Water Pump Condition	No unusual pump noises heard	
Cooling System Leaks	No	
Coolant Color / Appearance	3 - Normal Wear & Tear	
Coolant Color/Appearance Notes	Normal Translucent appearance, no visual signs of contamination	
Oil Leaks	Yes	
Oil Leak Notes	Dried oil seepages seen	
Comments	Valve cover has minor residual oil buildup, signs of oil leak from front of engine (front cover, front main seal)

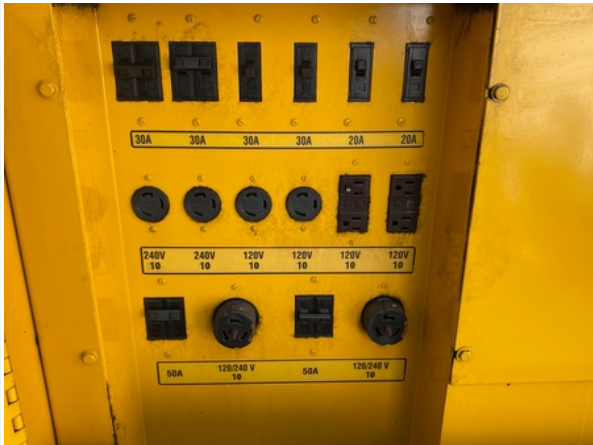
110V	Yes
110V Outlet Condition	3 - Normal Wear & Tear
110V Outlet Photos

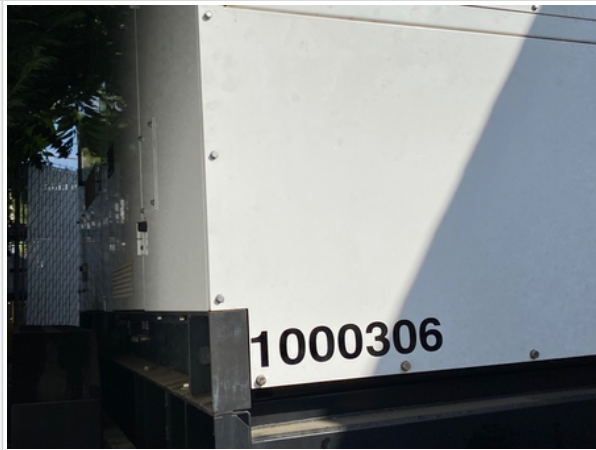
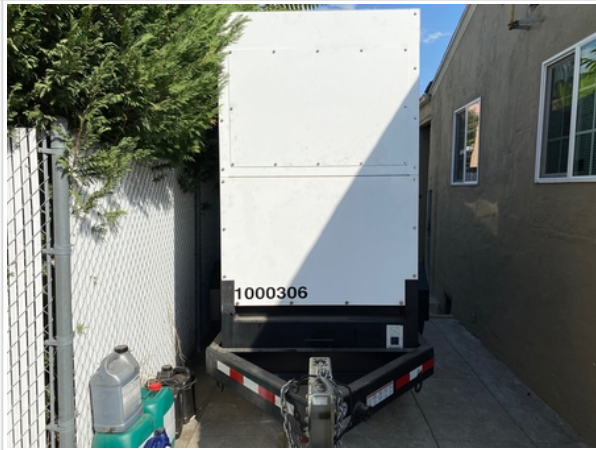
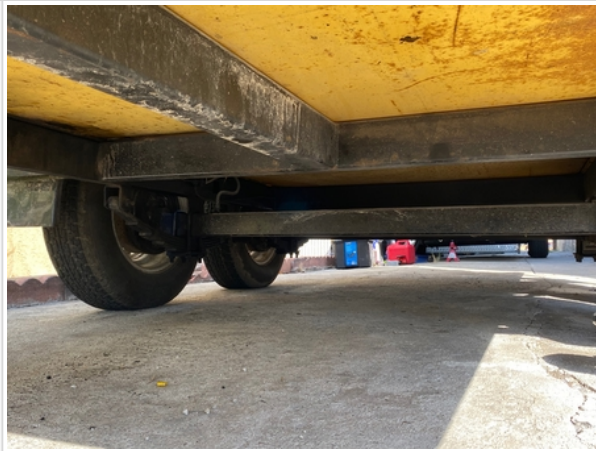
Frame Photos

Frame Condition	3 - Normal Wear & Tear
-----------------	------------------------

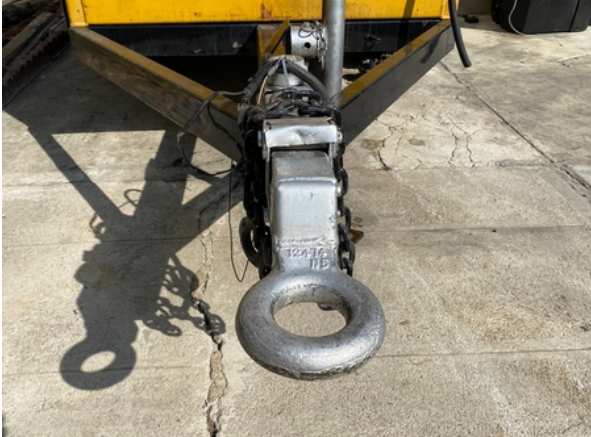
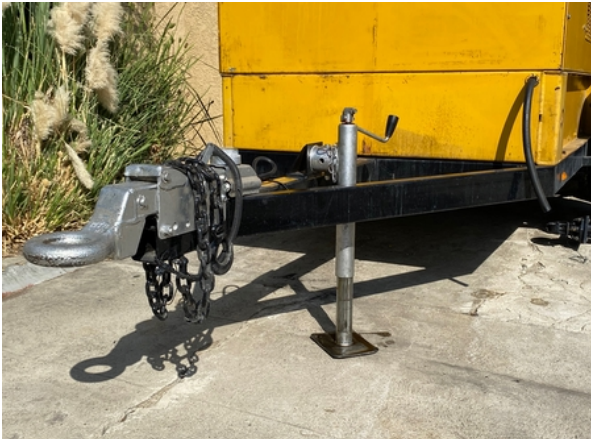
Hitch Condition	3 - Normal Wear & Tear
Hitch Photos

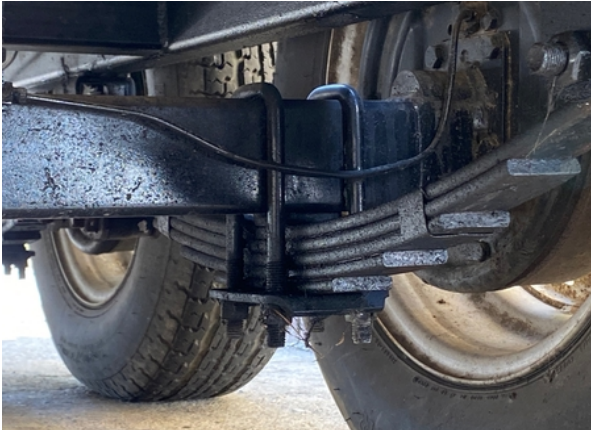
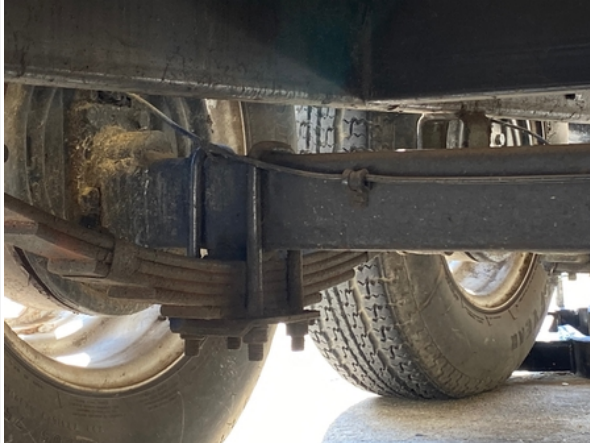
Springs	3 - Normal Wear & Tear
Springs Photos

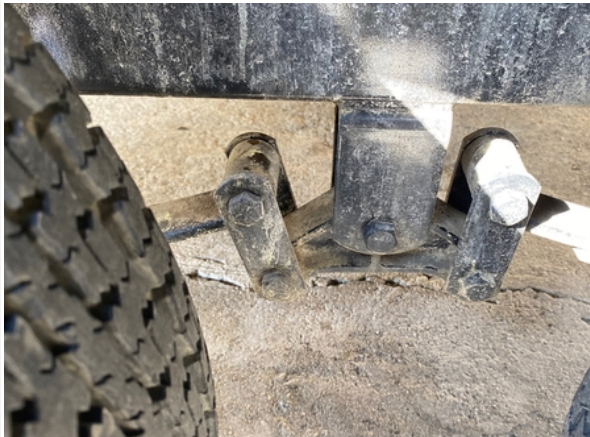
U-Bolts	3 - Normal Wear & Tear	
Equalizer	3 - Normal Wear & Tear	
Equalizer Photos

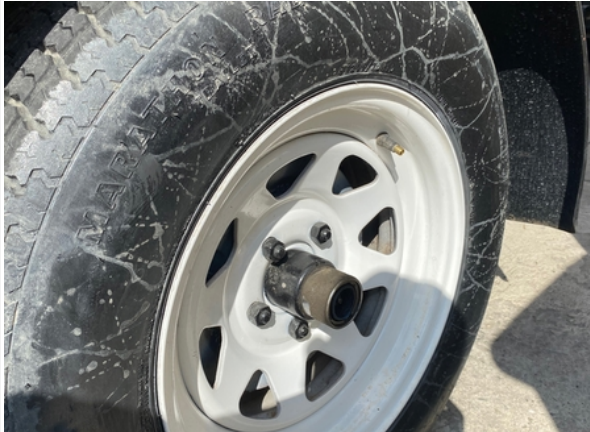
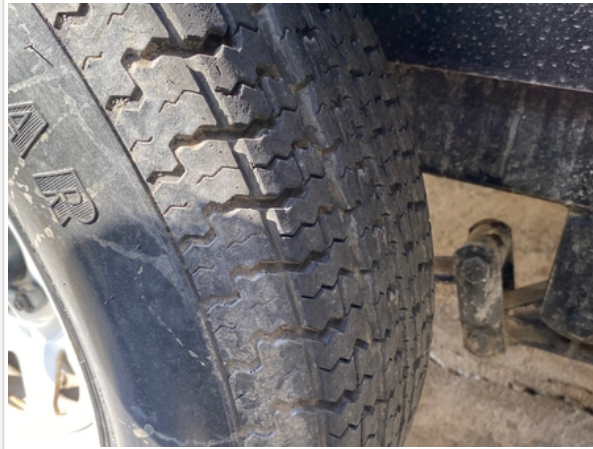
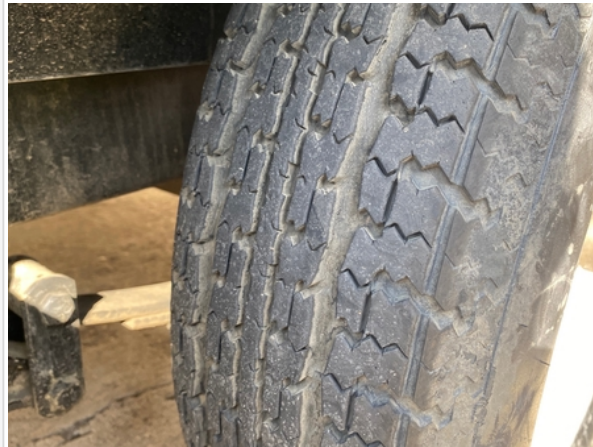
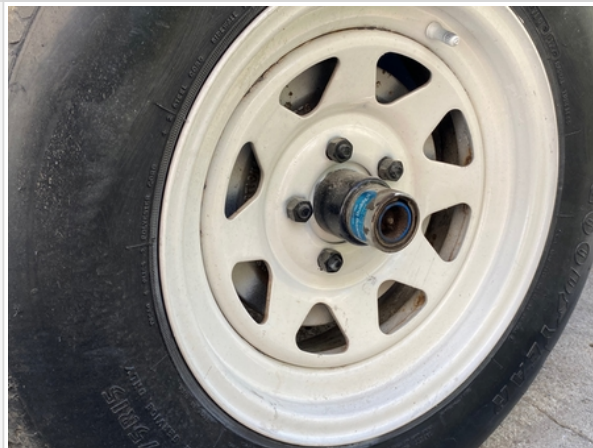
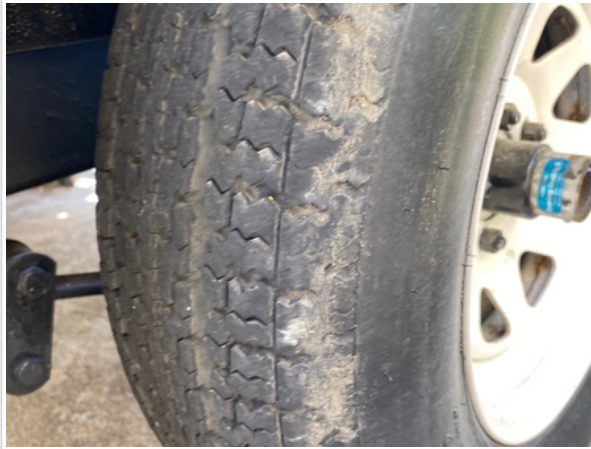
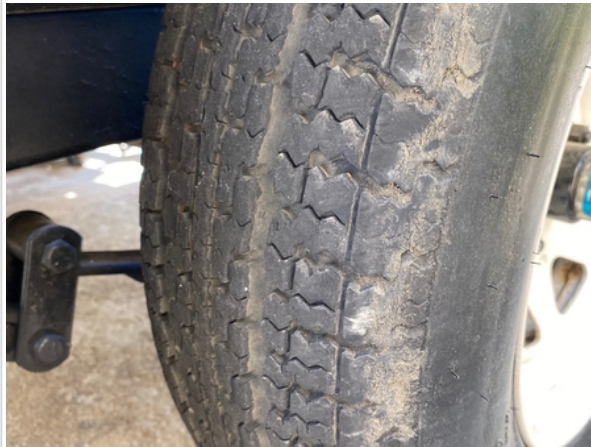
Wheels & Hub Condition	3 - Normal Wear & Tear	
Wheels & Hub Photos

Loose Lugs	No
Tire Brand	Goodyear
Tire Size	ST205/75R/15
Front Left Tire - Ratio Remaining	50%
Front Right Tire - Ratio Remaining	50%
Rear Right Tire - Ratio Remaining	50%
Rear Left Tire - Ratio Remaining	50%

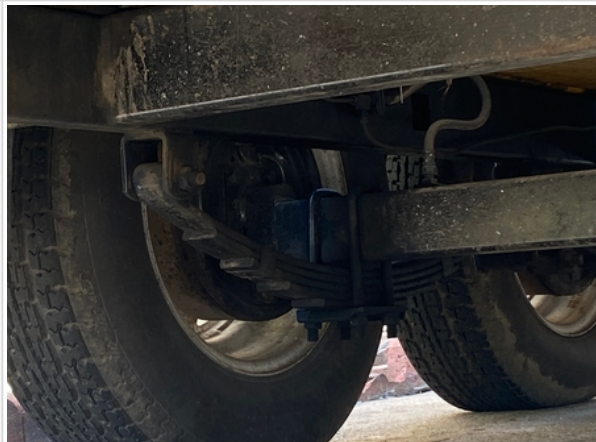
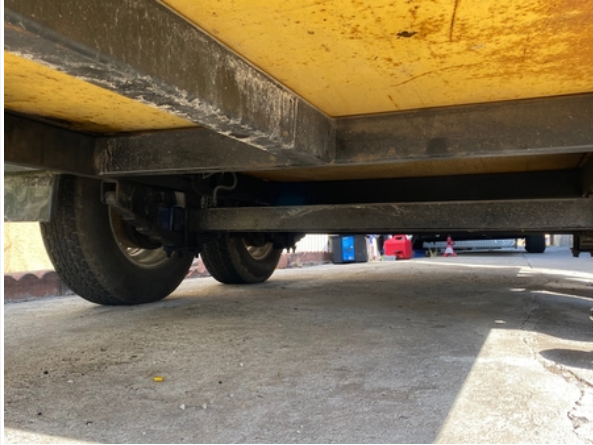
Overall Trailer	3 - Normal Wear & Tear
Overall Trailer Comments	Trailer in good shape
Overall Trailer & Undercarriage Photos
