Inspection Report (Wheel Loader)

Year	1981
Make	CAT
Model	930B - unit 15-101
Serial Number	41K10862
Hour Meter Reading	4,018
Previous Application (e.g., earth moving, mining, demolition, etc)	General Construction excavation

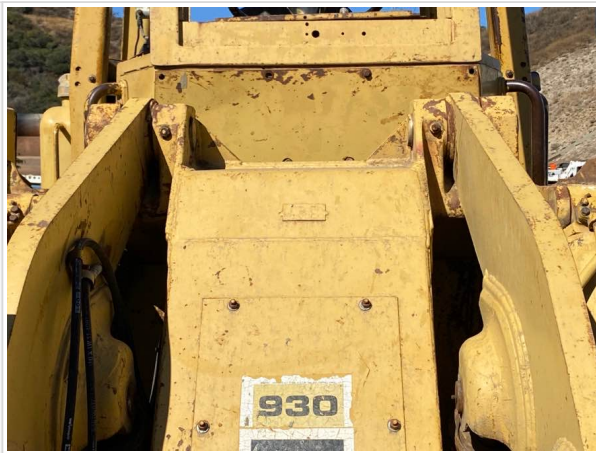
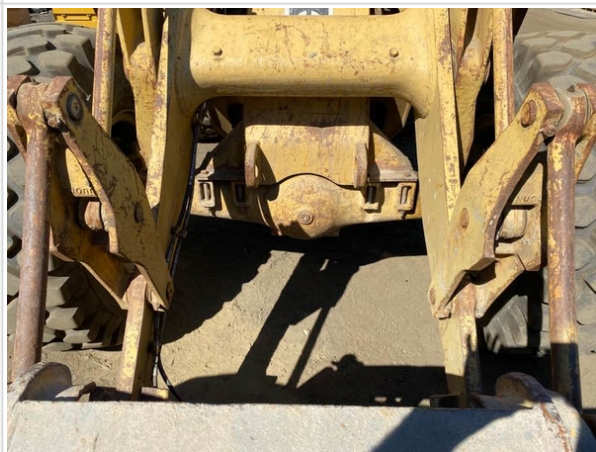
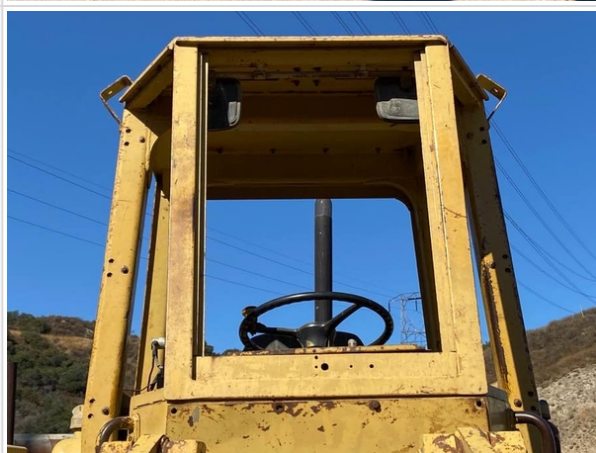
Front	3 - Normal Wear & Tear
Front Condition	No visible damage

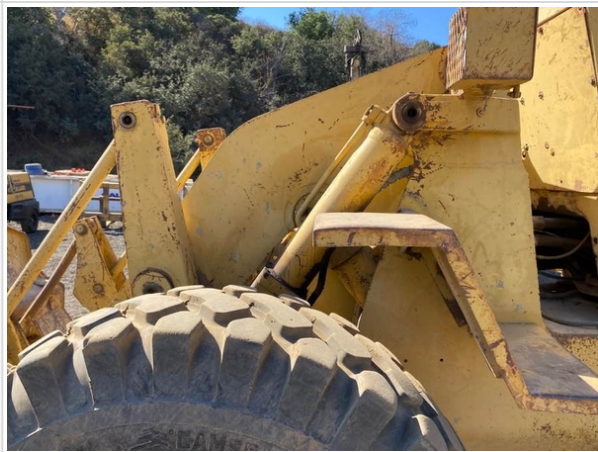
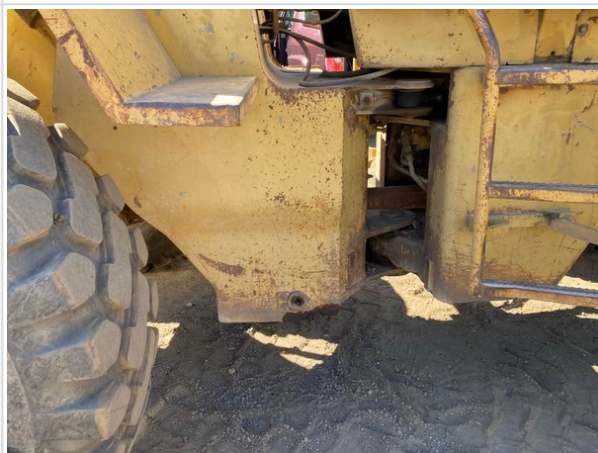
Left	3 - Normal Wear & Tear	
Left Condition	No visible damage	
Left Photos

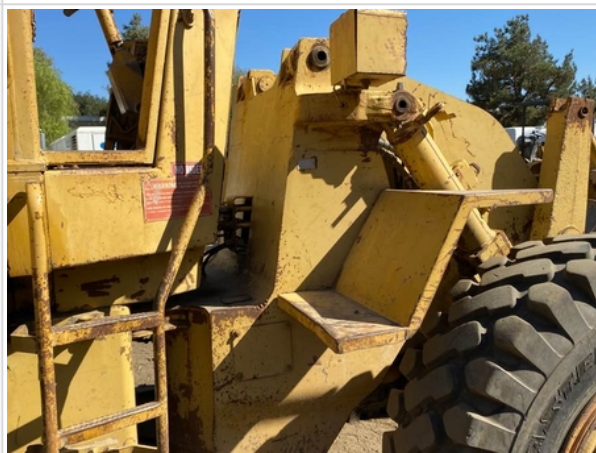
<p>Right</p>	<p>3 - Normal Wear & Tear</p>
<p>Right Condition</p>	<p>No visible damage</p>
<p>Right Photos</p>

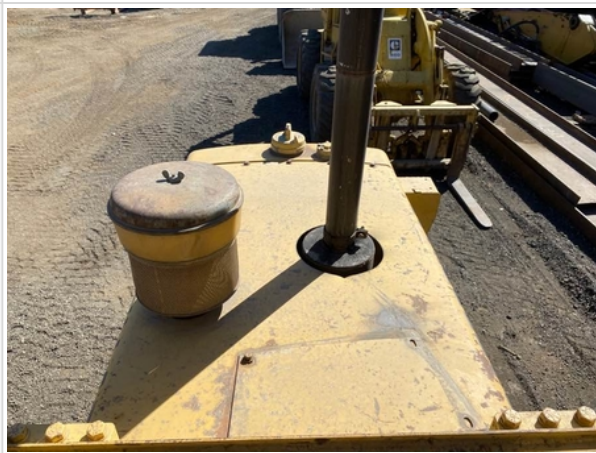
Upper	3 - Normal Wear & Tear
Upper Condition	No visible damage
Upper Photos

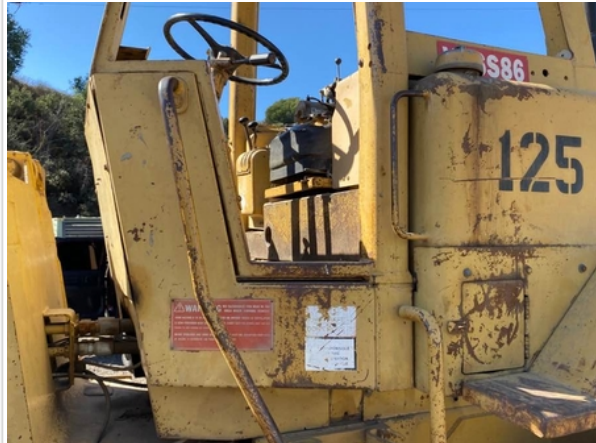
Handrails	3 - Normal Wear & Tear
Handrails Condition	Handrails are fully intact and appear structurally sound
Handrail Photos

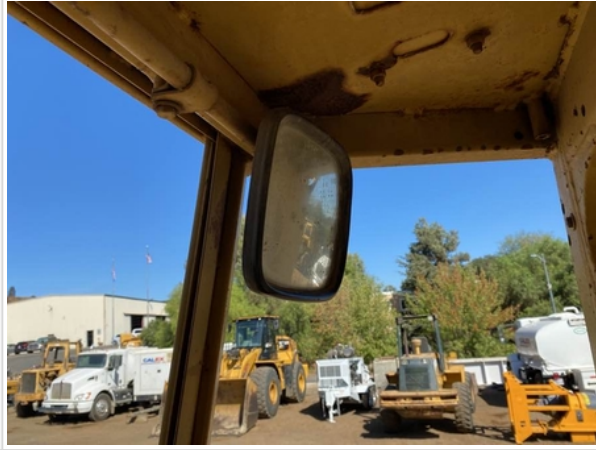
Glass Condition	0
Mirrors	3 - Normal Wear & Tear
Mirror Condition Notes	Mirrors present and intact, no visible damage
Mirrors Photos

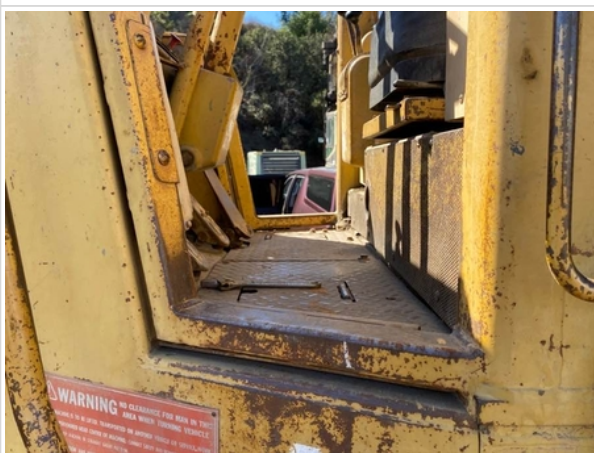
<p>Operator Cabin Overall</p>	<p>3 - Normal Wear & Tear</p>
<p>Operator Cabin Overall Condition</p>	<p>Minor cosmetic wear to cabin surfaces, floors, panels, and ceiling</p>
<p>Operator Cabin Photos</p>

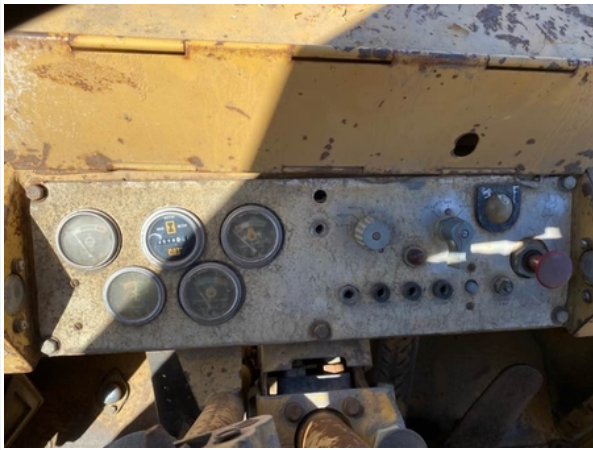
Other Gauge Activity	3 - Normal Wear & Tear
Other Gauge Condition	All cockpit gauges are functional and in good condition
Other Gauge Activity Photos

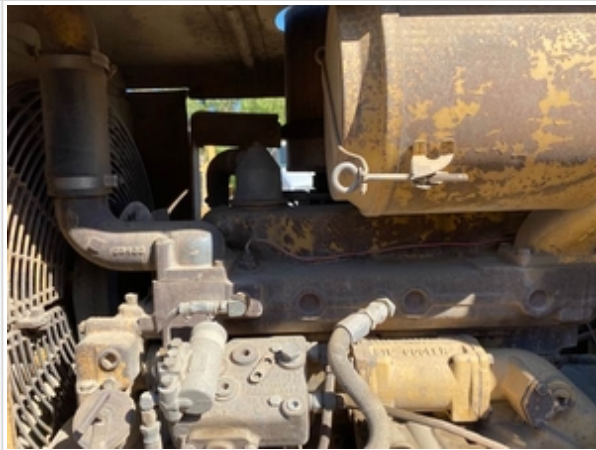
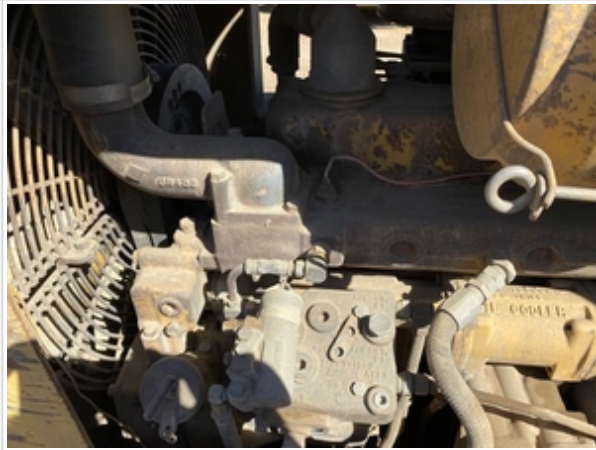
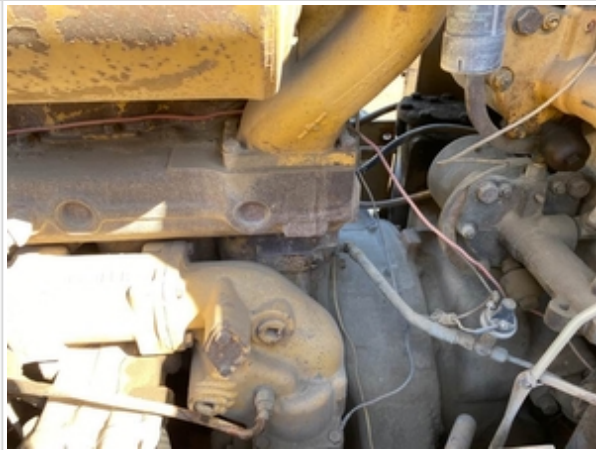
Blow-by (Visual Observation Check)	Yes
Comments	Yes minor blowby
Unusual Noises (Upon Start-up, Idle, Shutdown)	No
Unusual Noise Notes	No unusual noises heard
Engine Smoke (Upon Start-up, Idle, Shutdown)	No
Engine Smoke Notes	No engine smoke issues observed

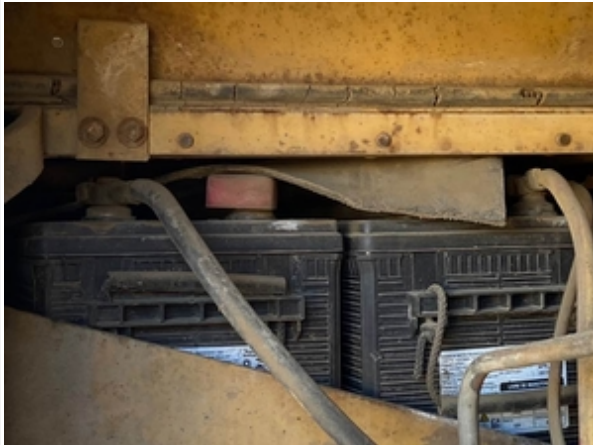
Engine Exhaust Color	Clear
Battery	3 - Normal Wear & Tear
Battery Condition	Dusty & dirty appearance, Clean & dry appearance, tight connections
Battery Condition Photos

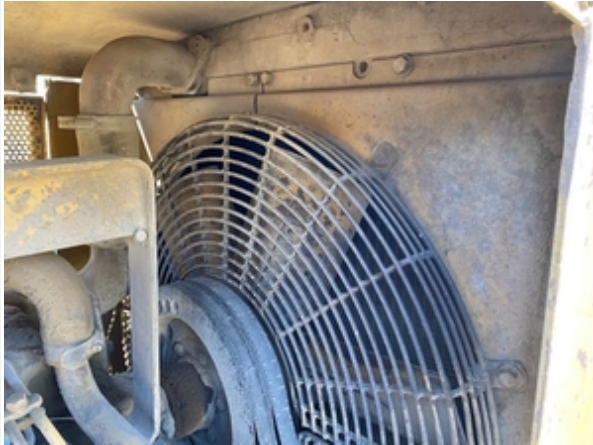
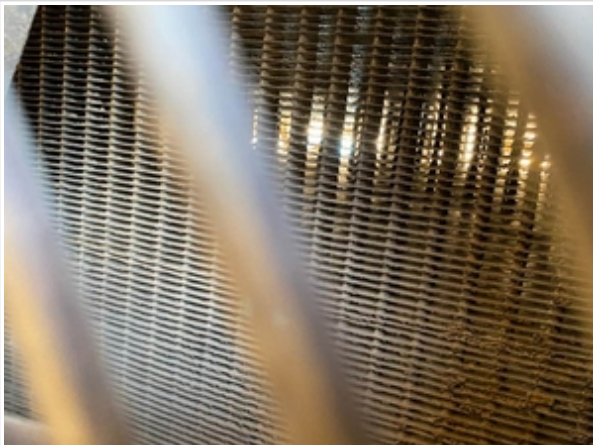
Radiator	3 - Normal Wear & Tear
Radiator Condition	Radiator fins & components appear to be in good working order, no signs of damage or leaks
Radiator Photos

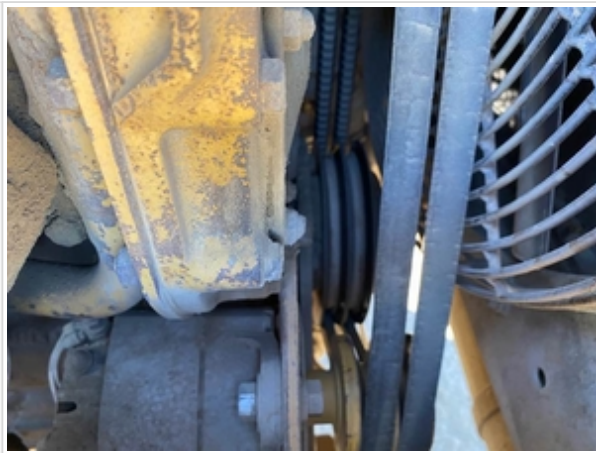
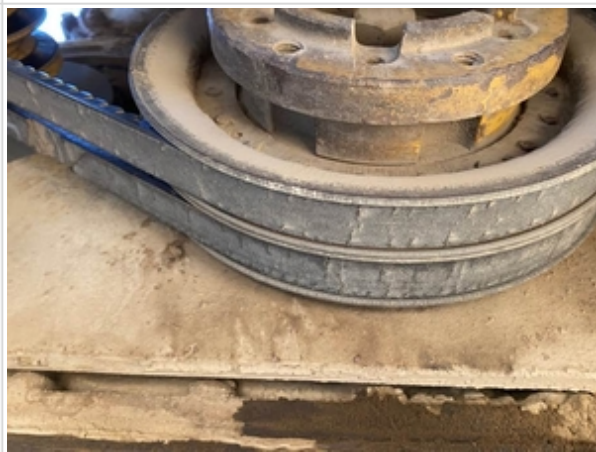
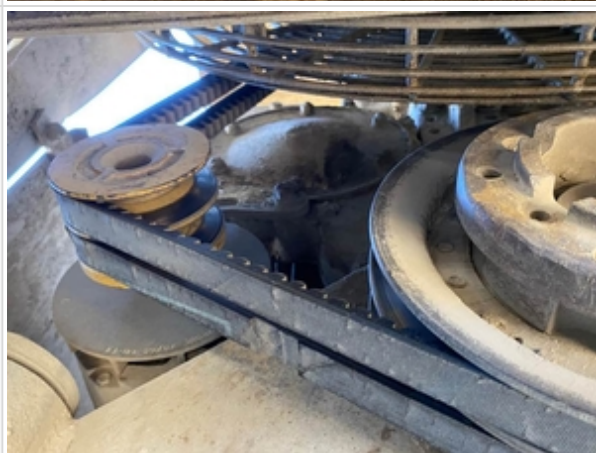
Belts	3 - Normal Wear & Tear
Belt Condition	Belts appear in good condition & alignment with proper tension

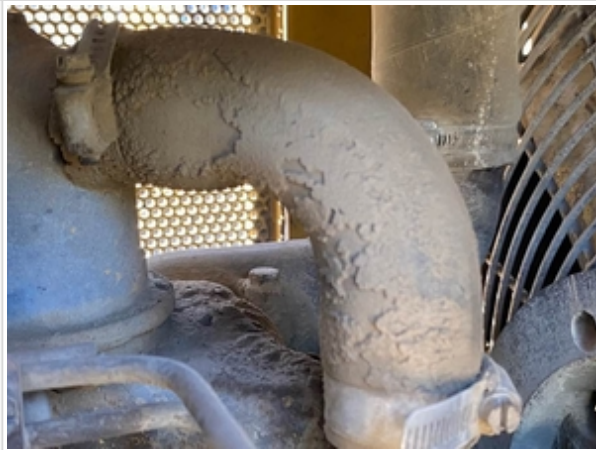
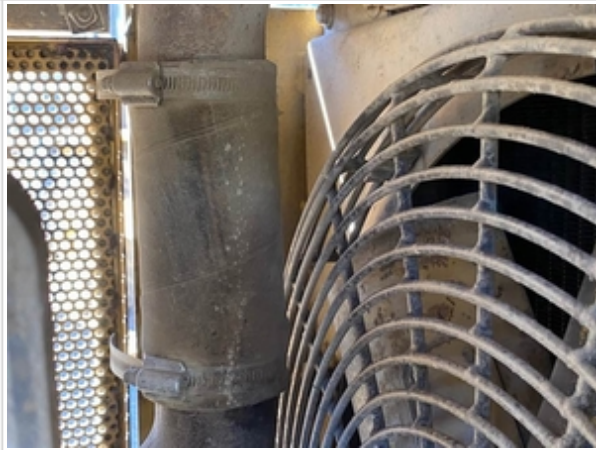
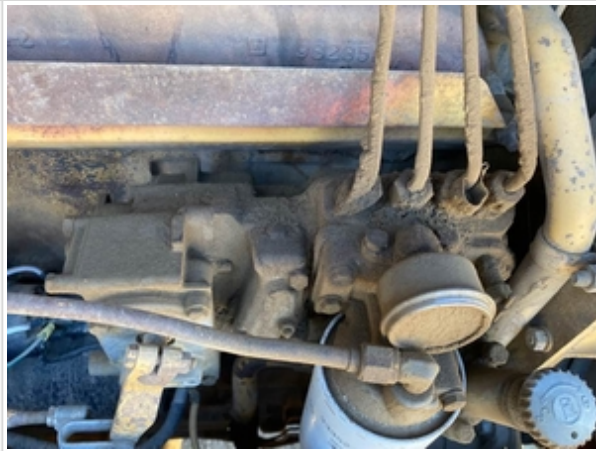
<p>Hoses</p>	<p>3 - Normal Wear & Tear</p>
<p>Hose Condition</p>	<p>Firm, pliant hoses with no signs of wear or leaks</p>

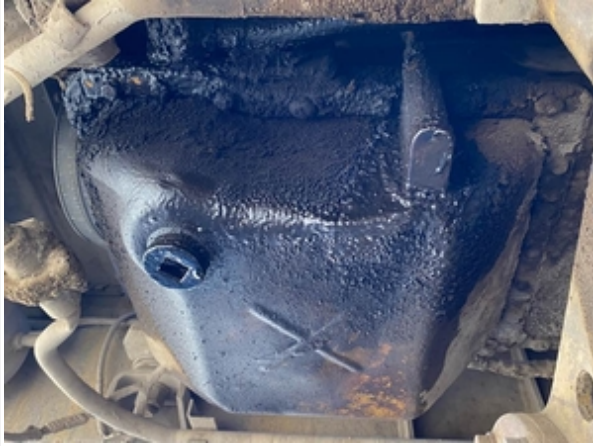
Water Pump	3 - Normal Wear & Tear
Water Pump Condition	No unusual pump noises heard
Cooling System Leaks	No
Coolant Color / Appearance	3 - Normal Wear & Tear
Coolant Color/Appearance Notes	Normal Translucent appearance, no visual signs of contamination
Oil Leaks	Yes
Oil Leak Notes	Wetness & discoloration observed

Comments	Oil pan has oil buildup and shows signs of active leak.
Oil Leak Photos

Oil Color / Appearance	3 - Normal Wear & Tear
Oil Color / Appearance Notes	Clean oil appearance, no signs of cross contamination, Appropriate oil level, Other (see comments)
Fuel Leaks	No
Equipped with DPF (Diesel Particulate Filter)	No
Requires DEF (Diesel Exhaust Fluid)	No
Overall Engine Appearance	Active leaks/pooling observed in & around engine compartment, Areas of dried seepage seen on engine hoses & components
Overall Engine Comments	Overall engine sounds okay. Engine oil leaks exist.

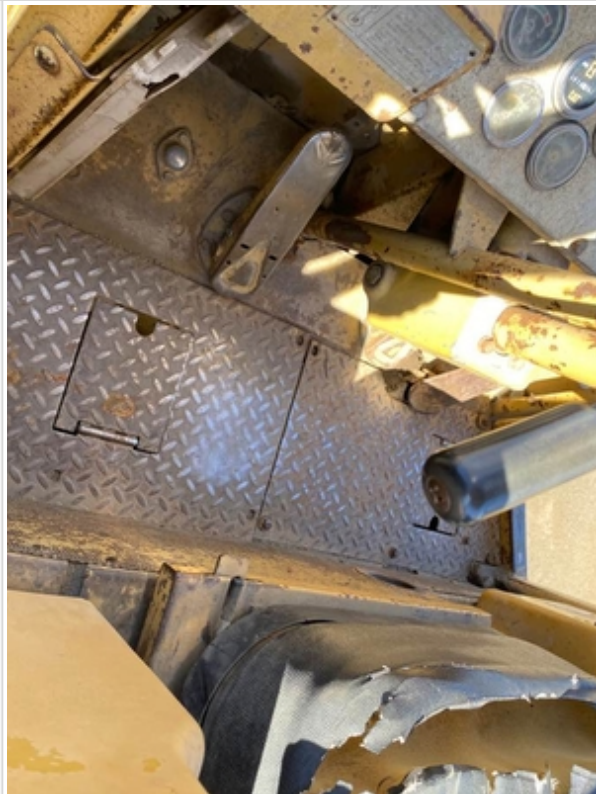
Foot Brake	3 - Normal Wear & Tear
Foot Brake Condition	Good brake function

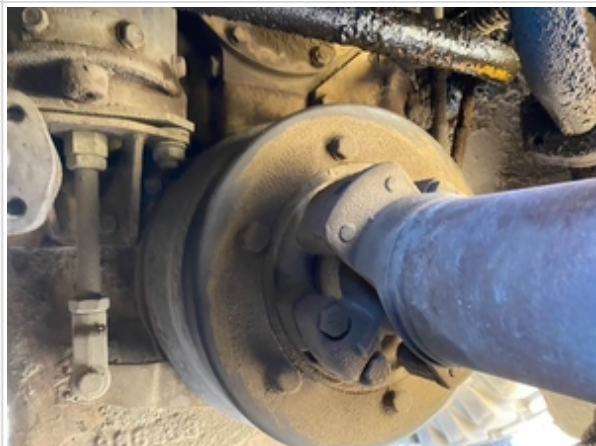
Parking Brake	3 - Normal Wear & Tear
Parking Brake Condition	Good brake function
Parking Brake Photos

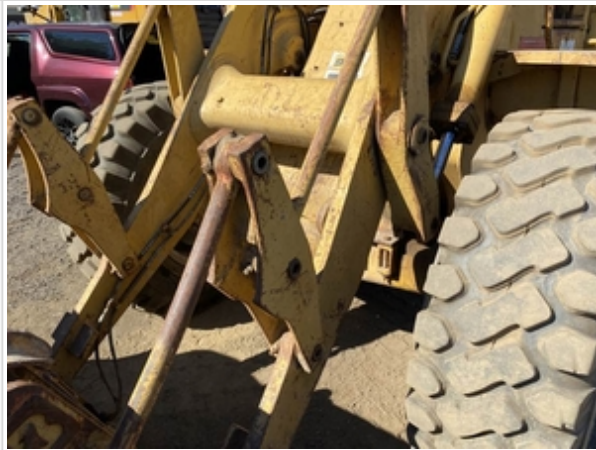
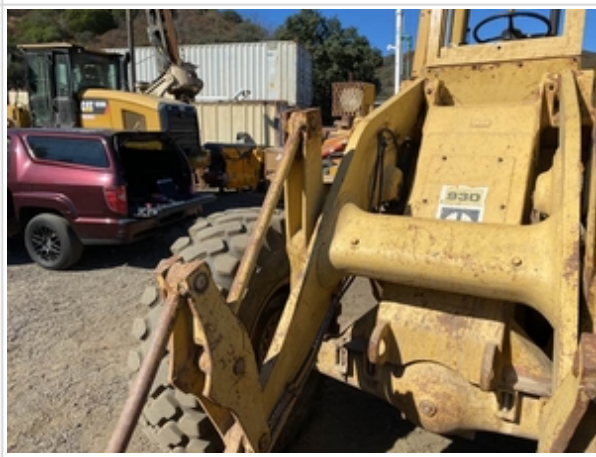
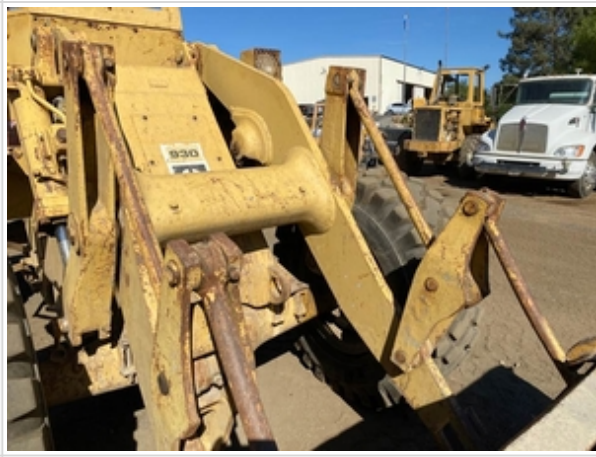
Tilt Linkage	3 - Normal Wear & Tear	
Comments	Front L/S tilt linkage bar slightly bent

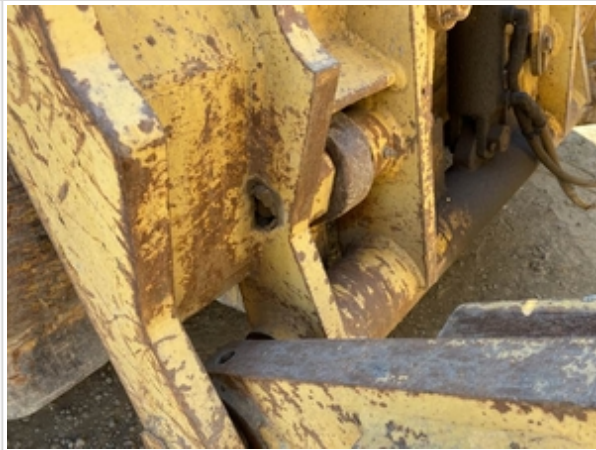
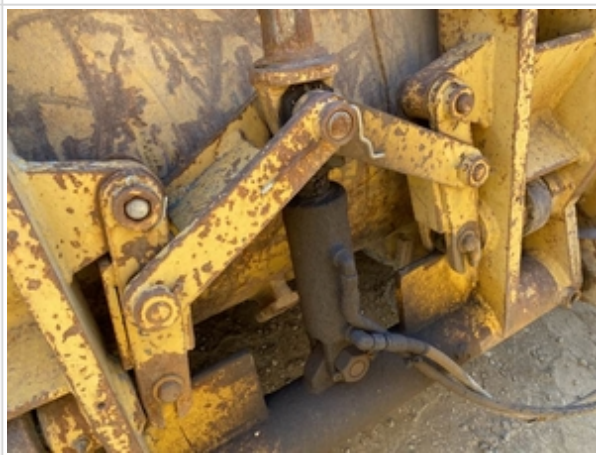
<p>Quick Coupler to Arms Pins</p>	<p>3 - Normal Wear & Tear</p>
<p>Comments</p>	<p>Quick coupler to loader arms bores have excessive play</p>

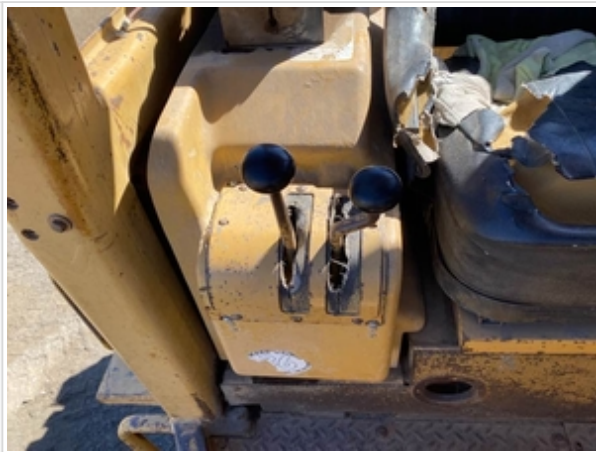
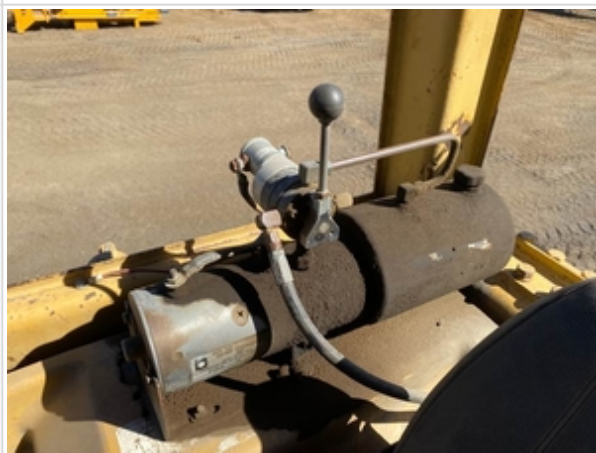
Unusual Noises (Hydraulic Pump)	No
Hydraulic Pump Notes	No unusual noises heard during operation
External Controls / Levers	3
External Controls / Levers Condition	Good function & condition of hydraulic controls

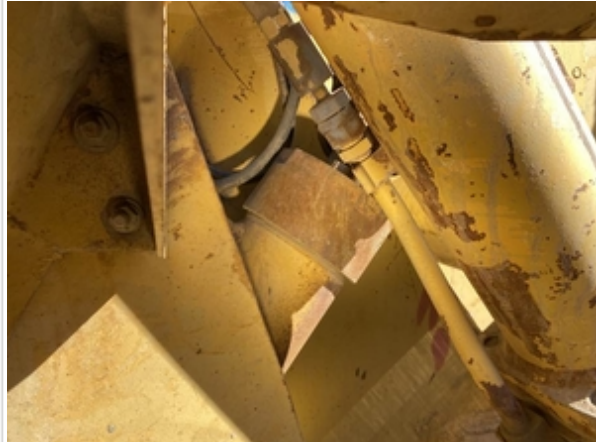
Lift Cylinder	Check the lift cylinder. Note any wear, pitting, discoloration, etc. Take photos.
Lift Cylinder: Mounting Pin	3
Lift Cylinder: Oil Leaks	No
Lift Cylinder Photos

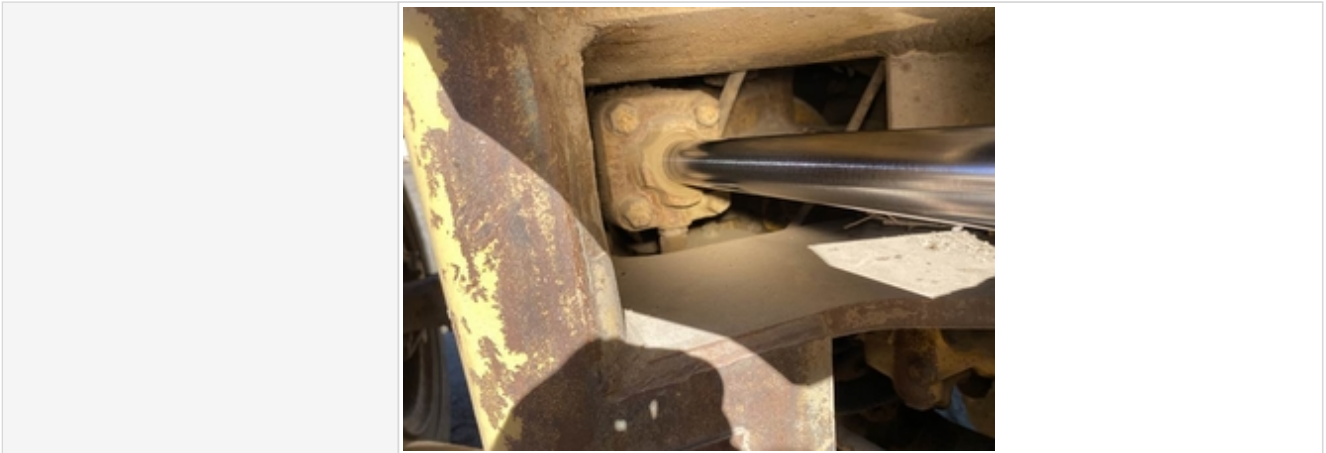
Steering Cylinder	Check the steering cylinder. Note any wear, pitting, discoloration, etc. Take photos.	
Steering Cylinder: Mounting Pin	3	
Steering Cylinder: Oil Leaks	Yes	
Comments	L/S Steer Cylinder seeping oil	
Steering Cylinder Photos

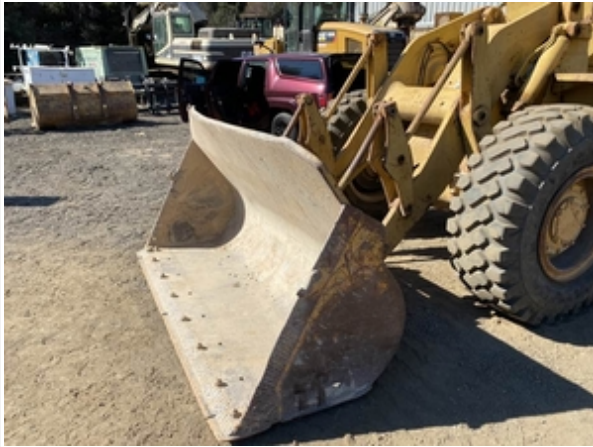
Bucket	3 - Normal Wear & Tear
Comments	8' wide r/s top of bucket bent back
Bucket Photos
