Inspection Report (Generator)

Year	2006
Make	CAT Generator
Model	XQ300
Serial Number	X3R00217 - Enclosure SN# - E33 BXFGS
Hour Meter Reading	6,787
Previous Application (e.g., earth moving, mining, demolition, etc)	General Construction

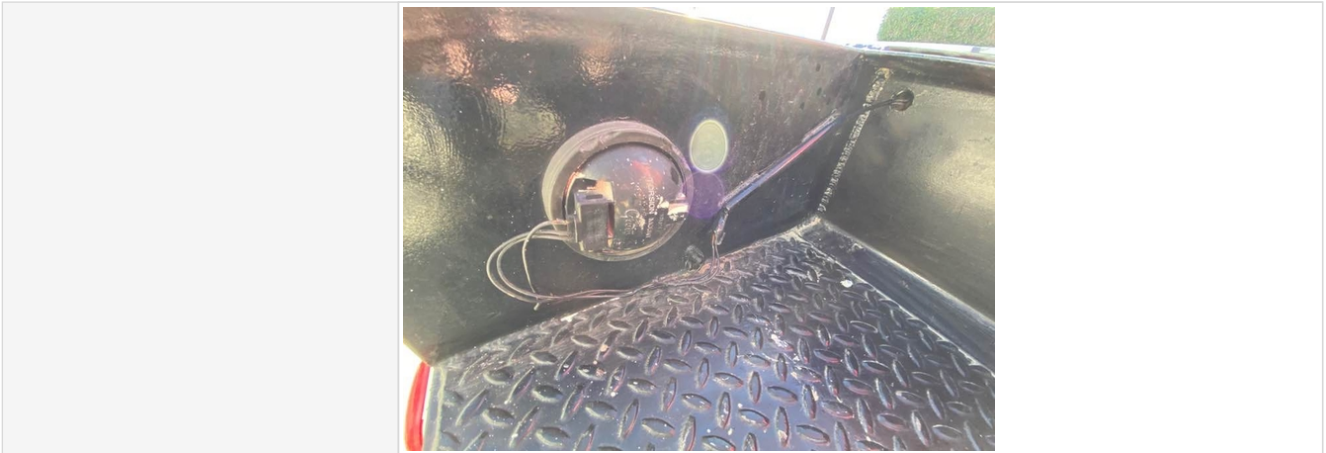
Lighting System Photos

Upper	3 - Normal Wear & Tear
Upper Condition	No visible damage
Body Panels (Any Rust Damage?)	3 - Normal Wear & Tear
Body Panel Condition	No visible damage, good paint condition and panel fitment
Doors / Canopy Latches	3 - Normal Wear & Tear
Doors / Canopy Latches Condition	No visible damage
Glass Condition	0
Mirrors	0
Lighting System	3 - Normal Wear & Tear
Lighting System Condition	No visible damage, lighting system is operational, Other (see comments)
Comments	Unable to test light system on trailer. Light fixtures intact looked okay.

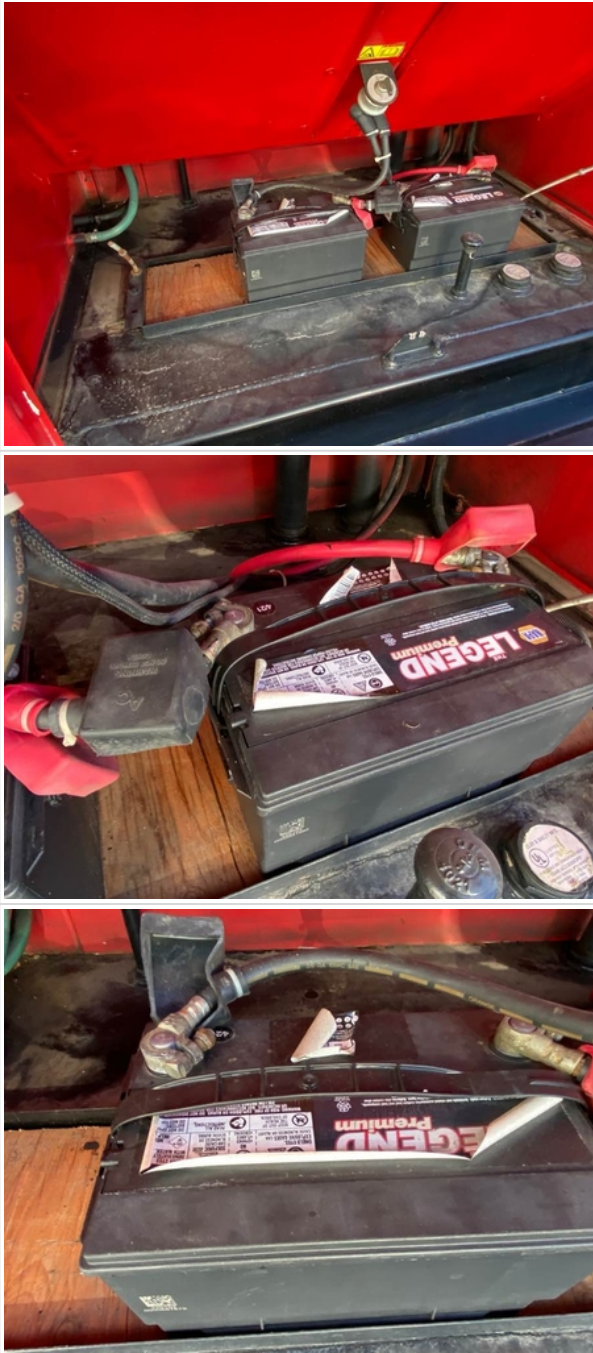
Engine Exhaust Color	Clear, Black
Battery	3 - Normal Wear & Tear
Battery Condition	Clean & dry appearance, tight connections
Battery Condition Photos

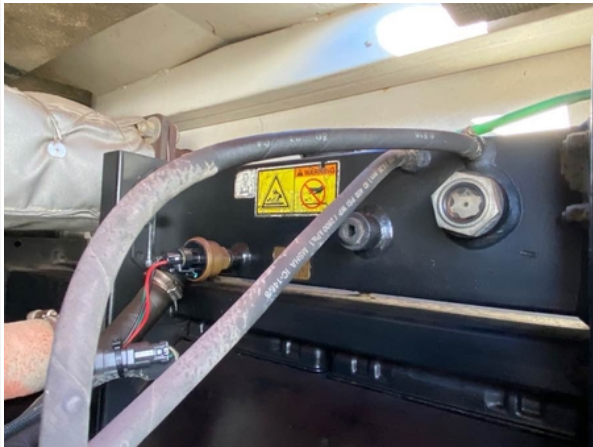
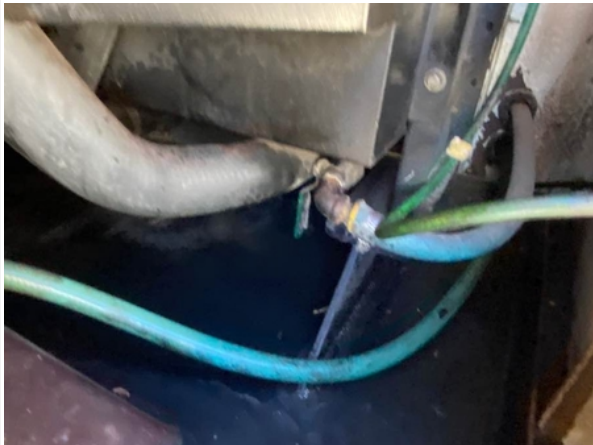
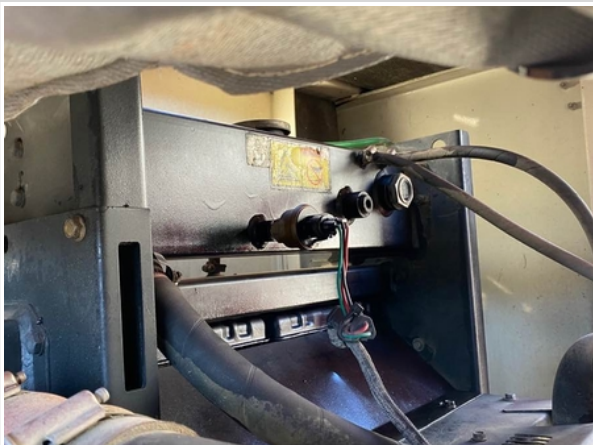
Radiator Photos

Radiator	3 - Normal Wear & Tear
Radiator Condition	Radiator fins & components appear to be in good working order, no signs of damage or leaks, Other (see comments)
Comments	Coolant level low, no active coolant leaks found

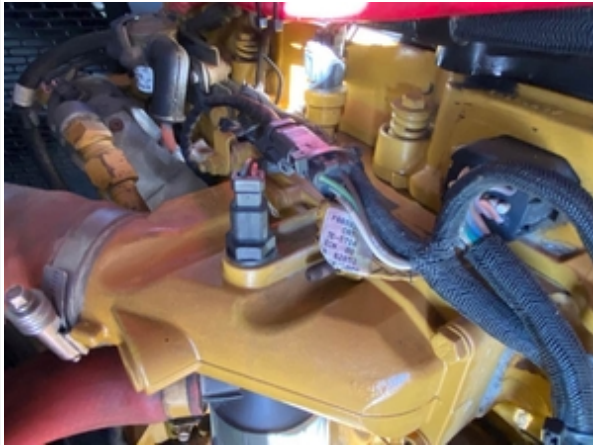
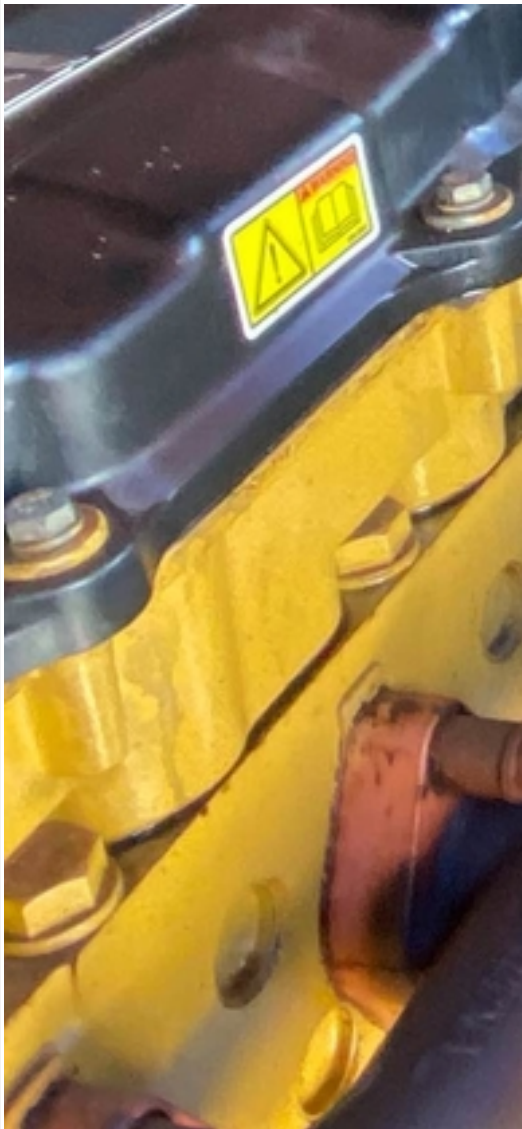
Comments	Oil seepage around valve cover
Oil Leak Photos

Comments	Engine service recommended
Fuel Leaks	No
Equipped with DPF (Diesel Particulate Filter)	No
Requires DEF (Diesel Exhaust Fluid)	No
Overall Engine Appearance	Clean & dry, Active leaks/pooling observed in & around engine compartment
Overall Engine Comments	Minor oil found around valve cover area. Possible valve cover gasket worn or residual oil leftover from topping off engine oil.

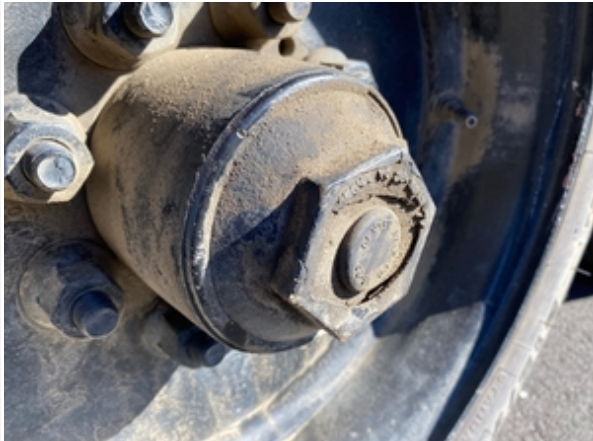
Wheels & Hub Condition	3 - Normal Wear & Tear
Comments	Tires rated at 50% due to sidewalls starting to crack
Wheels & Hub Photos

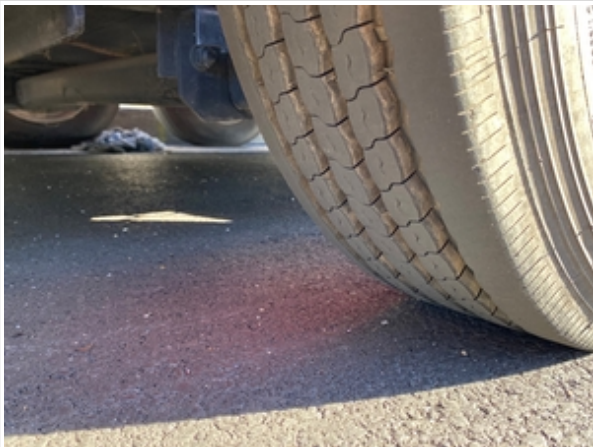
Loose Lugs	No	
Tire Brand	Milestar	
Tire Size	215/75R/17.5	
Front Left Tire - Ratio Remaining	50%	
Front Left Tire Photos

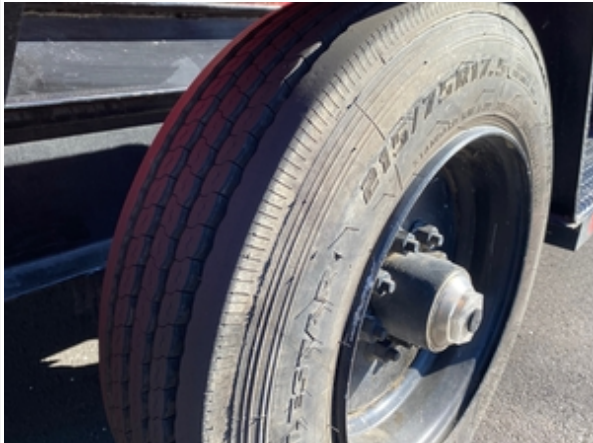
Rear Left Tire - Ratio Remaining	50%
Rear Left Tire Photos

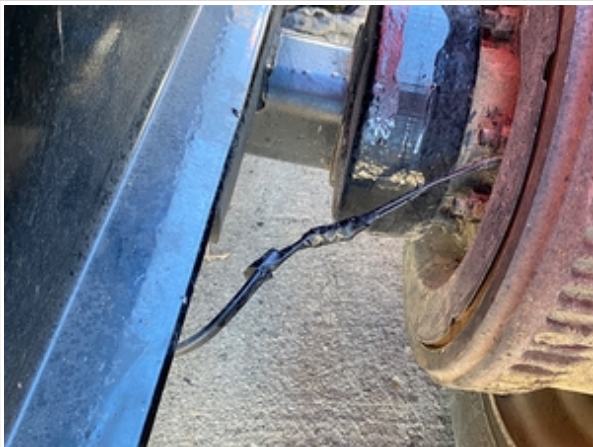
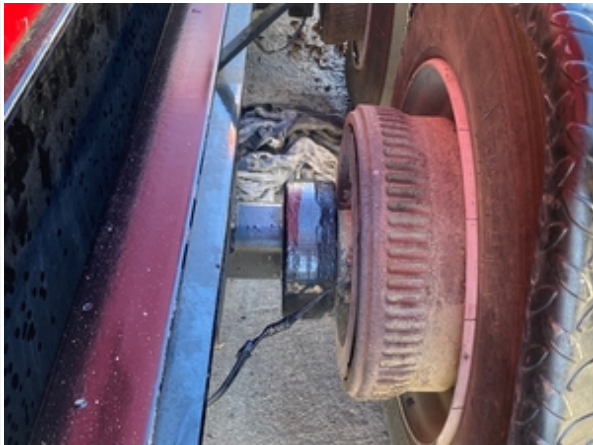
Wire Connections Photos

Brake Type	Electric Brakes
Brake Controller	No
Wire Connections	2 - Above Average Wear
Comments	Electric brake wires to hubs been repaired (electrical tape)

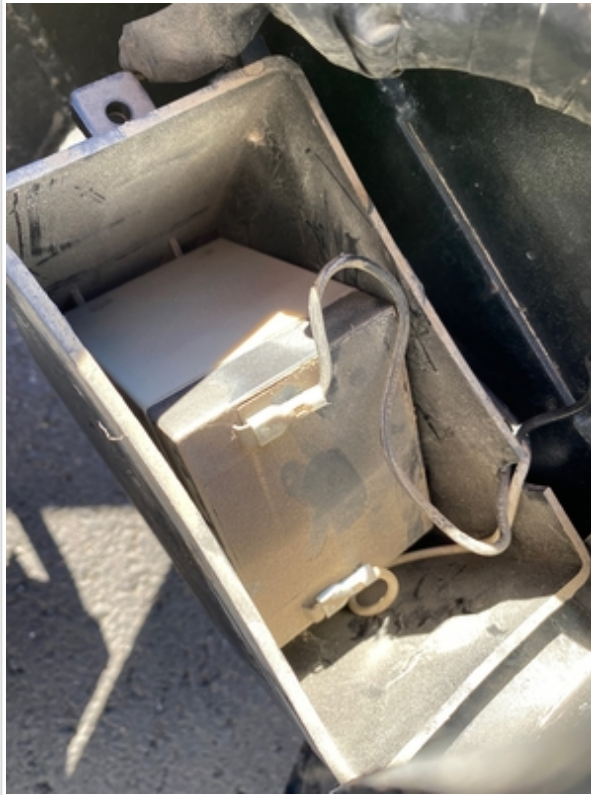
Emergency Brake/Break-Away
Photos

Brake Shoe Thickness	50%
Comments	Unable to access brake shoes
Emergency Brake/Break-Away	3 - Normal Wear & Tear
Comments	Electric breakaway device intact but unable to test

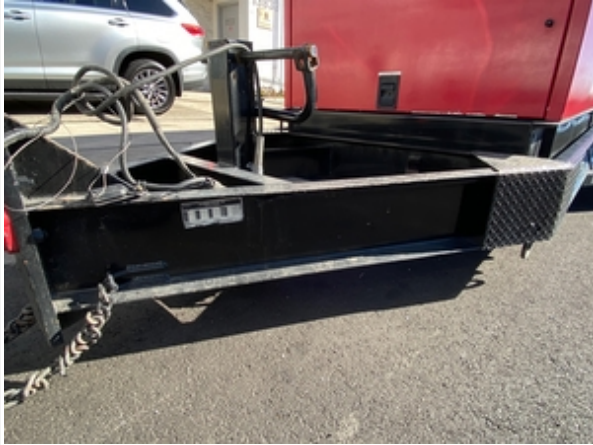
Overall Trailer	3 - Normal Wear & Tear
Overall Trailer Comments	Overall trailer in okay condition. Recommend getting all wheel bearings serviced and performing a 90 day inspection. Tires okay but starting to show signs of side wall cracks. Lights were not tested and GVWR unknown due to id plate being worn.
Overall Trailer & Undercarriage Photos
