Inspection Report (Wheel Loader)

Year	2013
Make	CAT
Model	924K
Serial Number	PWR01937
Hour Meter Reading	17,642
Previous Application (e.g., earth moving, mining, demolition, etc)	General Construction

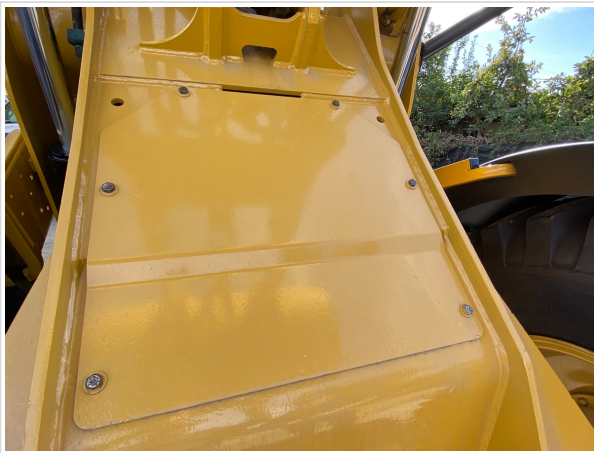
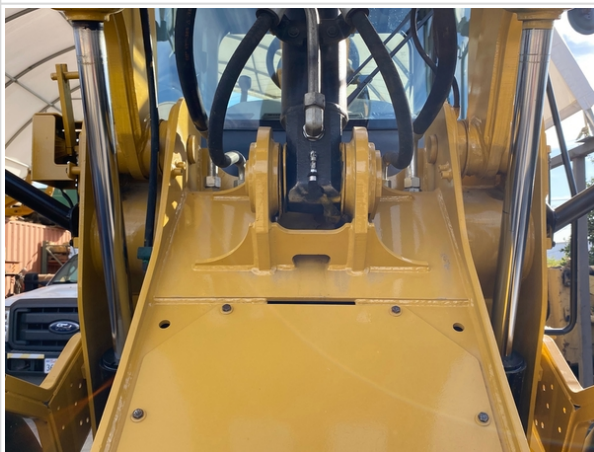
<p>Front Photos</p>

Front	4 - Like New, Recently Replaced
Front Condition	No visible damage

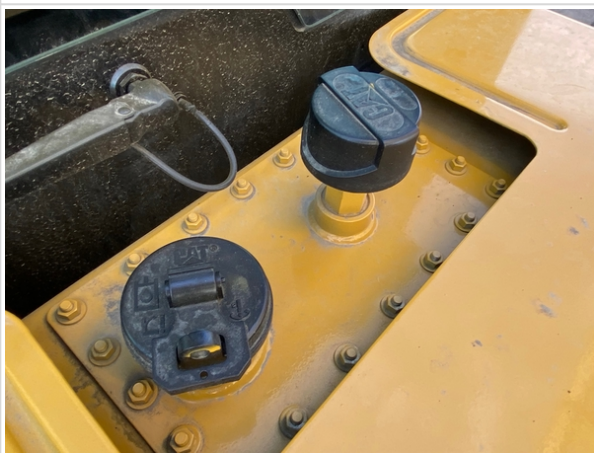
<p>Rear</p>	<p>4 - Like New, Recently Replaced</p>
<p>Rear Condition</p>	<p>No visible damage</p>
<p>Rear Photos</p>

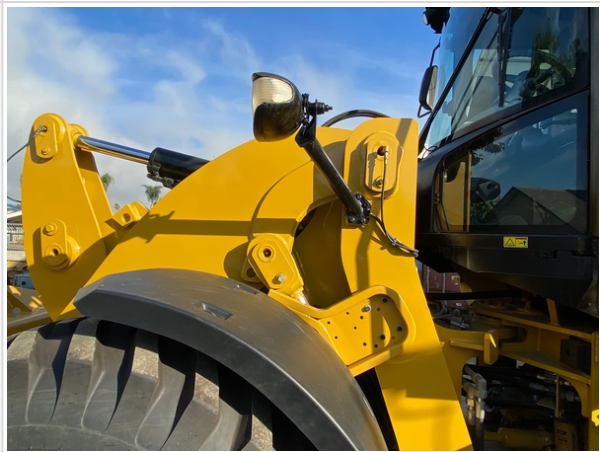
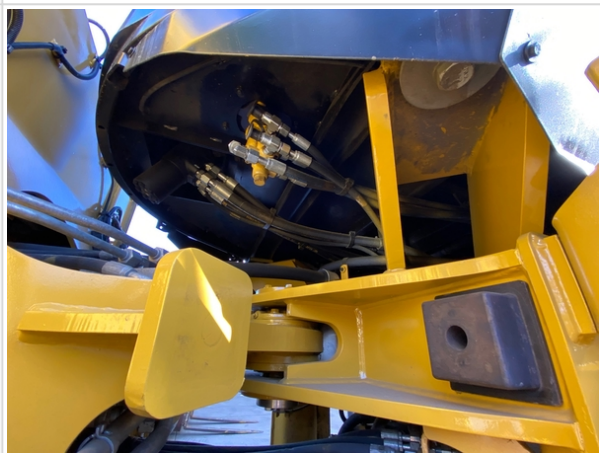
Left	4 - Like New, Recently Replaced	
Left Condition	No visible damage	
Left Photos

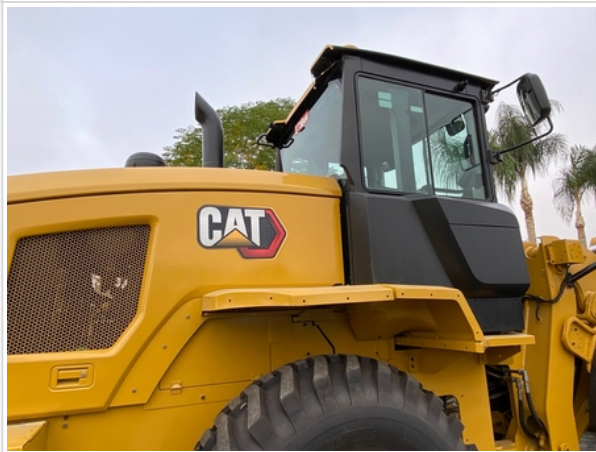
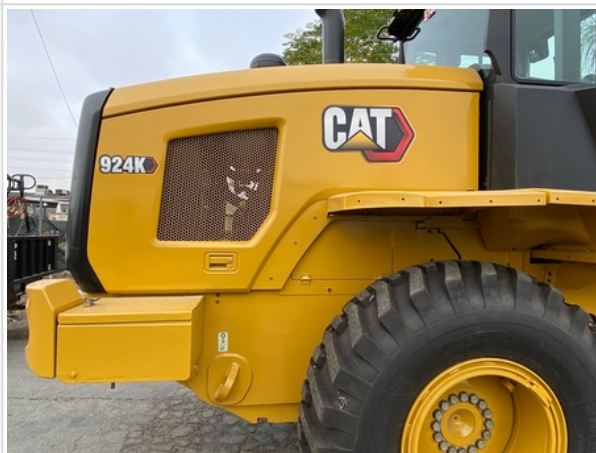
<p>Right</p>	<p>4 - Like New, Recently Replaced</p>	
<p>Right Condition</p>	<p>No visible damage</p>	
<p>Right Photos</p>

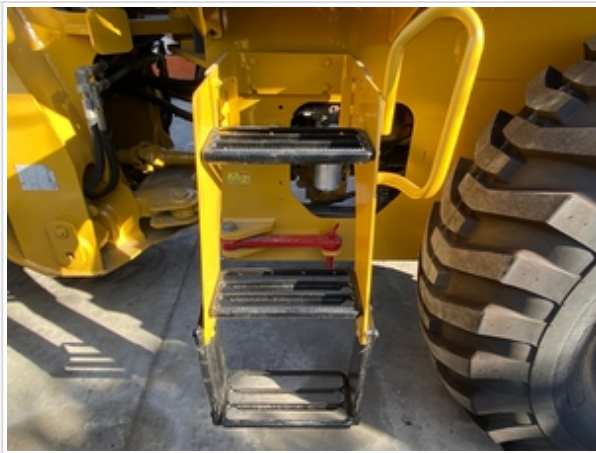
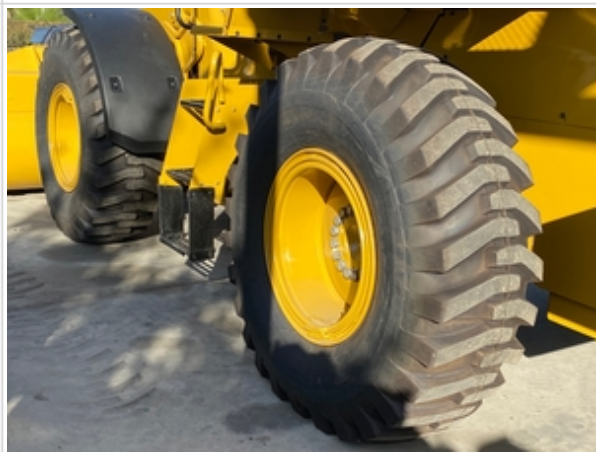
<p>Steps / Ladders Photos</p>

Steps / Ladders	3 - Normal Wear & Tear
Steps / Ladders Condition	Steps/ladders are fully intact and appear structurally sound

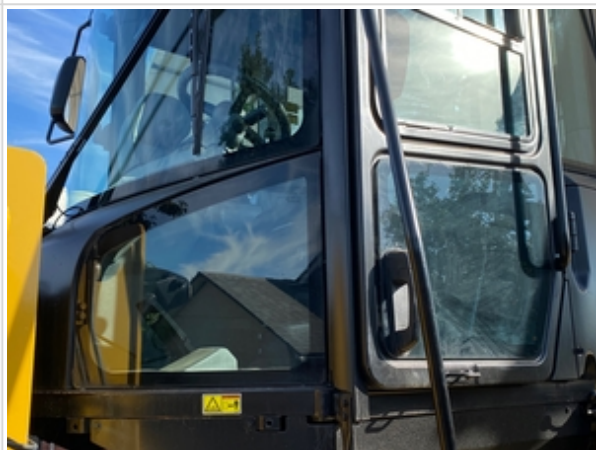
<p>Handrails</p>	<p>3 - Normal Wear & Tear</p>
<p>Handrails Condition</p>	<p>Handrails are fully intact and appear structurally sound</p>
<p>Handrail Photos</p>

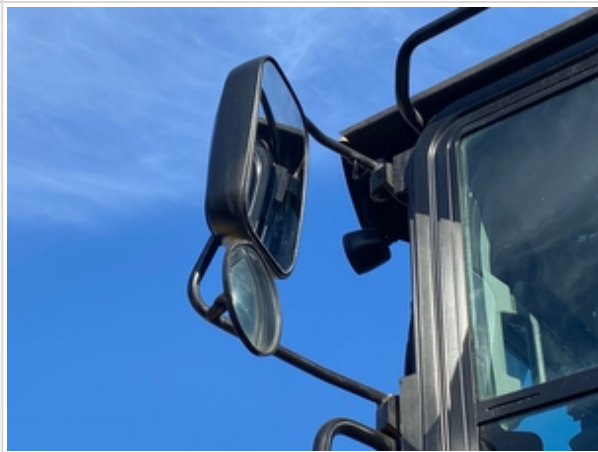
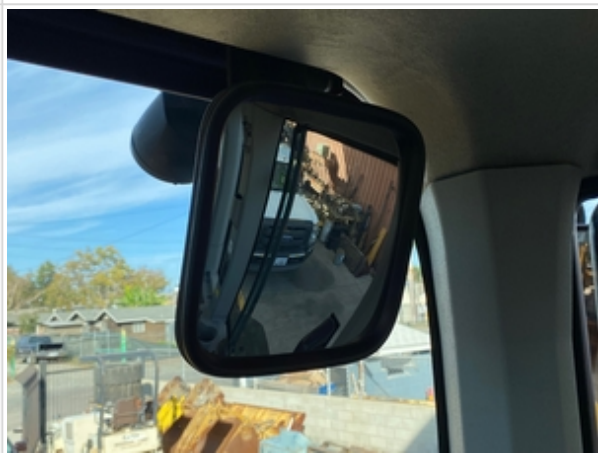
Mirrors	3 - Normal Wear & Tear	
Mirror Condition Notes	Mirrors present and intact, no visible damage	
Mirrors Photos

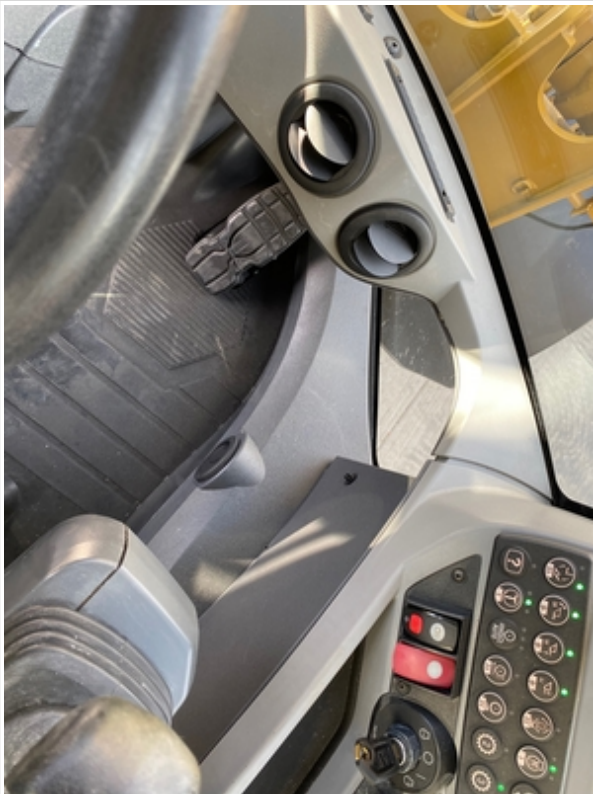
Operator Cabin Overall	3 - Normal Wear & Tear
Operator Cabin Overall Condition	Good cabin appearance, solid floors, panels, and ceiling
Operator Cabin Photos

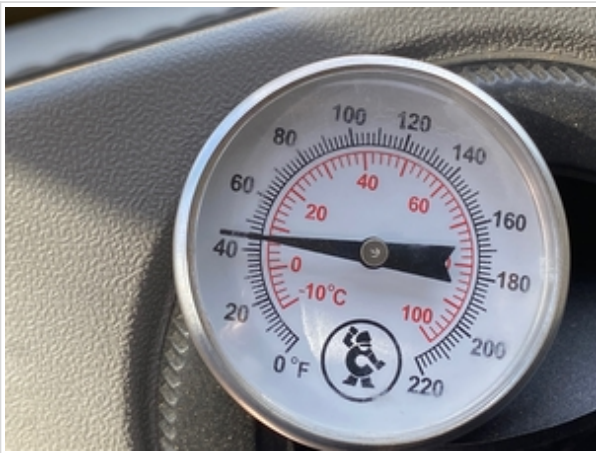
<p>Heater & A/C Photos</p>

Heater & A/C	3 - Normal Wear & Tear
Heater & A/C Condition	Heater and A/C work and transition through full temperature range

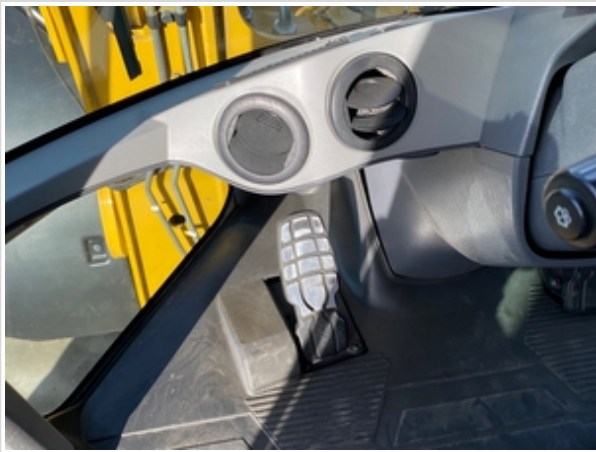
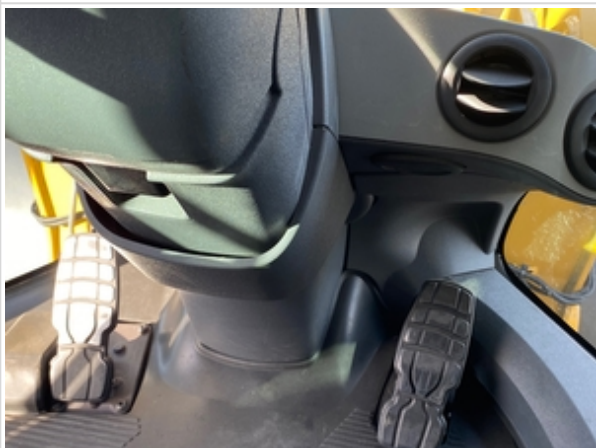
<p>Fans / Vents</p>	<p>3 - Normal Wear & Tear</p>	
<p>Fans / Vents Condition</p>	<p>Fan vents are functional, in good condition, and move through a full adjustable range of motion</p>	
<p>Fans / Vents Photos</p>

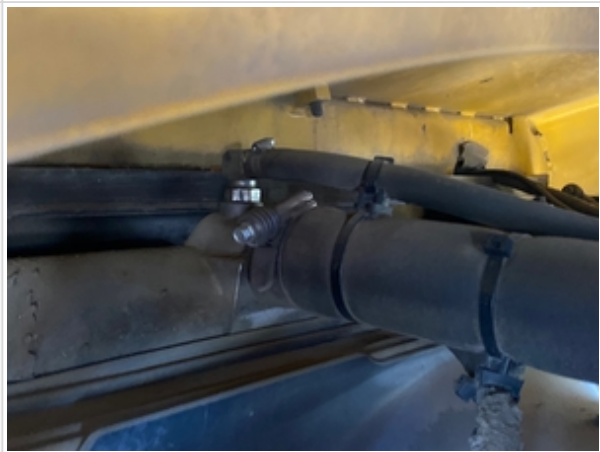
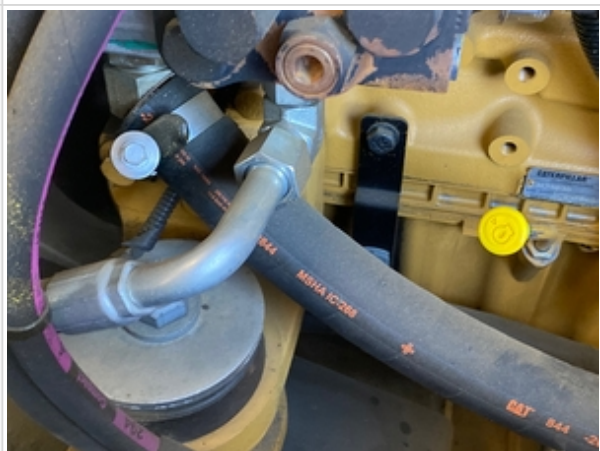
Belts	3 - Normal Wear & Tear	
Belt Condition	Belts appear in good condition & alignment with proper tension	
Hoses	3 - Normal Wear & Tear	
Hose Condition	Firm, pliant hoses with no signs of wear or leaks	
Hose Photos

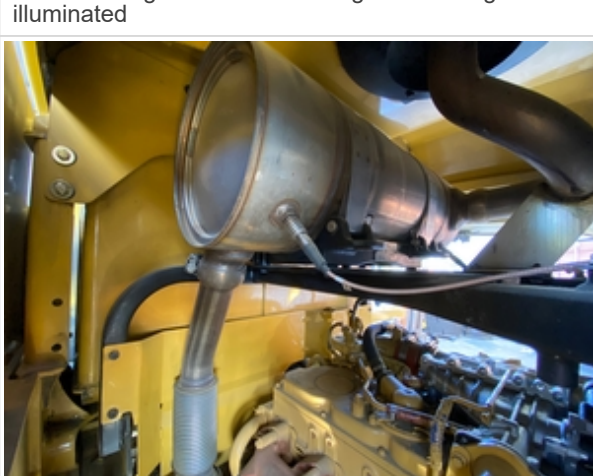
Water Pump	3 - Normal Wear & Tear	
Water Pump Condition	No unusual pump noises heard	
Cooling System Leaks	No	
Coolant Color / Appearance	3 - Normal Wear & Tear	
Coolant Color/Appearance Notes	Normal Translucent appearance, no visual signs of contamination	
Oil Leaks	No	
Oil Color / Appearance	3 - Normal Wear & Tear	
Oil Color / Appearance Notes	Clean oil appearance, no signs of cross contamination, Appropriate oil level	
Fuel Leaks	No	
Equipped with DPF (Diesel Particulate Filter)	Yes	
DPF Condition	3 - Normal Wear & Tear	
DPF Condition Notes	Filter housing is intact with no signs of damage or malfunction, DPF indicator is not illuminated	
DPF Photos

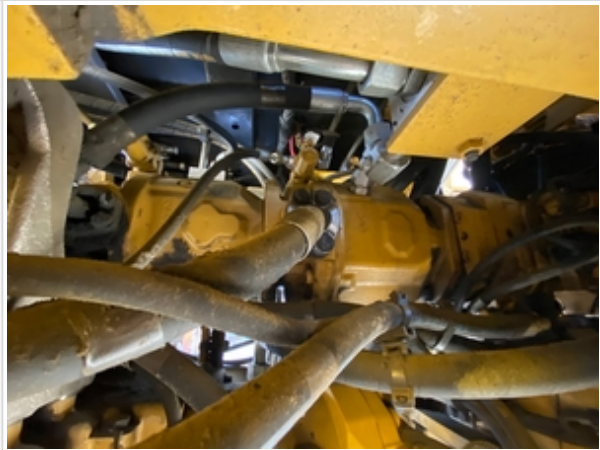
Hydrostatic Transmission?	Yes
2 Speed?	Yes
Hydrostatic Drive Configuration	Split Transmission
Drive Motors	2 - Above Average Wear
Comments	Speed ranges from 1 to 4
Drive Motor Photos

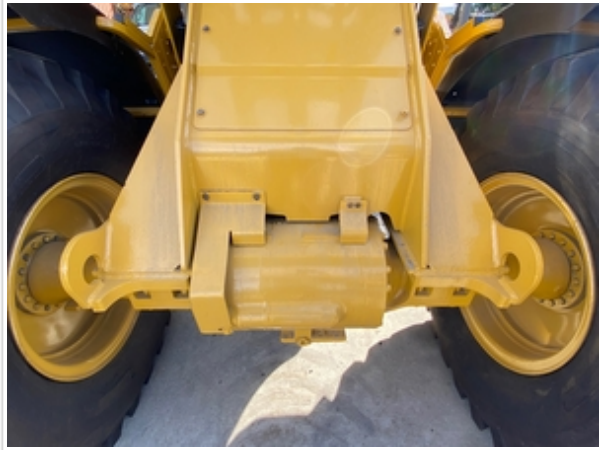
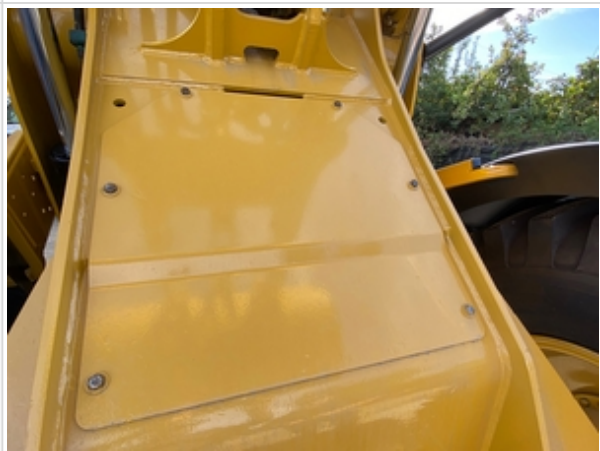
Frame	4 - Like New, Recently Replaced	
Frame Photos

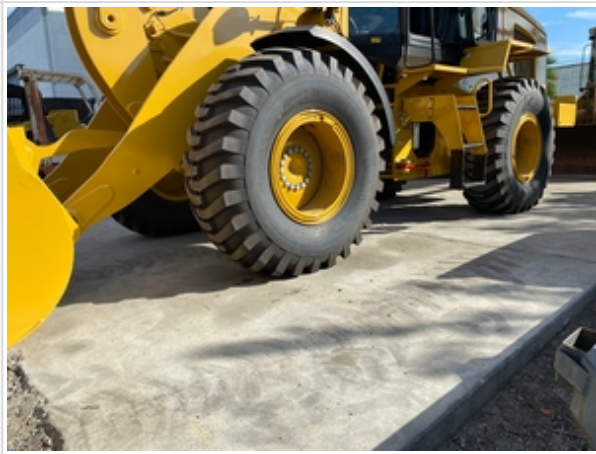
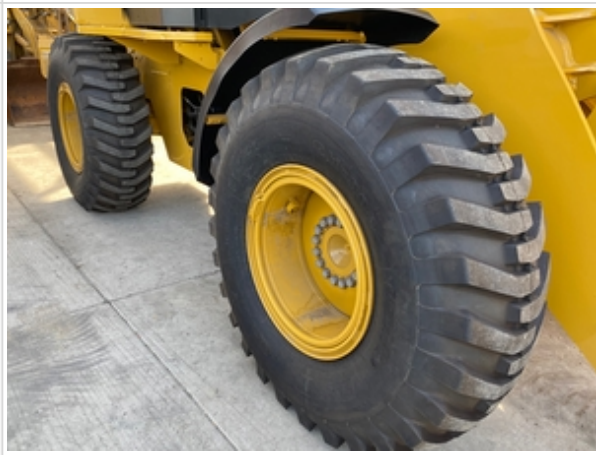
<p>Stance</p>	<p>3 - Normal Wear & Tear</p>	
<p>Stance Photos</p>

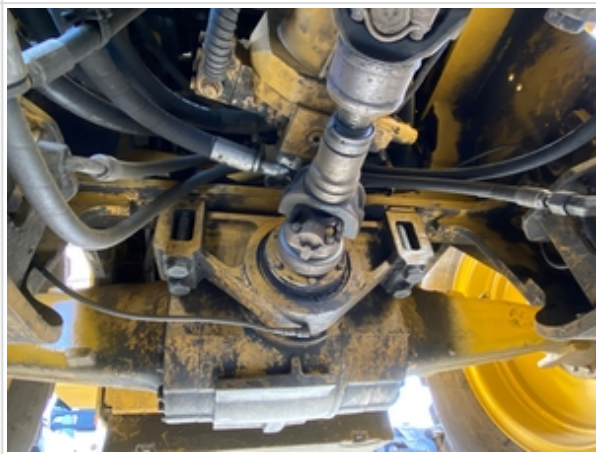
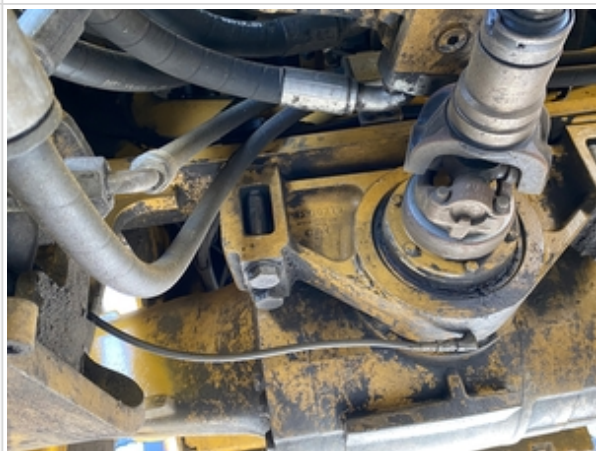
Rear Axle Appearance	3 - Normal Wear & Tear	
Rear Axle Appearance Photos

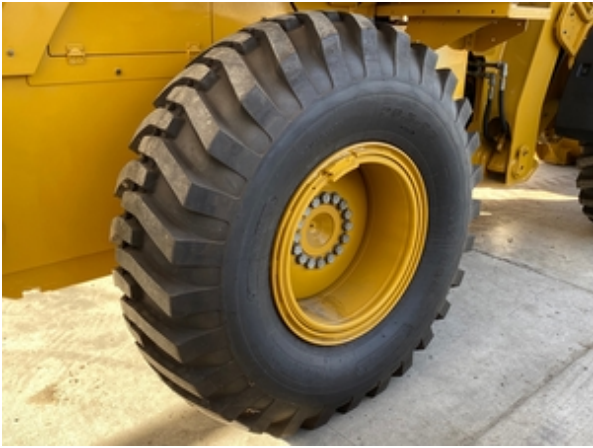
Rear Right Tire - Ratio Remaining	90%	
Comments	Tires above 90% brand new	
Rear Right Tire Photos

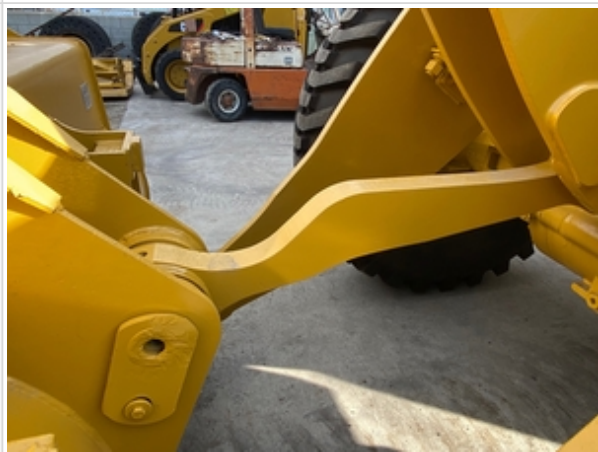
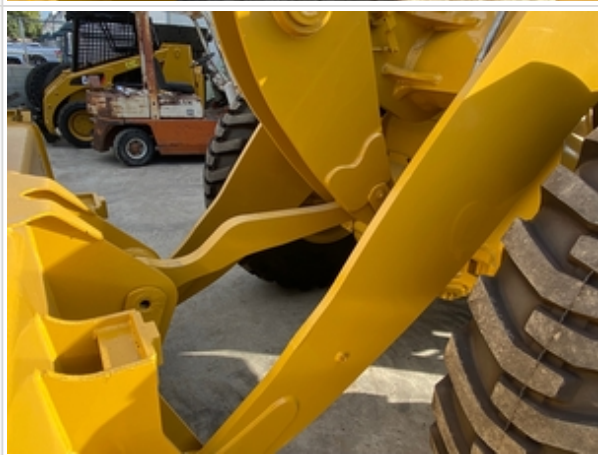
<p>Tilt Linkage</p>	<p>3 - Normal Wear & Tear</p>	
<p>Tilt Linkage Photos</p>

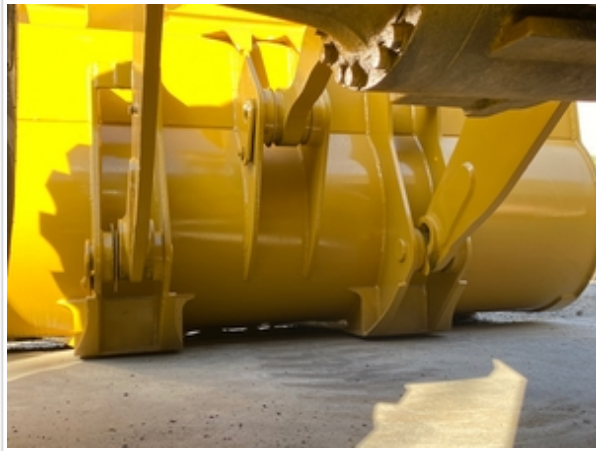
Tilt Linkage Pins and Bushings	3 - Normal Wear & Tear
Tilt Linkage Pins and Bushings Photos

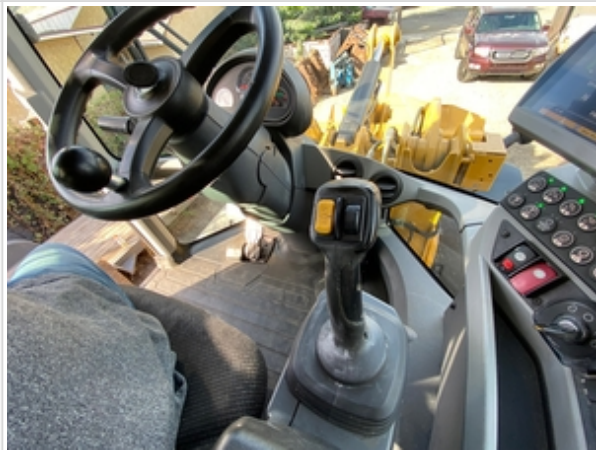
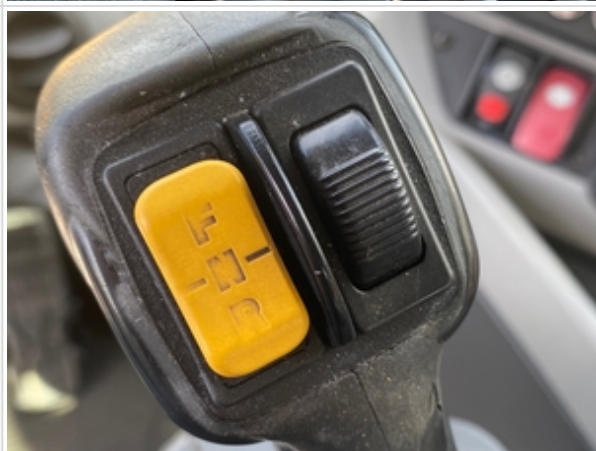
Unusual Noises (Hydraulic Pump)	No	
Hydraulic Pump Notes	No unusual noises heard during operation	
External Controls / Levers	3	
External Controls / Levers Condition	Good function & condition of hydraulic controls	
External Controls / Levers Photos

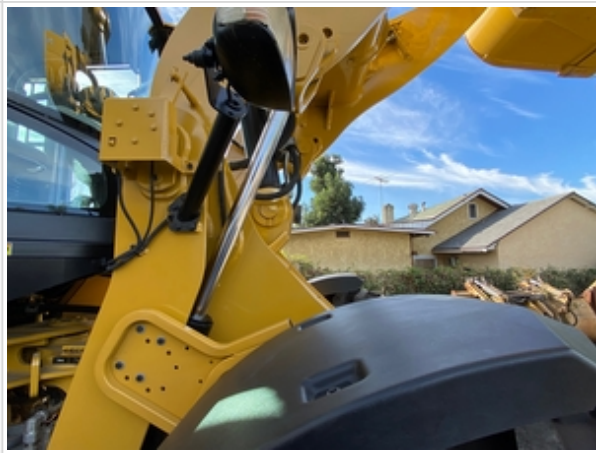
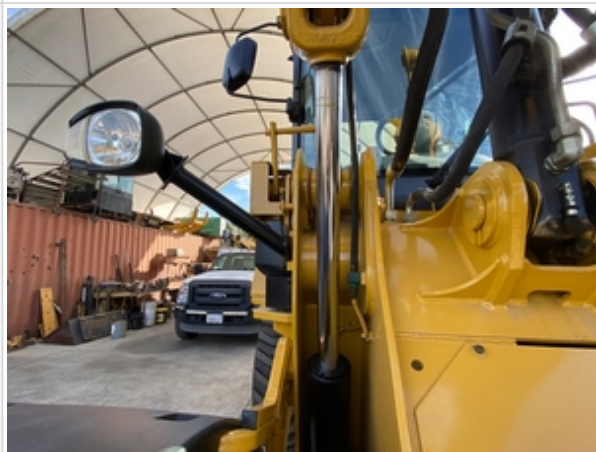
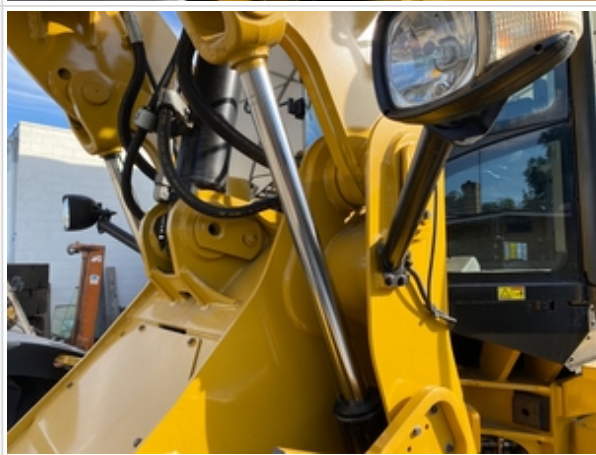
Lift Cylinder	Check the lift cylinder. Note any wear, pitting, discoloration, etc. Take photos.
Lift Cylinder: Mounting Pin	3

Lift Cylinder: Oil Leaks	No
Lift Cylinder Photos

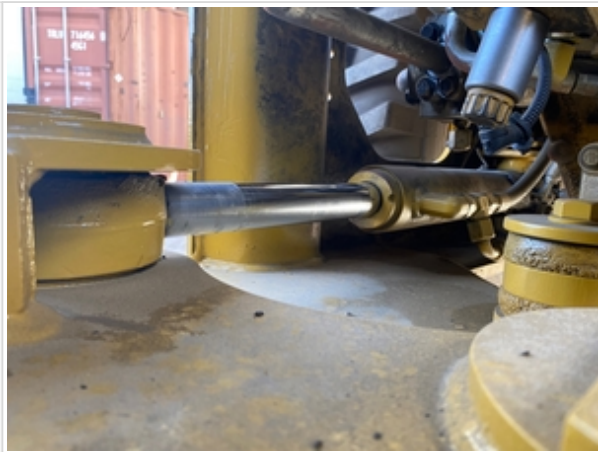
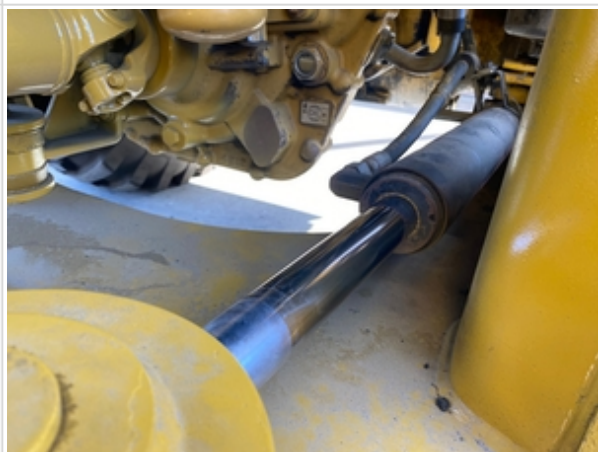
Steering Cylinder Photos

Steering Cylinder	Check the steering cylinder. Note any wear, pitting, discoloration, etc. Take photos.	
Steering Cylinder: Mounting Pin	3	
Steering Cylinder: Oil Leaks	No

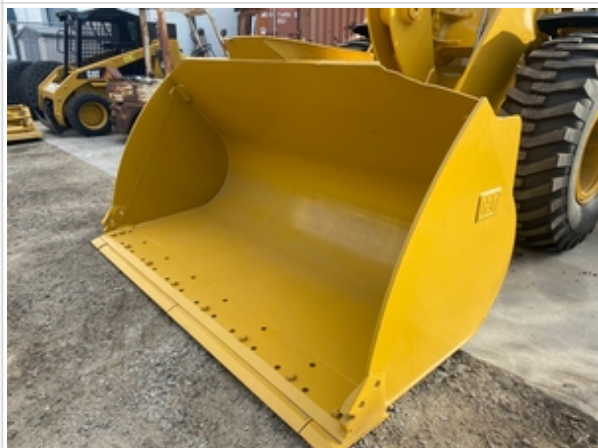
Bucket	4 - Like New, Recently Replaced
Bucket Photos
