## Inspection Report (On-Highway Dump Truck)

Year	2012
Make	Peterbilt
Model	388
Serial Number	1XP-WD49X-8-CD168910
Truck Odometer Reading	650,050
Current Inspection / State Cert / DOT	N/A
Previous Application (e.g., earth moving, mining, demolition, etc)	General Construction

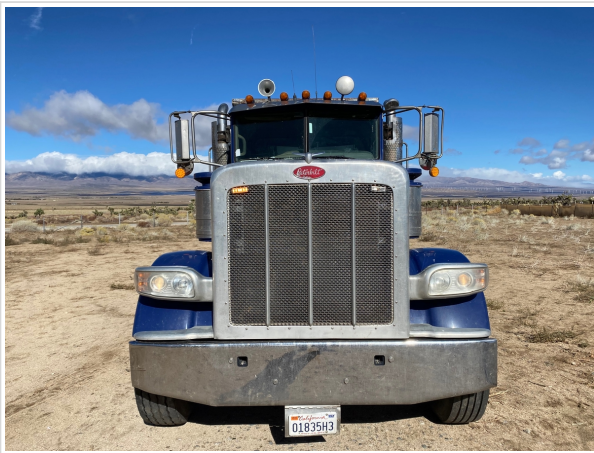
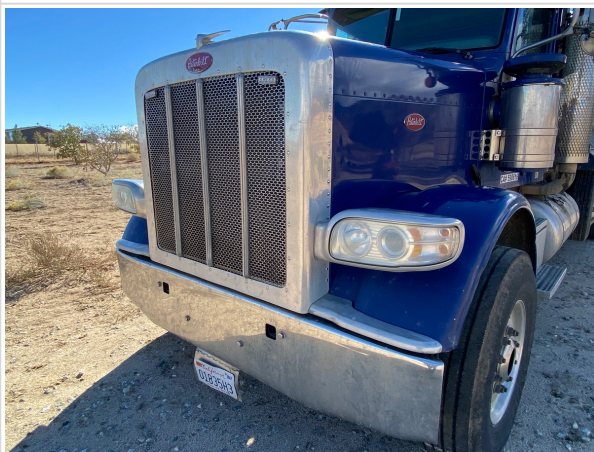
Front	3 - Normal Wear & Tear
Front Condition	No visible damage

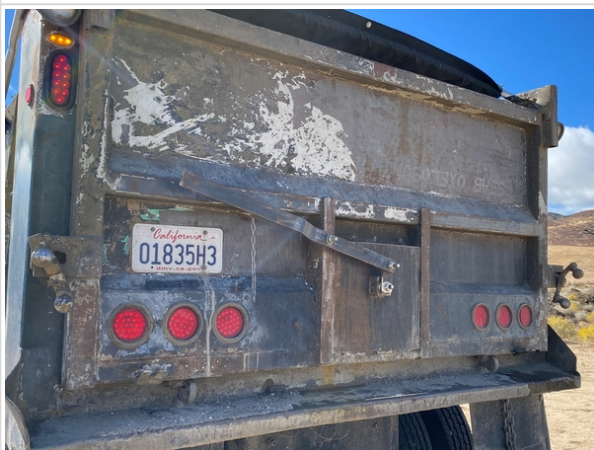
<b>Rear</b>	3 - Normal Wear & Tear
<b>Rear Condition</b>	No visible damage
<b>Rear Photos</b>

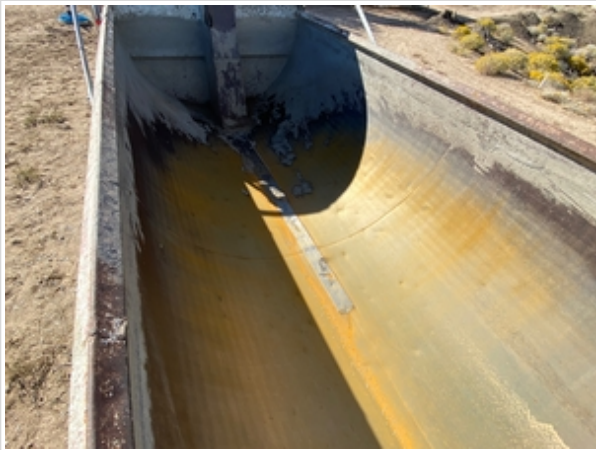
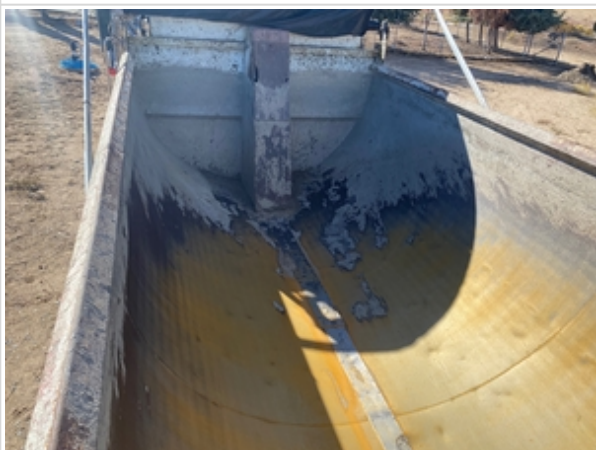
<b>Body Panels (Any Rust Damage?)</b>	2 - Above Average Wear	
<b>Body Panel Condition</b>	Other (see comments)	
<b>Comments</b>	Rear dump body has surface rust in some areas	
<b>Doors / Canopy Latches</b>	3 - Normal Wear & Tear	
<b>Doors / Canopy Latches Condition</b>	No visible damage	
<b>Doors / Canopy Latches Photos</b>

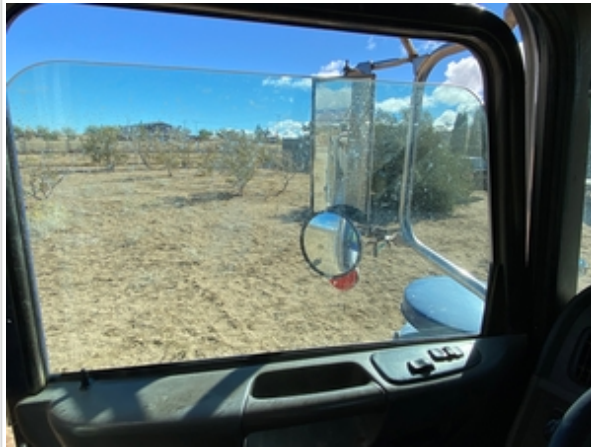
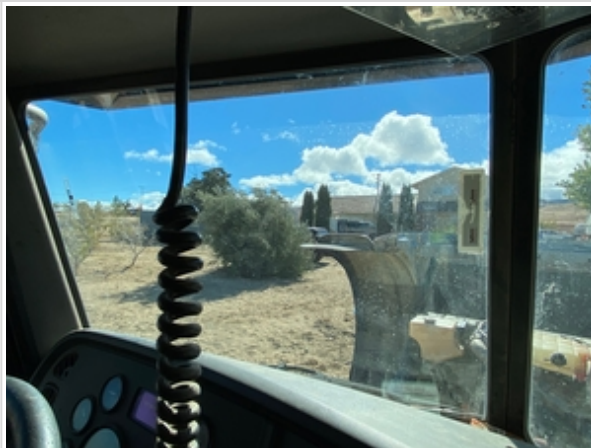
Glass Condition Photos

Glass Condition	3 - Normal Wear & Tear
Glass Condition Notes	Glass intact, no visible damage, Minor chips or cracks observed
Comments	Some cracked chips in front windshield

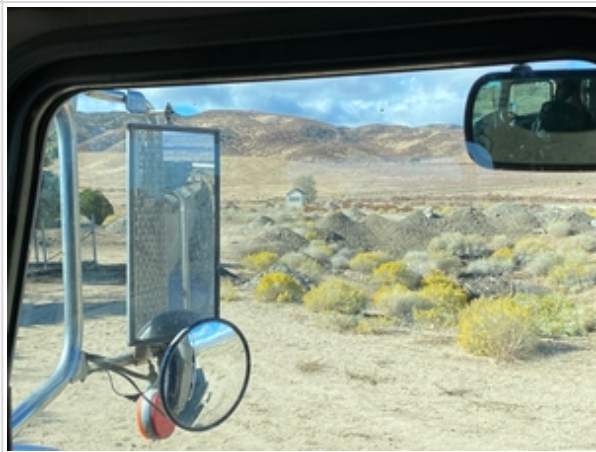
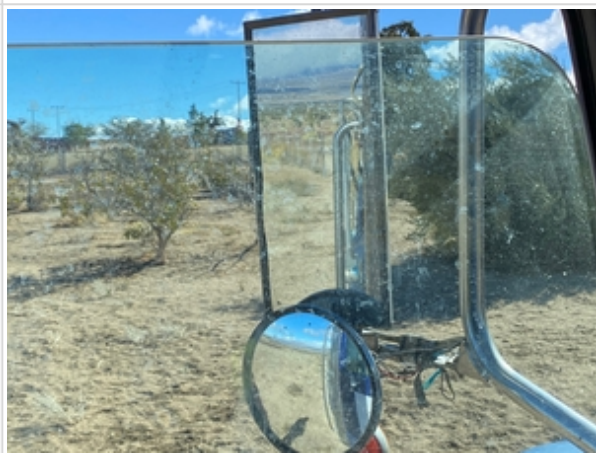
<b>Mirrors</b>	3 - Normal Wear & Tear	
<b>Mirror Condition Notes</b>	Mirrors present and intact, no visible damage	
<b>Mirrors Photos</b>

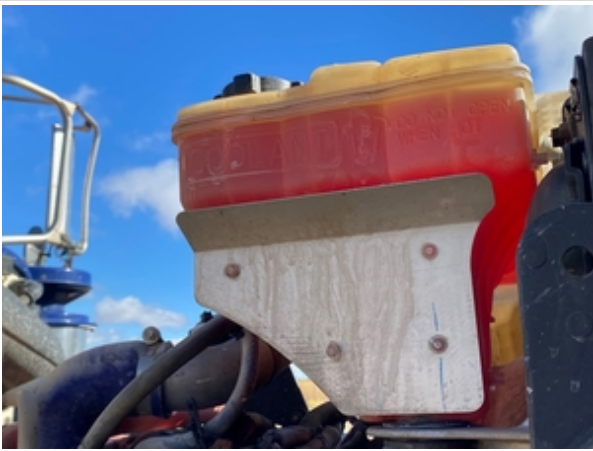
<b>Blow-by (Visual Observation Check)</b>	No
<b>Unusual Noises (Upon Start-up, Idle, Shutdown)</b>	No
<b>Unusual Noise Notes</b>	No unusual noises heard
<b>Engine Smoke (Upon Start-up, Idle, Shutdown)</b>	No
<b>Engine Smoke Notes</b>	No engine smoke issues observed
<b>Engine Exhaust Color</b>	Clear
<b>Battery</b>	3 - Normal Wear & Tear
<b>Battery Condition</b>	Other (see comments), Like new, recently replaced
<b>Comments</b>	(Per customer) recently replaced
<b>Radiator</b>	3 - Normal Wear & Tear
<b>Radiator Condition</b>	Radiator fins & components appear to be in good working order, no signs of damage or leaks

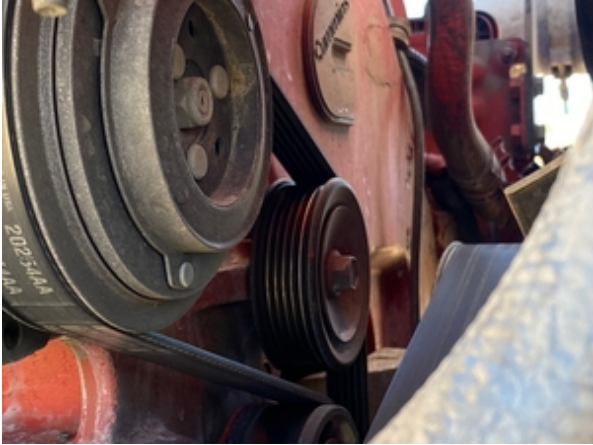
<b>Belts</b>	3 - Normal Wear & Tear	
<b>Belt Condition</b>	Belts appear in good condition & alignment with proper tension	
<b>Belt Photos</b>

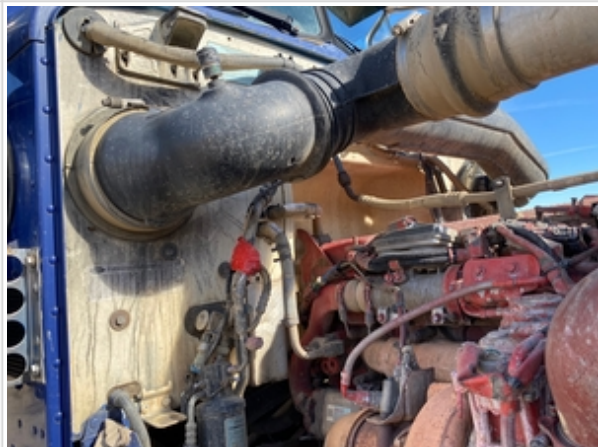
<b>Hoses</b>	3 - Normal Wear & Tear	
<b>Hose Condition</b>	Firm, pliant hoses with no signs of wear or leaks	
<b>Hose Photos</b>

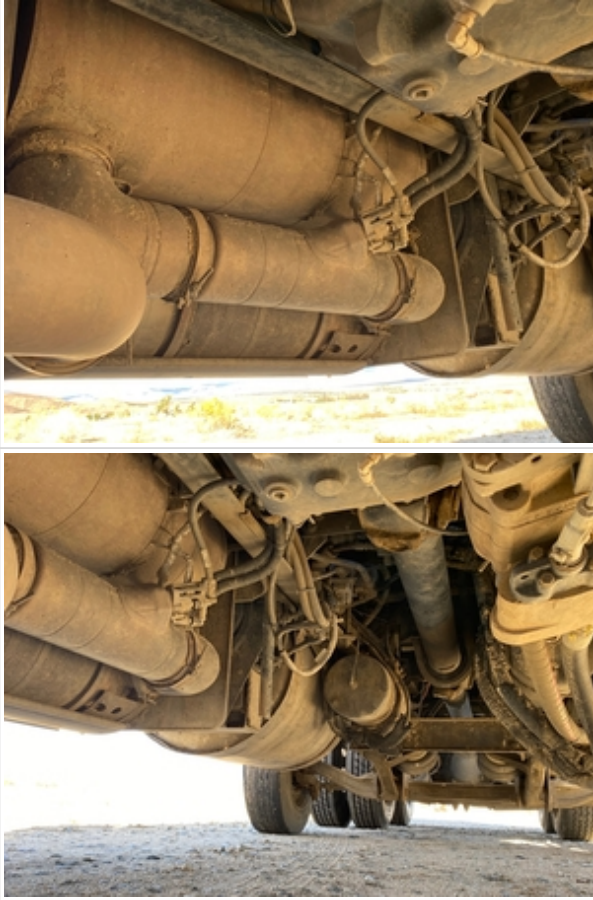
Fuel Leaks	No
Equipped with DPF (Diesel Particulate Filter)	Yes
DPF Condition	3 - Normal Wear & Tear
DPF Condition Notes	Filter housing is intact with no signs of damage or malfunction, DPF indicator is not illuminated
DPF Photos

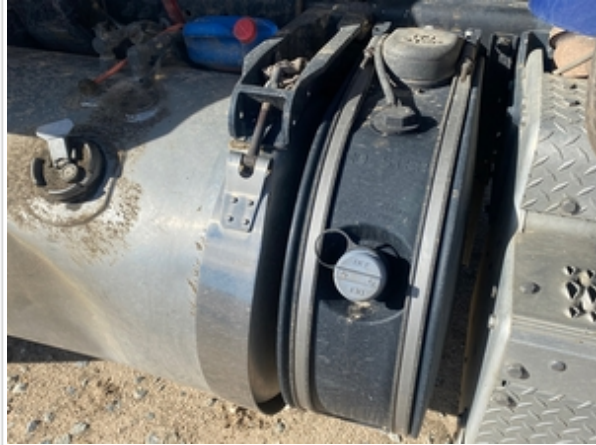
DEF Tank Photos

Requires DEF (Diesel Exhaust Fluid)	Yes
DEF Tank	3 - Normal Wear & Tear
DEF Tank Condition	Area around DEF tank cap is clean, fluid is clear & appears free of contaminants

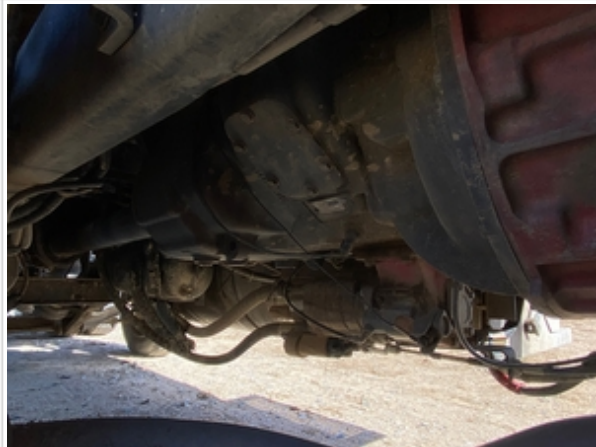
Transmission Info (Make/Model)	10 speed
Drive Type	4X2
Overdrive	No
Transmission	3 - Normal Wear & Tear
Transmission Condition	No unusual noises or vibrations
Transmission Condition Photos

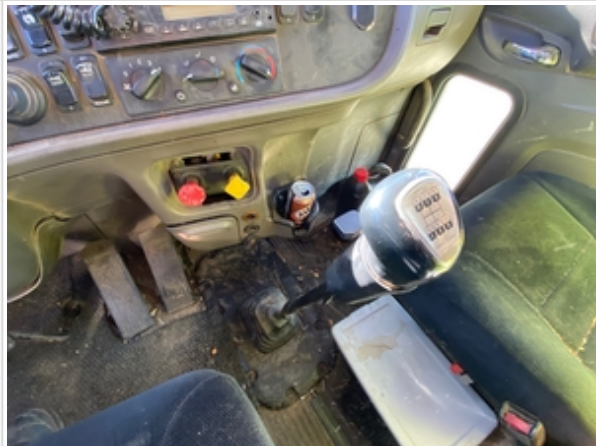
<b>Clutch</b>	3 - Normal Wear & Tear	
<b>Clutch Condition</b>	Clutch is functioning as expected	
<b>Shift Lever</b>	3 - Normal Wear & Tear	
<b>Shift Lever Condition</b>	Good forward and reverse function	
<b>Shift Lever Photos</b>

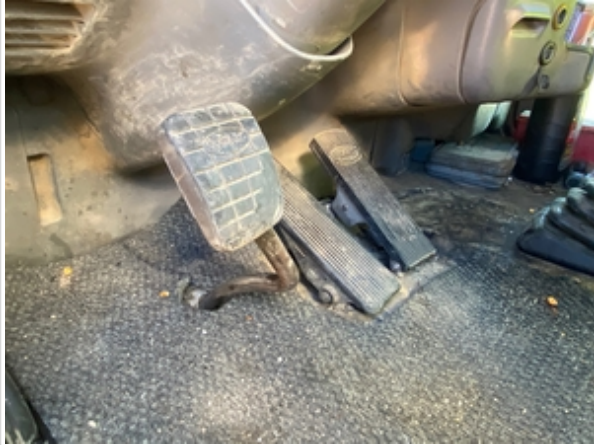
Foot Brake Photos

<b>Foot Brake</b>	3 - Normal Wear & Tear	
<b>Foot Brake Condition</b>	Good brake function

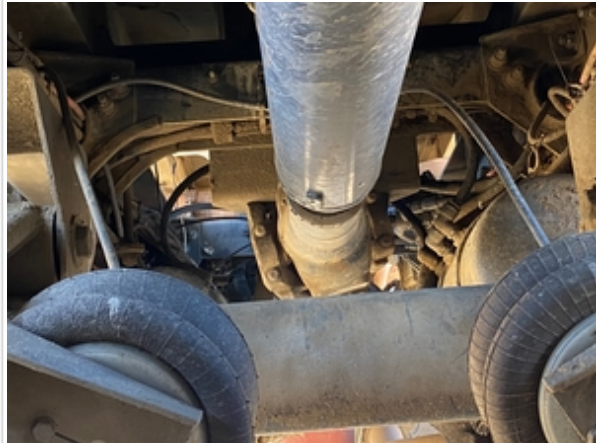
<b>Instructions</b>	Check the condition of additional axle(s), wheels & tires. Note any damage or wear. Take photos.	
<b>Axle Description &amp; Position</b>	Drop down axle	
<b>Steerable?</b>	No	
<b>Drop Axle?</b>	Yes	
<b>Super Dump?</b>	Yes	
<b>Axle Condition</b>	3 - Normal Wear & Tear	
<b>Axle Condition Photos</b>
