Inspection Report (Telehandler)

Year	2012
Make	JLG Skytrak
Model	8042
Serial Number	0160048079
Hour Meter Reading	2,994
Previous Application (e.g., earth moving, mining, demolition, etc)	Equipment Rental

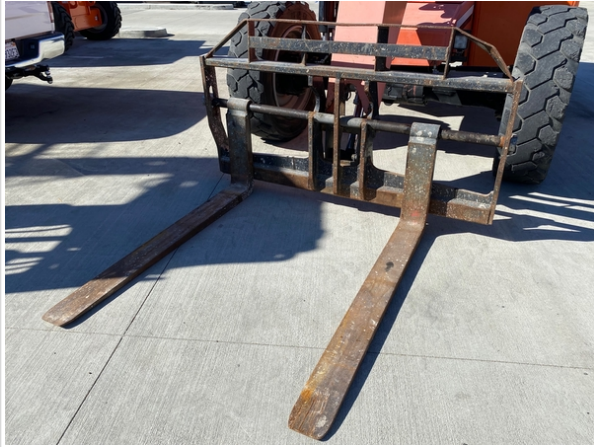
Front	3 - Normal Wear & Tear
Front Condition	No visible damage
Front Photos

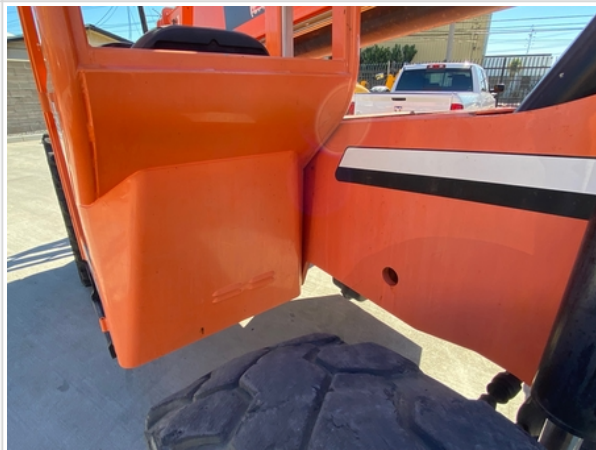
Rear	3 - Normal Wear & Tear
Rear Condition	No visible damage
Rear Photos

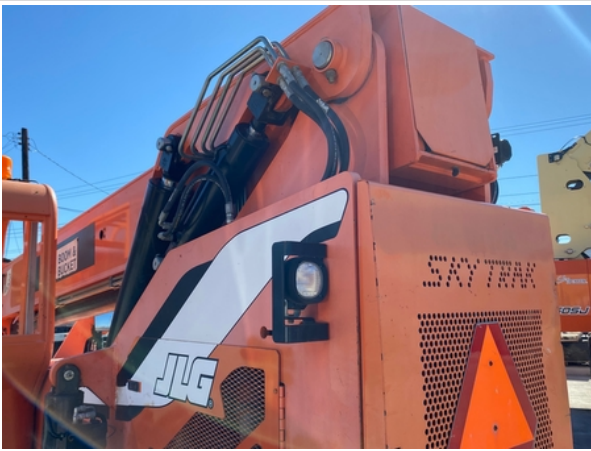
Right	3 - Normal Wear & Tear	
Right Condition	No visible damage	
Right Photos

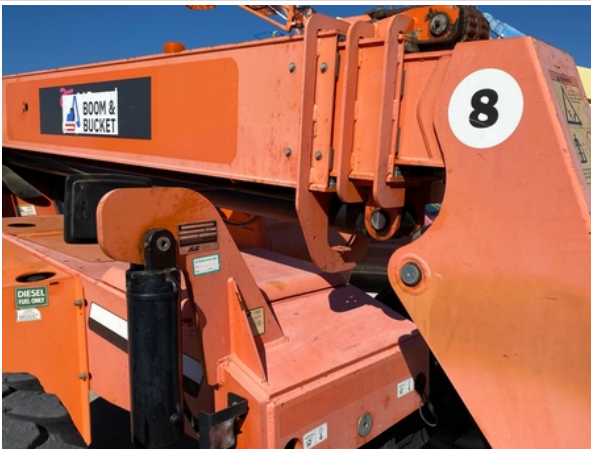
Upper	3 - Normal Wear & Tear	
Upper Condition	No visible damage	
Upper Photos

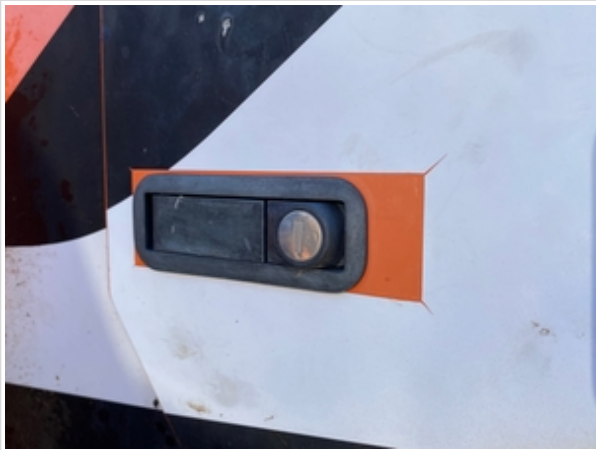
Doors / Canopy Latches	3 - Normal Wear & Tear	
Doors / Canopy Latches Condition	No visible damage	
Doors / Canopy Latches Photos

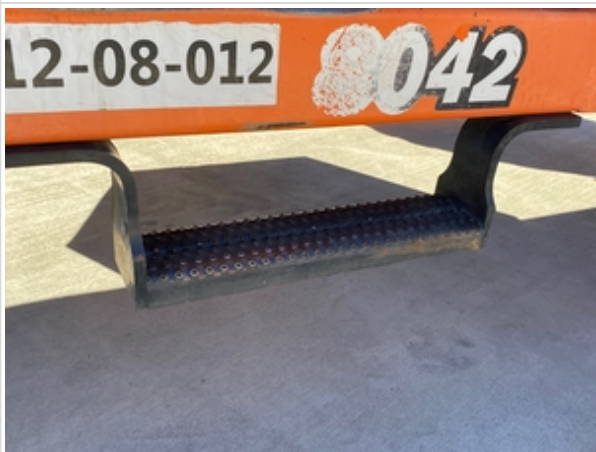
Steps / Ladders	3 - Normal Wear & Tear	
Steps / Ladders Condition	Steps/ladders are fully intact and appear structurally sound	
Steps / Ladders Photos

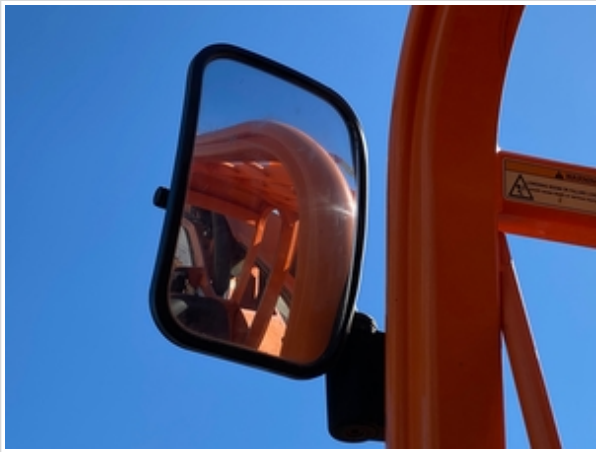
Handrails	0	
Glass Condition	0	
Mirrors	3 - Normal Wear & Tear	
Mirror Condition Notes	Mirrors present and intact, no visible damage	
Mirrors Photos

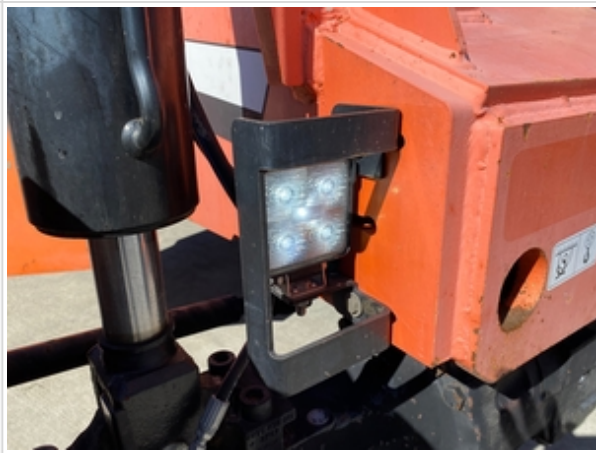
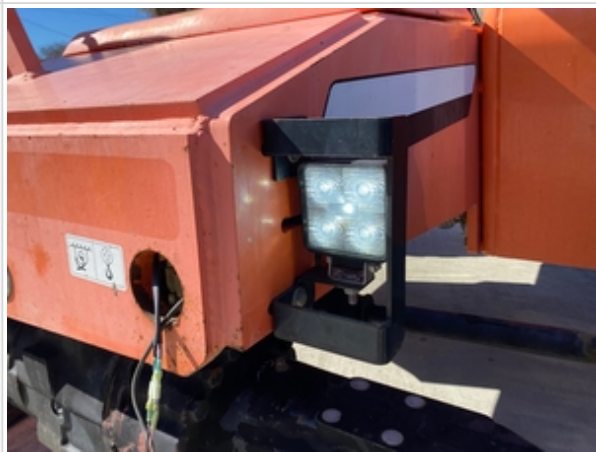
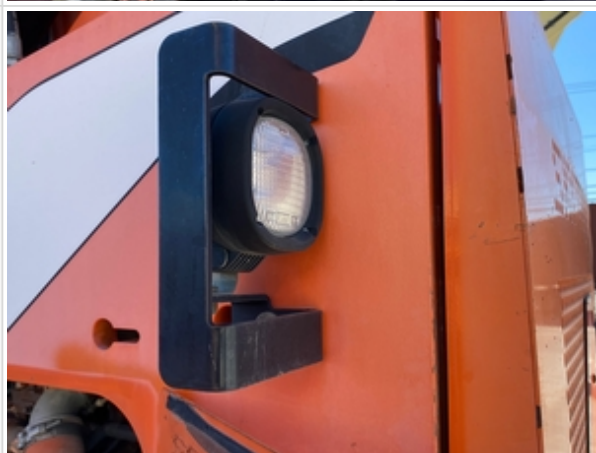
Lighting System Condition	No visible damage, lighting system is operational
Lighting System Photos

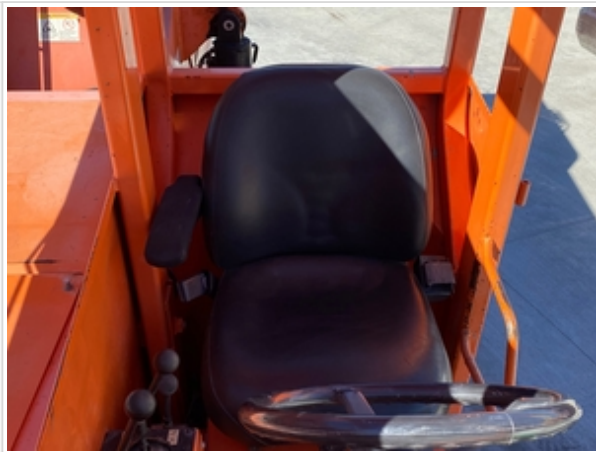
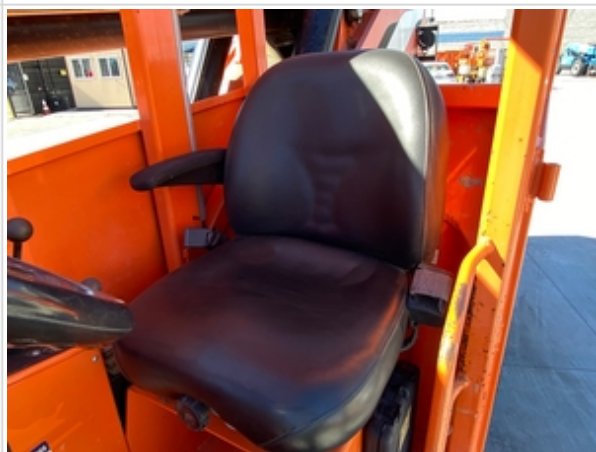
Operator's Seat & Arm Rests	3 - Normal Wear & Tear
Operator's Seat & Arm Rests Condition	Seat(s) in good condition, no stains or tears in upholstery

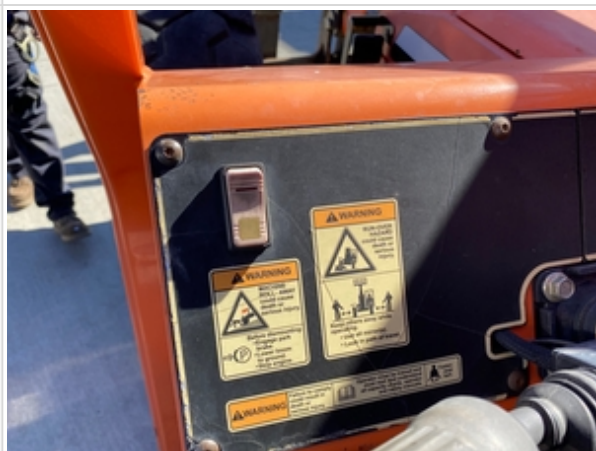
Seat Belt	3 - Normal Wear & Tear
Seat Belt Condition	Seat belt secures properly. Belt is intact and in good condition
Cabin Lights	0
Safety Lock Out / Stop	0
Controls & Switches	3 - Normal Wear & Tear
Controls & Switches Condition	All switches are installed and functional
Controls & Switches Photos

What's Great About the Machine	The machine is well maintained and it shows. All functions operate as they should and no major obvious repairs required. Engine, transmission and hydraulics sound great. Structurally the machine is solid and implements is great shape.
What Needs Work	A few hydraulic hoses may need to be replaced soon. Operator controls should be relabeled (decals worn). Tires worn Below 50%.
Date/Time	11-10-2022

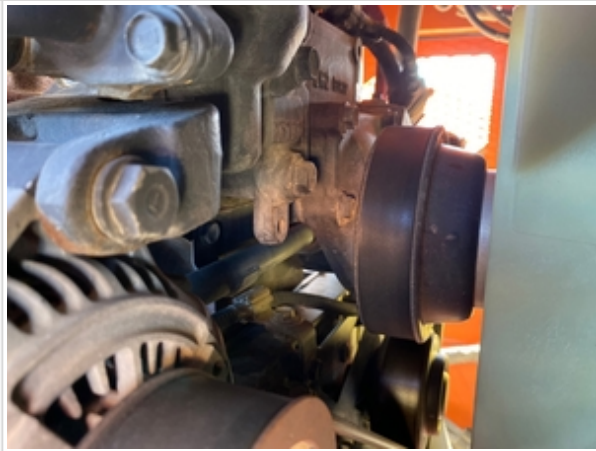
Belts	3 - Normal Wear & Tear
Belt Condition	Belts appear in good condition & alignment with proper tension

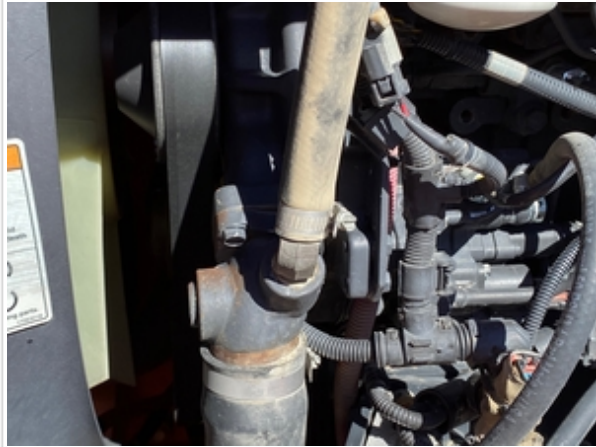
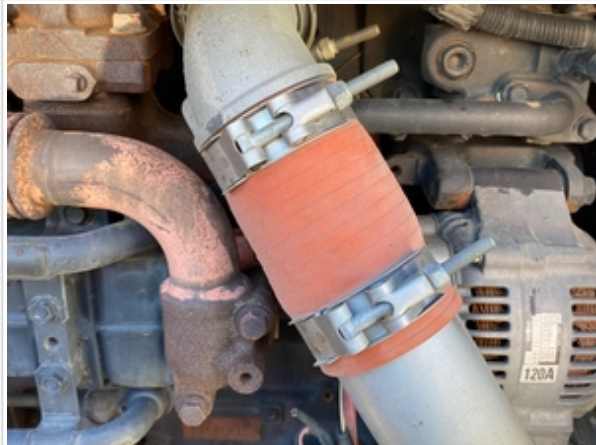
Hoses	3 - Normal Wear & Tear
Hose Condition	Firm, pliant hoses with no signs of wear or leaks
Hose Photos

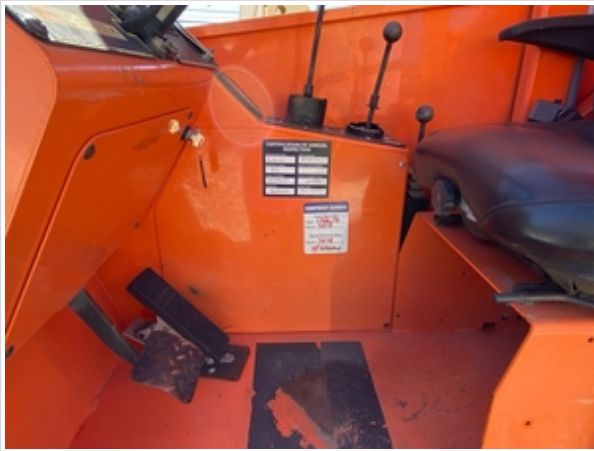
Foot Brake	3 - Normal Wear & Tear
Foot Brake Condition	Good brake function

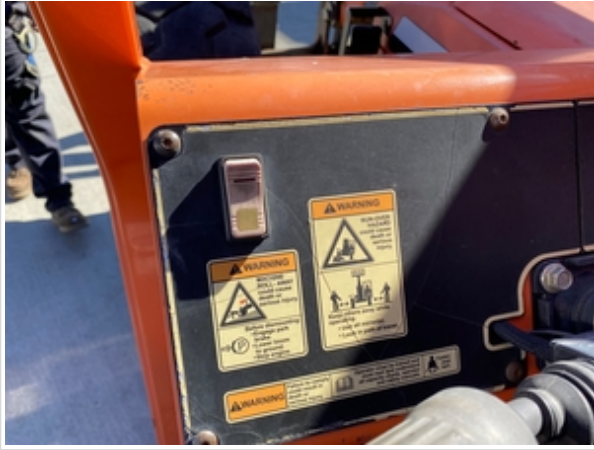
Inching Brake	0
Parking Brake	3 - Normal Wear & Tear
Parking Brake Condition	Good brake function
Parking Brake Photos

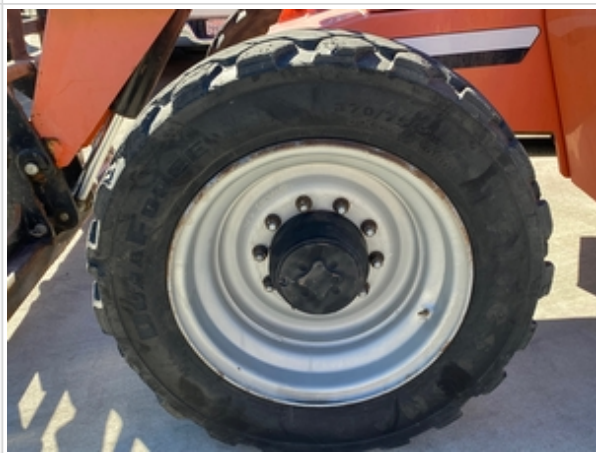
<p>Wheels & Tires</p>	<p>3 - Normal Wear & Tear</p>	
<p>Wheels & Tires Photos</p>

Tire Brand	Firestone	
Tire Size	360/75-28	
Front Left Tire - Ratio Remaining	30%	
Rear Left Tire - Ratio Remaining	30%	
Front Right Tire - Ratio Remaining	10%	
Rear Right Tire - Ratio Remaining	30%	
Boom Condition	3 - Normal Wear & Tear	
Boom Condition Photos

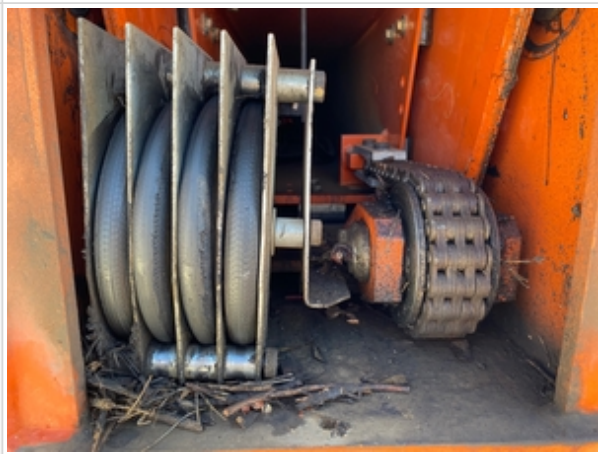
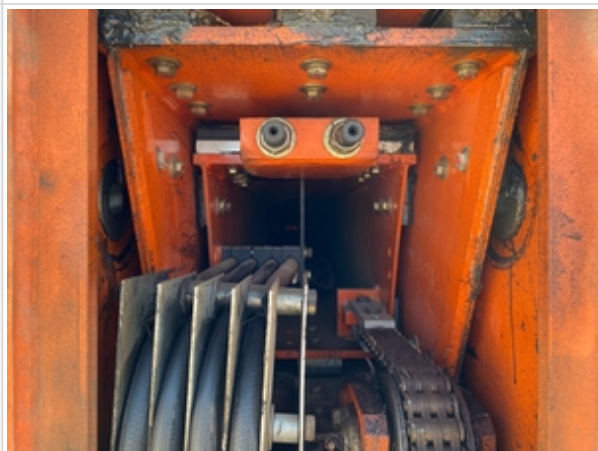
<p>Chain / Tensioners</p>	<p>3 - Normal Wear & Tear</p>	
<p>Chain / Tensioners Photos</p>

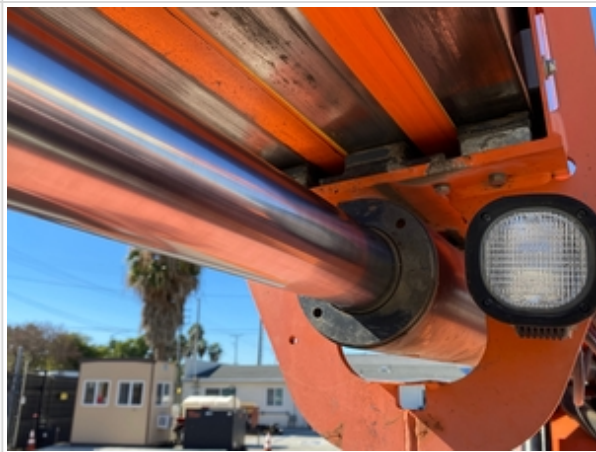
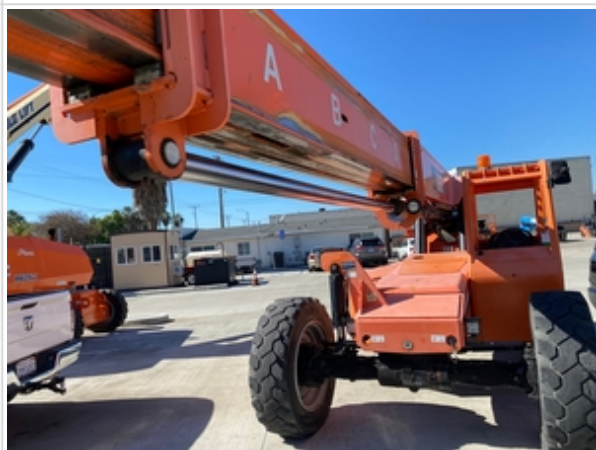
Rollers & Guides	3 - Normal Wear & Tear	
Boom Wear Guides	3 - Normal Wear & Tear	
Boom Wear Guides Photos

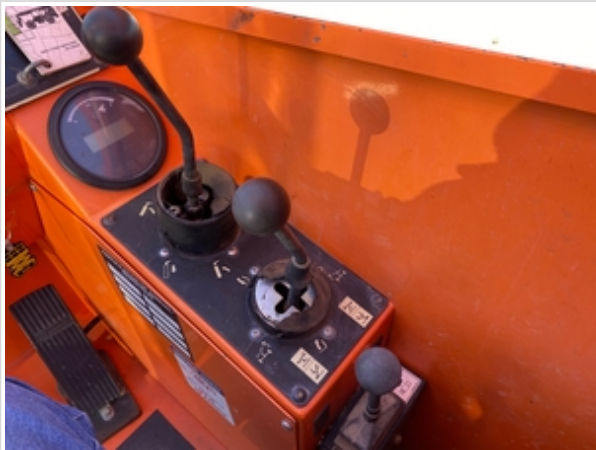
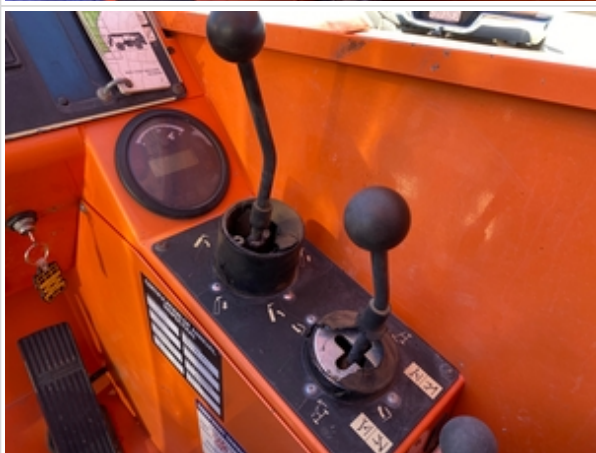
Unusual Noises (Hydraulic Pump)	No	
Hydraulic Pump Notes	No unusual noises heard during operation	
External Controls / Levers	3	
External Controls / Levers Condition	Good function & condition of hydraulic controls	
External Controls / Levers Photos

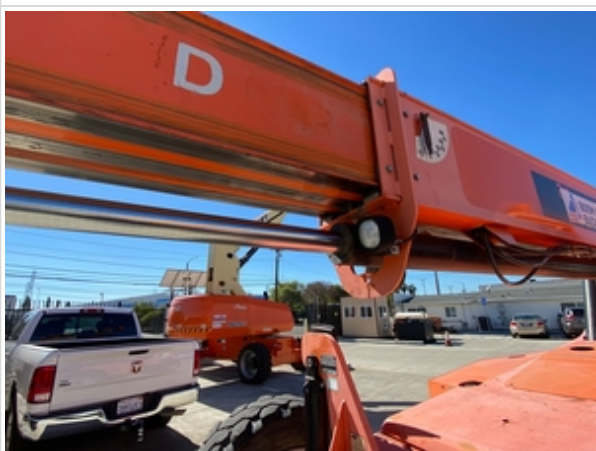
Telescopic Boom Cylinders	Check the telescopic boom cylinders. Note any wear, pitting, discoloration, etc. Take photos.	
Telescopic Boom Cylinders: Mounting Pin	3	
Telescopic Boom Cylinders: Oil Leaks	No	
Telescopic Boom Cylinders Photos

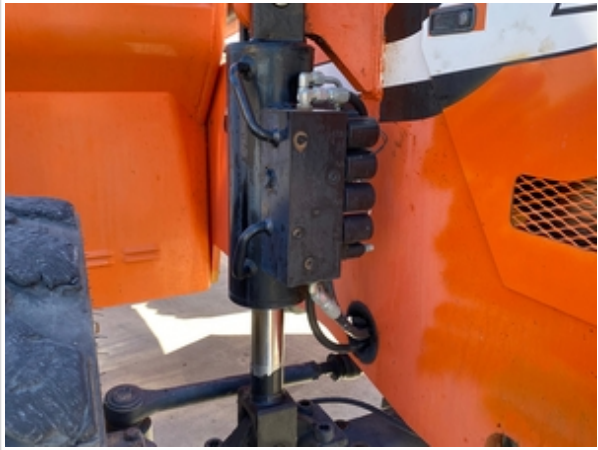
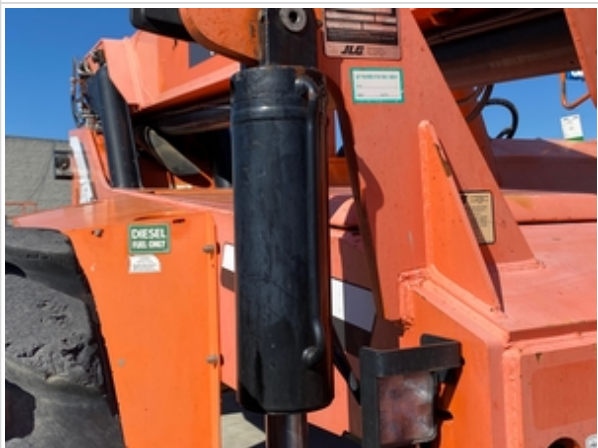
Frame Leveling Cylinders	Check the frame leveling cylinders. Note any wear, pitting, discoloration, etc. Take photos.	
Frame Leveling Cylinders: Mounting Pin	3	
Frame Leveling Cylinders: Oil Leaks	No	
Frame Leveling Cylinders Photos

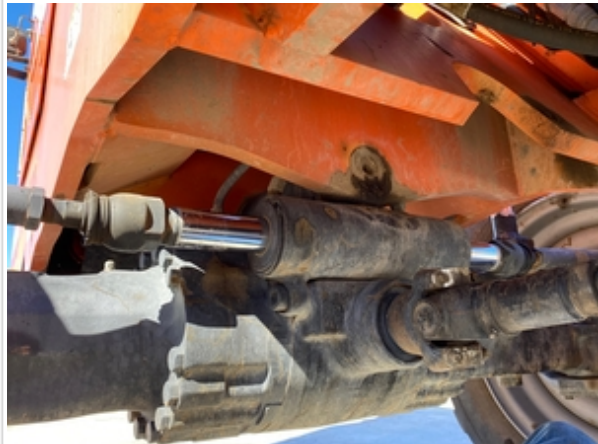
Side Shift Cylinder	Check the side shift cylinder. Note any wear, pitting, discoloration, etc. Take photos.	
Outrigger Cylinders	Check the outrigger cylinders. Note any wear, pitting, discoloration, etc. Take photos.	
Steering Cylinders	Check the steering cylinders. Note any wear, pitting, discoloration, etc. Take photos.	
Steering Cylinders: Mounting Pin	3	
Steering Cylinders: Oil Leaks	No	
Steering Cylinders Photos

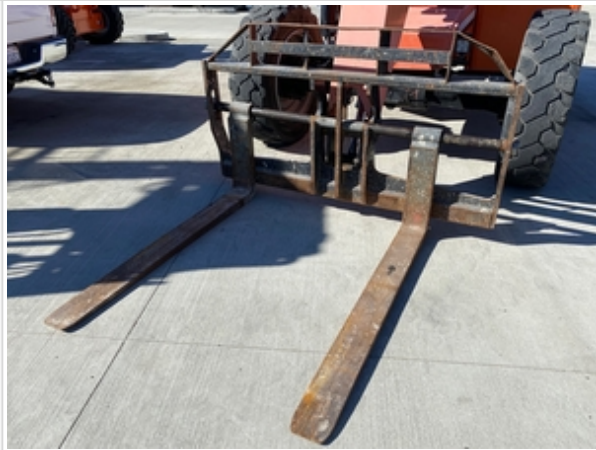
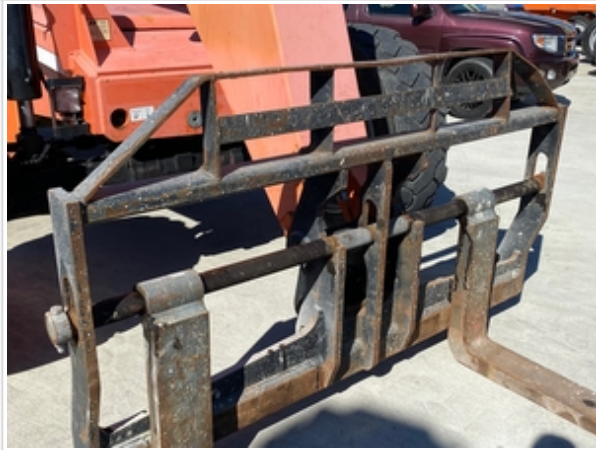
Forks / Work Tool Condition	3 - Normal Wear & Tear
-----------------------------	------------------------
