Inspection Report (Skid Steer)

Year	2006
Make	Bobcat
Model	S250
Serial Number	526018752
Hour Meter Reading	3,059
Previous Application (e.g., earth moving, mining, demolition, etc)	Demo Construction

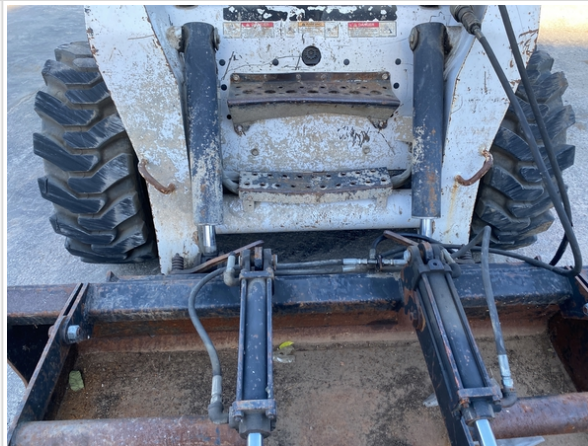
Front	3 - Normal Wear & Tear
Front Condition	Visible chipped paint or dents, Other (see comments)
Comments	Bent step
Front Photos

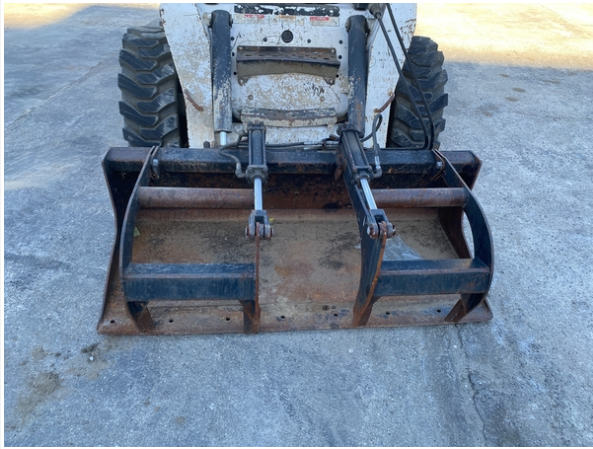
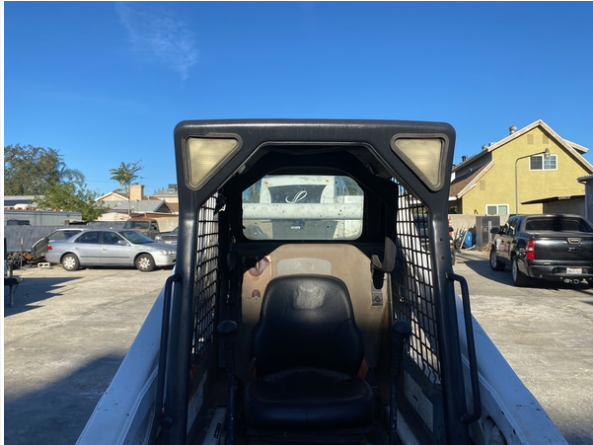
Rear	3 - Normal Wear & Tear	
Rear Condition	No visible damage, Other (see comments)	
Comments	Rear l/s light missing	
Rear Photos

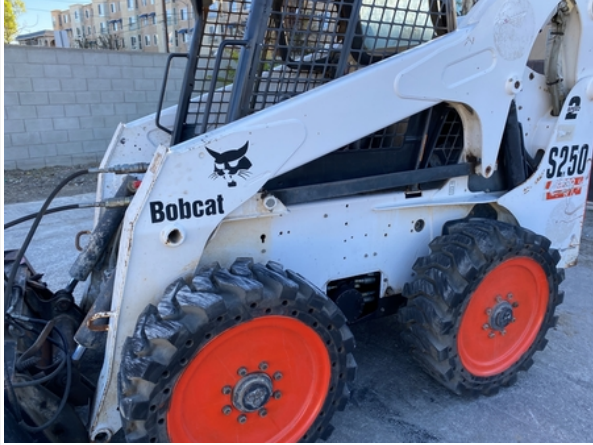
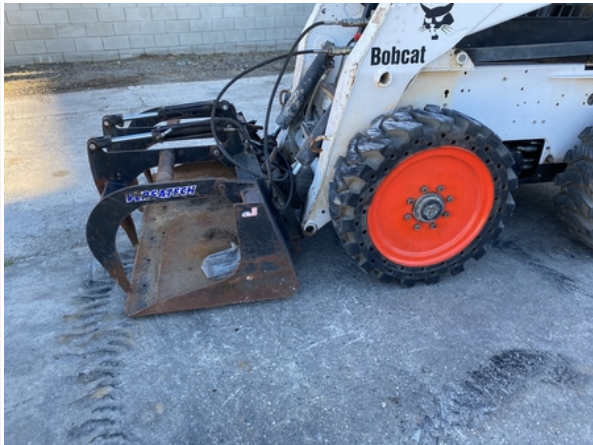
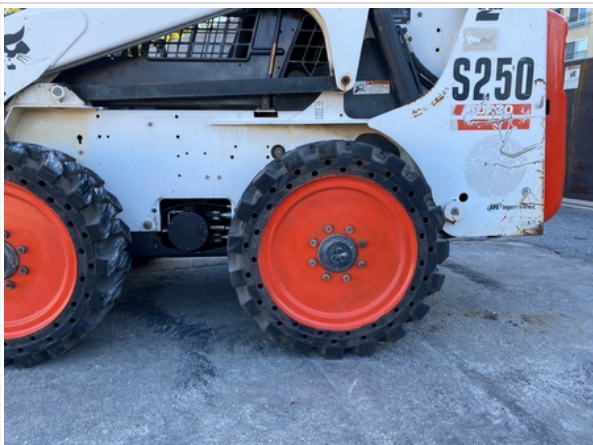
Left	3 - Normal Wear & Tear	
Left Condition	No visible damage, Other (see comments)	
Comments	L/S Drive Motor Cover Missing

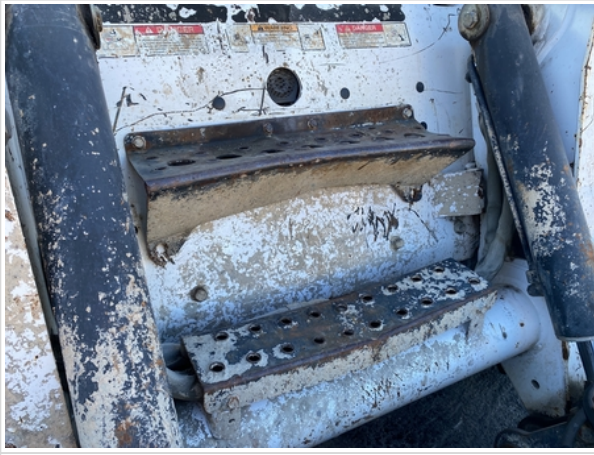
Steps / Ladders	3 - Normal Wear & Tear
Steps / Ladders Condition	Bent or broken steps or rungs, Other (see comments)
Comments	Steps bent
Steps / Ladders Photos

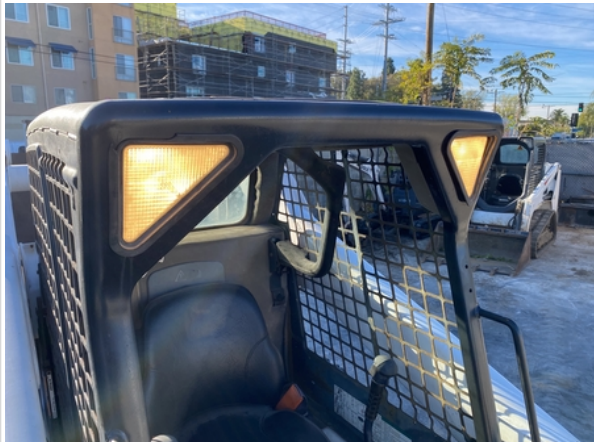
Mirrors	0
Lighting System	2 - Above Average Wear
Lighting System Condition	One or more exterior lights are non-operational
Comments	Rear light inop. & L/S light fixture missing
Lighting System Photos

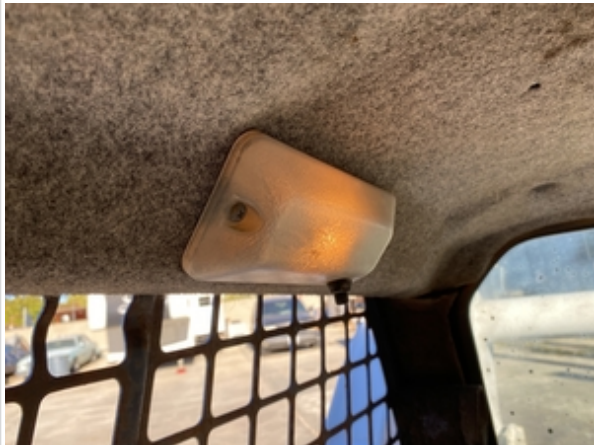
Cabin Lights	2 - Above Average Wear	
Cabin Lights Condition	Cabin lights are installed with all light covers in place, bulbs are installed and working properly, Other (see comments)	
Comments	Cabin light cover dull	
Cabin Lights Photos

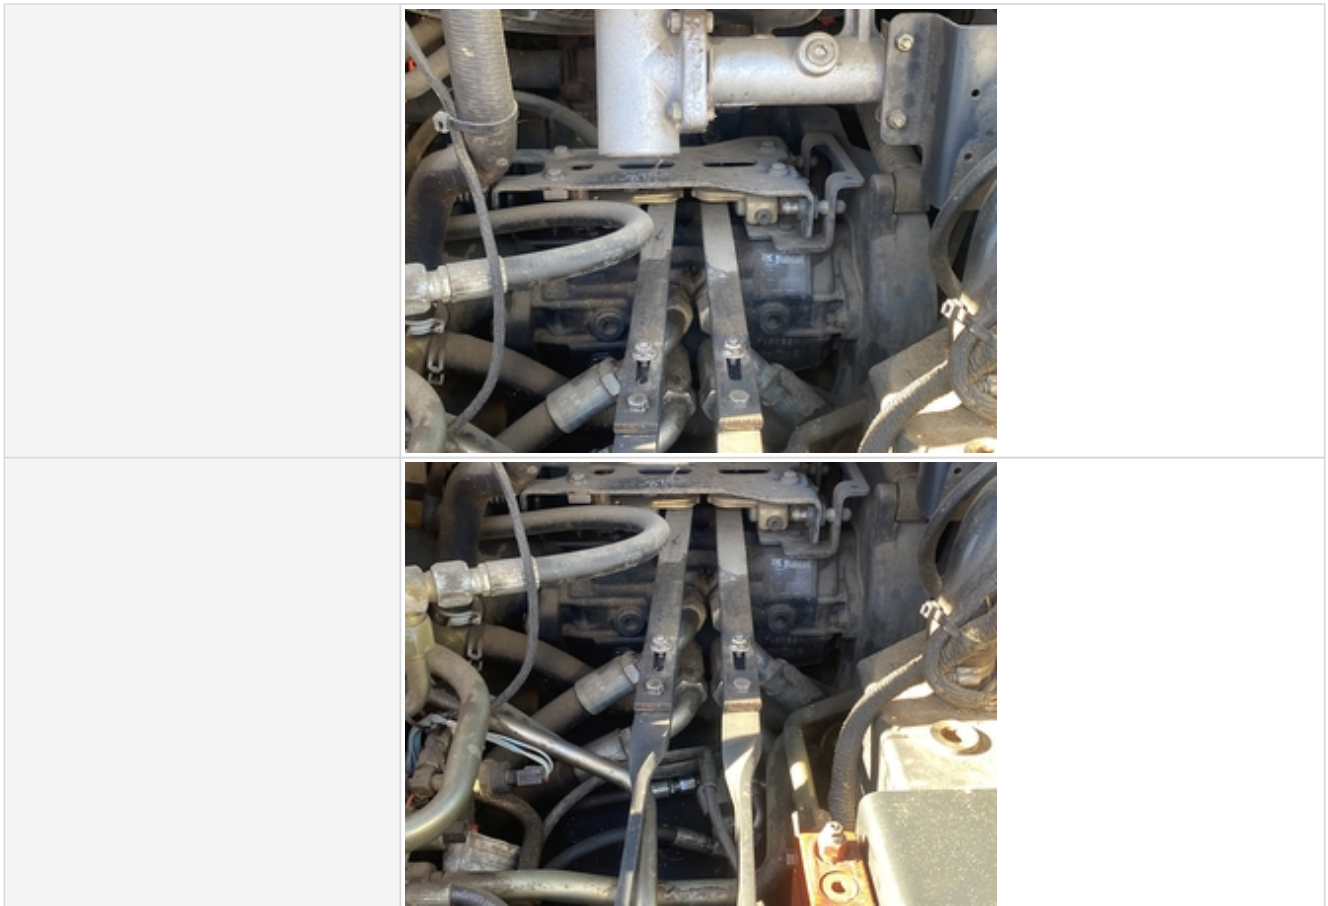
Unusual Noises (Hydraulic Pump)	No	
Hydraulic Pump Notes	No unusual noises heard during operation, Other unusual sounds (see comments)	
Comments	Minor seepage r/s of hydraulic pump	
External Controls / Levers	3	
External Controls / Levers Condition	Good function & condition of hydraulic controls	
External Controls / Levers Photos

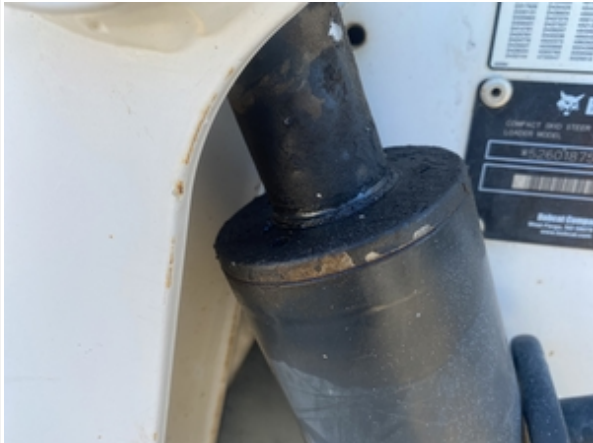
Lift Cylinder	Check the lift cylinder. Note any wear, pitting, discoloration, etc. Take photos.
Lift Cylinder: Mounting Pin	3
Lift Cylinder: Oil Leaks	Yes
Comments	L/S lift cylinder leaking minor amount of oil
Lift Cylinder Photos

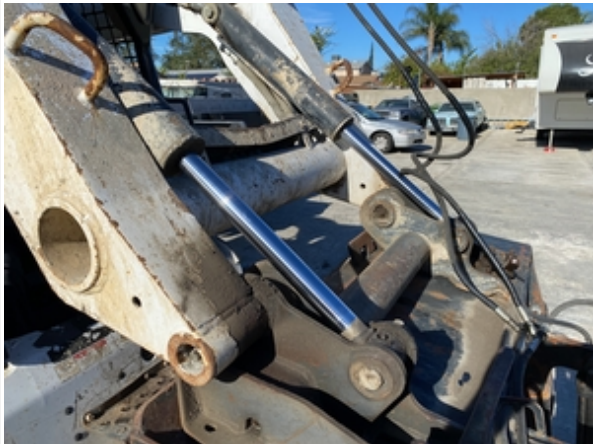
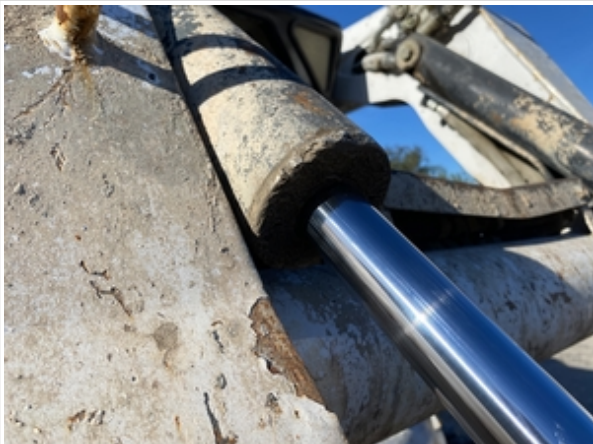
Bucket Cylinder	Check the bucket cylinder. Note any wear, pitting, discoloration, etc. Take photos.	
Bucket Cylinder: Mounting Pin	3	
Bucket Cylinder: Oil Leaks	No	
Comments	Minor scores on both bucket cylinders	
Bucket Cylinder Photos

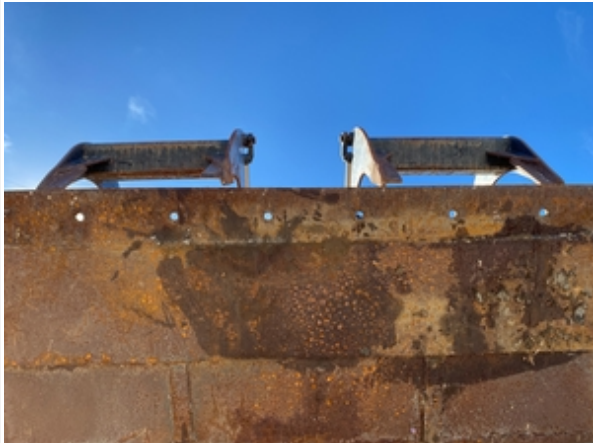
Bucket Edge / Deflectors	1 - Service Required	
Comments	Missing cutting edge and hardware	
Bucket Edge / Deflectors
