Inspection Report (On-Highway Dump Truck)

Year	2011
Make	Peterbilt
Model	367
Serial Number	1NP - TLUOX - 8 - BD127978
Truck Odometer Reading	400,445 Mi.
Previous Application (e.g., earth moving, mining, demolition, etc)	Asphalt Construction

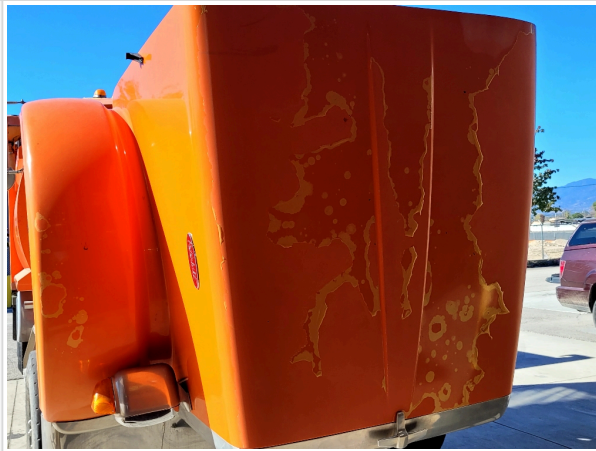
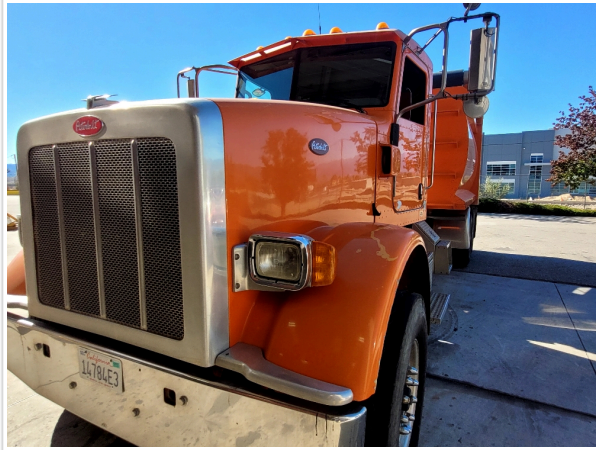
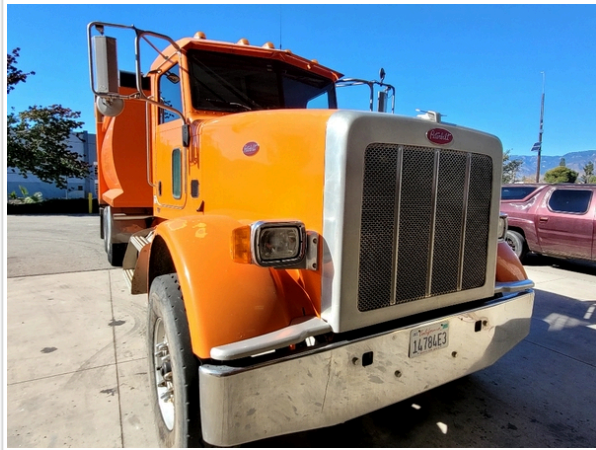
<p>Front Photos</p>

Front	3 - Normal Wear & Tear
Front Condition	No visible damage, Other (see comments)
Comments	minor clear coat peeling

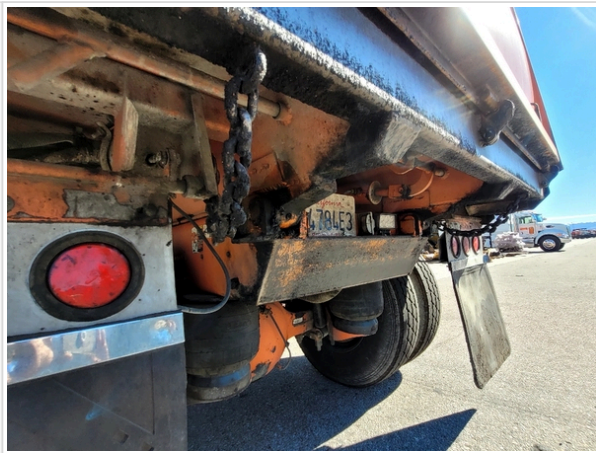
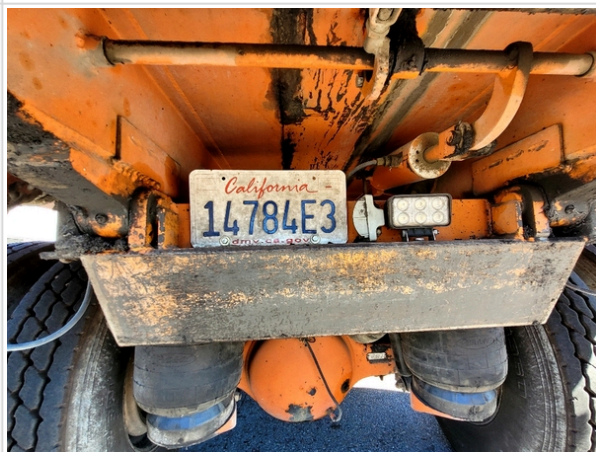
<p>Rear Photos</p>

<p>Rear</p>	<p>3 - Normal Wear & Tear</p>
<p>Rear Condition</p>	<p>No visible damage, Other (see comments)</p>
<p>Comments</p>	<p>normal wear and tear</p>

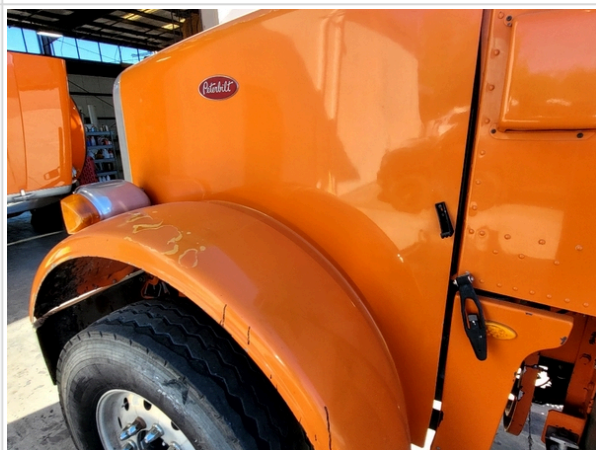
<p>Left</p>	<p>3 - Normal Wear & Tear</p>
<p>Left Condition</p>	<p>No visible damage</p>
<p>Left Photos</p>

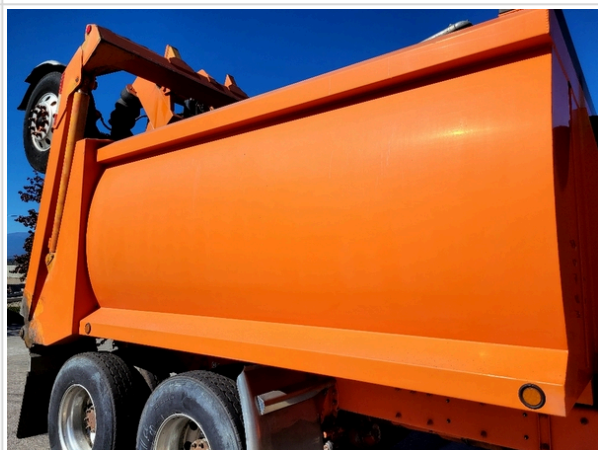
Right	3 - Normal Wear & Tear	
Right Condition	No visible damage	
Right Photos

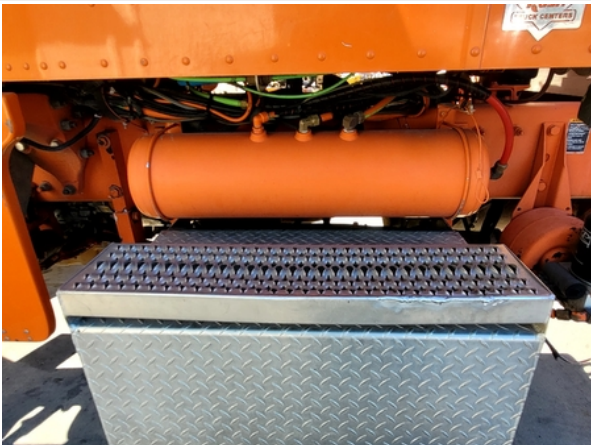
Body Panels (Any Rust Damage?)	3 - Normal Wear & Tear	
Body Panel Condition	No visible damage, good paint condition and panel fitment, Other (see comments)	
Doors / Canopy Latches	3 - Normal Wear & Tear	
Doors / Canopy Latches Condition	No visible damage	
Steps / Ladders	3 - Normal Wear & Tear	
Steps / Ladders Photos

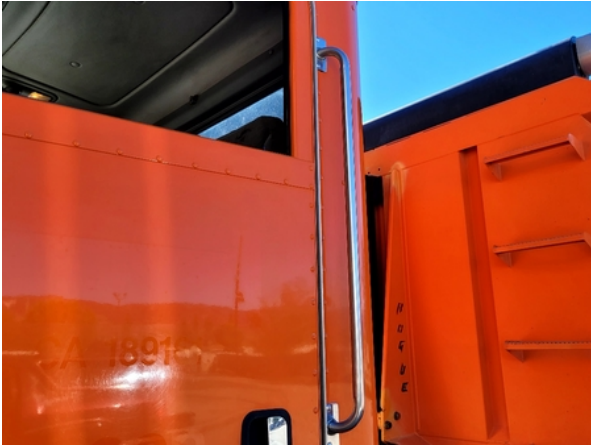
Handrails	3 - Normal Wear & Tear	
Handrails Condition	Handrails are fully intact and appear structurally sound	
Handrail Photos

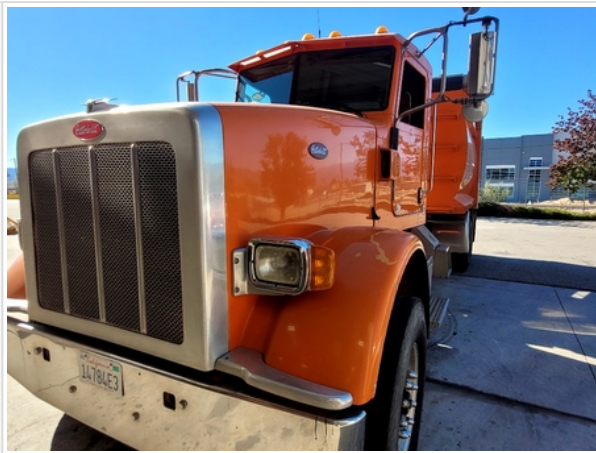
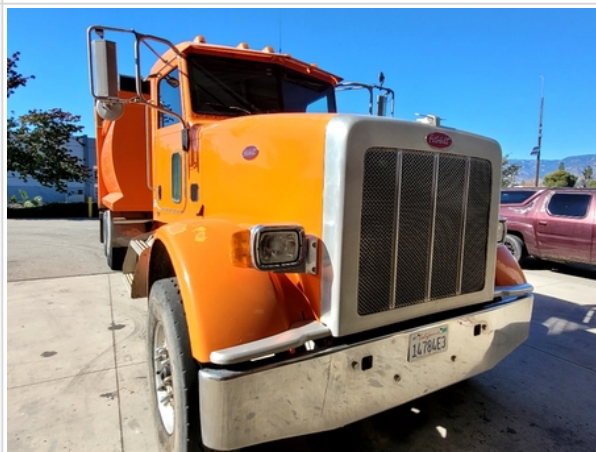
Mirrors Photos

Mirrors	3 - Normal Wear & Tear
Mirror Condition Notes	Mirrors present and intact, no visible damage

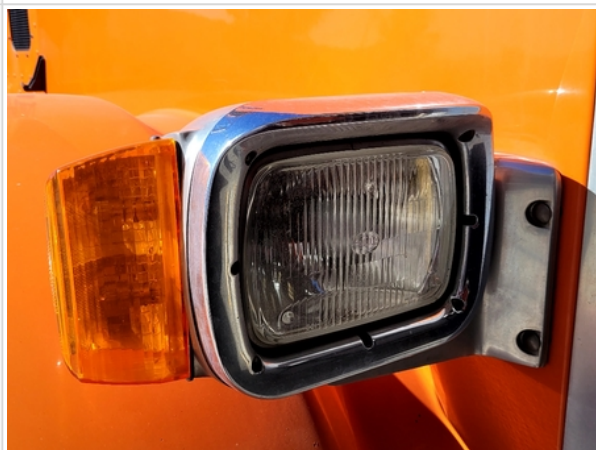
Lighting System	3 - Normal Wear & Tear
Lighting System Condition	No visible damage, lighting system is operational
Lighting System Photos

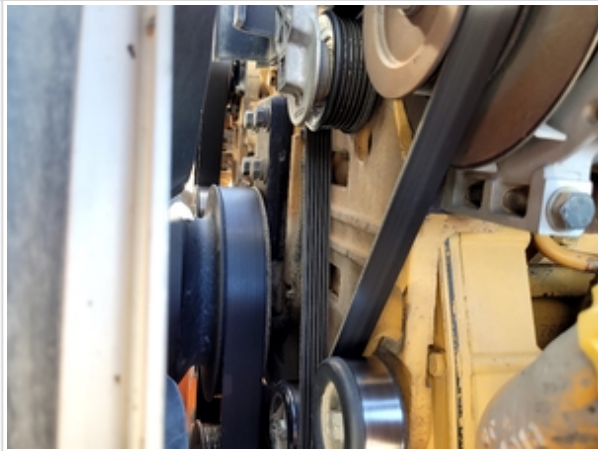
Belts	3 - Normal Wear & Tear	
Belt Condition	Belts appear in good condition & alignment with proper tension	
Belt Photos

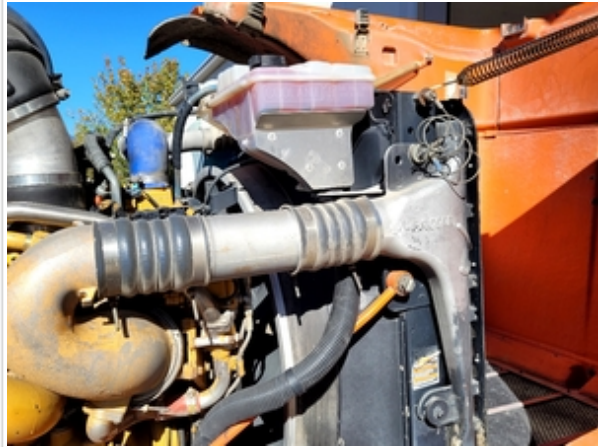
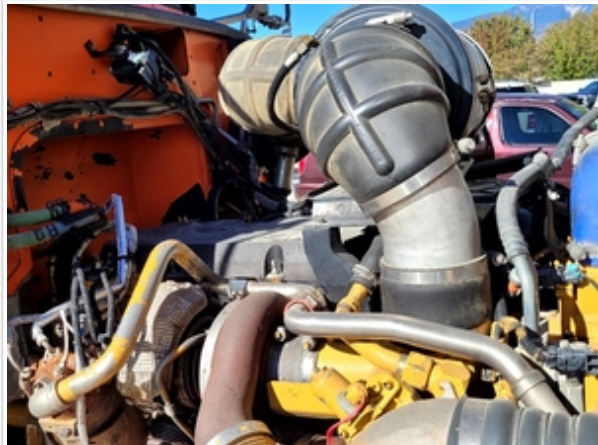
Hoses	3 - Normal Wear & Tear	
Hose Condition	Firm, pliant hoses with no signs of wear or leaks	
Hose Photos

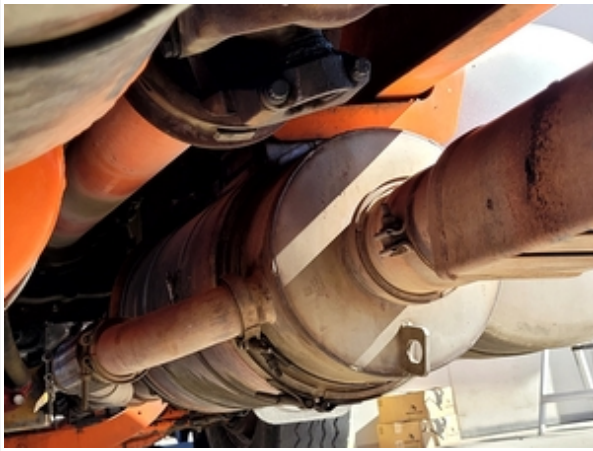
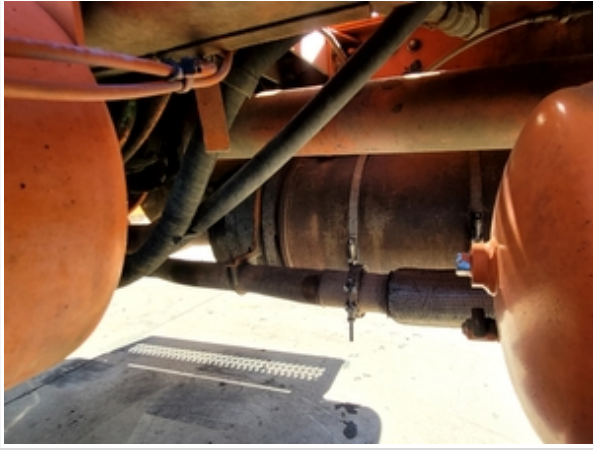
Oil Color / Appearance	3 - Normal Wear & Tear
Oil Color / Appearance Notes	Clean oil appearance, no signs of cross contamination, Appropriate oil level
Fuel Leaks	No
Equipped with DPF (Diesel Particulate Filter)	Yes
DPF Condition	3 - Normal Wear & Tear
DPF Condition Notes	Filter housing is intact with no signs of damage or malfunction, DPF indicator is not illuminated
DPF Photos

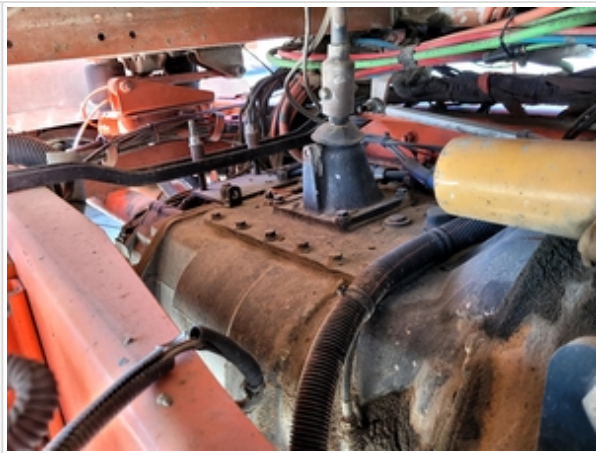
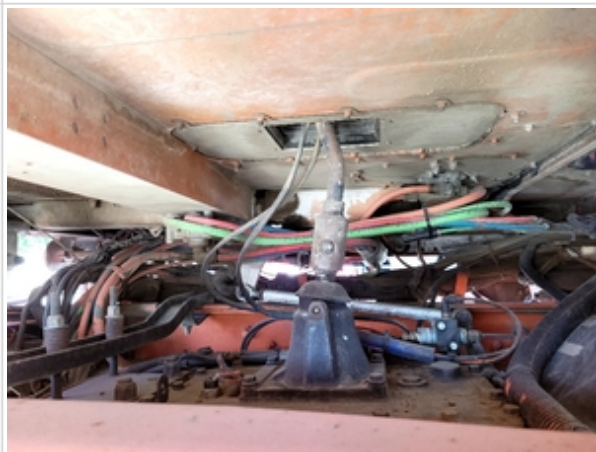
Shift Lever Photos

Clutch	3 - Normal Wear & Tear
Clutch Condition	Clutch is functioning as expected
Shift Lever	3 - Normal Wear & Tear
Shift Lever Condition	Good forward and reverse function

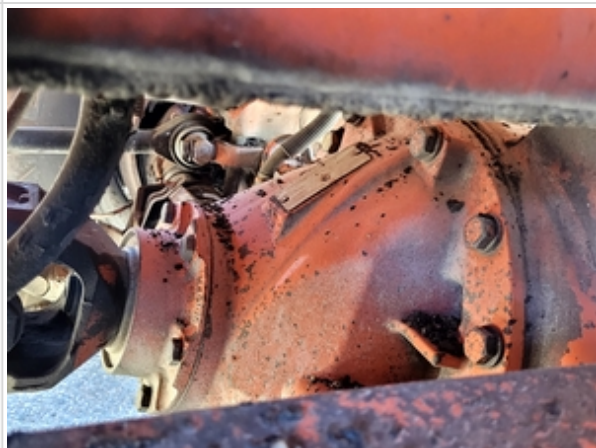
Differential	Check condition of the differential(s). Take photos and notes as relevant.
Rear Differential	3 - Normal Wear & Tear
Rear Differential Condition	Dry housing appearance, no unusual noises heard during operation
Rear Differential Photos

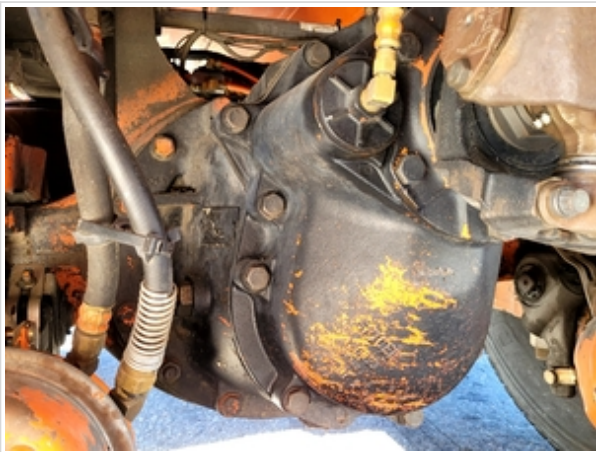
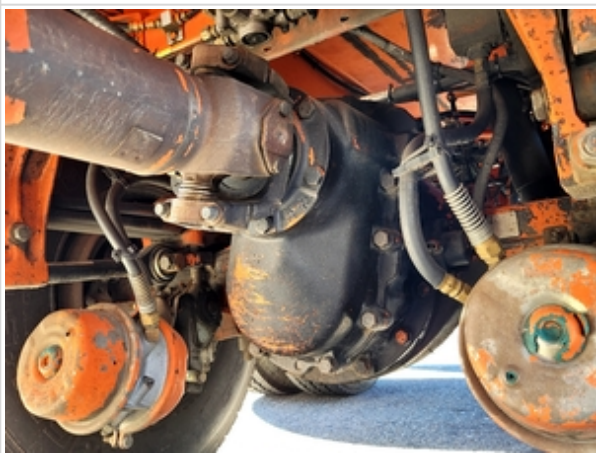
Front Differential Photos

Front Differential	3 - Normal Wear & Tear	
Front Differential Condition	Dry housing appearance, no unusual noises heard during operation

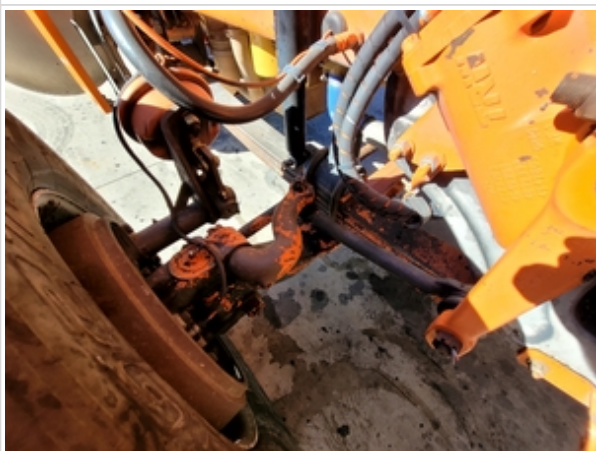
Brake System Type	Air Brakes	
Air Brakes Build Correct Pressure	Yes	
Air Brake System Leaks	No	
Air Brake Hose Condition	3 - Normal Wear & Tear	
Air Brake System Photos
