## Inspection Report (Mini Excavator)

| Make | Bobcat |
| Model | 324M |
| Serial Number | AKY522295 |

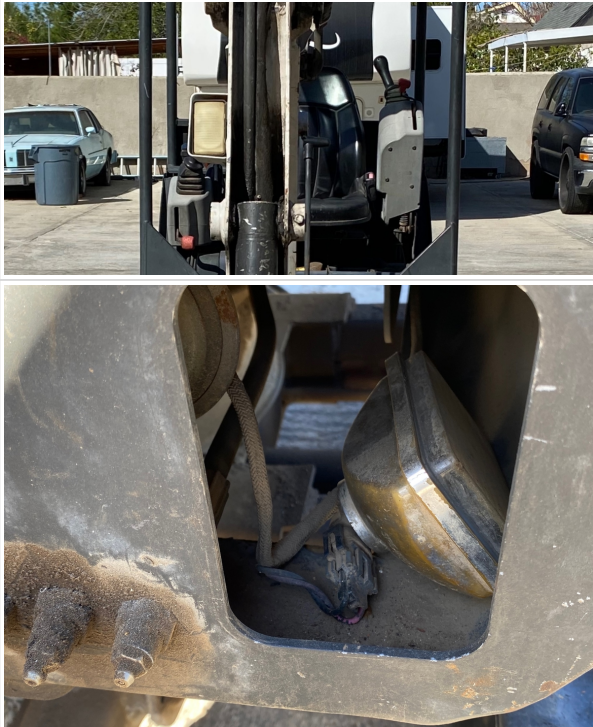
| Lighting System Photos | |

| Lighting System | 2 - Above Average Wear |
| Lighting System Condition | Other (see comments), One or more exterior lights are non-operational |
| Comments | Normal light exterior wear (lens dull) |

| <b>What Needs Work</b> | Bucket cylinder may need to be resealed. Hydraulic leaks at bucket cylinder needs attention. Lights inoperable. Front blade wear plate bent out and should be addressed for proper fitment. Minor seepage seen at engine fuel injector hardlines. |

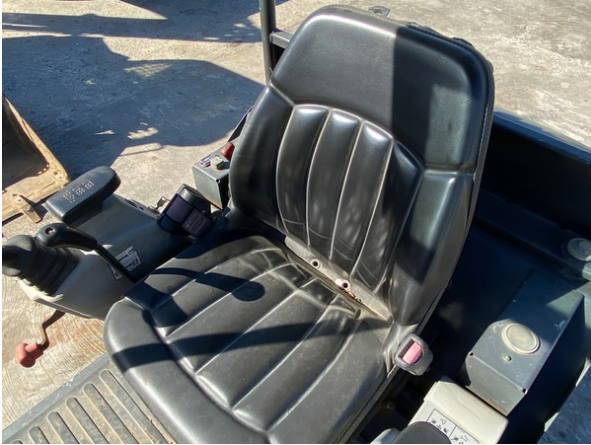
| <b>Operator's Seat &amp; Arm Rests Photos</b> | |

| <b>Operator's Seat &amp; Arm Rests Condition</b> | Seat(s) in good condition, no stains or tears in upholstery, Seat(s) have minor surface staining or small tears, Other (see comments) | |
| <b>Comments</b> | No tears just minor surface wear | |

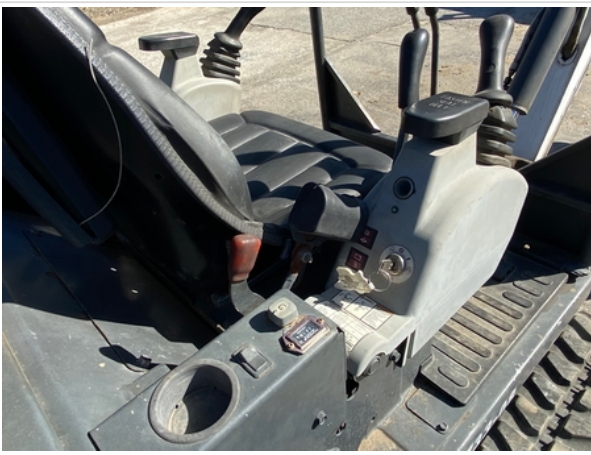
| <b>Controls &amp; Switches Photos</b> | |

| <b>Controls &amp; Switches Condition</b> | Switches have good functionality, minor cosmetic damage observed |
| <b>Comments</b> | Switch decals worn (unreadable) |

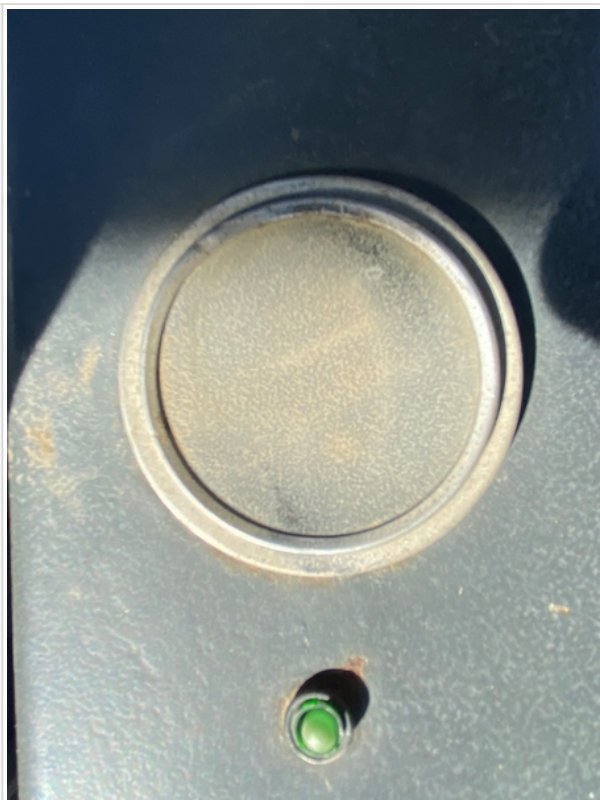
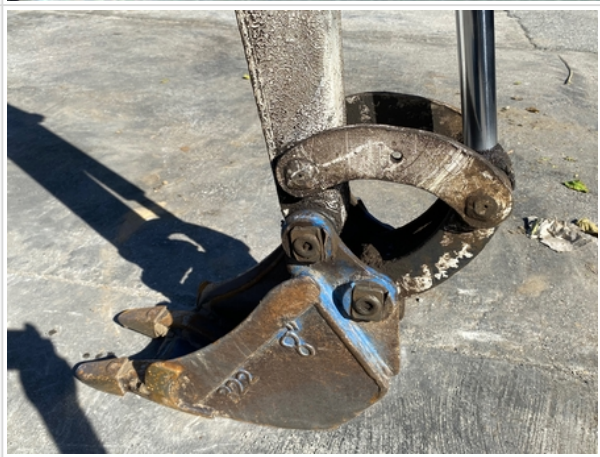
| Other Gauge Activity Photos | | |

| <p>Other Gauge Condition</p> | <p>One or more gauges are unreadable or not functioning (specify in comments), Other (see comments)</p> |
| <p>Comments</p> | <p>Gauges work, worn and unreadable</p> |

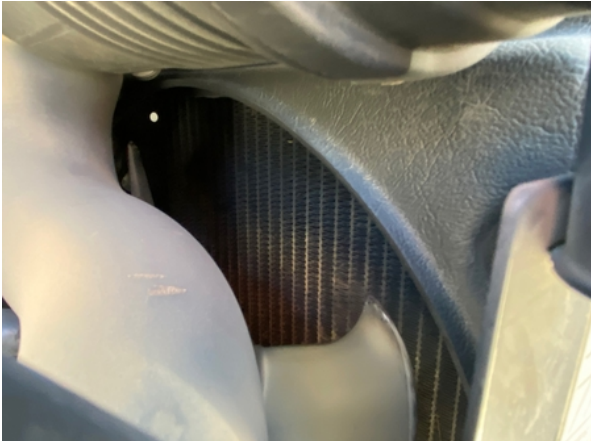
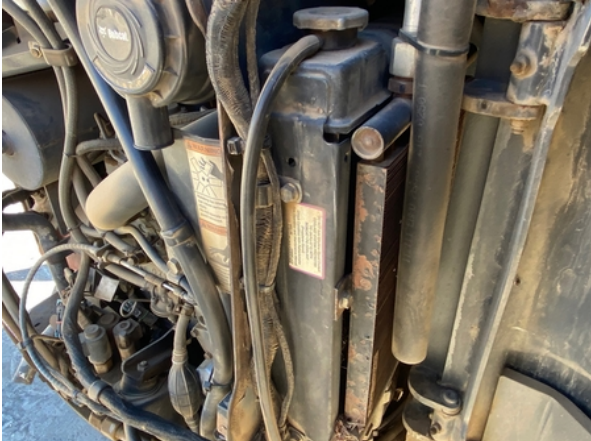
| Radiator Photos | |

| Radiator Condition | Radiator fins & components appear to be in good working order, no signs of damage or leaks |

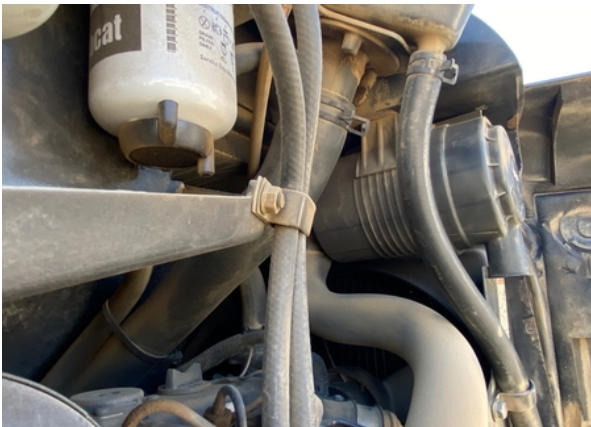
| Hose Photos | |

| Hose Condition | Firm, pliant hoses with no signs of wear or leaks |

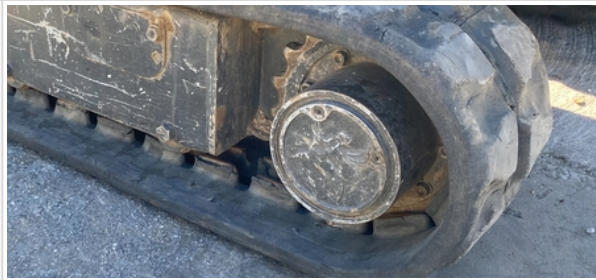
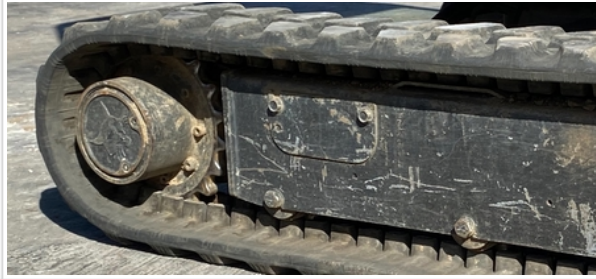
| Drive Motor Photos | |

| <b>Drive Motors</b> | 2 - Above Average Wear |
| <b>Comments</b> | Drive motors working well |

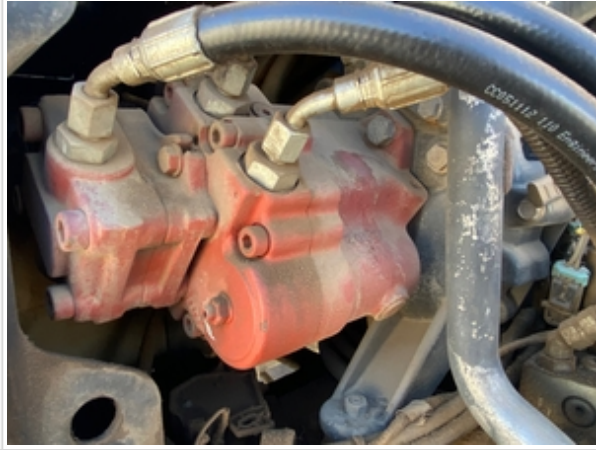
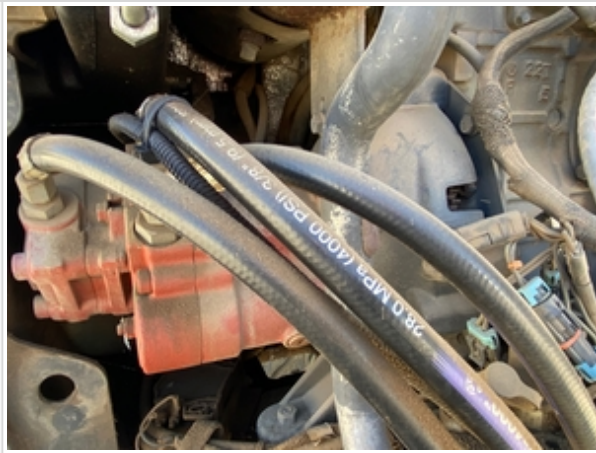
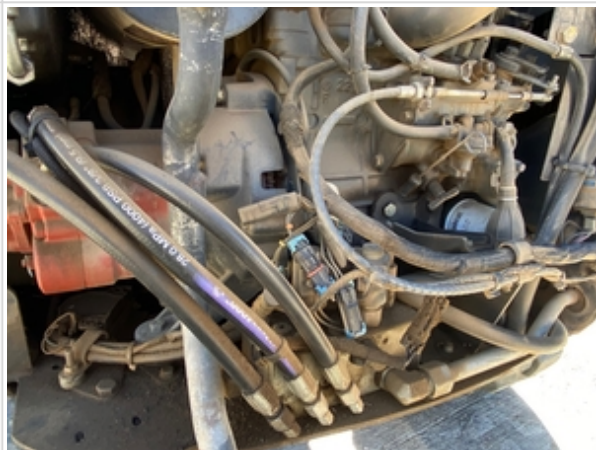
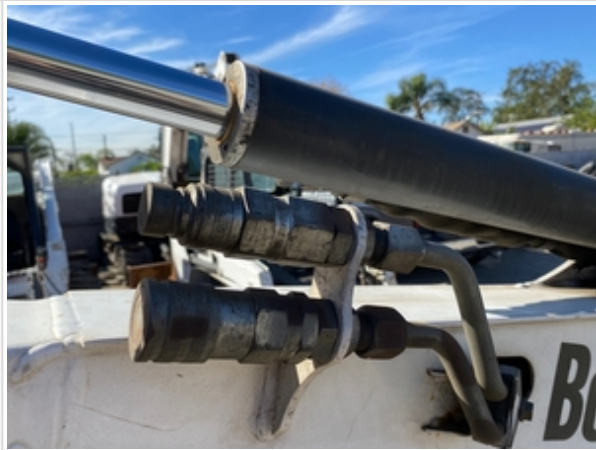
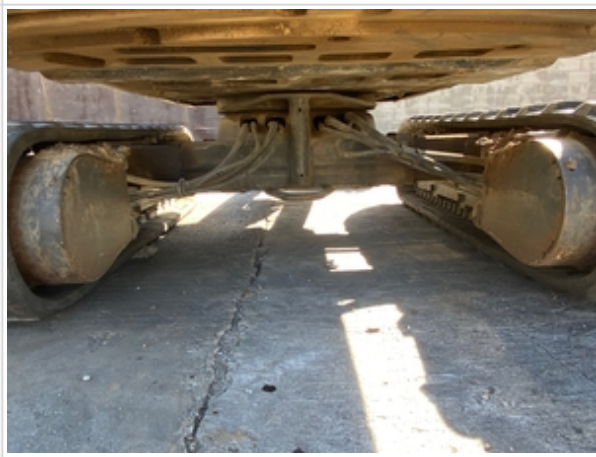
| <b>Appearance of Hydraulic Lines / Fittings Photos</b> | |

| Wet or Damp Hydraulic Lines / Fittings | Yes |

| <b>Hydraulic Lines / Fittings Condition</b> | Hydraulic lines & fittings are clean and in good condition, Active leaks in hoses or fittings observed, Other (see comments) |

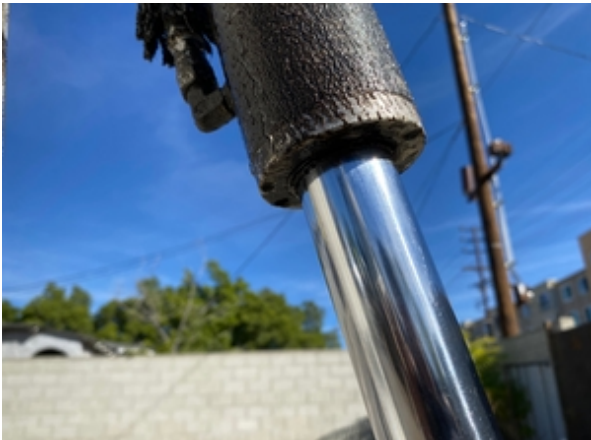
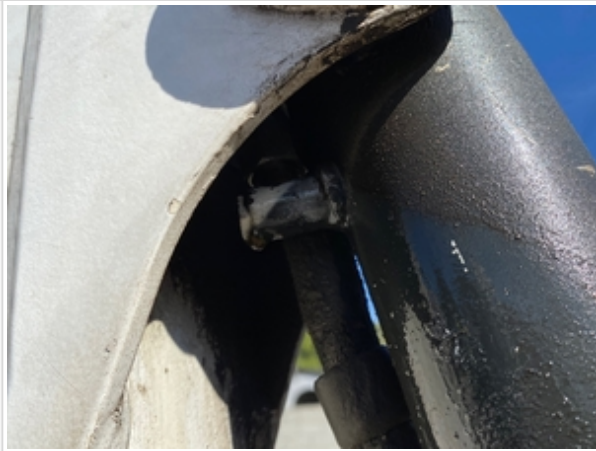
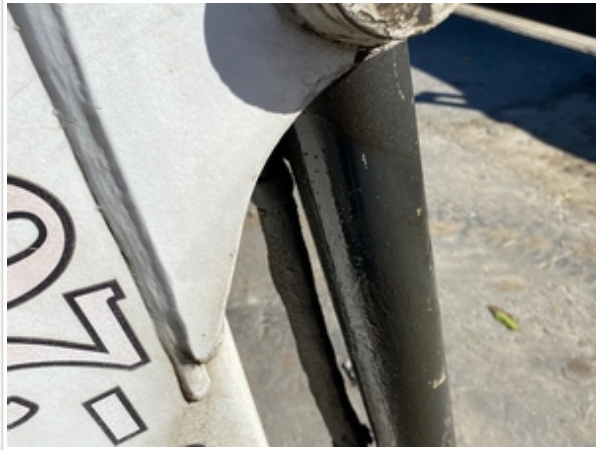
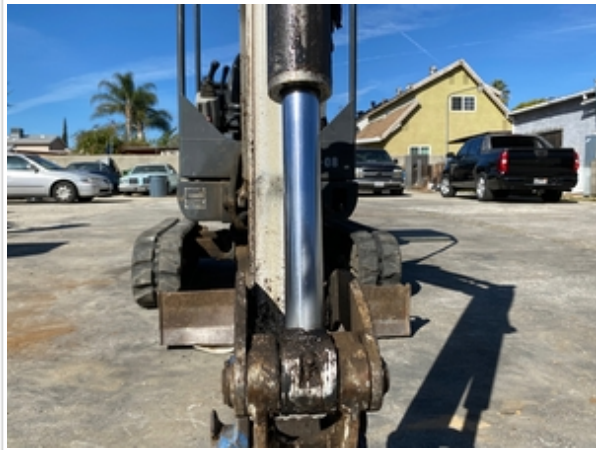
| <b>Bucket Cylinder Photos</b> | | |

| <b>Bucket Cylinder: Oil Leaks</b> | Yes | |
| <b>Comments</b> | Bucket cylinder leaks observed from hoses/fittings and possibly cylinder rod seal | |

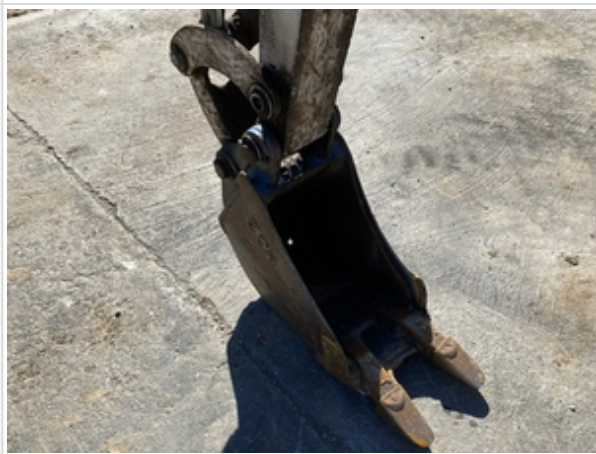
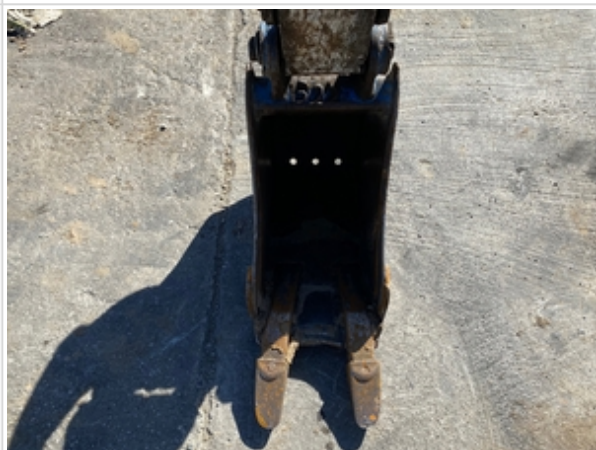
| Bucket Photos | |

| Comments | 2 buckets with machine are 8" and 12" |
