Inspection Report (Mini Excavator)

Year	2014
Make	Bobcat
Model	E85 M
Serial Number	B34T11776
Hour Meter Reading	2,232
Previous Application (e.g., earth moving, mining, demolition, etc)	General Construction

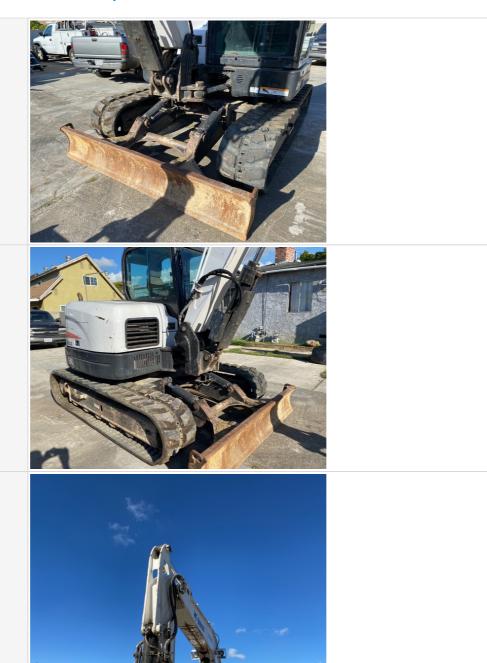
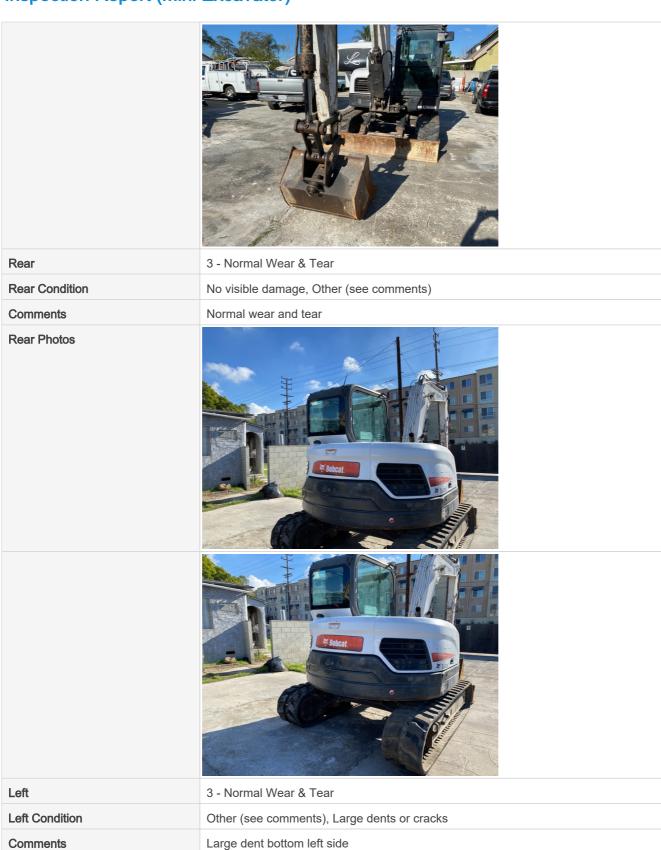
Front Photos

General Appearance	
Front	3 - Normal Wear & Tear
Front Condition	No visible damage, Other (see comments)
Comments	Normal wear and tear

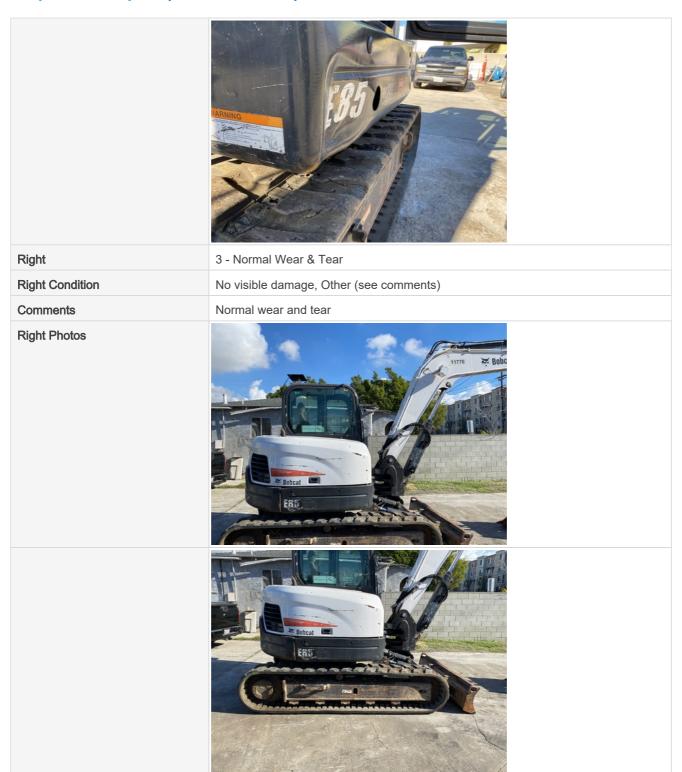
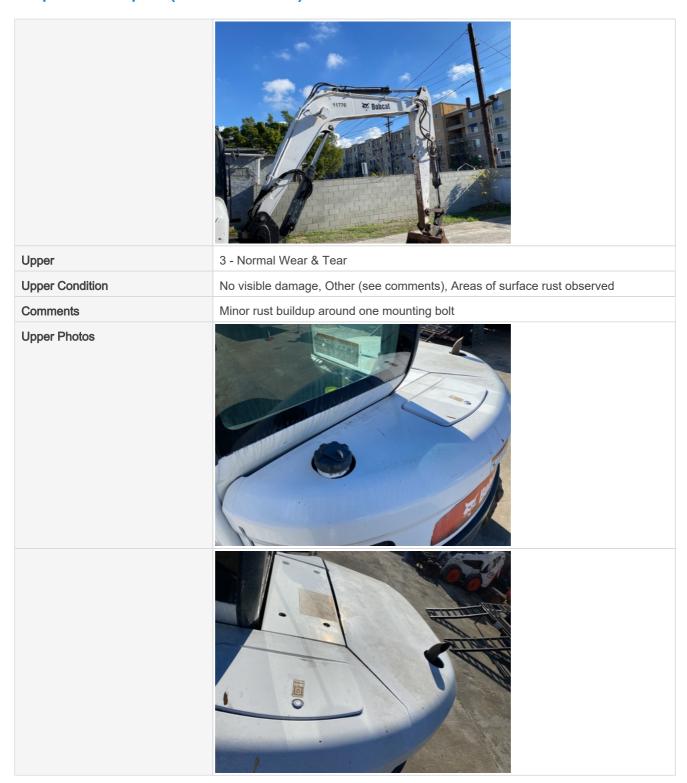
Left Photos

Body Panels (Any Rust Damage?)	3 - Normal Wear & Tear
Body Panel Condition	Other (see comments)
Comments	Normal wear and tear scuff marks all the way around
Doors / Canopy Latches	3 - Normal Wear & Tear
Doors / Canopy Latches Condition	No visible damage
Steps / Ladders	3 - Normal Wear & Tear
Steps / Ladders Condition	Steps/ladders are fully intact and appear structurally sound
Handrails	3 - Normal Wear & Tear
Glass Condition	3 - Normal Wear & Tear
Glass Condition Notes	Glass intact, no visible damage

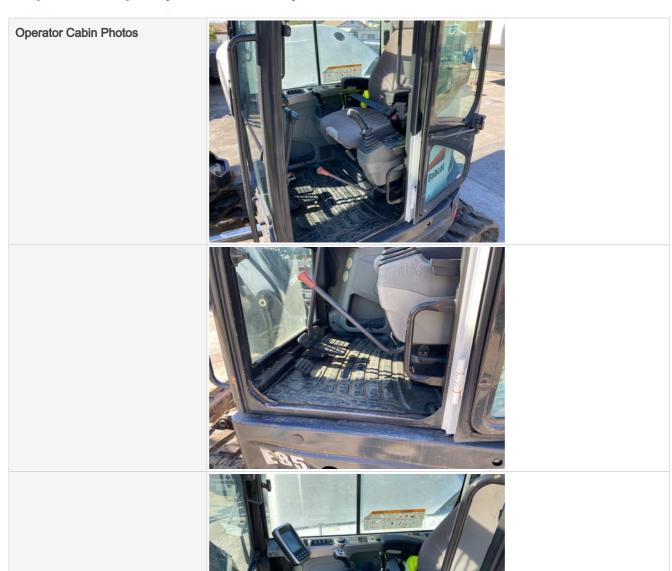
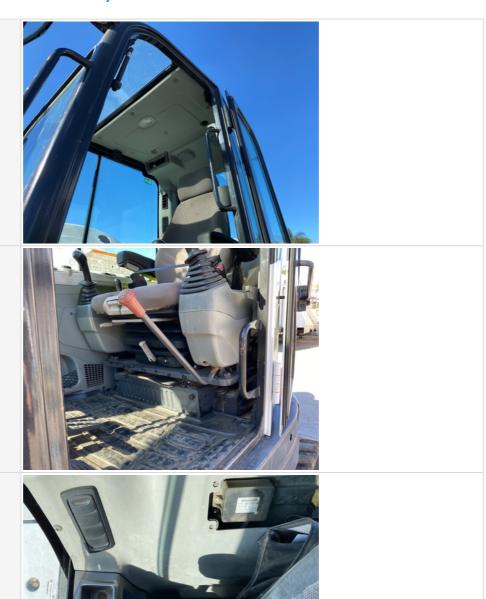
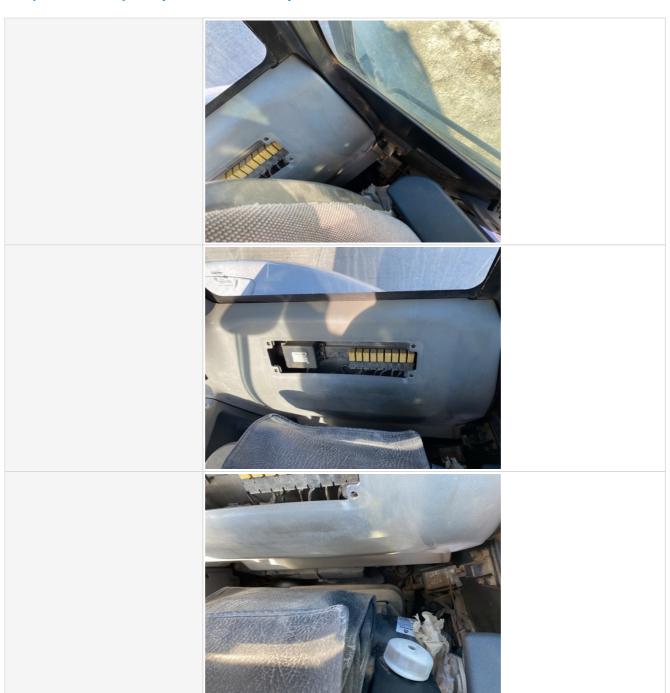
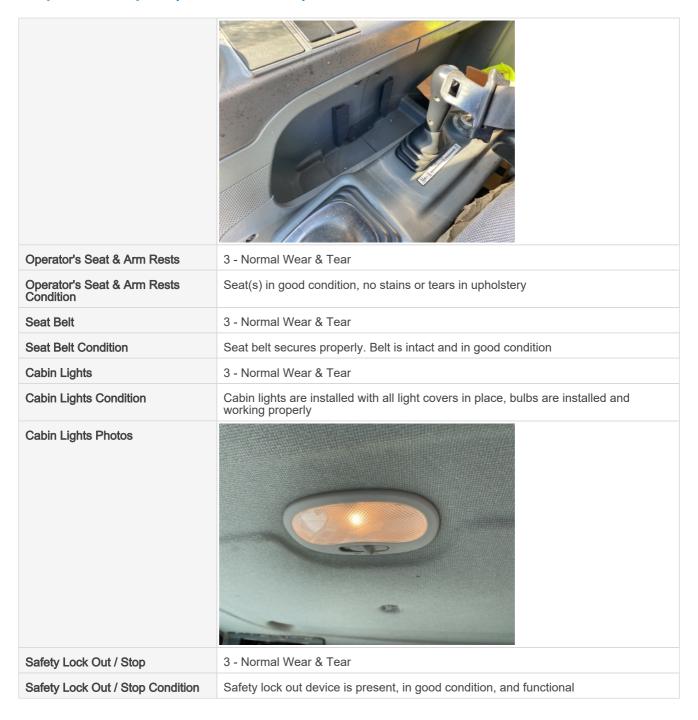
Good cabin appearance, solid floors, panels, and ceiling

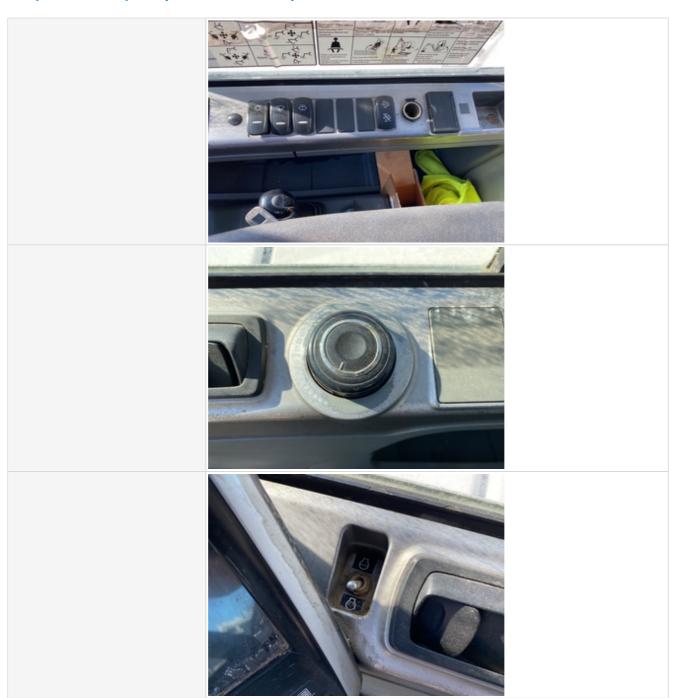
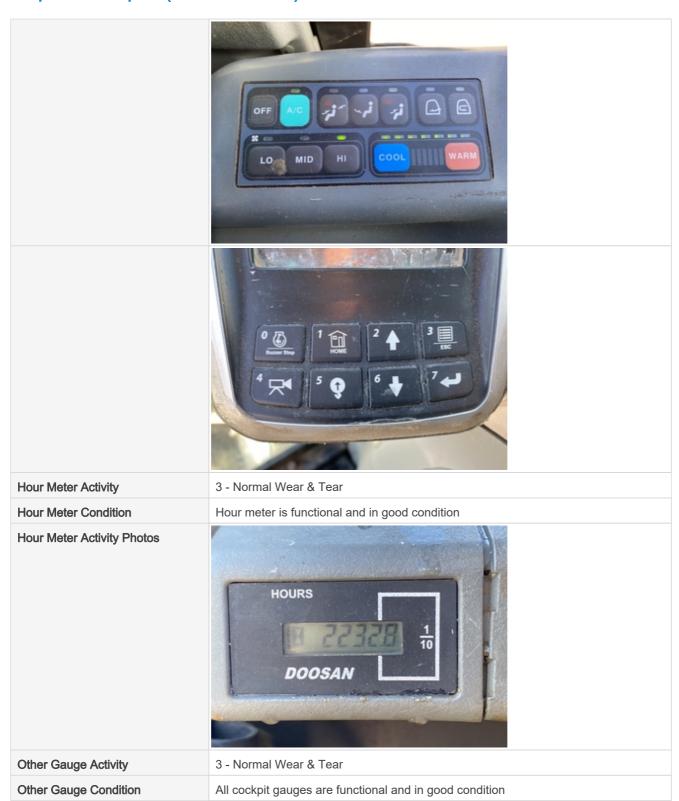
Controls & Switches Photos

All switches are installed and functional

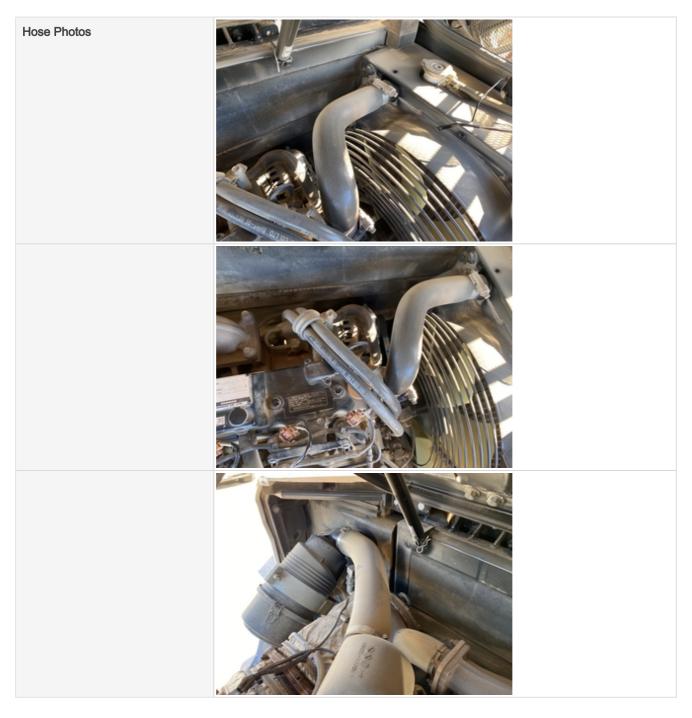
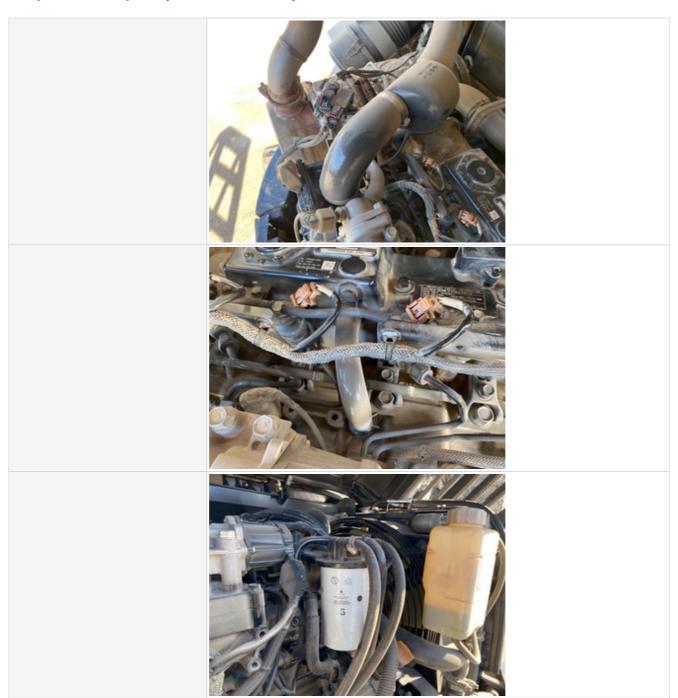
Belts 3 - Normal Wear & Tear	
Belt Condition Belts appear in good condition & alignment with proper tension	
Belt Photos	
D2I IIAO ROULUNDS B44 PROULUNDS B44 PAULUNDS B44	
Hoses 3 - Normal Wear & Tear	
Hose Condition Firm, pliant hoses with no signs of wear or leaks

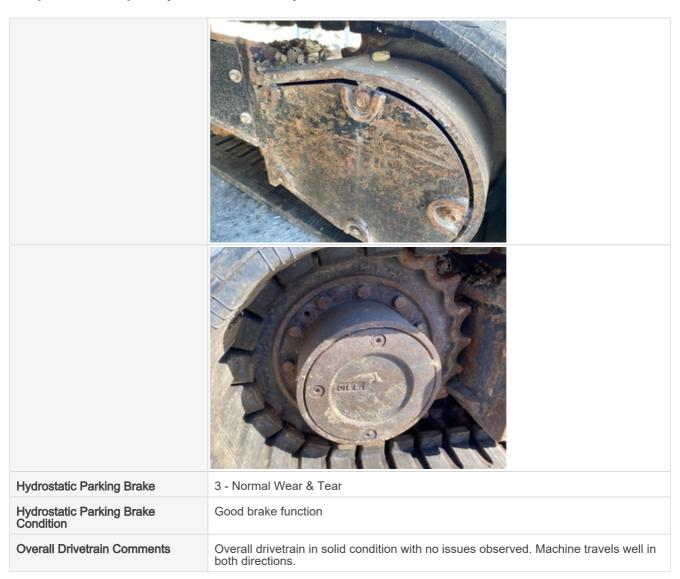
Drivetrain Inspection Points	
Drivetrain	
Hydrostatic Transmission?	Yes
2 Speed?	Yes
Hydrostatic Drive Configuration	Split Transmission
Drive Motors	2 - Above Average Wear
Drive Motor Photos

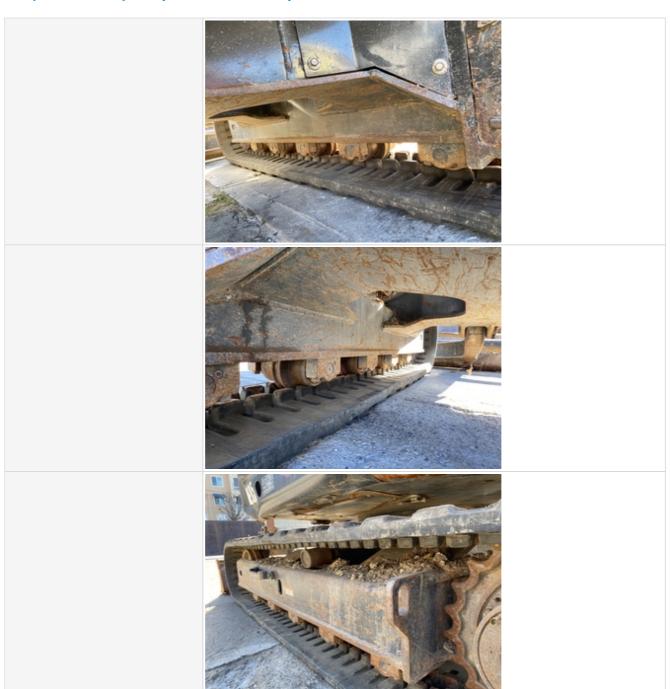
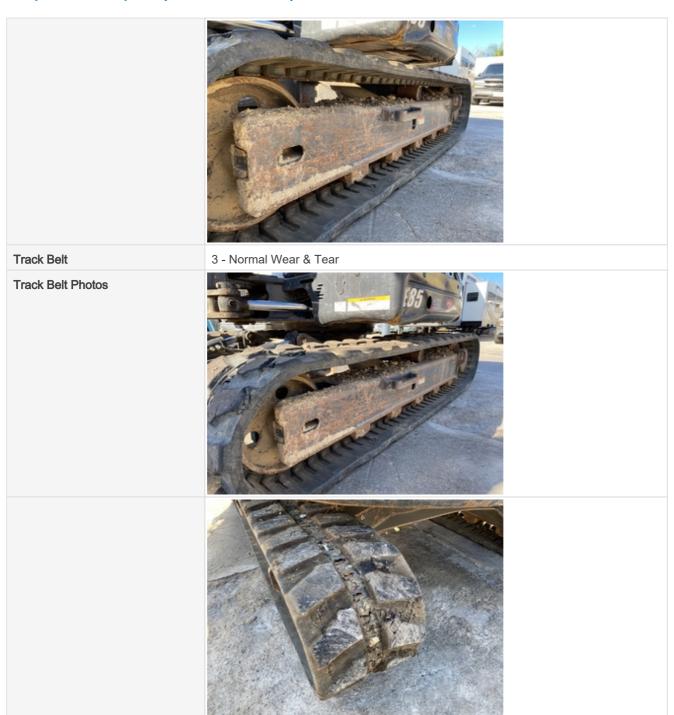
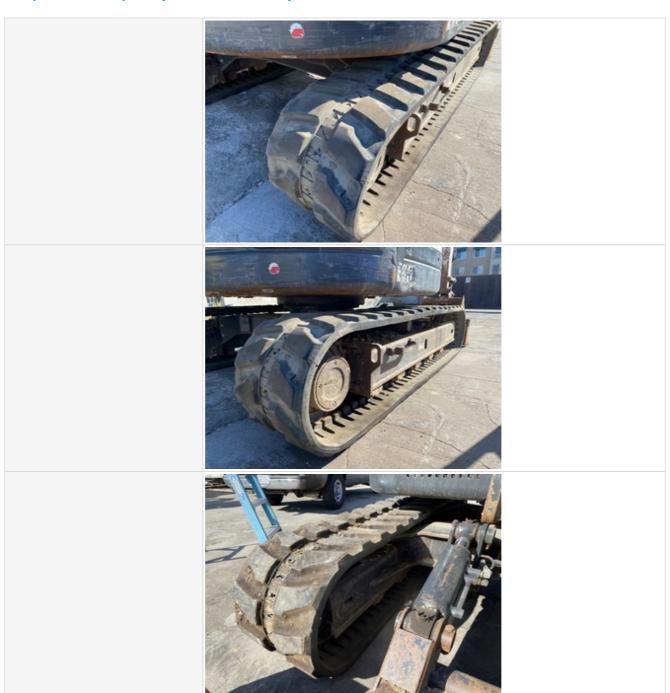
Roller Frames Photos

3 - Normal Wear & Tear

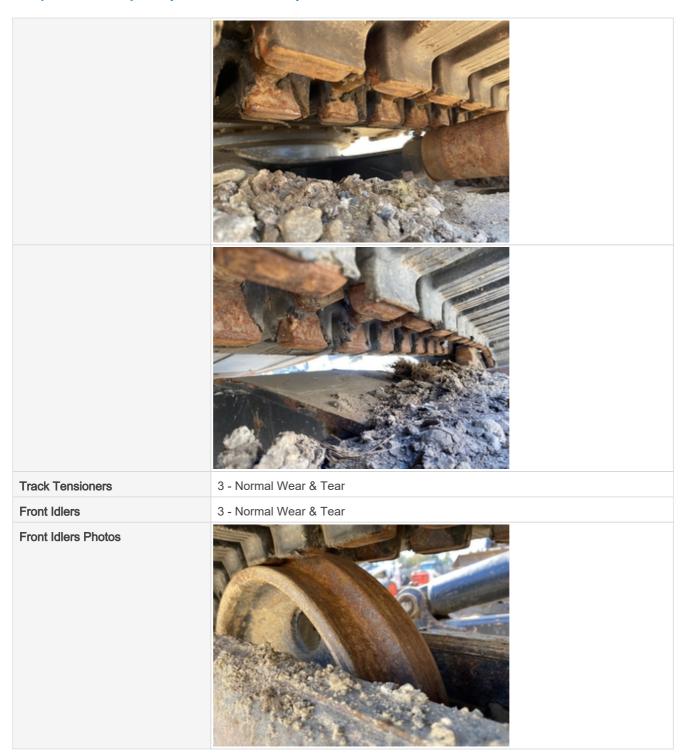
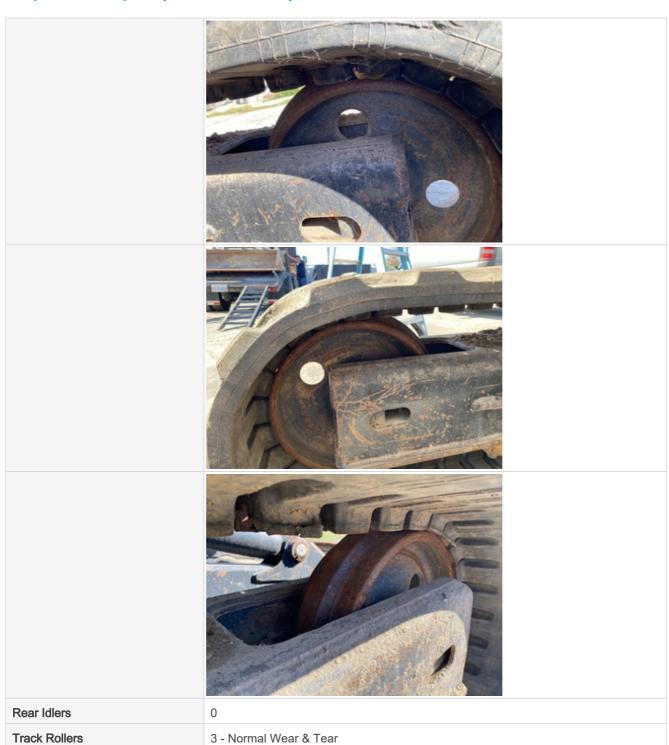
Rubber Belt Drive Lugs Photos

3 - Normal Wear & Tear

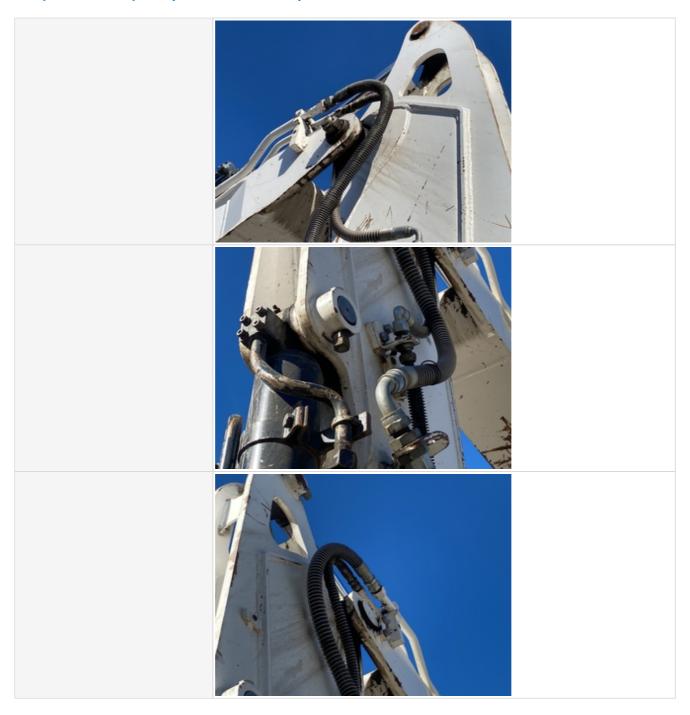
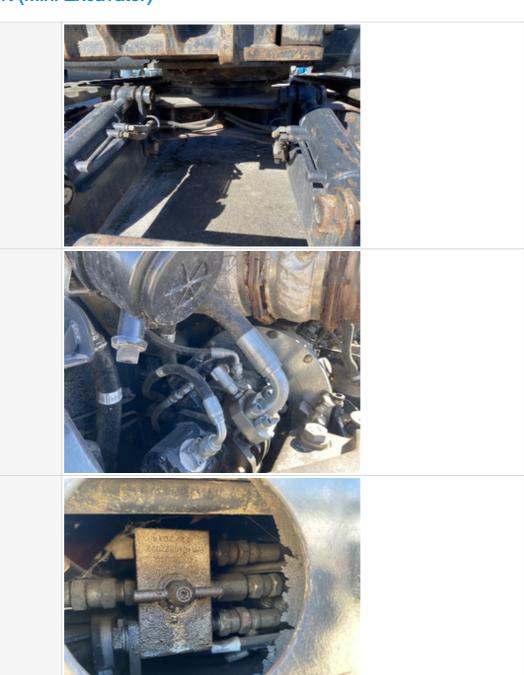
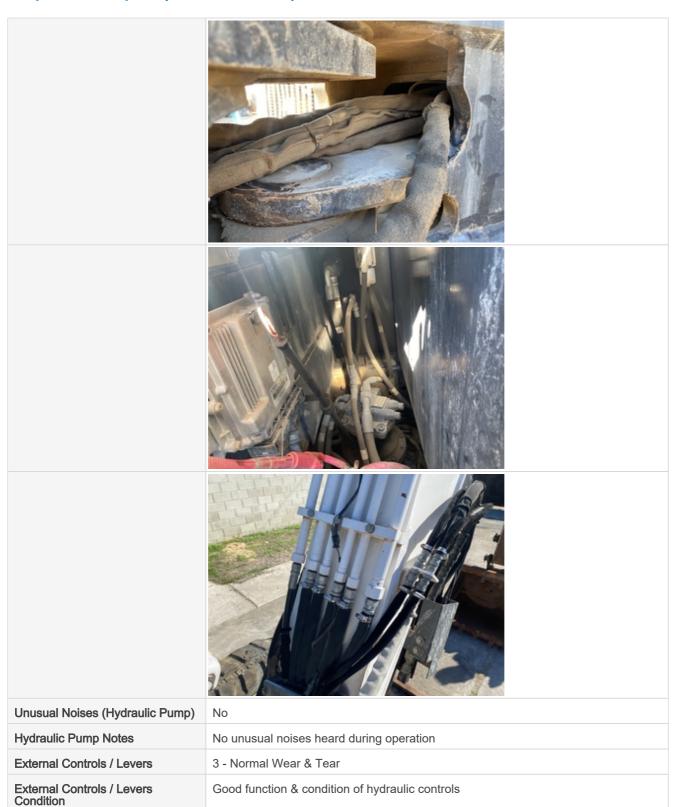
Appearance of Hydraulic Lines / Fittings Photos

Hydraulics Overall	
Wet or Damp Hydraulic Lines / Fittings	No
Appearance of Hydraulic Lines / Fittings	3 - Normal Wear & Tear
Hydraulic Lines / Fittings Condition	Hydraulic lines & fittings are clean and in good condition

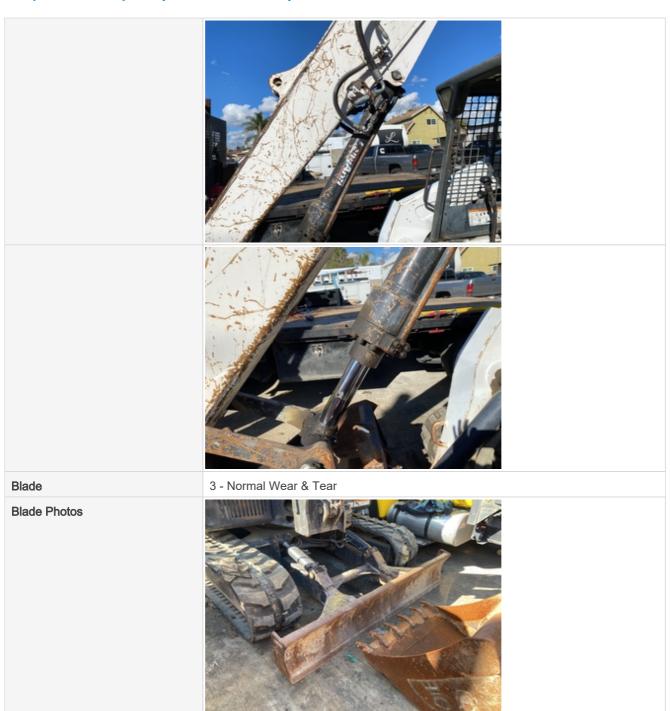
Stick Cylinder Photos	
Bucket Cylinder: Mounting Pin	3 - Normal Wear & Tear
Bucket Cylinder: Oil Leaks	Yes
Comments	Residual oil observed from rod seal indicating possible oil leak
Bucket Cylinder Photos	S25b
