#### **Inspection Report (Vibratory Compactor)**

Year	2012
Make	Bomag
Model	BMP 8500
Serial Number	101 720 11 2686
Hour Meter Reading	562 Hours
Previous Application (e.g., earth moving, mining, demolition, etc)	General Construction

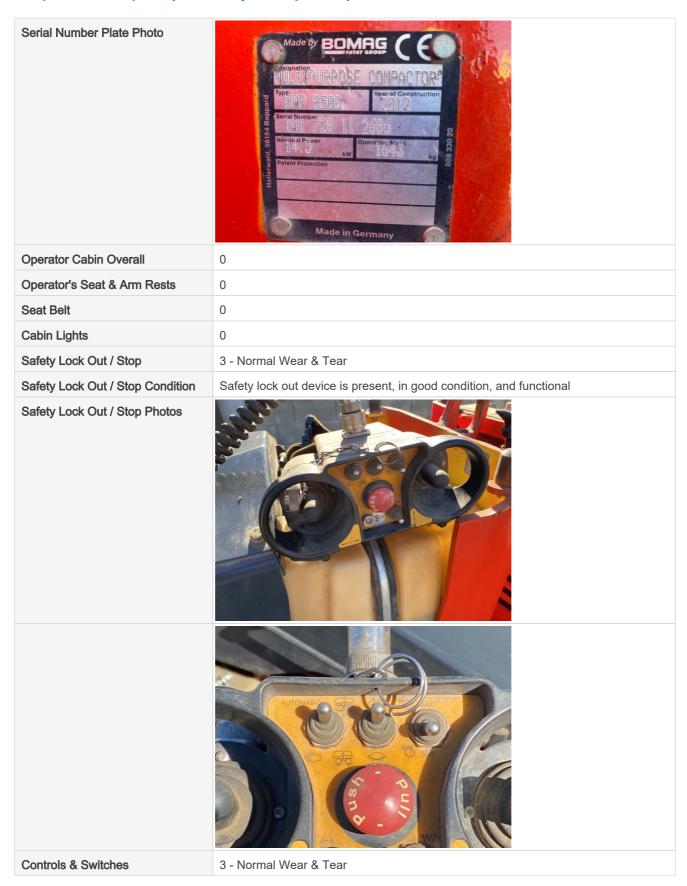
Controls & Switches Condition	All switches are installed and functional
Controls & Switches Photos	
Hour Meter Activity	3 - Normal Wear & Tear
Hour Meter Condition	Hour meter is functional and in good condition
Hour Meter Activity Photos	BOMBS BOMBS
Other Gauge Activity	3 - Normal Wear & Tear
Other Gauge Condition	All cockpit gauges are functional and in good condition
Other Gauge Activity Photos	E. C.
Heater & A/C	0
Fans / Vents	0

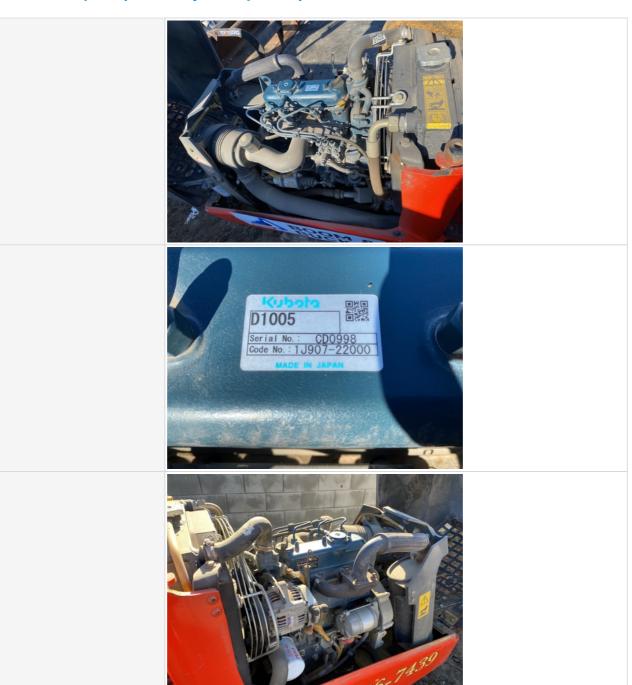
<b>Engine Inspection Points</b>	
Engine	
Engine Type (Make, Model, Cylinders, Hp)	Kubota - D1005-ET06 - 3Cyl 19HP
Emissions Tier	Tier 4F
Engine Serial Number	CD0998
Engine Fuel Type	Diesel
Engine Photos	
	BOOM &

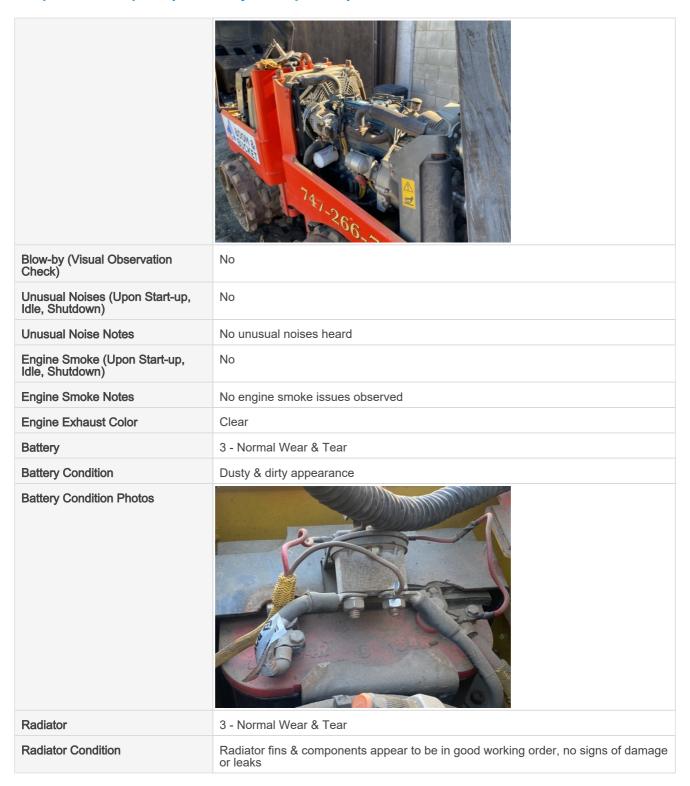
Radiator Photos	
Belts	3 - Normal Wear & Tear
Belt Condition	Belts appear in good condition & alignment with proper tension
Belt Photos	
Hoses	3 - Normal Wear & Tear
Hose Condition	Firm, pliant hoses with no signs of wear or leaks
Water Pump	3 - Normal Wear & Tear
Water Pump Condition	No unusual pump noises heard
Cooling System Leaks	No

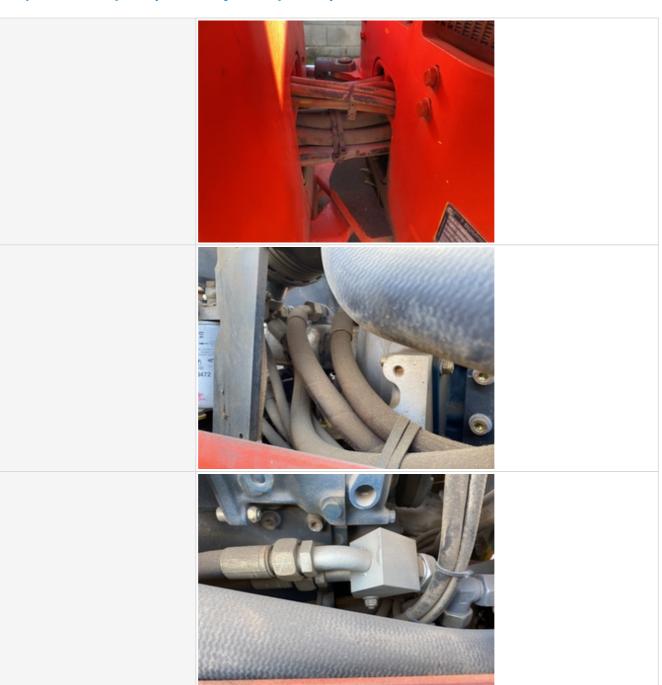
Appearance of Hydraulic Lines / Fittings Photos

Hydraulics Overall	
Wet or Damp Hydraulic Lines / Fittings	No
Appearance of Hydraulic Lines / Fittings	3
Hydraulic Lines / Fittings Condition	Hydraulic lines & fittings are clean and in good condition
