Inspection Report (On-Highway Dump Truck)

Year	2007
Make	Western Star
Model	4900
Serial Number	5KKHAECV87PY54268
Truck Odometer Reading	299,830
Current Inspection / State Cert / DOT	N/A
Previous Application (e.g., earth moving, mining, demolition, etc)	Pipeline Construction

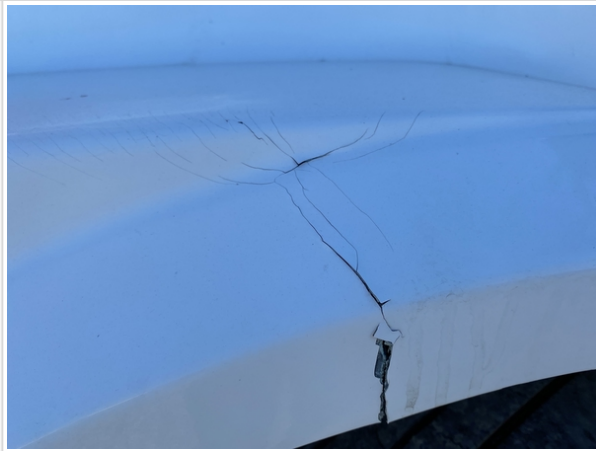
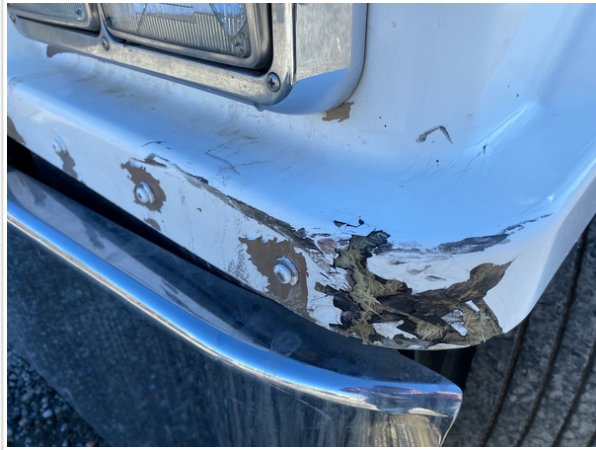
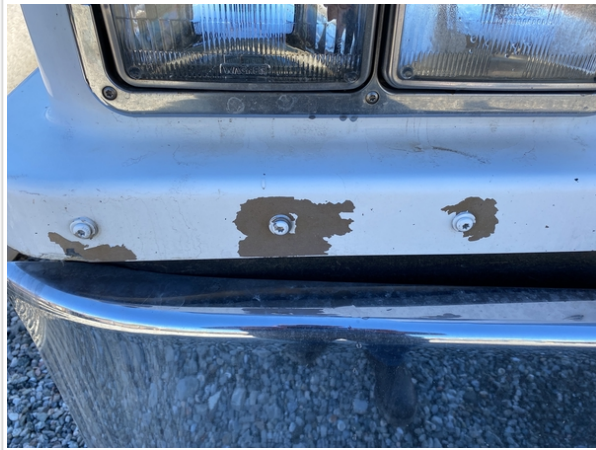
Front	3 - Normal Wear & Tear
Front Condition	Other (see comments)
Comments	Small fiberglass damage to bottom part of hood

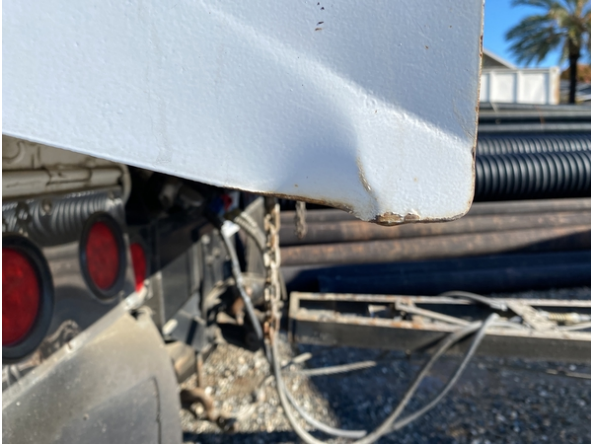
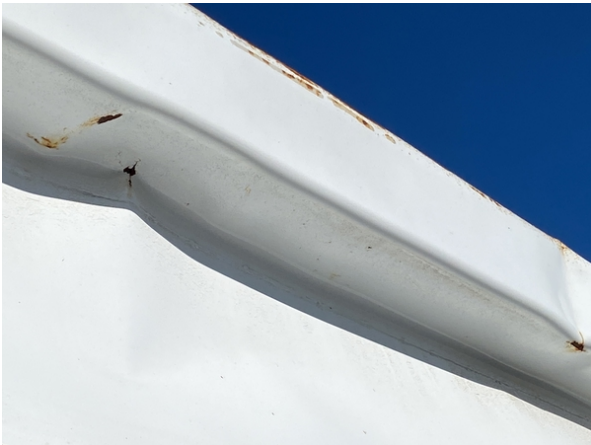
Rear	3 - Normal Wear & Tear
Rear Condition	Visible chipped paint or dents, Other (see comments)
Comments	Small dents on rear left side of tailgate

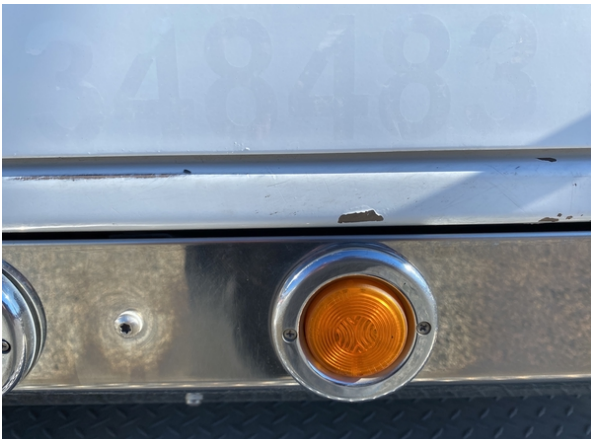
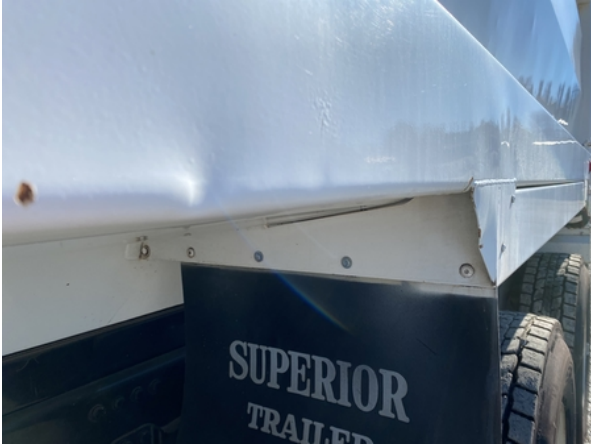
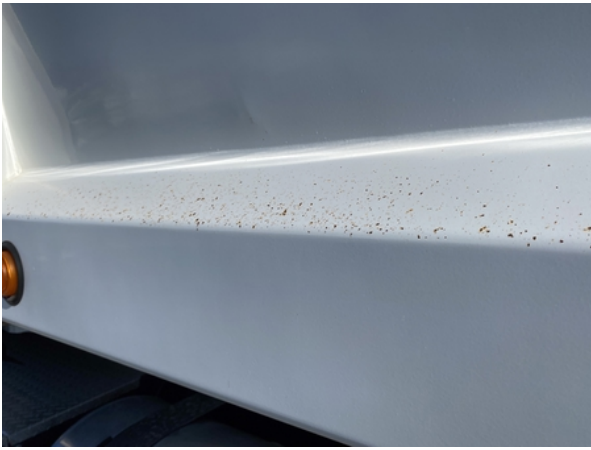
Left	3 - Normal Wear & Tear
Left Condition	Other (see comments)
Comments	Minor dents and minor rust buildup
Left Photos

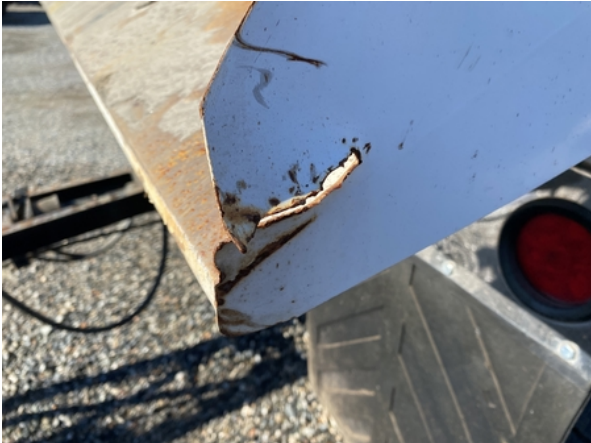
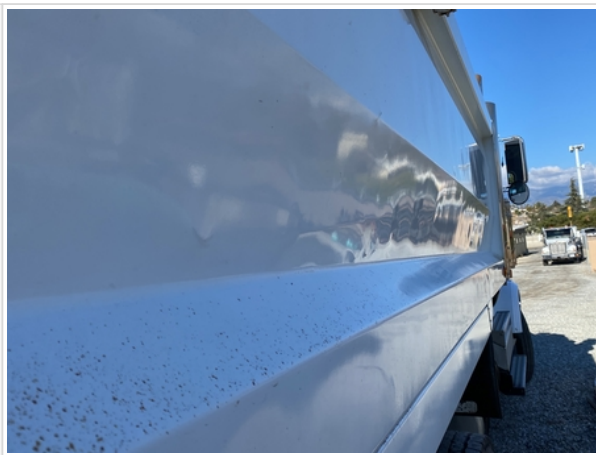
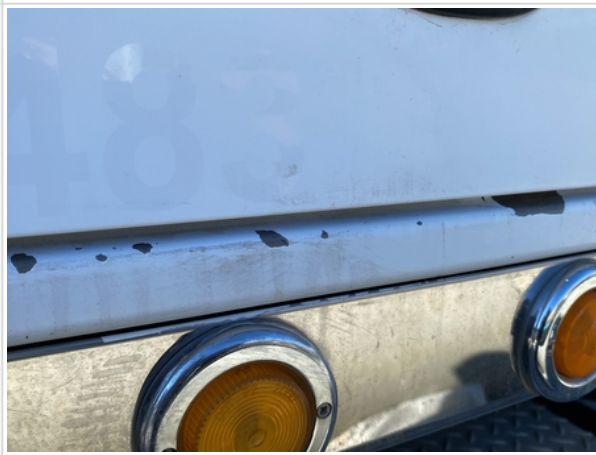
Right	3 - Normal Wear & Tear	
Right Condition	Other (see comments)	
Comments	Minor damage & normal wear and tear	
Right Photos

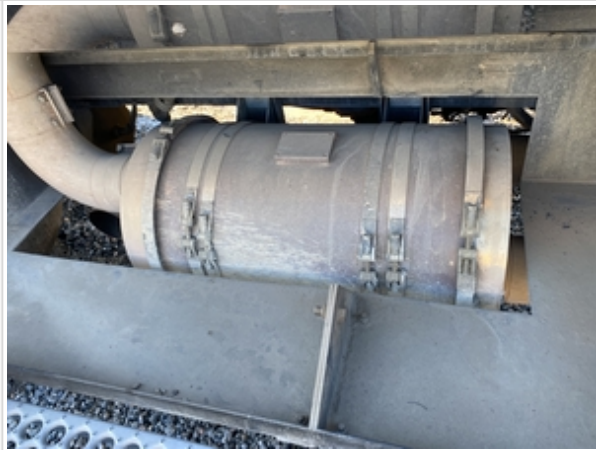
Belts	3 - Normal Wear & Tear
Belt Condition	Belts appear in good condition & alignment with proper tension
Hoses	3 - Normal Wear & Tear
Hose Condition	Firm, pliant hoses with no signs of wear or leaks
Water Pump	3 - Normal Wear & Tear
Water Pump Condition	No unusual pump noises heard
Cooling System Leaks	No
Coolant Color / Appearance	3 - Normal Wear & Tear
Coolant Color/Appearance Notes	Normal Translucent appearance, no visual signs of contamination
Oil Leaks	No
Oil Color / Appearance	3 - Normal Wear & Tear
Oil Color / Appearance Notes	Clean oil appearance, no signs of cross contamination, Appropriate oil level
Fuel Leaks	No
Equipped with DPF (Diesel Particulate Filter)	Yes
DPF Condition	3 - Normal Wear & Tear
DPF Condition Notes	Filter housing is intact with no signs of damage or malfunction, DPF indicator is not illuminated

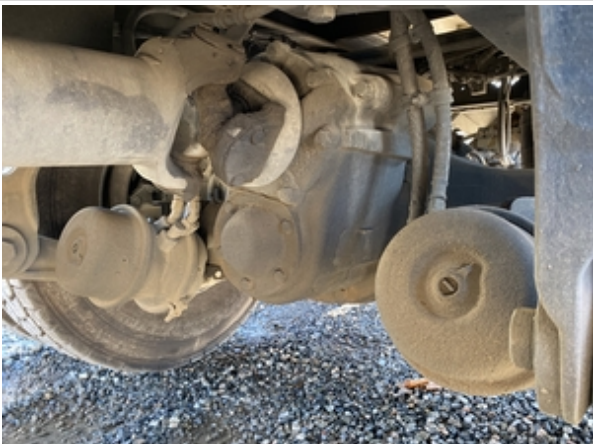
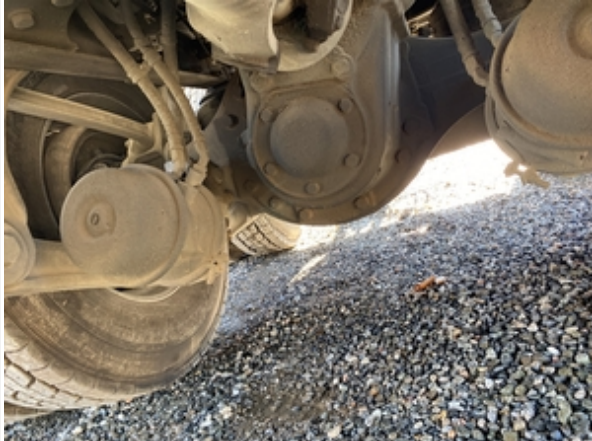
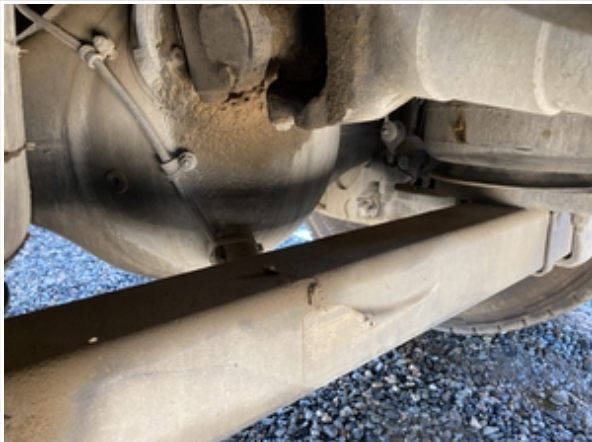
Front Differential	3 - Normal Wear & Tear	
Front Differential Condition	Dry housing appearance, no unusual noises heard during operation, Other (see comments)	
Comments	Minor signs of seepage seen from driveshaft yoke seal front & back	
Front Differential Photos

Overall Drivetrain Comments	Overall drivetrain in good shape. Transmission and axles look good. Minor oil seepage buildup at driveshaft yoke seal on both sides of front diff. No active leaks seen.
-----------------------------	--

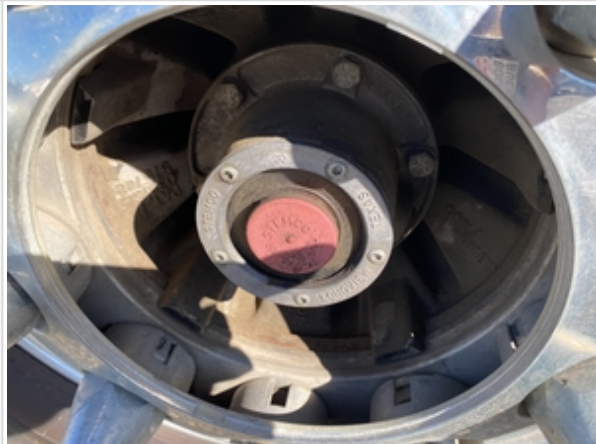
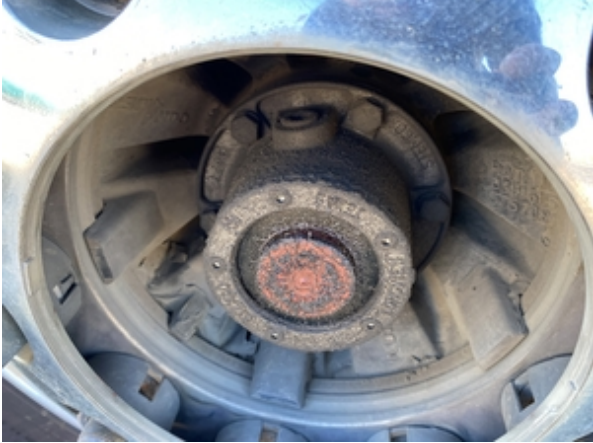
Wheels & Hub Condition	3
Comments	Minor leak at front right side hub cap (should be replaced)
Wheels & Hub Photos
