## Inspection Report (On-Highway Truck Cab + Chassis)

| Make | Kenworth |
| Model | T800 |
| Serial Number | 1XKDDP9X9EJ387099 |

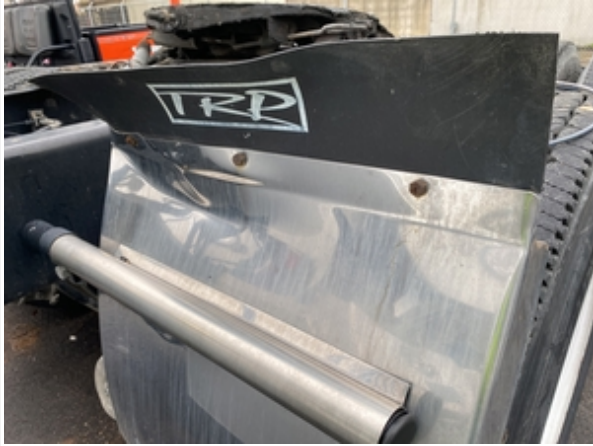
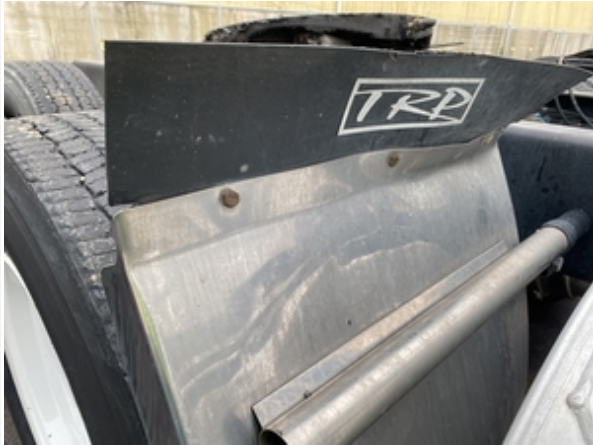
| Body Panels Photos | | |

| Body Panels | 3 - Normal Wear & Tear |
| Body Panel Condition | No visible damage, good paint condition and panel fitment, Other (see comments) |
| Comments | Center of front bumper dented in, rear tire mudguards bent |

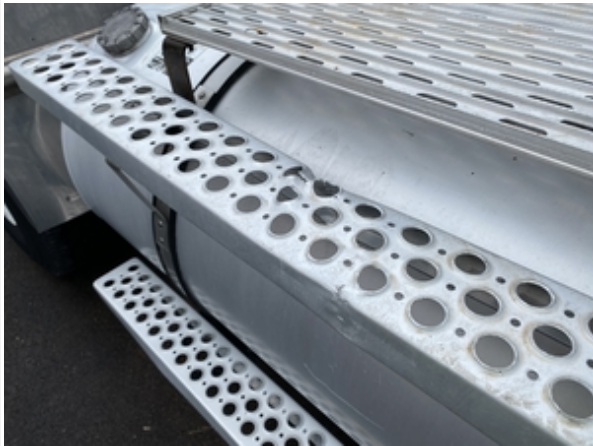
| Steps / Ladders Photos | | |

| Steps / Ladders | 3 - Normal Wear & Tear | |
| Steps / Ladders Condition | Bent or broken steps or rungs | |

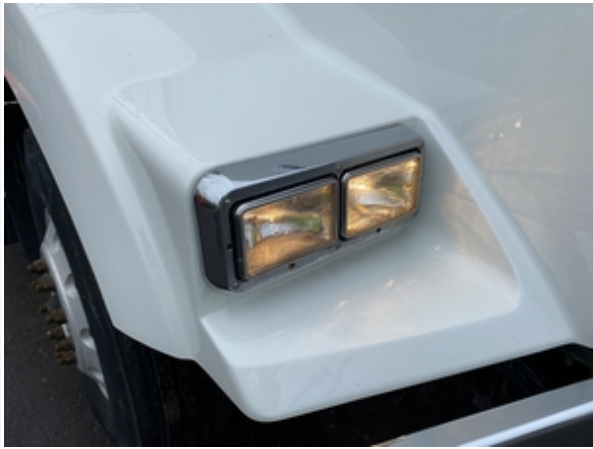
| Exterior Lights Photos | |

| Exterior Lights | 3 - Normal Wear & Tear |
| Exterior Lights Condition | No visible damage, lighting system is operational, Other (see comments) |
| Comments | A few small, roof mounted running lights, inoperable, rear right signal light inoperable |

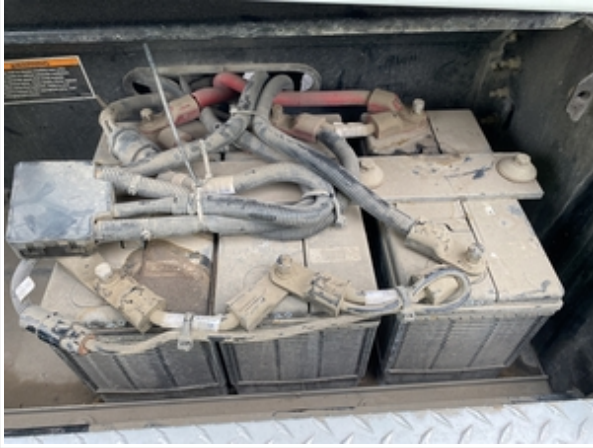
| Battery Condition Photos | |

| Battery | 1 - Service Required | |
| Battery Condition | Needs charge or replacement, Other (see comments) | |
| Comments | Should be replaced soon | |

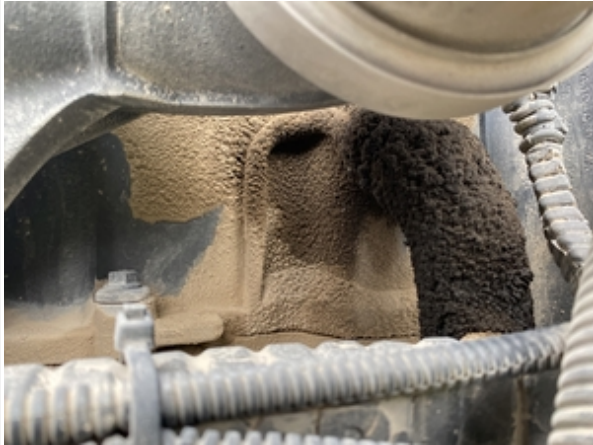
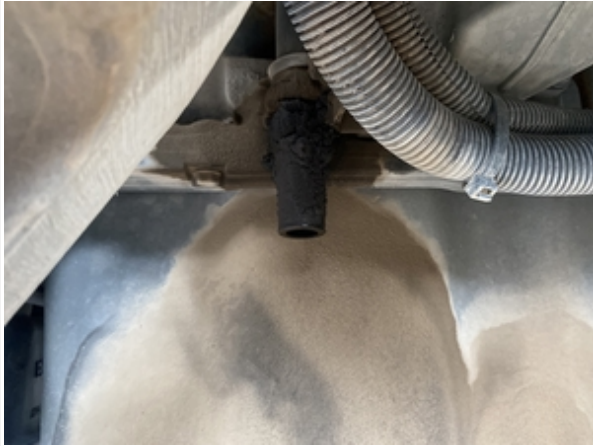
| Oil Leak Photos | |

| Oil Leaks | Yes |
| Oil Leak Notes | Other (see comments), Dried oil seepages seen |
| Comments | Possible oil seepage at valve cover and oil pan (around breather tube) |

| Overall Engine Comments | Overall engine well maintained, minor seepage at valve cover breather. |

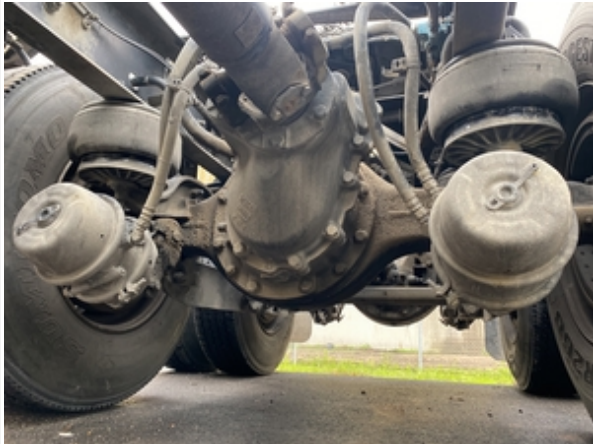
| Front Differential Photos | |

| Front Differential | 3 - Normal Wear & Tear |
| Front Differential Condition | Dried seepages seen on differential housing cover, Other (see comments) |

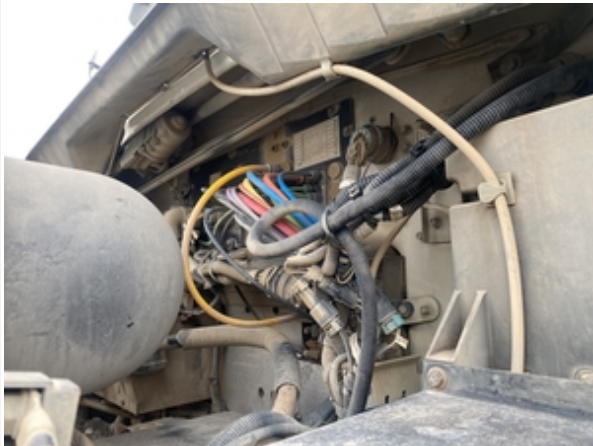
| Air Brake System Photos | | |

| Air Brake System Leaks | Yes | |
| Comments | Minor air leak engine compartment firewall area | |

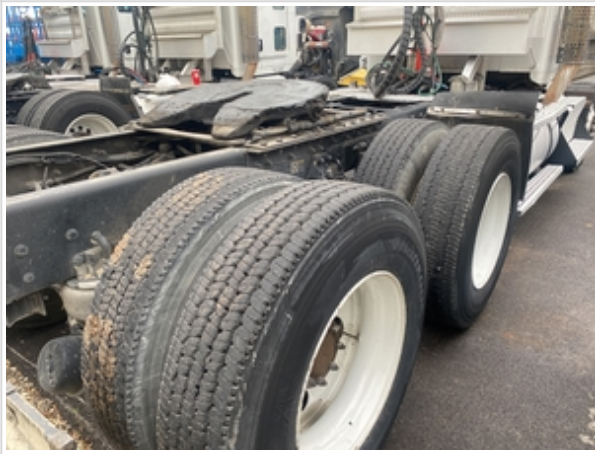
| Rear Right Tire Photos | |

| Rear Right Tire - Ratio Remaining | 30% |
