## Inspection Report (On-Highway Flatbed Truck)

Year	2015
Make	Ford
Model	F750XLT
Serial Number	3FRXF7FE0FV662351
Truck Odometer Reading	193,992
Current Inspection / State Cert / DOT	Last performed 6/2020
Previous Application (e.g., earth moving, mining, demolition, etc)	Compact Rentals Equipment Tow/Hauler

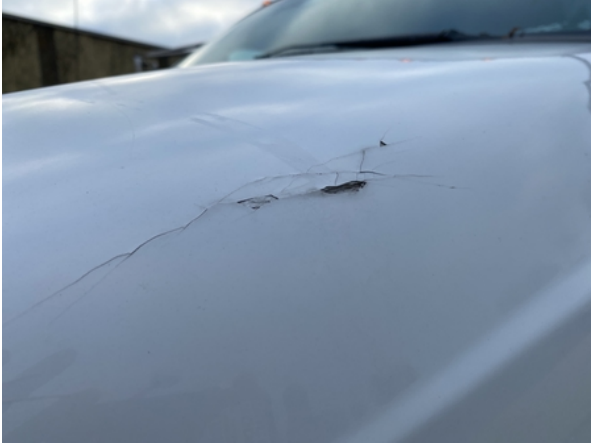
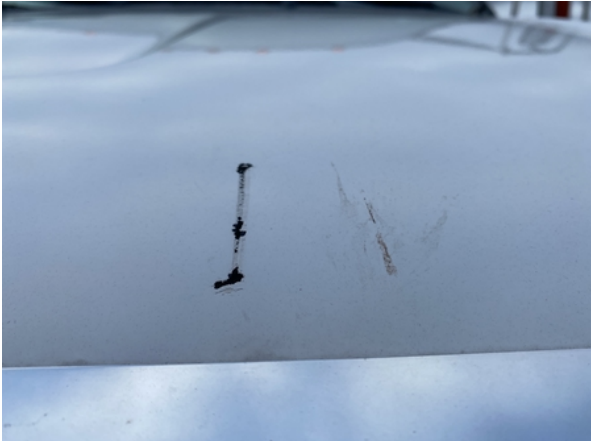
<b>Body Panels</b>	3 - Normal Wear & Tear	
<b>Body Panel Condition</b>	No visible damage, good paint condition and panel fitment, Other (see comments)	
<b>Comments</b>	Minor fiberglass damage to front left side of hood, small dent center of front bumper	
<b>Body Panels Photos</b>

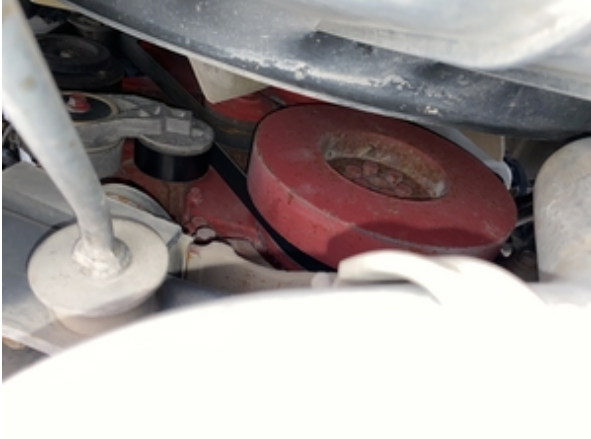
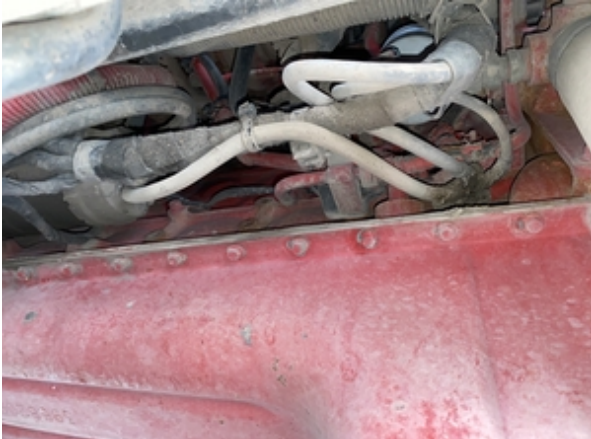
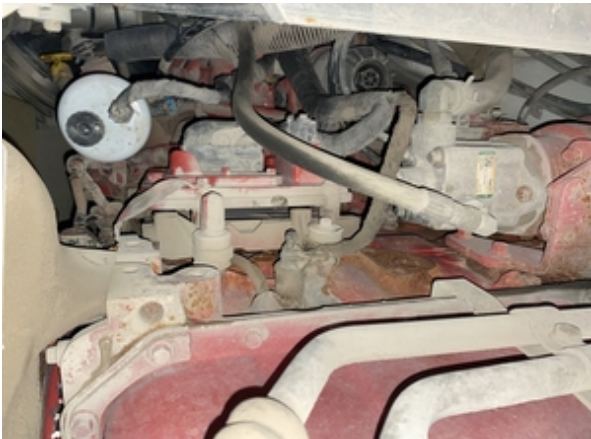
<b>Blow-by (Visual Observation Check)</b>	Yes
<b>Comments</b>	Minor (normal) blowby seen at tube
<b>Unusual Noises (Upon Start-up, Idle, Shutdown)</b>	No
<b>Unusual Noise Notes</b>	No unusual noises heard
<b>Engine Smoke (Upon Start-up, Idle, Shutdown)</b>	No
<b>Engine Smoke Notes</b>	No engine smoke issues observed

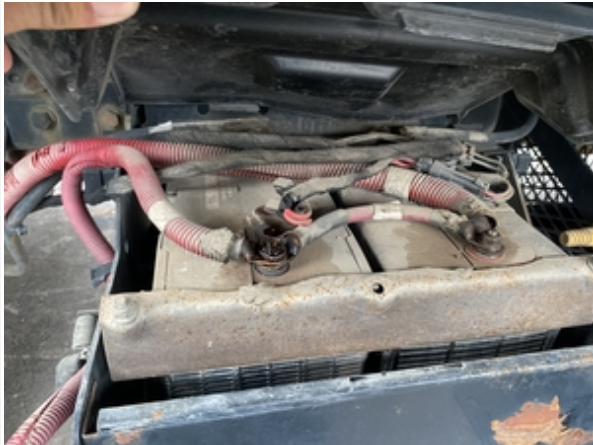
Engine Exhaust Color	Clear
Battery	3 - Normal Wear & Tear
Battery Condition	Clean & dry appearance, tight connections, Dusty & dirty appearance
Battery Condition Photos

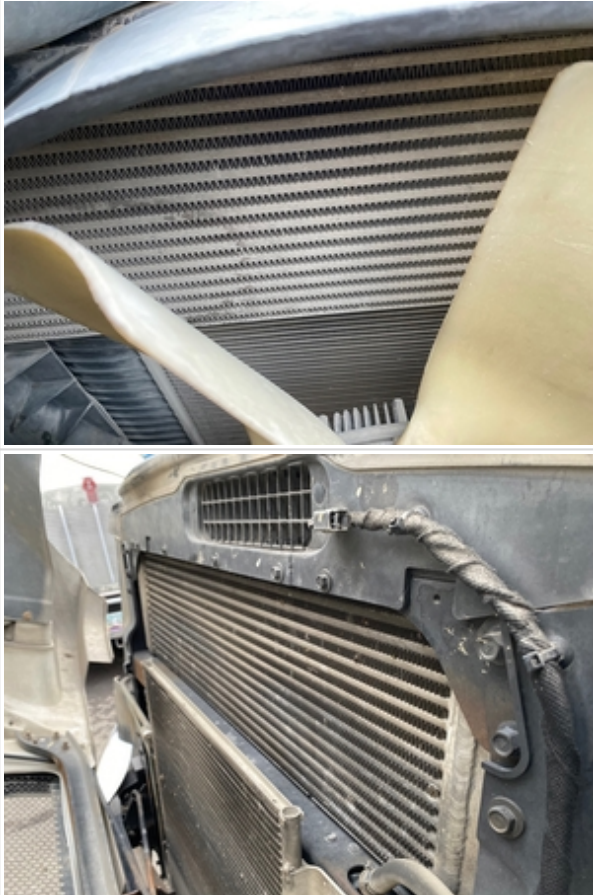
Radiator	3 - Normal Wear & Tear
Radiator Condition	Radiator fins & components appear to be in good working order, no signs of damage or leaks
Radiator Photos

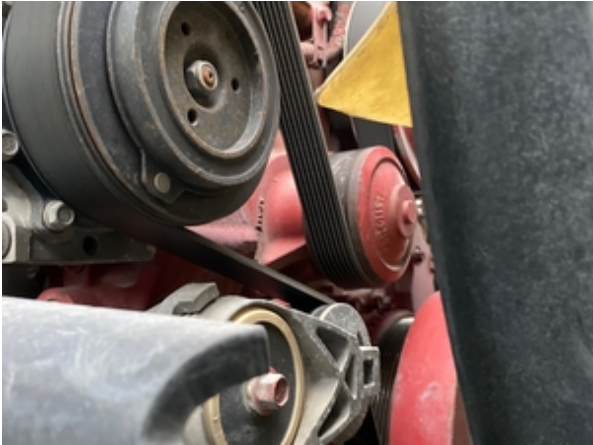
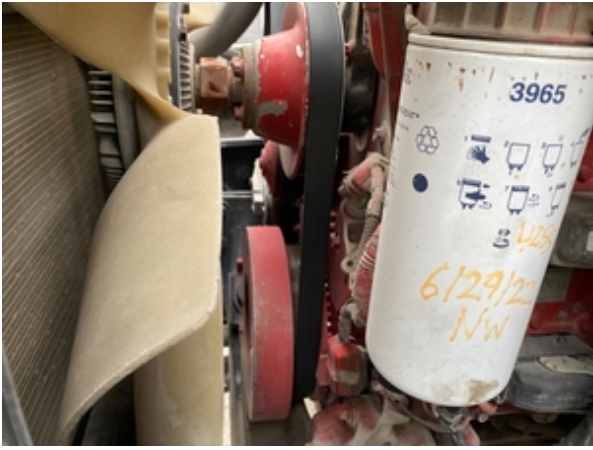
<b>Belts</b>	3 - Normal Wear & Tear	
<b>Belt Condition</b>	Belts appear in good condition & alignment with proper tension	
<b>Belt Photos</b>

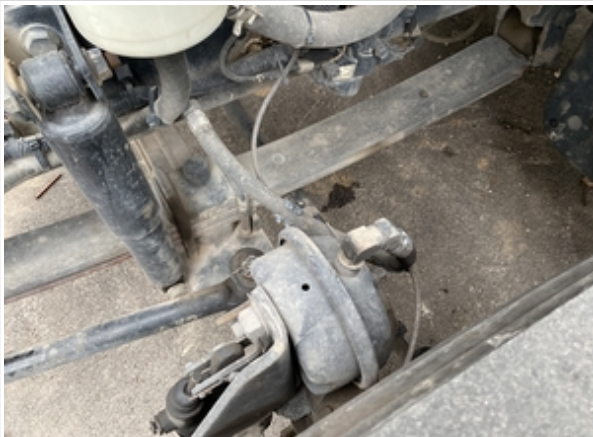
<b>Front Differential</b>	0
<b>Brake System Type</b>	Air Brakes
<b>Air Brakes Build Correct Pressure</b>	Yes
<b>Air Brake System Leaks</b>	Yes
<b>Comments</b>	Very minor leaks noticed after truck has been off and parked a while
<b>Air Brake Hose Condition</b>	3 - Normal Wear & Tear
<b>Air Brake System Photos</b>

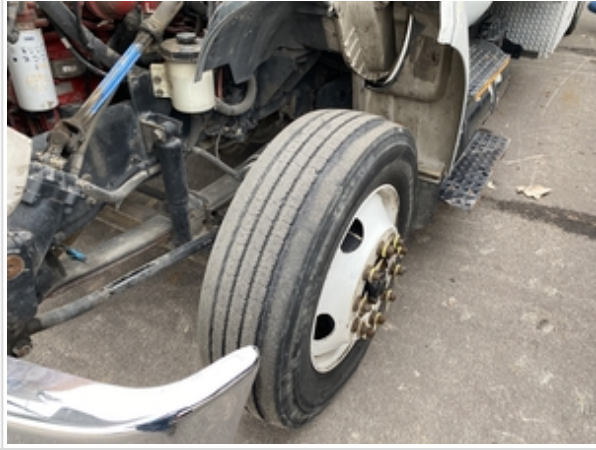
Wheel Seal Leaks	No	
Tire Brand	Front-Sumitomo. Rear - Hankook	
Tire Size	275/70R/22.5	
Front Left Tire - Ratio Remaining	10%	
Front Left Tire Photos

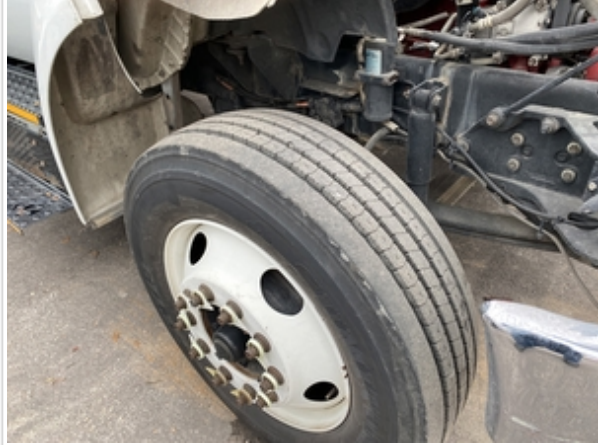
Front Right Tire Photos

Front Right Tire - Ratio Remaining	70%

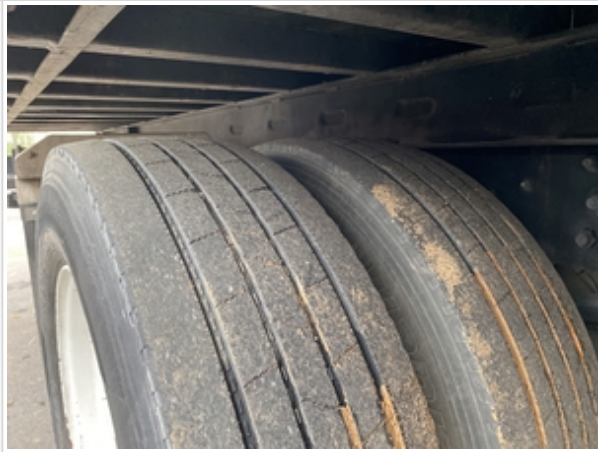
Rear Right Tire - Ratio Remaining	10%	
Rear Right Tire Photos

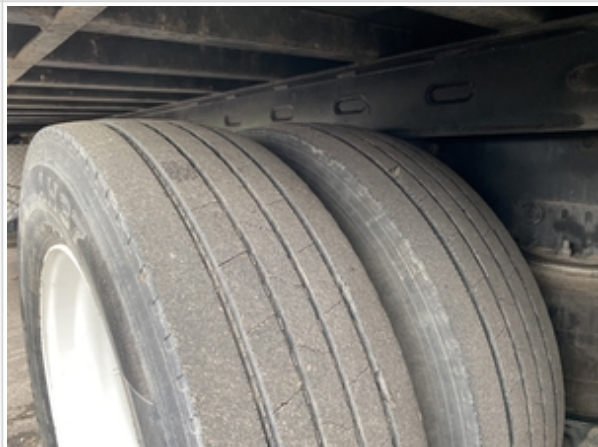
Rear Left Tire - Ratio Remaining	10%	
Rear Left Tire Photos
