Inspection Report (On-Highway Flatbed Truck)

Year	Sunstate Heavy Haul Trailer
Make	2016 Trailking
Model	TK80HT
Serial Number	ID - 144681 - VIN# - 1TKA04824GM067858
Truck Odometer Reading	N/A
Current Inspection / State Cert / DOT	N/A
Previous Application (e.g., earth moving, mining, demolition, etc)	Equipment Rental Hauler

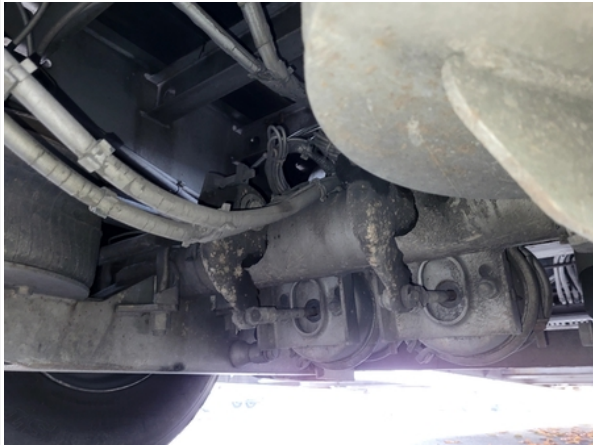
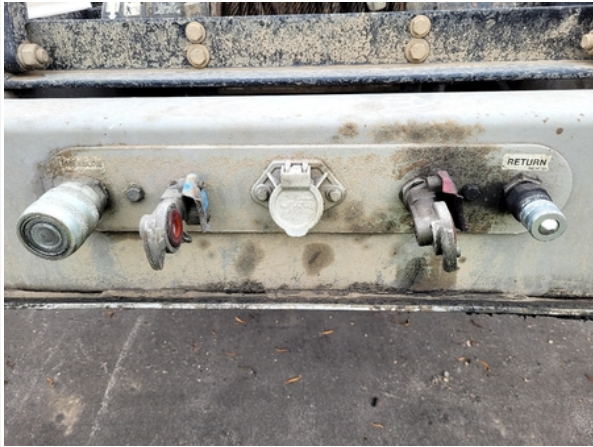
Air Brake Hose Condition	3 - Normal Wear & Tear
Air Brake System Photos

Foot Brake	0
Engine Brake Configuration	N/A
Parking Brake	3 - Normal Wear & Tear
Parking Brake Condition	Other (see comments)
Comments	Did not test with tractor. Visually, all four air brake assemblies look to be in good working condition.
Overall Drivetrain Comments	Overall drivetrain in good condition with no major problems observed.

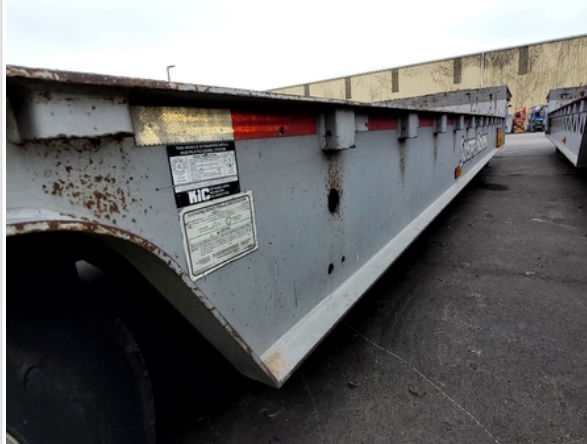
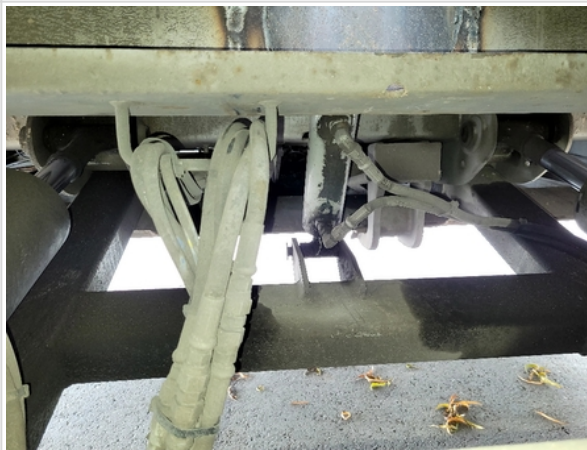
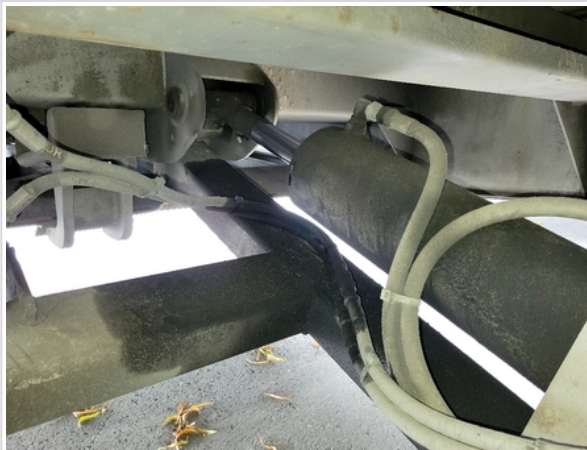
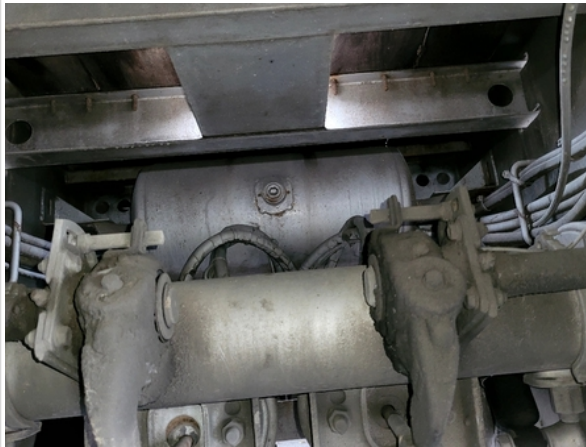
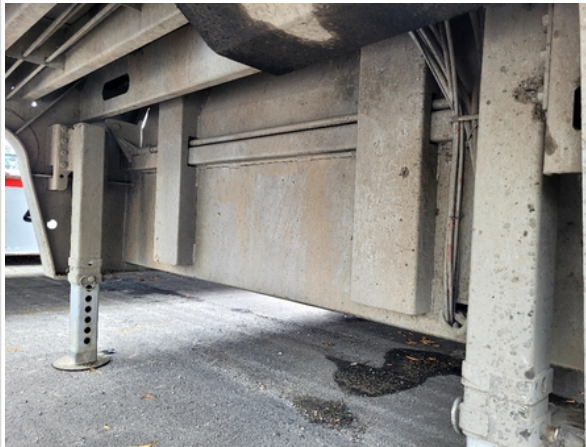
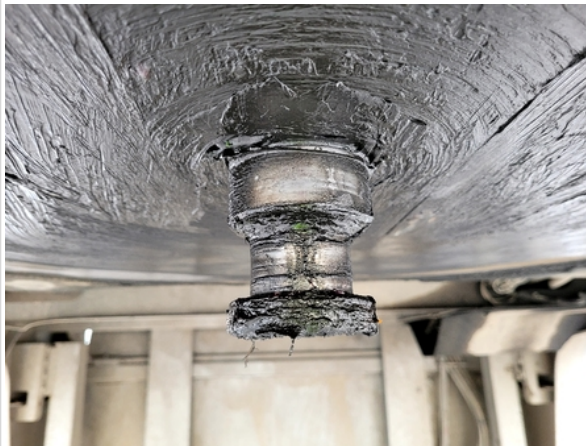
Frame Photos

Frame Condition	3
-----------------	---

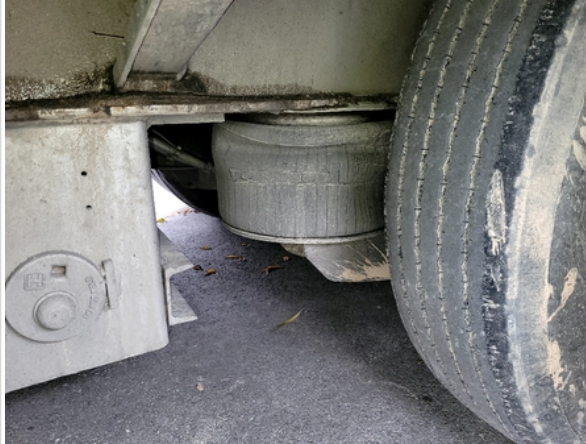
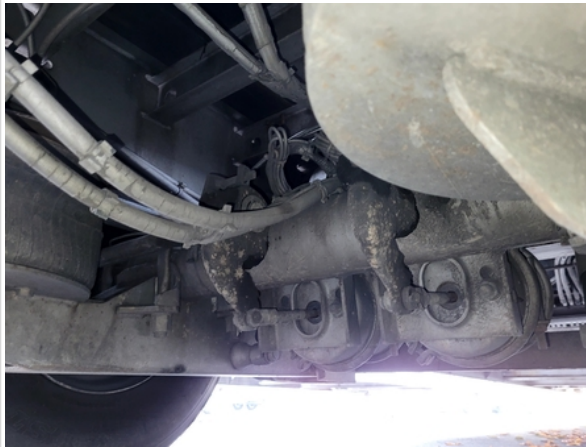
Suspension Photos

Suspension	3
------------	---

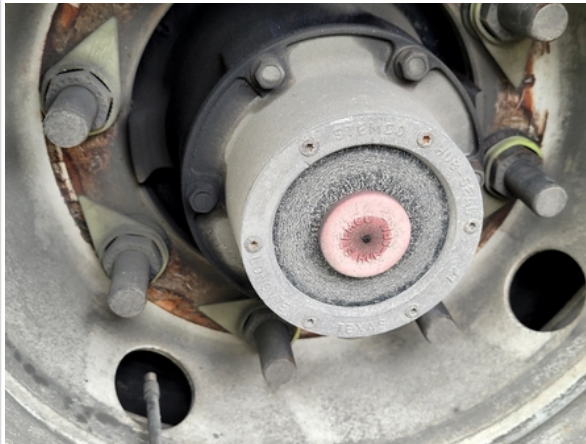
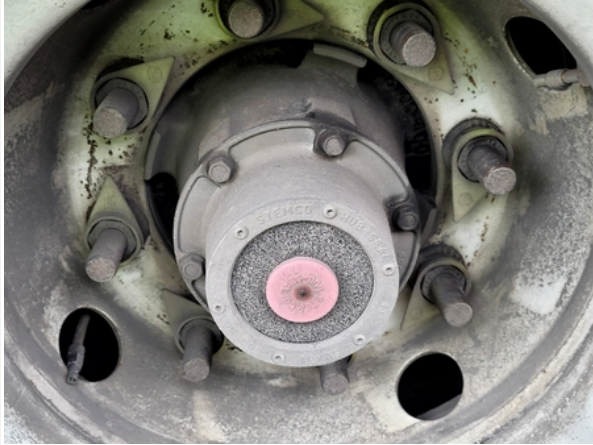
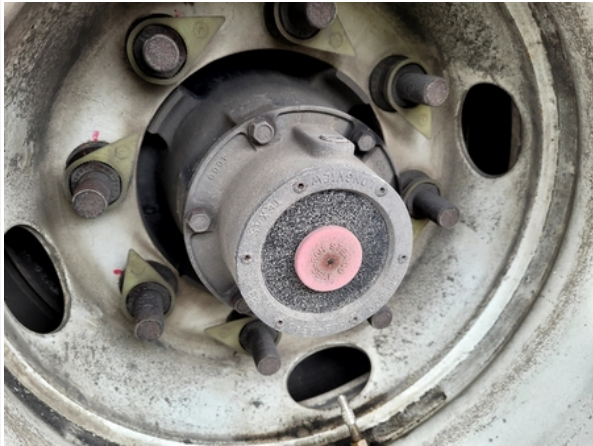
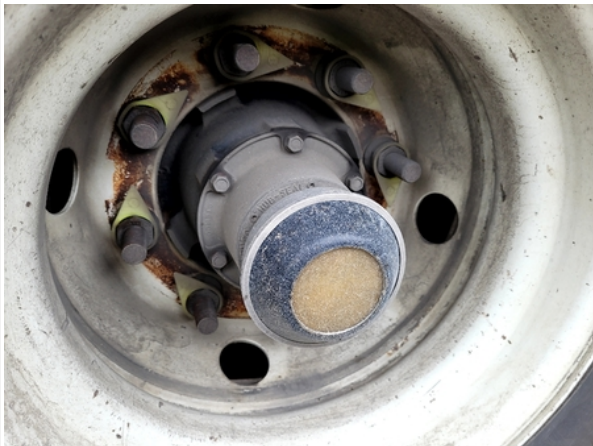
Wheels & Hub Photos

Wheels & Hub Condition	3
------------------------	---

Wheel Seal Leaks	No	
Tire Brand	Sumitomo ST 727	
Tire Size	10R/17.5H	
Front Left Tire - Ratio Remaining	10%

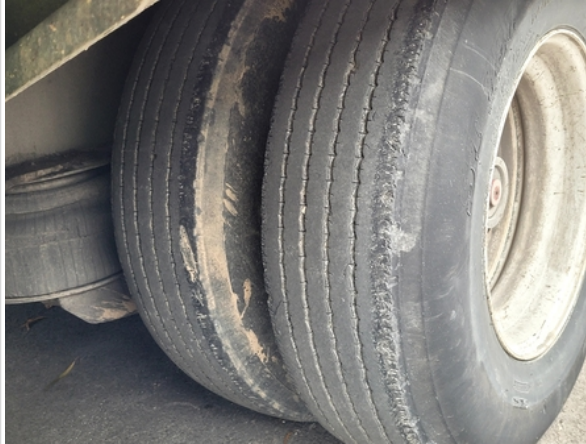
Rear Left Tire Photos

Front Left Tire Photos	 
Front Right Tire - Ratio Remaining	10%
Front Right Tire Photos	 
Rear Right Tire - Ratio Remaining	10%
Rear Right Tire Photos	 
Rear Left Tire - Ratio Remaining	10%

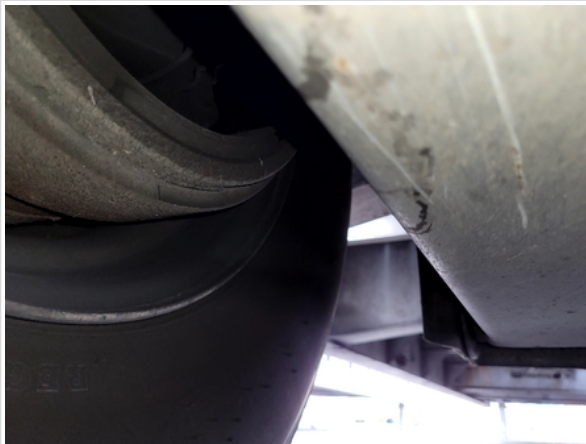
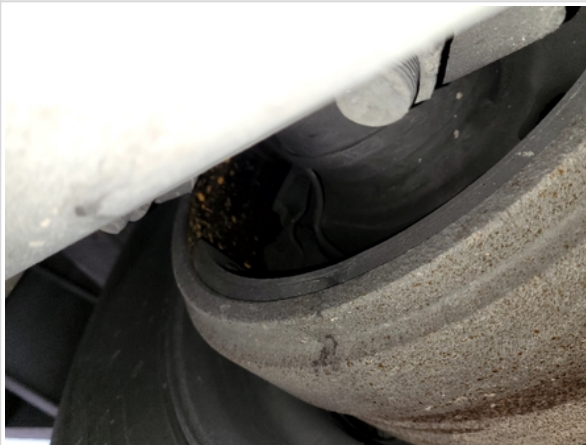
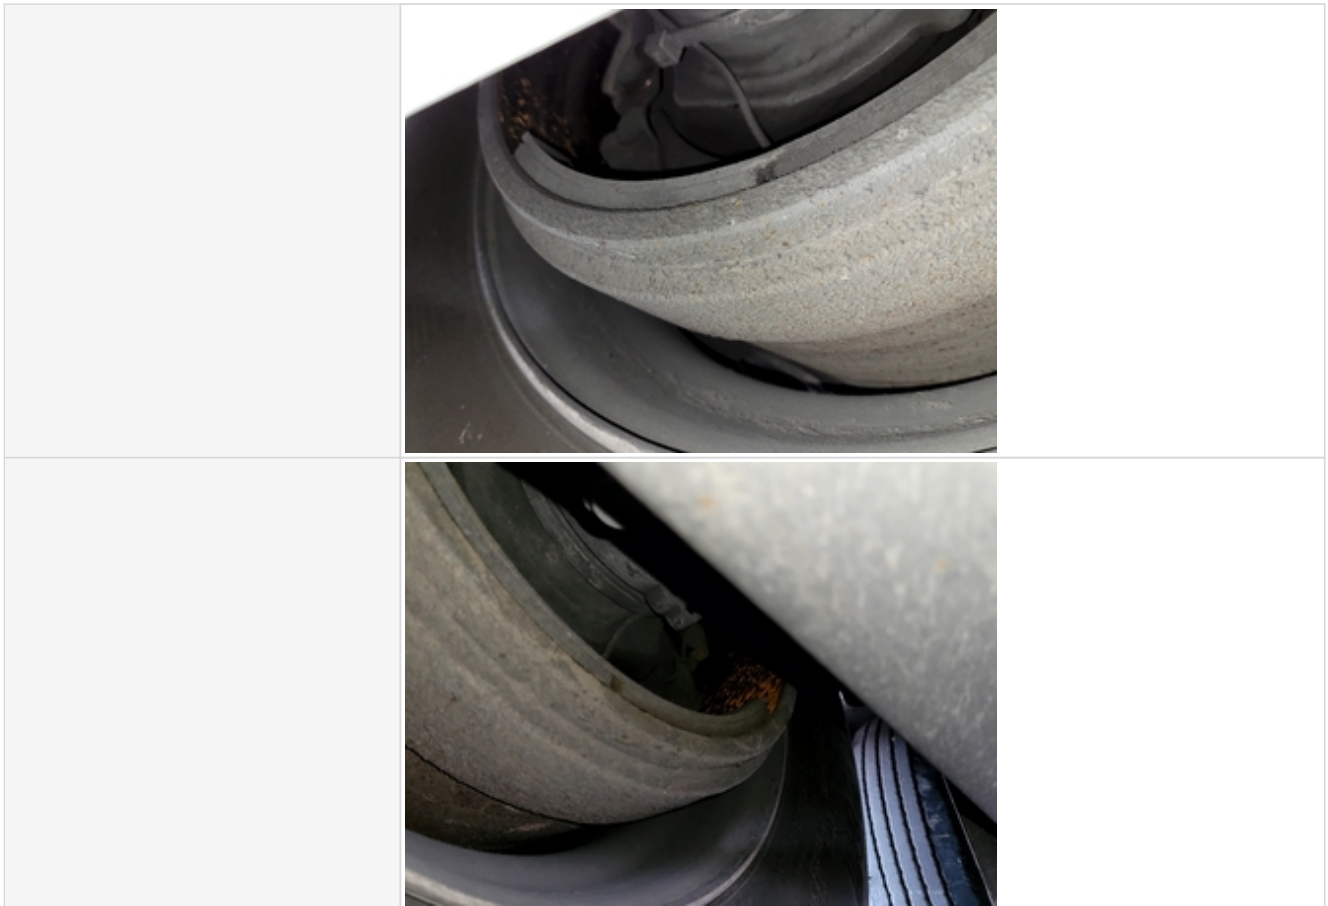
Brake Shoe Photos

50%

40 to 50 % brake shoe material left

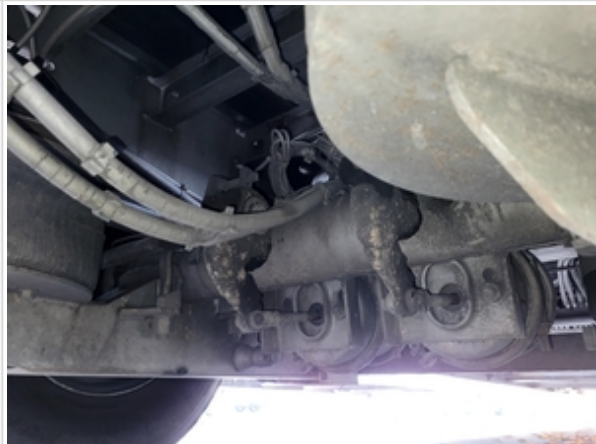
Overall Chassis	3
Overall Chassis Comments	Overall chassis in good condition. No major problems observed during inspection.
Overall Chassis & Undercarriage Photos
