Year	1980
Make	Grove
Model	RT980 -80
Serial Number	45308
Hour Meter Reading	2,612 (hours not accurate)
Previous Application (e.g., earth moving, mining, demolition, etc)	Boring Equipment Industry

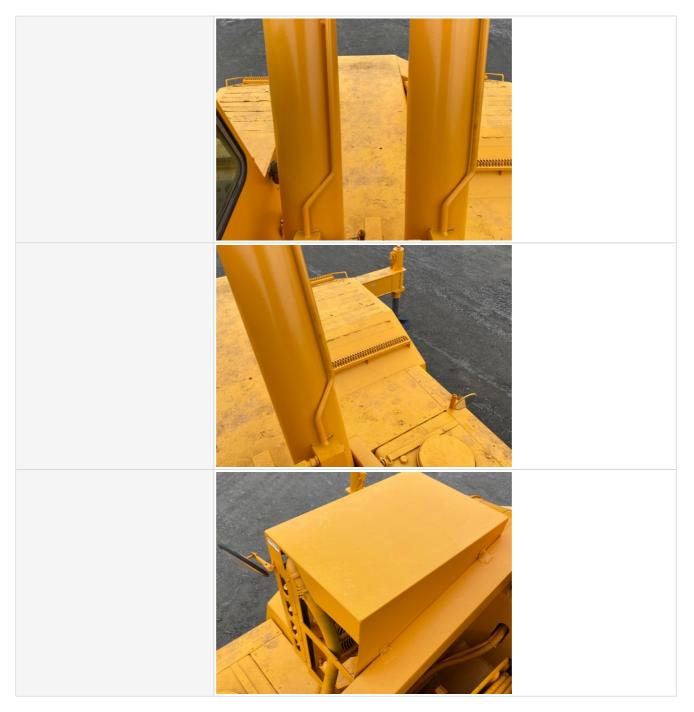
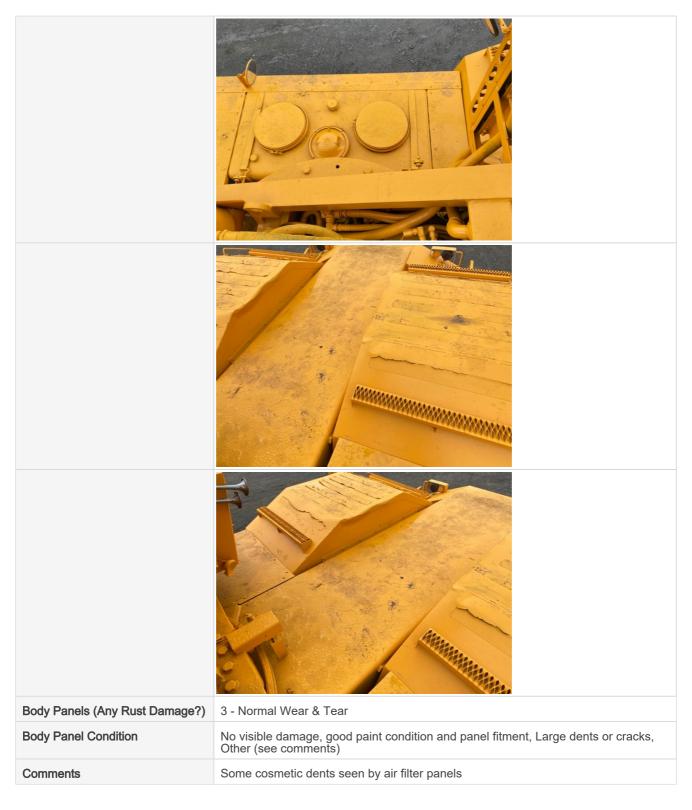
Rear	3 - Normal Wear & Tear
Rear Condition	No visible damage
Left	3 - Normal Wear & Tear
Left Condition	No visible damage
Right	3 - Normal Wear & Tear
Right Condition	No visible damage
Upper	3 - Normal Wear & Tear
Upper Condition	Large dents or cracks, No visible damage, Other (see comments)
Comments	Only damage seen near air filter panel
Upper Photos

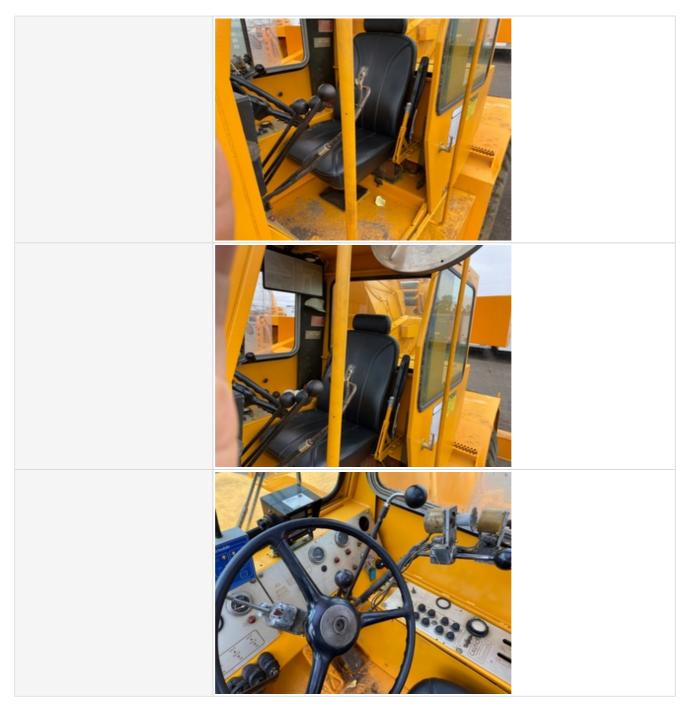
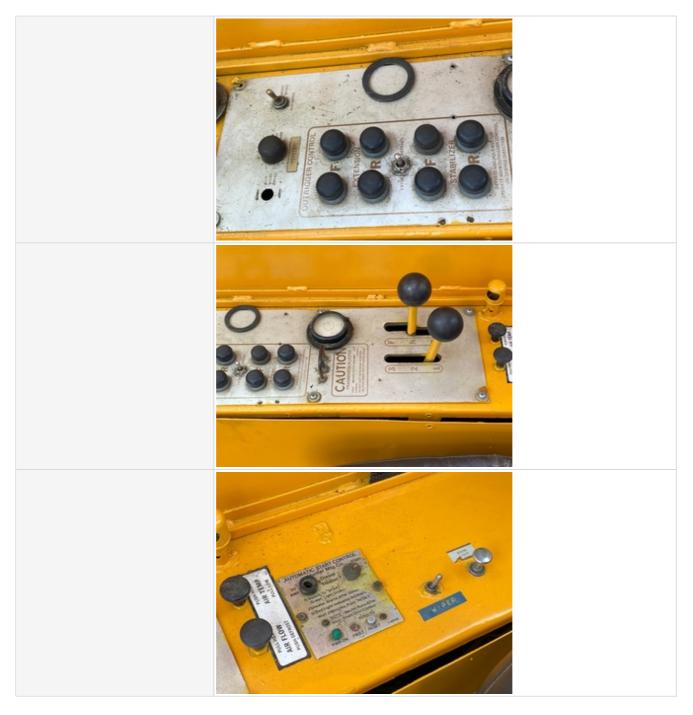
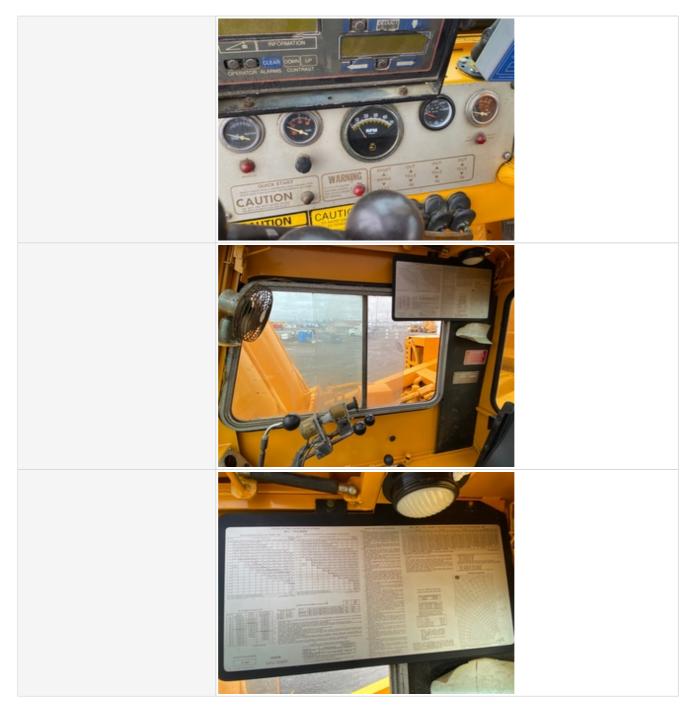
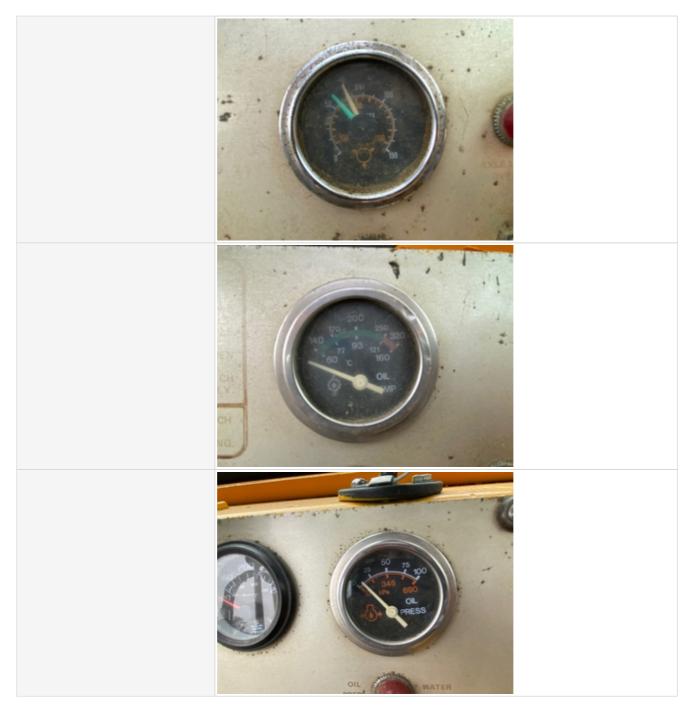
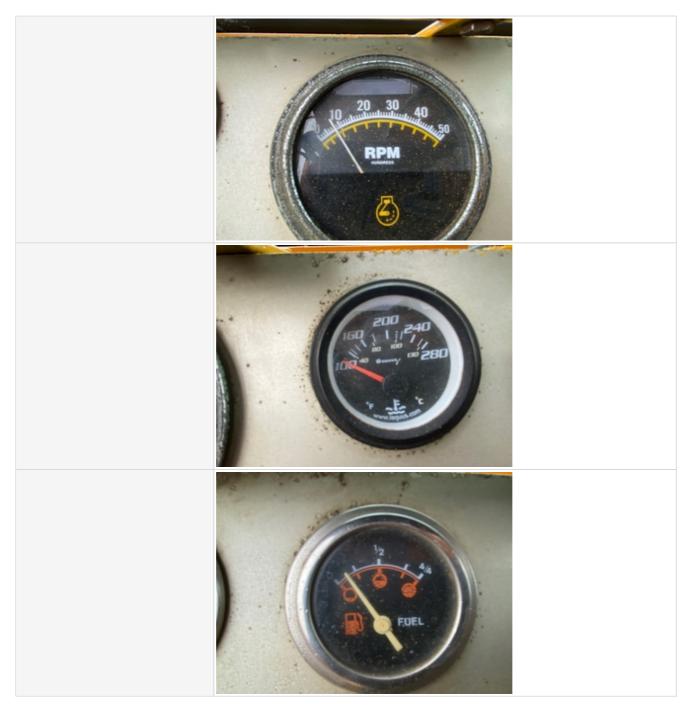
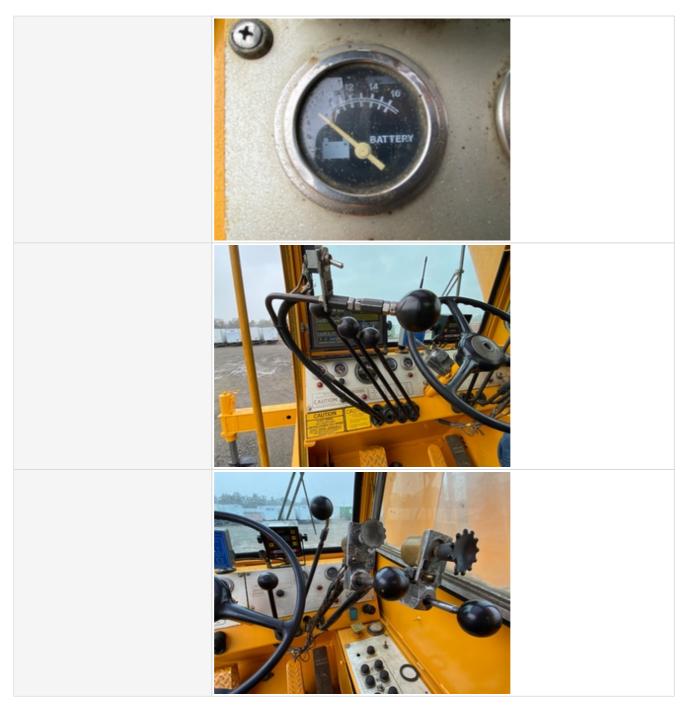
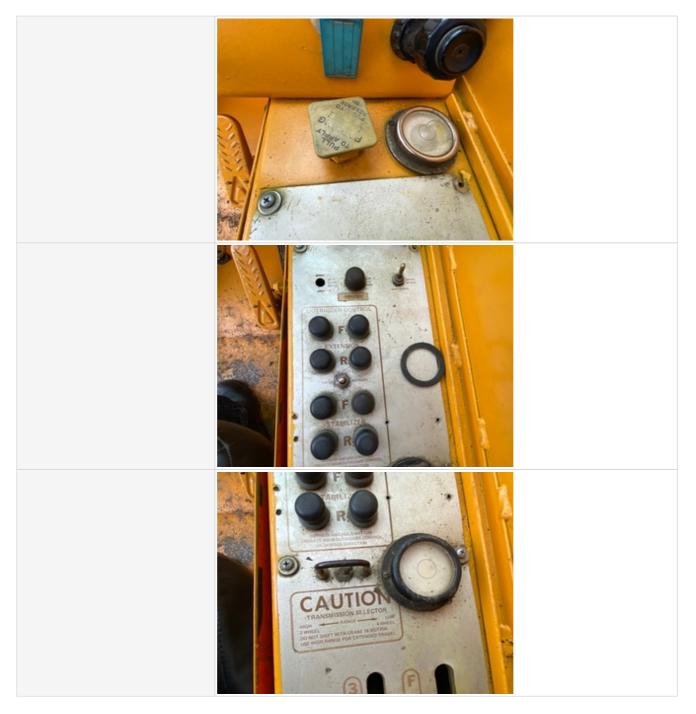
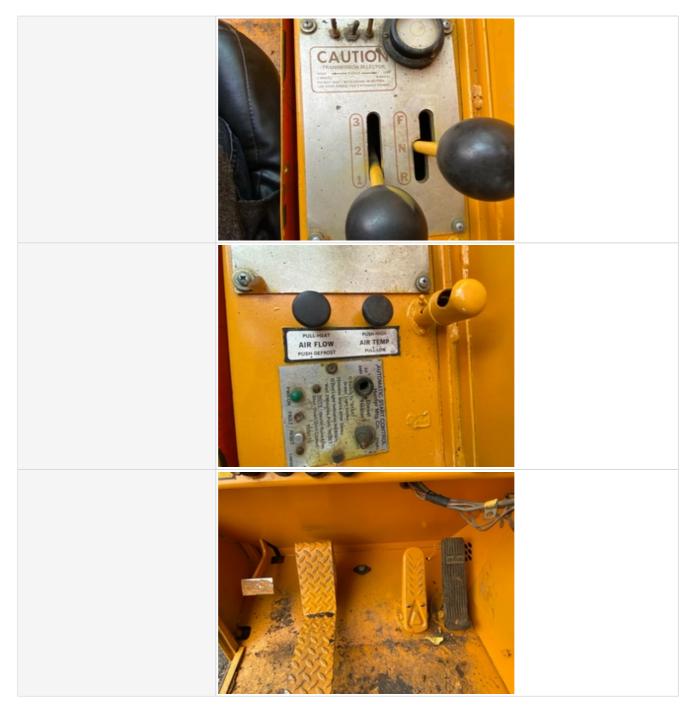
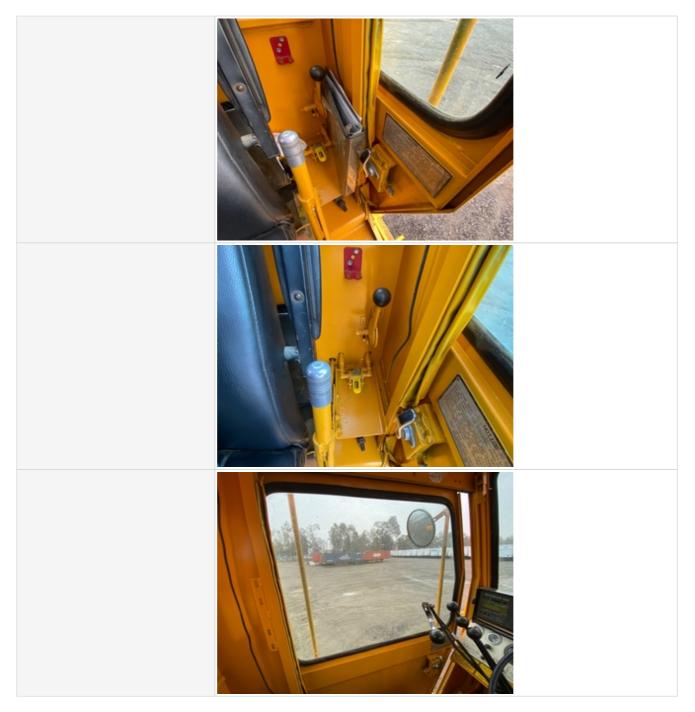
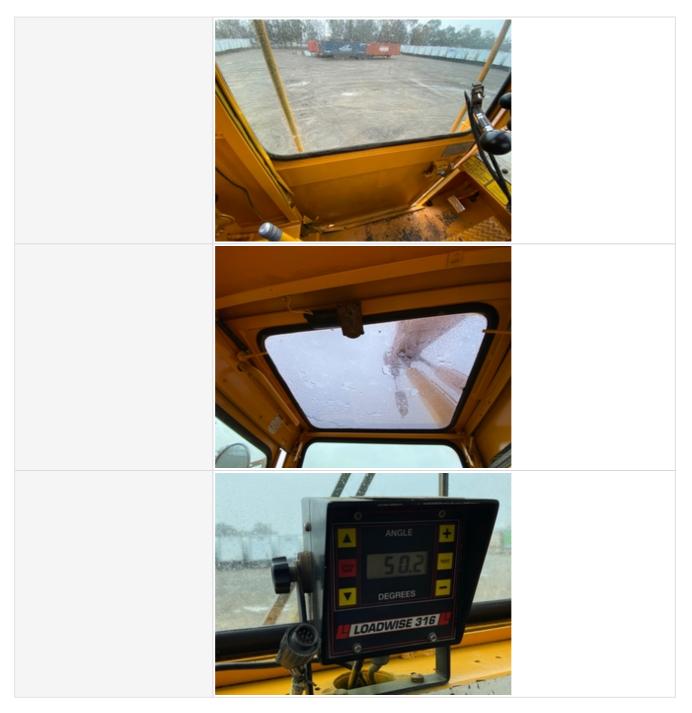
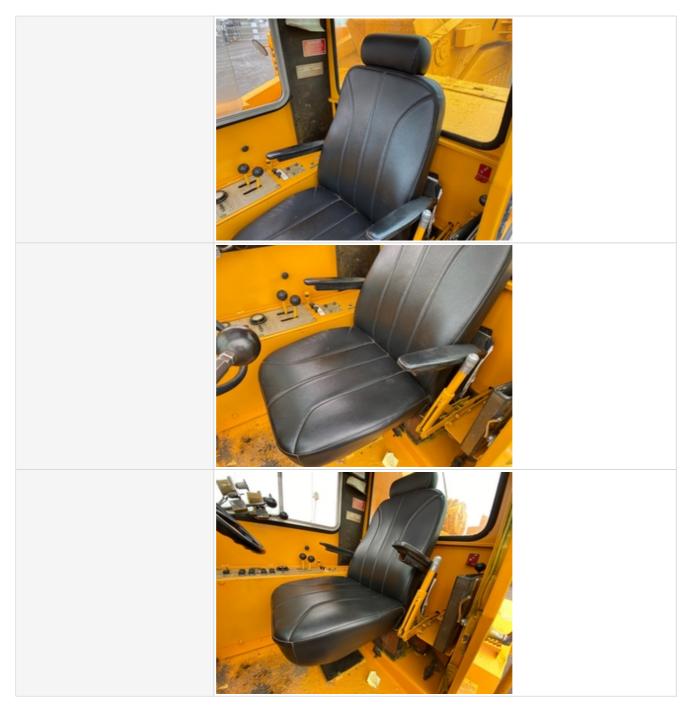
Serial Number Plate Photo	CROVE Hydraulic CRANE MOLE RT-980 SERIAL A6308 CROVE MANUFACTURING CO. SHADY GROVE, PA. U.S.A.
Operator Cabin Overall	3 - Normal Wear & Tear
Operator Cabin Overall Condition	Good cabin appearance, solid floors, panels, and ceiling, Minor cosmetic wear to cabin surfaces, floors, panels, and ceiling, Other (see comments)
Comments	Normal wear observed but overall in good condition
Operator Cabin Photos

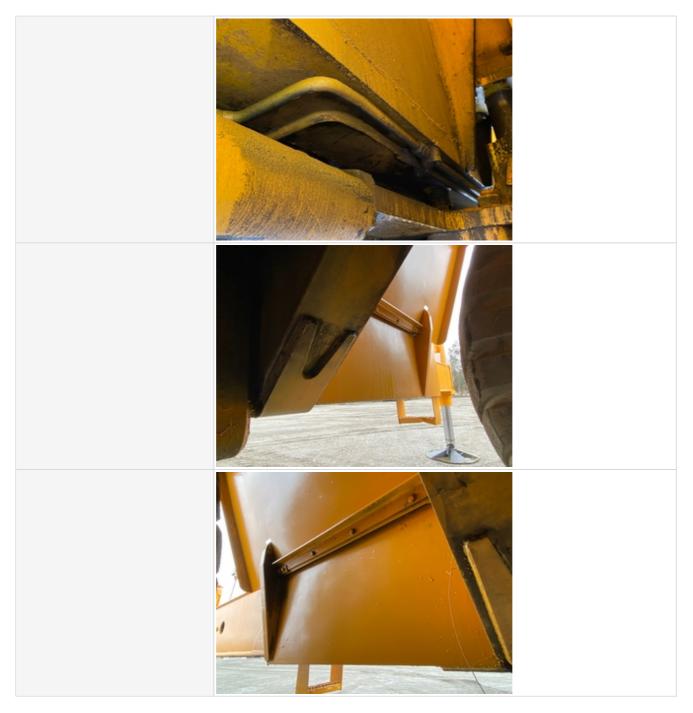
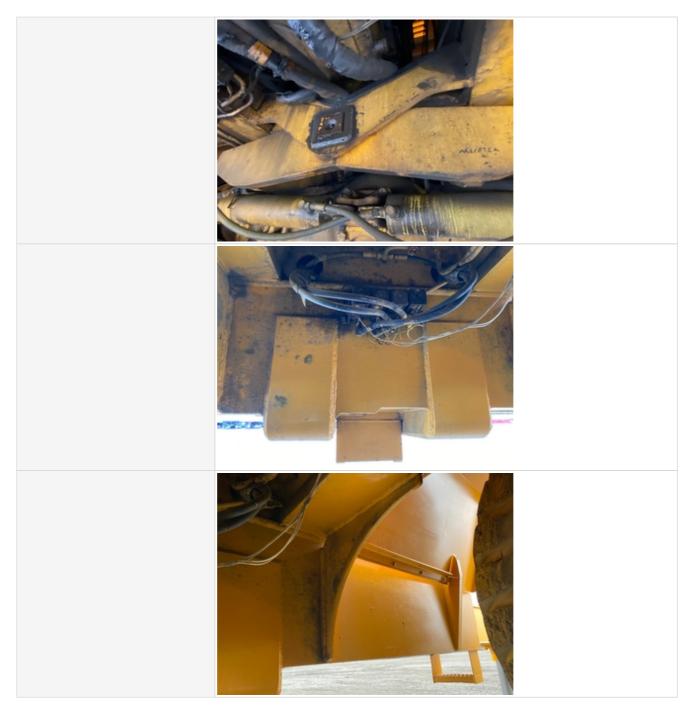
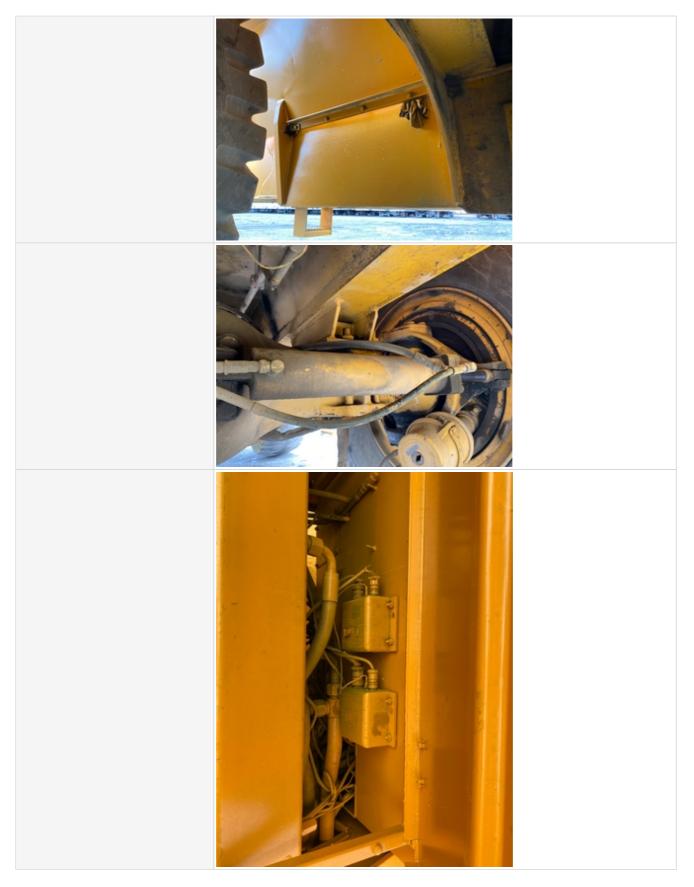
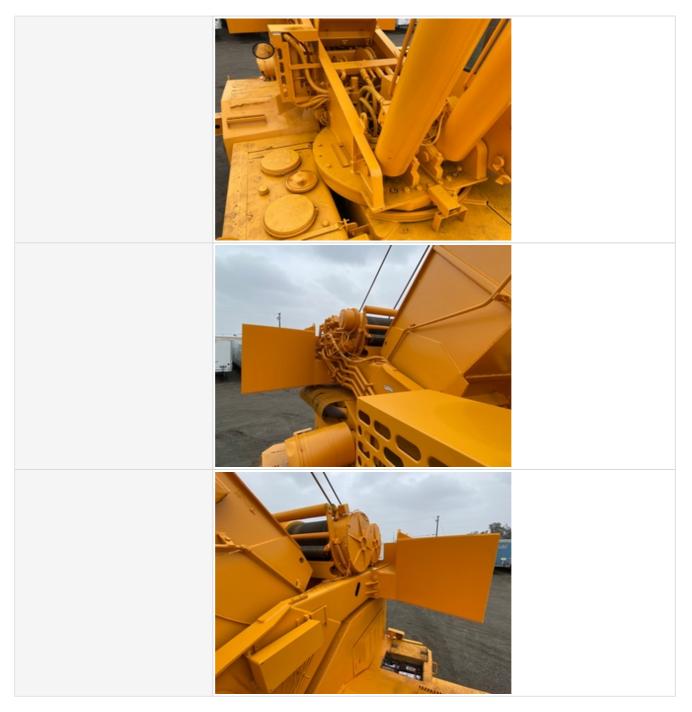
Frame	3 - Normal Wear & Tear
Comments	Frame looks solid
Frame Photos

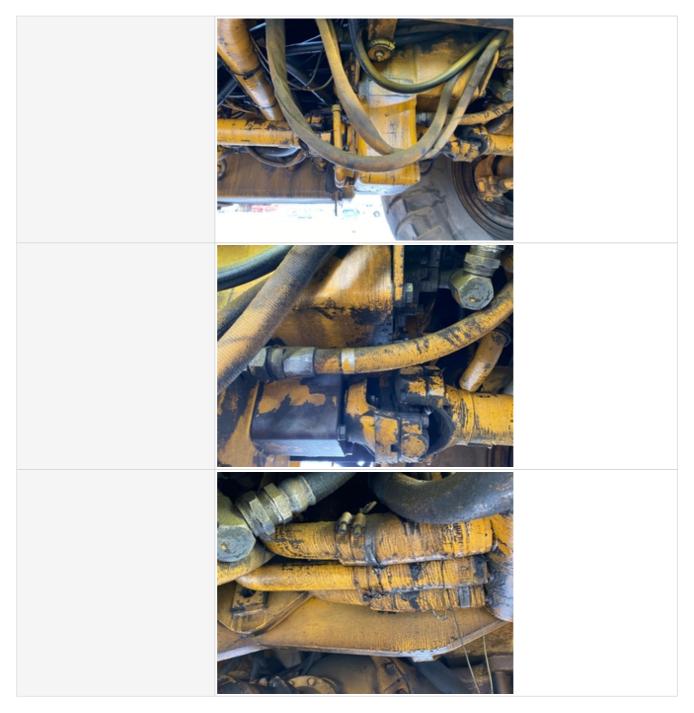
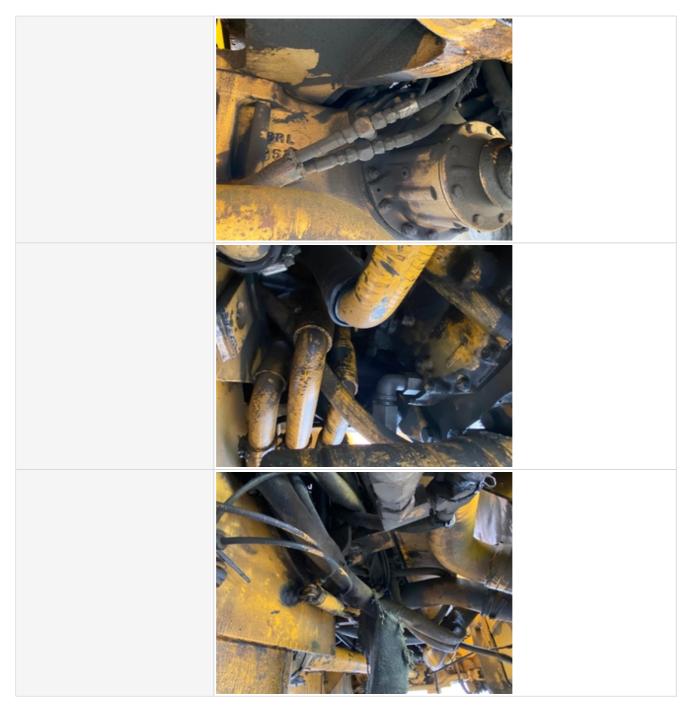
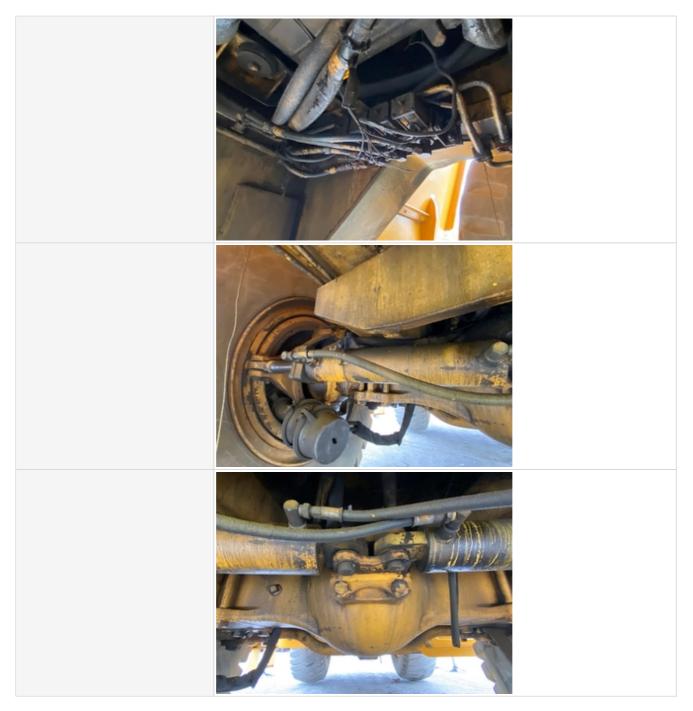
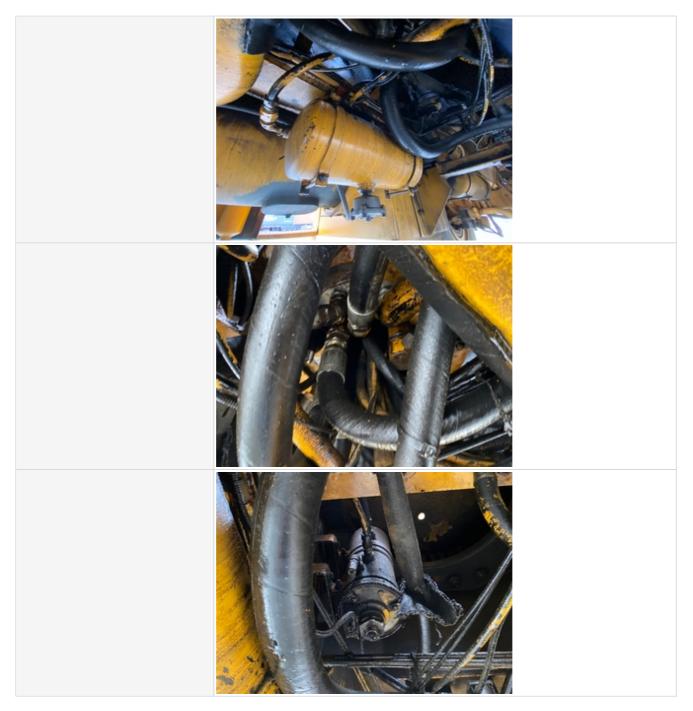
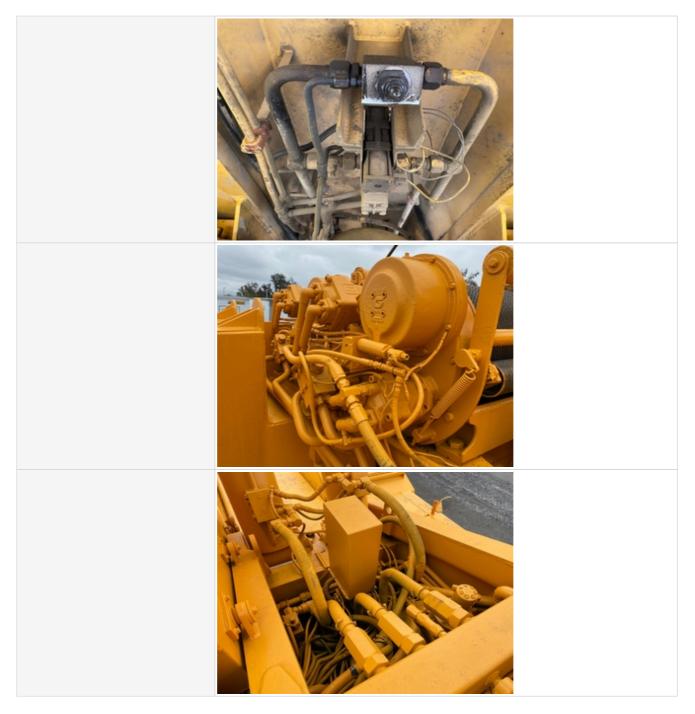
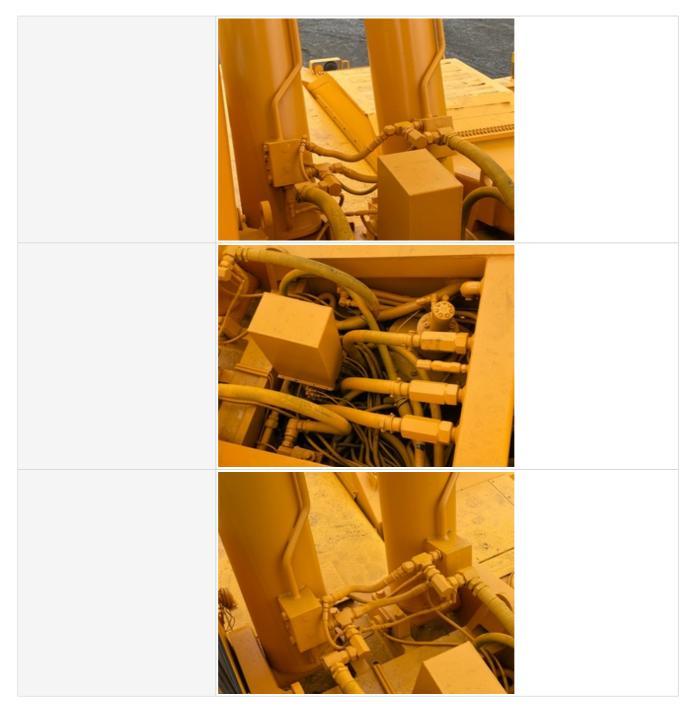
Appearance of Hydraulic Lines / Fittings	2
Hydraulic Lines / Fittings Condition	Twisted, kinked, or flattened hydraulic hoses, Active leaks in hoses or fittings observed, Hydraulic lines & fittings are clean and in good condition, Other (see comments)
Comments	Most hydraulic hoses/lines in good condition. Some twisted and others leaking a bit.
Appearance of Hydraulic Lines / Fittings Photos

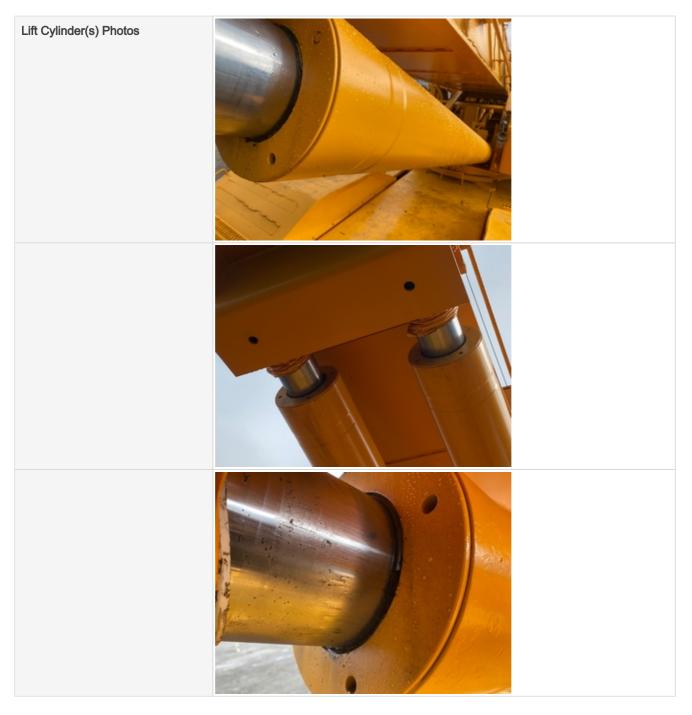
Lift Cylinder(s)	Check the lift cylinder. Note any wear, pitting, discoloration, etc. Take photos.
Lift Cylinder(s): Mounting Pins	3
Lift Cylinder(s): Oil Leaks	Yes
Comments	Minor leakage observed from rod seals
