General Info

Year	2015
Make	Bobcat
Model	E45 Mini Excavator
Serial Number	AG3G14390
Hour Meter Reading	2,602 Hrs.
Previous Application (e.g., earth moving, mining, demolition, etc)	Asphalt Paving Construction

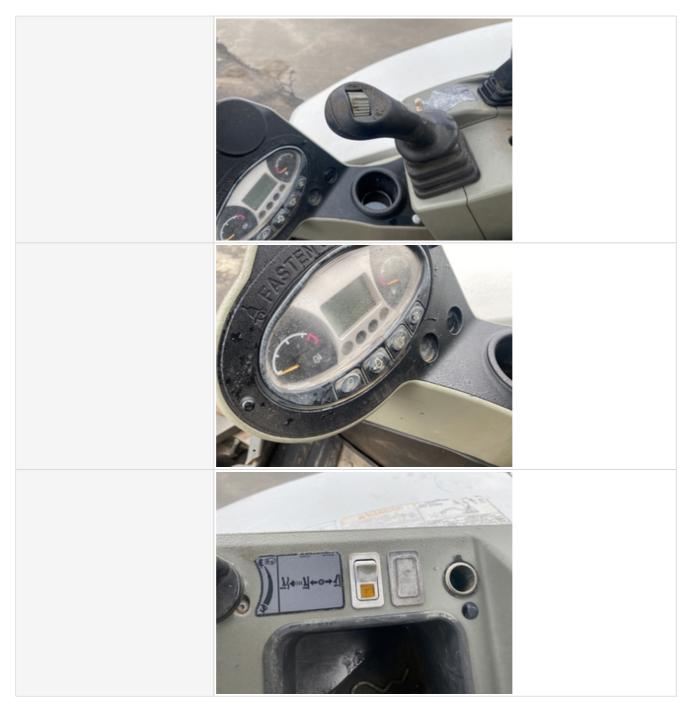
Comments	Machine starts with hydraulic lock ON (handle down)(SAFETY ISSUE)
Safety Lock Out / Stop Photos	
Controls & Switches	3 - Normal Wear & Tear
Controls & Switches Condition	All switches are installed and functional
Controls & Switches Photos

Exterior Rating	3 - Normal Wear & Tear
Interior Rating	3 - Normal Wear & Tear
Safety Rating	2 - Above Average Wear
Quality Rating	3 - Normal Wear & Tear
Functionality Rating	3 - Normal, Operating as Expected
Overall Rating	3 - Normal Wear & Tear
What's Great About the Machine	No excessive play observed in implements. Engine and Hydraulics sound healthy and work well. Undercarriage In good condition. Operator station also in good condition.
What Needs Work	Machine needs a bucket. Engine smoke after initial startup may be indicating possible injection system seeping into cylinders overnight. This may be the reason why excessive smoke observed only at initial startup. (1 or more injectors may need to be serviced/replaced or a simple injection service recommended). Left side armrest hydraulic lockout switch needs to be addressed for safety.
Date/Time	01-11-2023

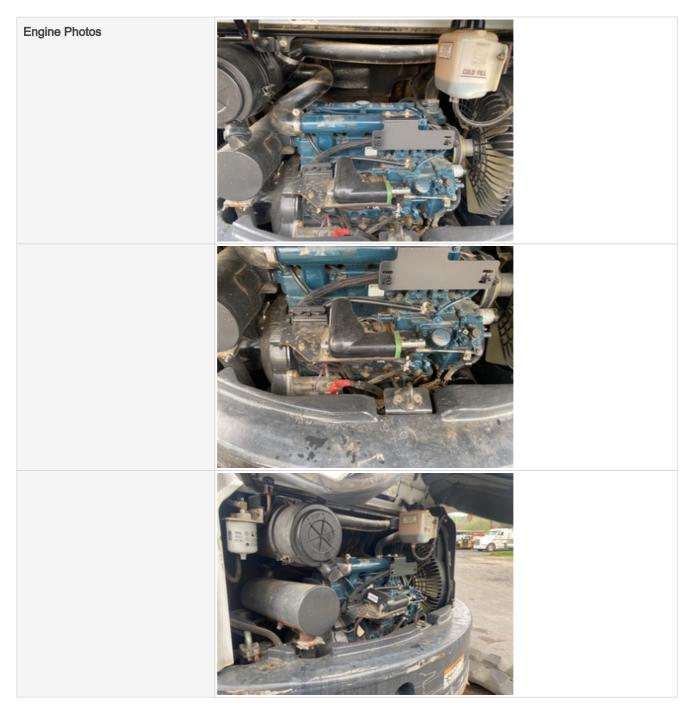
Blow-by (Visual Observation Check)	No
Unusual Noises (Upon Start-up, Idle, Shutdown)	No
Unusual Noise Notes	No unusual noises heard
Engine Smoke (Upon Start-up, Idle, Shutdown)	Yes
Engine Smoke Notes	Engine smoke observered upon start up, Other (see comments)

Comments	Engine smoke observed at initial start up and cleared up after 30 seconds. Afterwards, engine did not smoke after being shut off and restarted.
Engine Exhaust Color	White
Battery	3 - Normal Wear & Tear
Battery Condition	Clean & dry appearance, tight connections
Battery Condition Photos	
Radiator	3 - Normal Wear & Tear
Radiator Condition	Radiator fins & components appear to be in good working order, no signs of damage or leaks
Radiator Photos	
	DOLD FILL

Overall Engine Appearance	Clean & dry
Overall Engine Comments	Overall Engine shows a well maintained appearance. Runs well under load and sounds healthy. No active leaks observed.
	ENGINE RUNNING HIGHER THAN NORMAL AT IDLE (Engine Currently Running @1700rpm at idle)

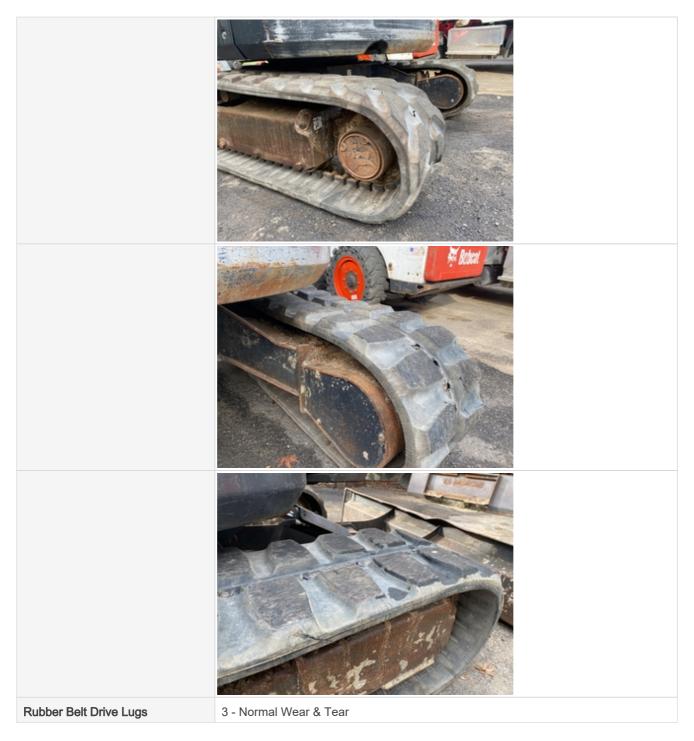
Track Belt	3 - Normal Wear & Tear
Comments	2 different styles, both above 70% tread left
Track Belt Photos

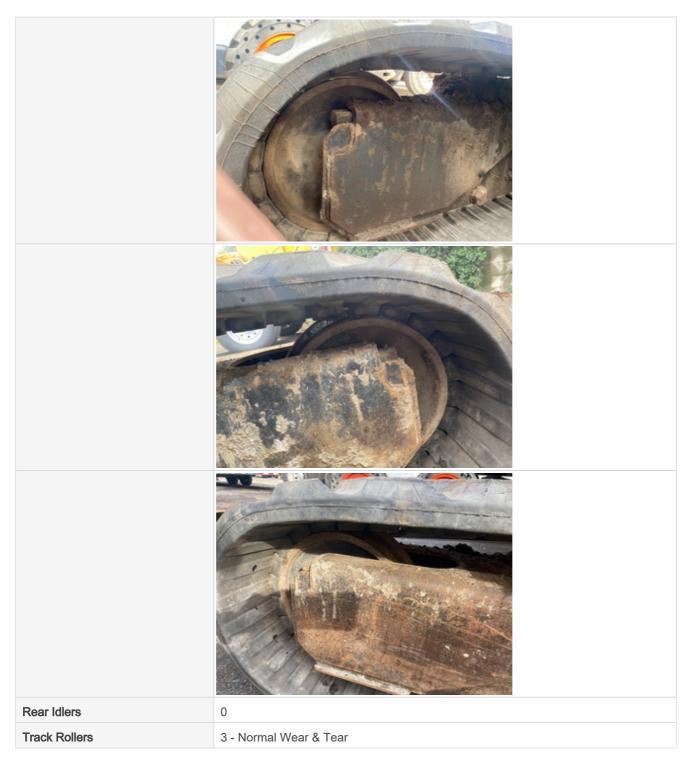
Rubber Belt Drive Lugs Photos	
Track Tensioners	2 - Above Average Wear
Comments	R/S track loose (should be checked to see if it adjust and holds tension)
Front Idlers	3 - Normal Wear & Tear
Front Idlers Photos
