Inspection Report (Compact Track Loader)

Year	2017
Make	Bobcat
Model	T740
Serial Number	B3CA12473
Hour Meter Reading	2,654
Previous Application (e.g., earth moving, mining, demolition, etc)	Asphalt Paving Construction

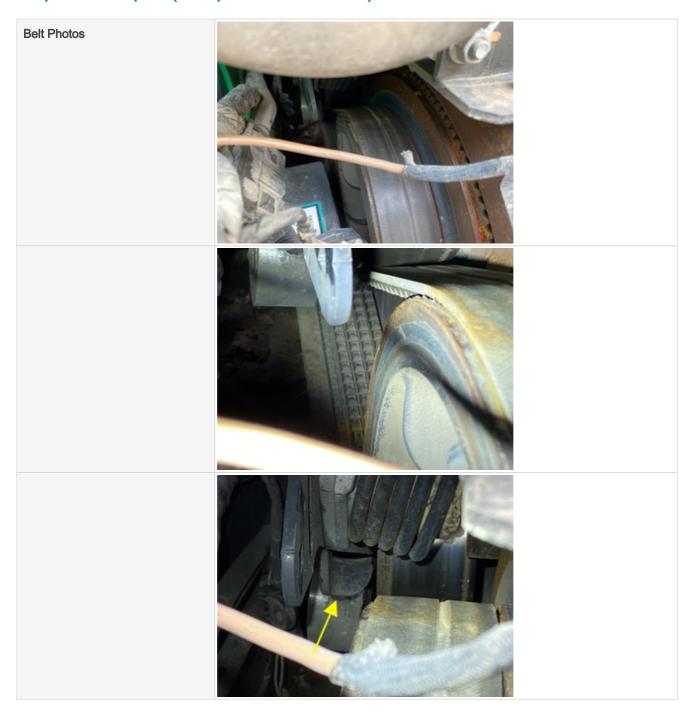
Blow-by (Visual Observation Check)	No
Unusual Noises (Upon Start-up, Idle, Shutdown)	No
Unusual Noise Notes	No unusual noises heard
Engine Smoke (Upon Start-up, Idle, Shutdown)	No
Engine Smoke Notes	No engine smoke issues observed
Engine Exhaust Color	Clear
Battery	3 - Normal Wear & Tear
Battery Condition	Clean & dry appearance, tight connections
Radiator	3 - Normal Wear & Tear
Radiator Condition	Radiator fins & components appear to be in good working order, no signs of damage or leaks
Belts	3 - Normal Wear & Tear
Belt Condition	Other (see comments), Belts appear in good condition & alignment with proper tension
Comments	Belts okay, tensioner has surface wear

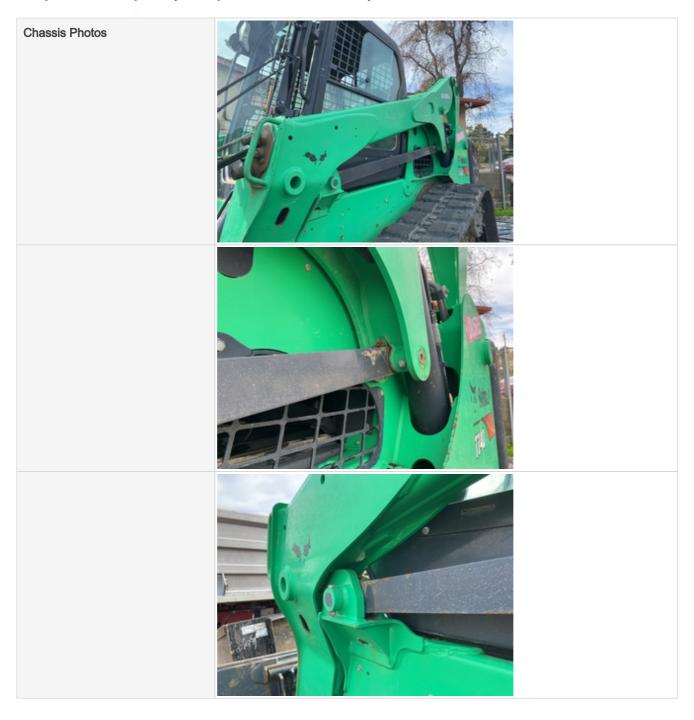
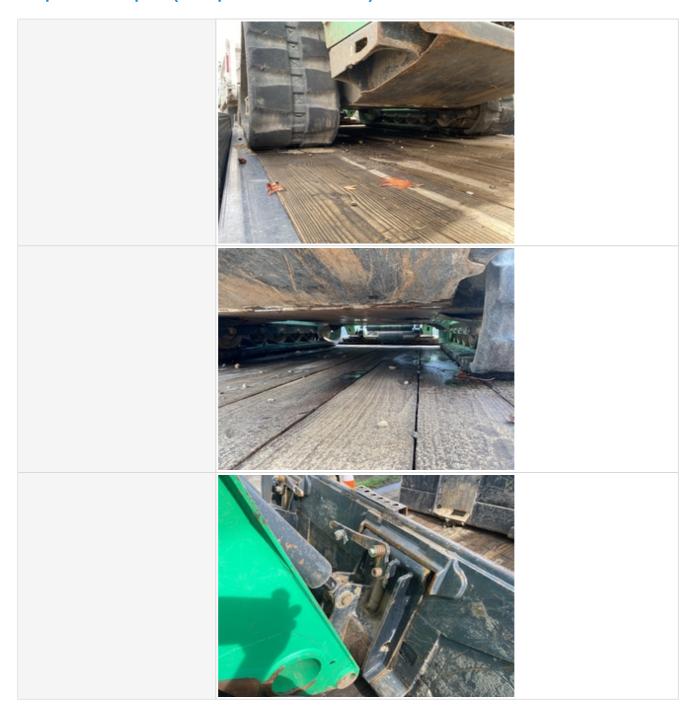
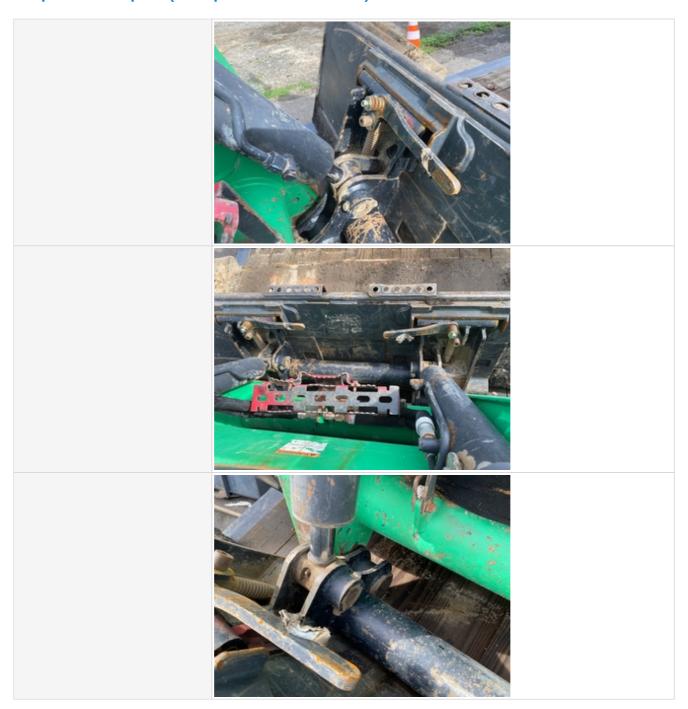
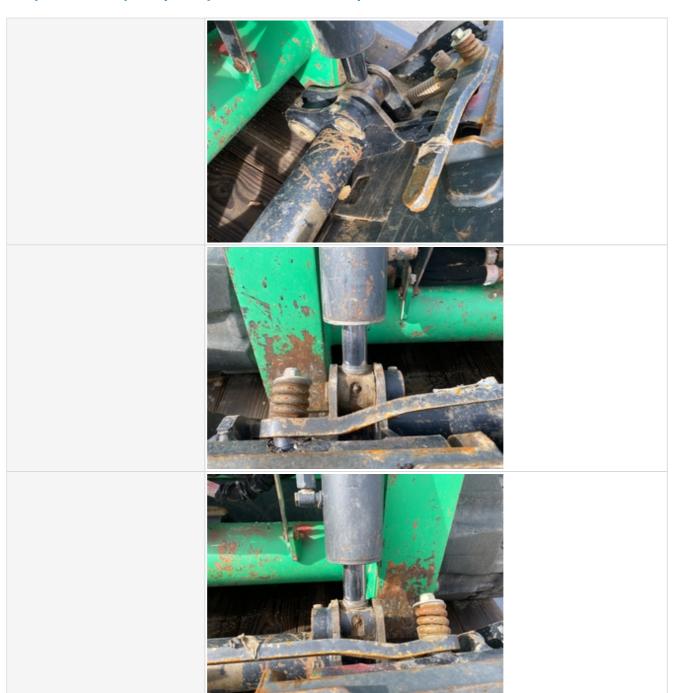
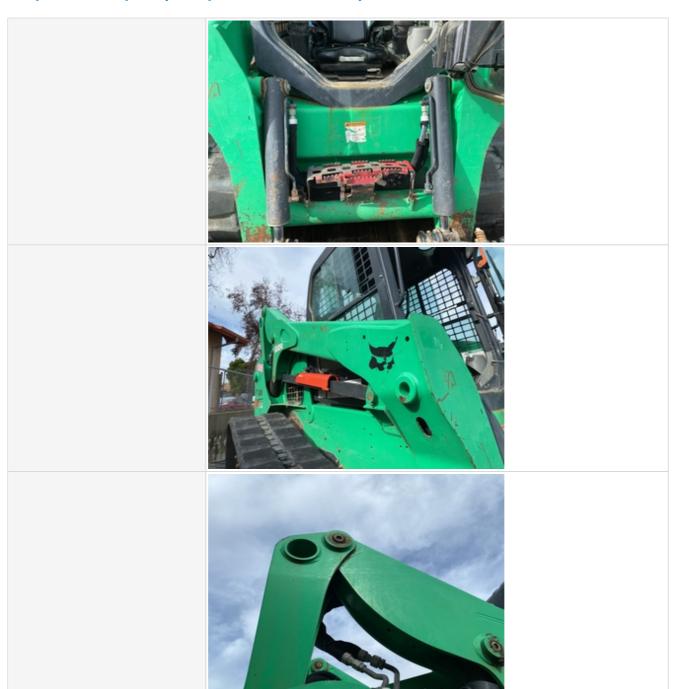
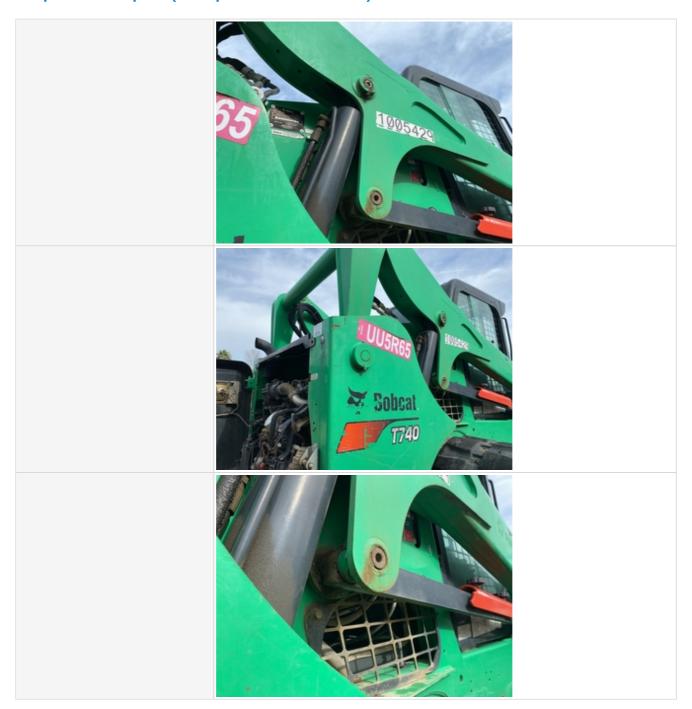
Chassis Photos	Take photos of the entire chassis and all relevant components including frame, stance, lift arm, and quick coupler.	
----------------	---------------------------------------------------------------------------------------------------------------------	--

Overall Chassis Overall Chassis Comments	Normal Wear & Tear Overall chassis in good condition with no obvious problems observed.
Quick Coupler to Arms Pins	3 - Normal Wear & Tear
Quick Coupler	3 - Normal Wear & Tear

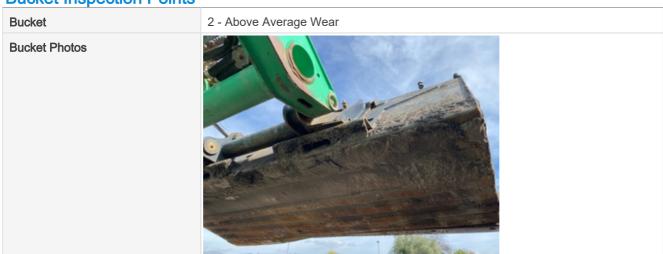
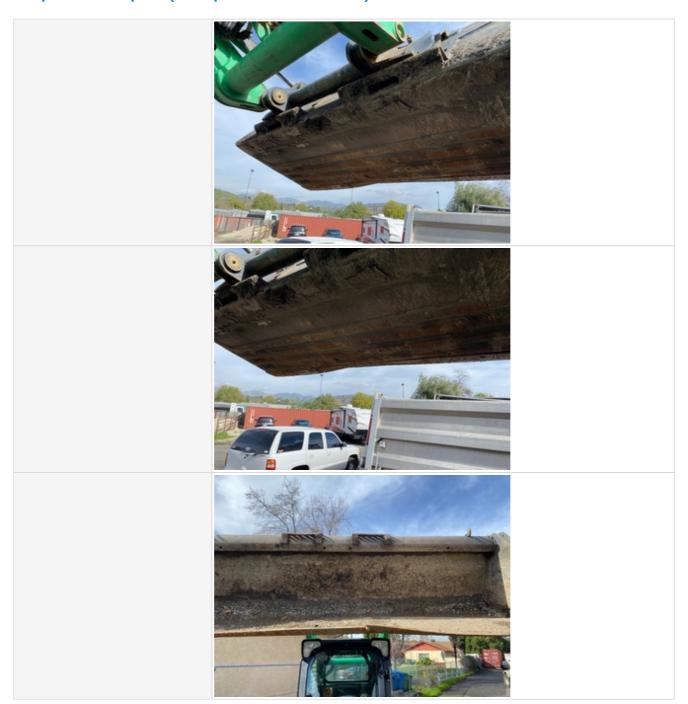
Bucket Inspection Points

Bucket Edge / Deflectors	1 - Service Required
Comments	Missing
